Re: Lyon-Seigmiller House
Architectural Assessment
Owosso, Michigan

ARCHITECTURAL ASSESSMENT

LYON-SEIGMILLER HOUSE
501 W. Williams St.
Owosso, Michigan

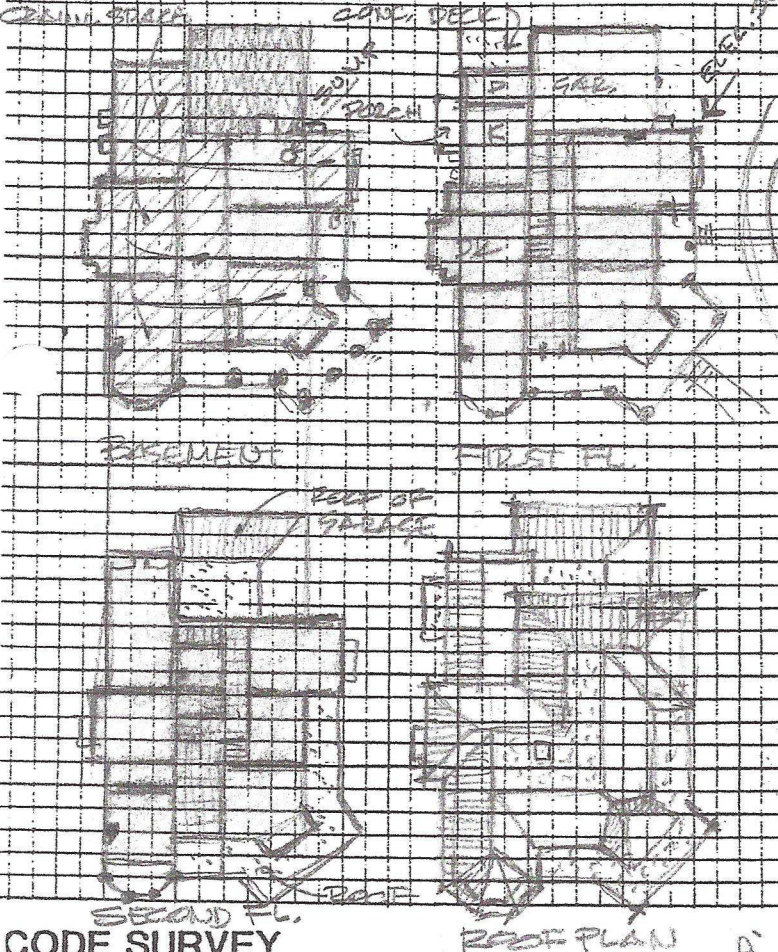
STRUCTURE	P	F	G	NOTES
FOUNDATION				FIELD STONE
WALLS/W/DOORS				BRICK BEARING
ROOF				WD / POOL @ GARAGE
SYSTEMS				TIMBER ATTIC W/ MAT JOINT
ROOFING				
CHIMNEYS				BRICK REBUILT
GUTTERS/DNSPOUTS				(A) ALUM. SOFFITS POOL
CORNICE				
MASONRY				FIELD STONE @ BAY
WOOD TRIM				SOME (A)
PORCH SKIRTING				
WIN FRM/SASH				DOUBLE HUNG
GLAZING				
DOORS				① FRONT ENTRY ② SIDE ENTRY
ENTRY				① DRS
PORCH/STEPS				① STONE (M) RECENT ② INST. STAIR
FINISHES				
DECORATION				BRACES + BALCONY
DECORATIVE WINDOW				END OF 2ND FL. HALL
SOFFITS				
AWNINGS				NONE
INTELS				
SKIN MATERIAL				STUCCO; BRICK @ EAST BAY
STUCCO PAINT				
PORCH SOFFIT				BEAD BD. UNPAINTED

NOTE: 1ST & 2ND FL WINDOWS TO WEST OF CORNER BAY MAY HAVE BEEN BRICKED IN & STUCCO MAY HAVE BEEN APPLIED TO ORIGINAL BRICK AS PROTECTION OR THE STUCCO PAINTED DARKER OR STUCCO WAS DARKER.
