March 11, 2013

John Carter  
Helena Public Schools – Maintenance Department  
1200 Sanders Street  
Helena, MT 59601

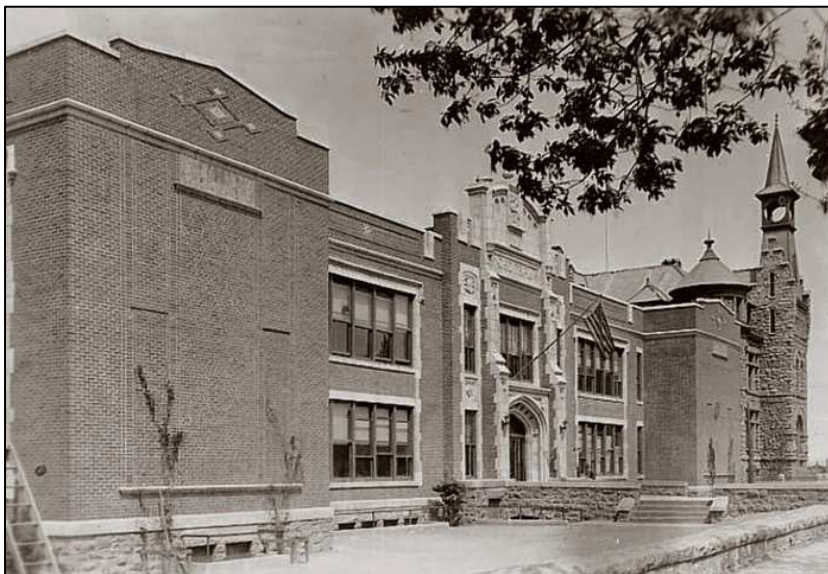
Figure 1: Central School from North Warren St.  
(Photo Credit: [www.helenahistory.org](http://www.helenahistory.org))

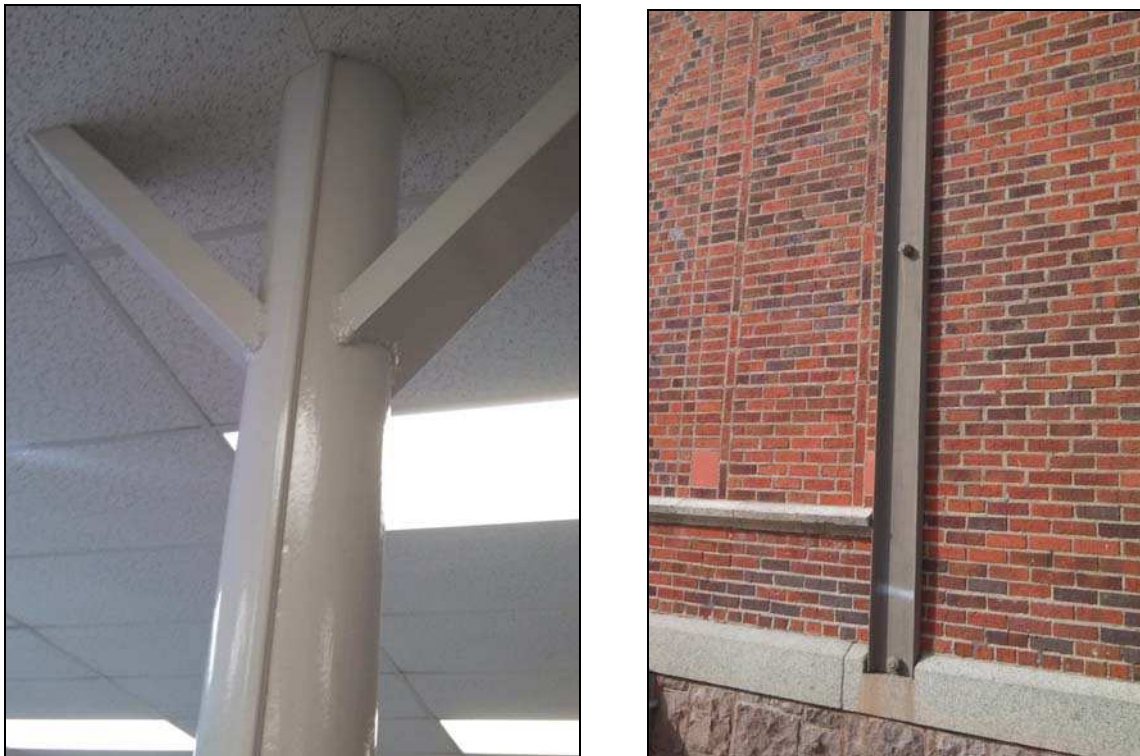
Figure 2: Post-construction retrofits. Steel columns and knee braces found in the classrooms in the original building portion are shown left and steel channels added to the exterior unreinforced masonry walls are shown right.

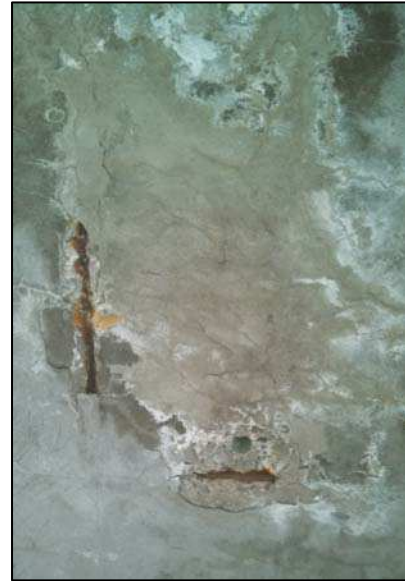
Figure 3: Spalling and exposed reinforcement on underside of slab at the main entry.

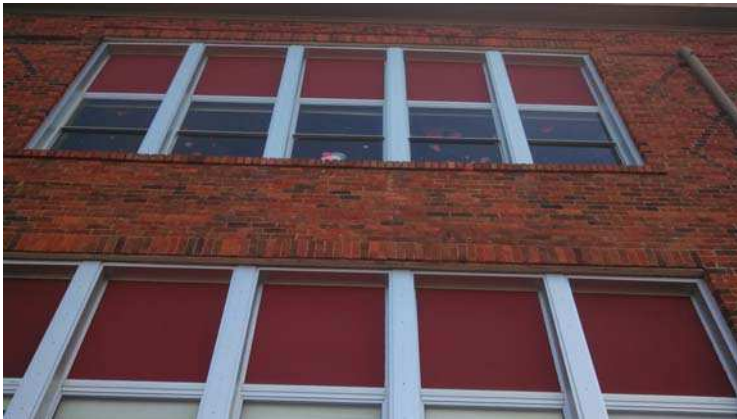
Figure 3A: Long Window Headers with Deflected Steel Angle Lintel

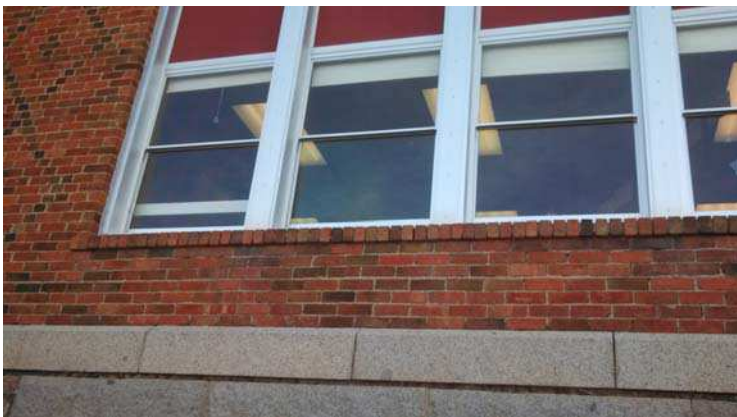
Figure 3B: Deteriorated Brick Sill

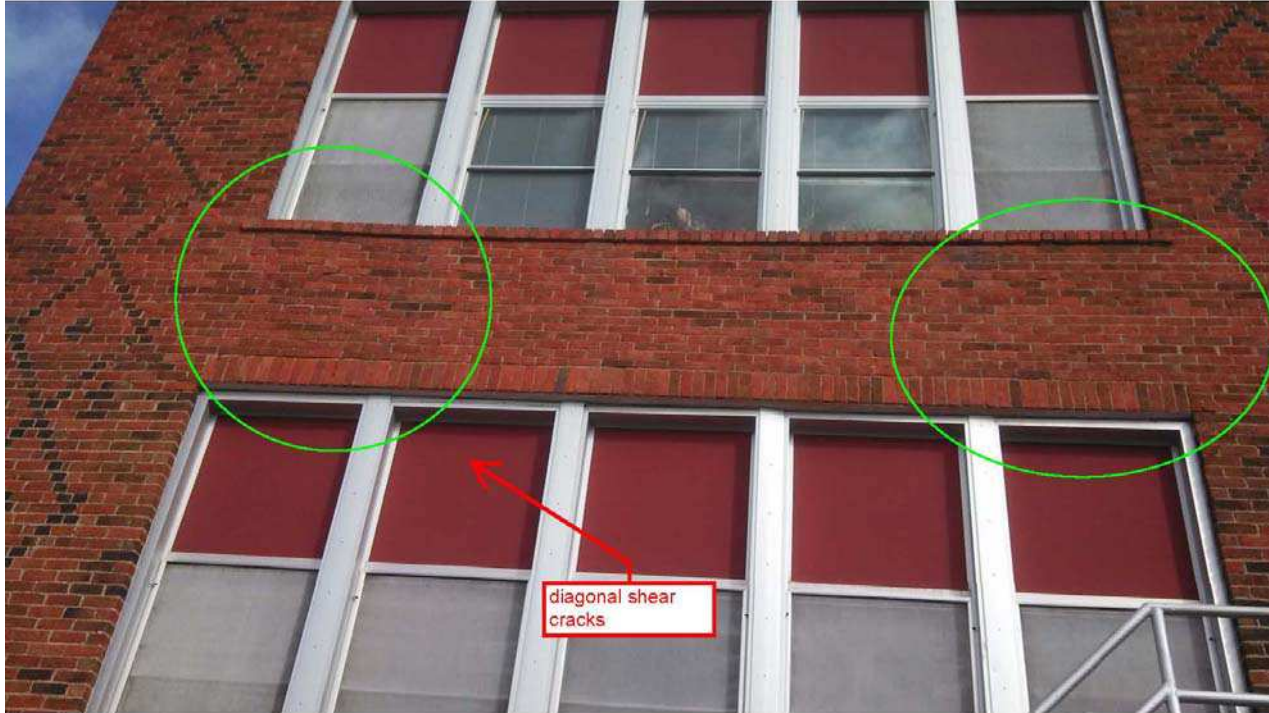
Figure 3C: Diagonal Shear Cracks Under Windows

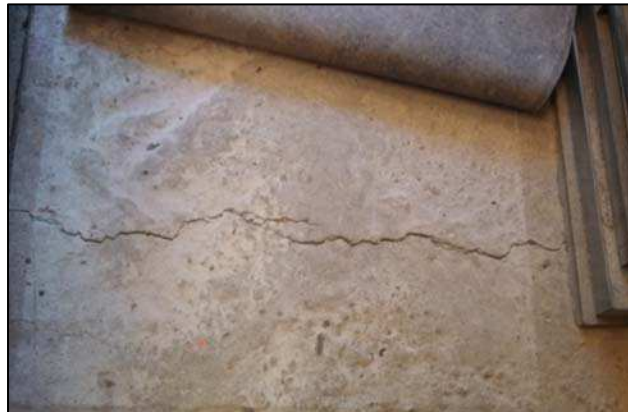
Figure 4: Cracking in the concrete roof slab.

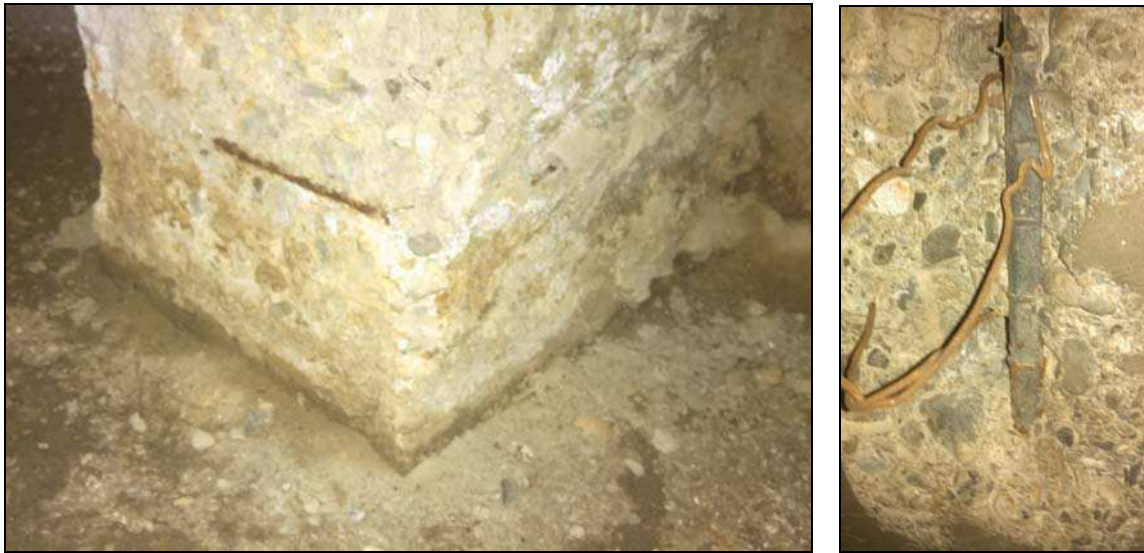
Figure 5: The concrete is deteriorated at the column bases in the sub-basement. In several locations, the concrete is spalling away and the reinforcement is exposed, leaving it susceptible to further corrosion and damage.
