ROAD SAFETY AUDIT

Route 128 at Route 62

Town of Danvers

December 27, 2013

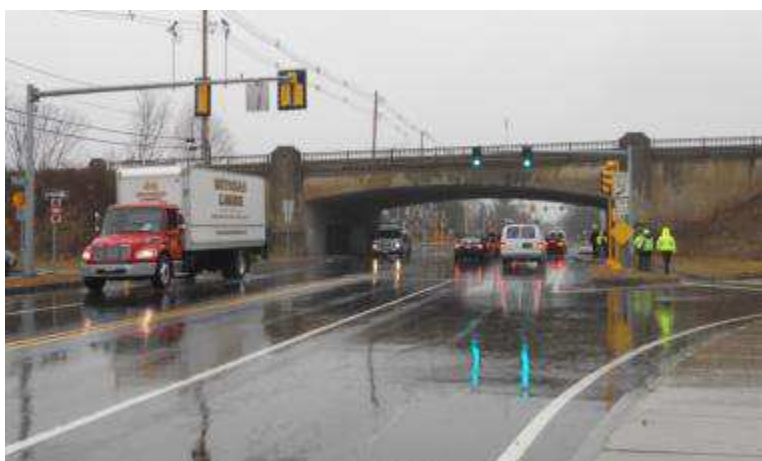
Route 62 westbound at Route 128 northbound ramps

The closely spaced signalized intersections and traffic demands entering and exiting Route 128 create a complex timing and phasing plan intended to prevent queuing through the intersections or onto Route 128. Although the geometry of the northbound and southbound ramps is very similar, left turn phasing varies between the two intersections. Left turns from Route 62 eastbound to Route 128 northbound are accommodated by a lead phase, where a protected phase is provided first before the permissive phase. Left turns from Route 62 westbound to Route 128 southbound are accommodated by a lag phase, where permissive left turns are allowed in conjunction with the westbound through movement before a protected

phase is provided for the westbound left turn. Design phasing for the westbound left turn to the southbound ramp included a protected only left turn phase, but the permissive phase was added with timing adjustments in late 2012 to address queuing concerns. Lead phasing is more common for left turns at signalized intersections, but it was noted that the lag phasing for the westbound left turn was introduced to clear the left turn lane and reduce queuing and blocking of the northbound ramp intersection.

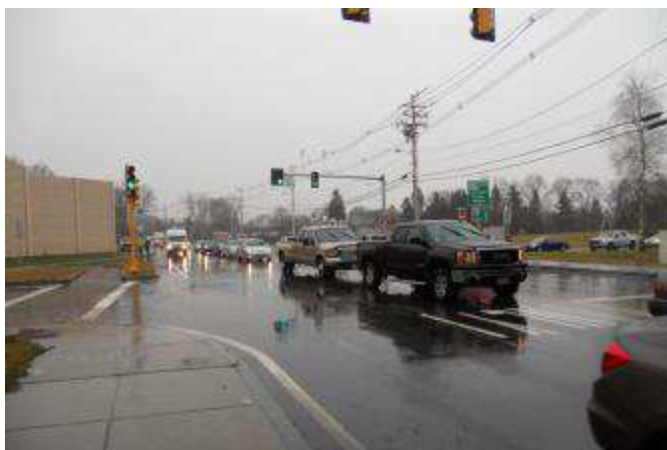
- Queues from the Route 62 westbound left turn to Route 128 southbound extend through the signalized intersection at the Route 128 northbound ramps. This requires eastbound left turns to Route 128 northbound to pass through queued traffic in the left lane, which blocks visibility of westbound through vehicles in the right lane. This impaired visibility occurs when westbound drivers stop to show courtesy, but can also occur both when westbound drivers stop before entering the intersection to prevent blocking, or when an eastbound driver aggressively noses into westbound queued traffic.

Queued westbound traffic blocking eastbound left turn during permissive phase

- Move the westbound stop line at the northbound ramp intersection back (east) approximately 50 feet. This would provide additional visibility of approaching traffic for eastbound left turns, especially when drivers do not queue through the intersection. This short-term, low cost improvement should be considered in conjunction with updated “Do Not Block Intersection” signage and markings.

- Install “Do Not Block Intersection” signs and markings for Route 62 westbound at the northbound ramp intersection. An R10-7 “Do Not Block Intersection” should be installed at or near the westbound stop line, and markings should be applied in accordance with Figure 3B-18 of the Manual on Uniform Traffic Control Devices (MUTCD). This is a short-term, low cost improvement.

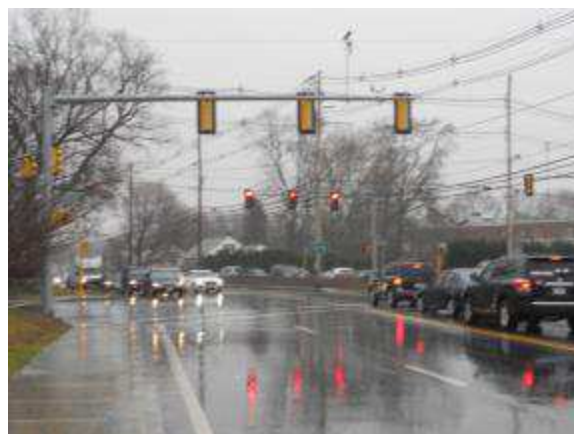
- The left turn lanes at both the northbound and southbound ramps are trap lanes, formed from through lanes at the previous intersection.
- Vehicles have been observed using the exclusive left turn lanes as through lanes. This can be accommodated because a two lane approach with a left turn lane and a single through lane is received by two through lanes on Route 62 westbound at Liberty Street and at the southbound ramps, and on Route 62 eastbound at the northbound ramps.

Left turn lane at Liberty Street aligns with through lane on departure side

- Install a painted or raised island for the left lane departing intersections where an exclusive left turn lane exists. This would reinforce the concept of a single through lane at each of these intersections, and would discourage drivers from using the left lane as a through lane as they do today because of the presence of a two lane departure. This improvement should be considered for Route 62 westbound departing both Liberty Street and the southbound ramp intersection, and for Route 62 eastbound departing the northbound ramp intersection. Painted islands are a short-term, low cost improvement; raised islands would be a short-term, medium cost improvement.

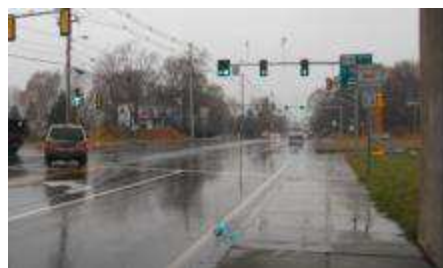
- Signal Visibility – Several comments related to signal visibility were identified.
 - The bridge that carries Route 128 over Route 62 blocks visibility of overhead signal indications at both the northbound and southbound ramps. This is most noticeable for Route 62 eastbound approaching the northbound ramps due to the slight downhill grade of Route 62 through the intersections.
 - Supplemental left-side ground-mounted signal heads are provided for the eastbound approach at the northbound ramps and for the westbound approach at the southbound ramps, but are not visible until a vehicle is under the bridge. Visibility of these signal heads can be blocked entirely by larger vehicles.

Supplemental left side heads

- Provide supplemental signal heads for Route 62 on the right side of the roadway. It was noted that left side signal heads are not visible to vehicles in the right lane when queues exist in the left lane. Supplemental heads should be provided on the right side for the approaches traveling under the bridge – eastbound at the northbound ramps, and westbound at the southbound ramps. This is a short-term, medium cost improvement.

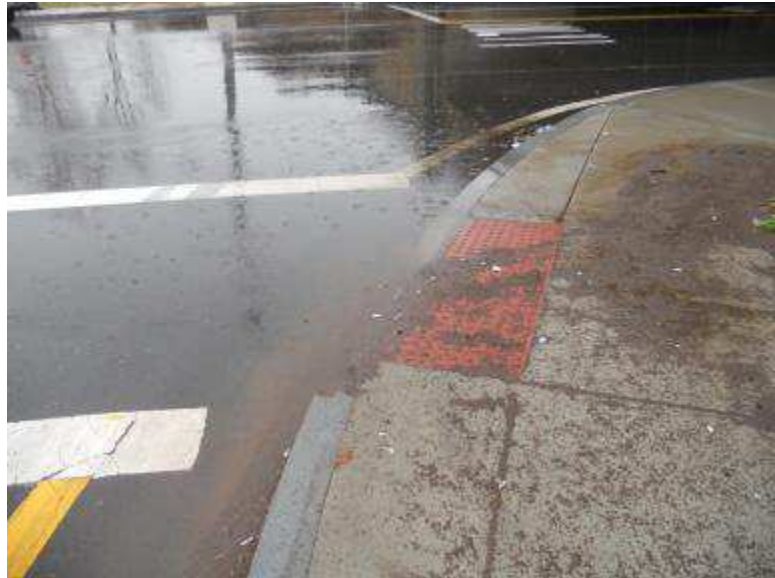
- Pedestrian Visibility – The retaining wall bordering the northbound on-ramp blocks the view of a pedestrian in the crosswalk from a vehicle entering the ramp from Route 62 westbound.
- Drainage – Ponding was observed along the west edge of the entry to the northbound on-ramp on the day of the audit. This creates a puddle right at the wheelchair ramp, and would create icing concerns for pedestrians during cold weather.

- Provide a pedestrian phase across the northbound on-ramps. Pedestrian signal heads should be installed at appropriate locations. It was suggested that the pedestrian phase could be concurrent with the northbound off-ramp vehicle phase. This is a mid-term, medium cost improvement.

- Relocate the wheelchair ramp on the east side of the northbound on-ramp. The ramp can be relocated further south so that approaching vehicles have a clearer view of a pedestrian in the crosswalk. This short-term, medium cost improvement would increase pedestrian crossing distance, but improve safety by increasing visibility of the pedestrian.
