# TEXAS STATE FIRE MARSHAL'S OFFICE

## Firefighter Fatality Investigation

Investigation FFF FY 13-03

Bryan Fire Department

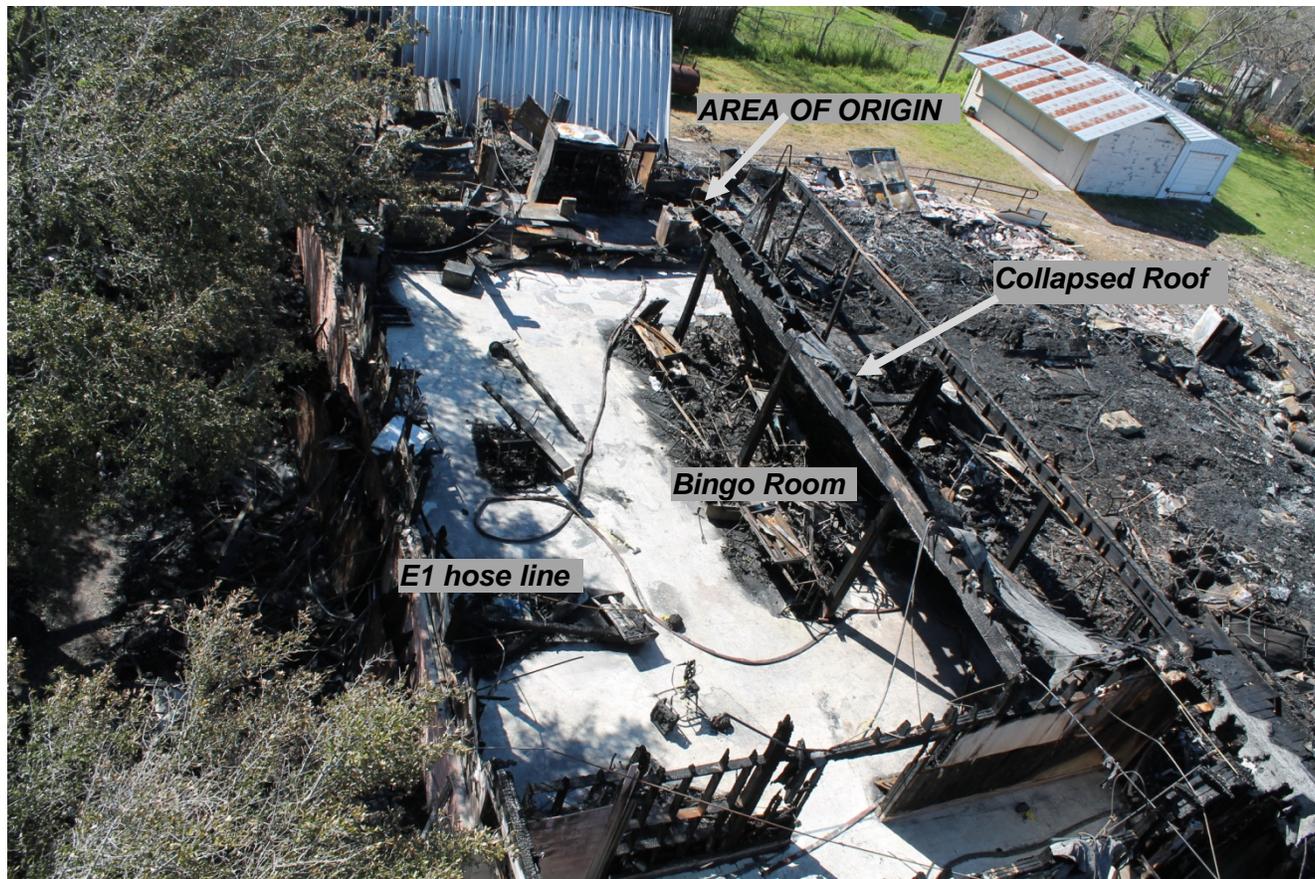
The area of origin was determined to be the northwest corner of the kitchen between the west wall and the west side of the movable beer keg cooler (kegger). Employee interviews revealed that the kegger was moved during events at the meeting hall and the kegger wheels would run over the top of a fan cord several times a month.

**Area of Origin. (Photo by State Fire Marshal's Office)**

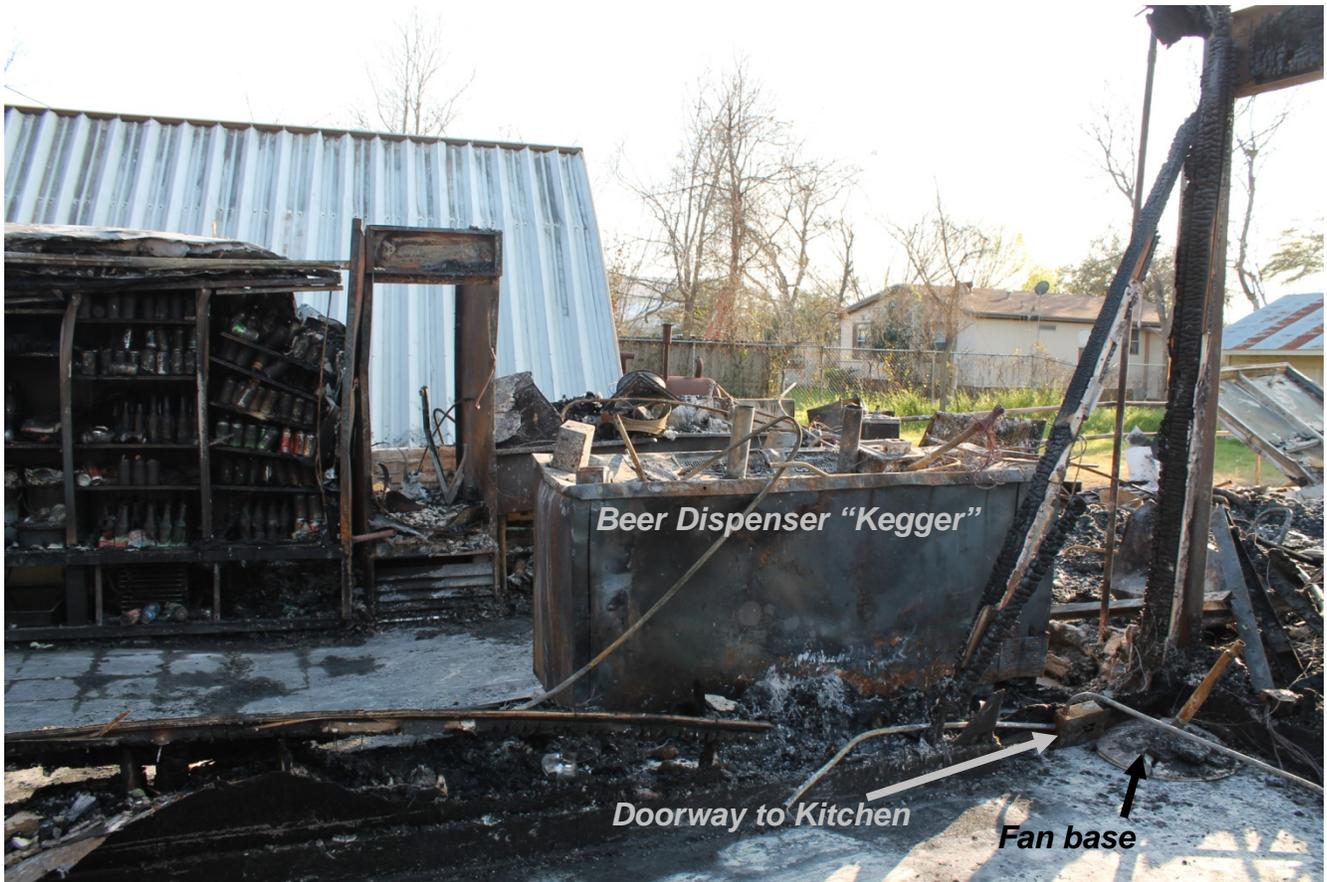
The cause of the fire was determined to be the result of heating and shorting within the insulation of a damaged power cord for a pedestal fan. The fan was located at the doorway leading into the kitchen from the bingo room. The power cord had been altered by a splice to add length to the power cord beyond the manufacturer's production specifications. The degradation of the strands within the insulation would lead to shorting and heat generation. The cause of this fire was determined to be accidental.

***Area of Origin. (Photo by State Fire Marshal's Office)***

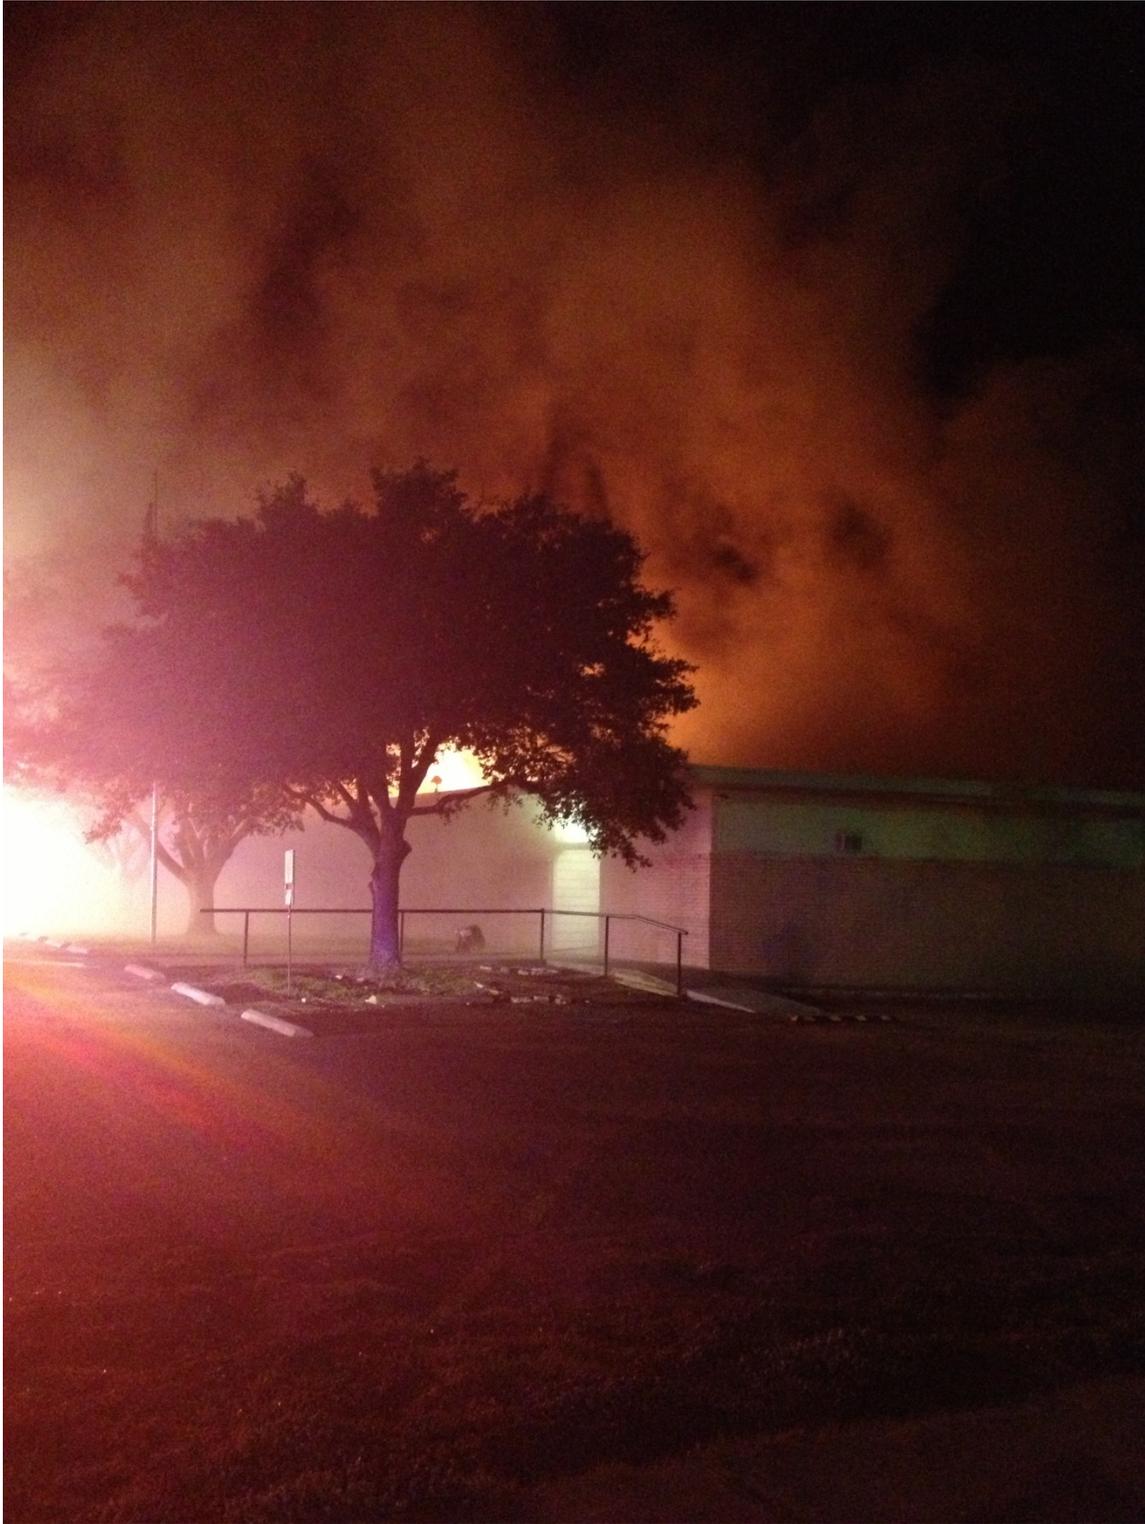
***View from the NE near BC1 location at 23:29. (Photo by Bryan PD Officer)  
E1 is inside and one PPV is at the doorway. Flames are visible above the AB corner.***

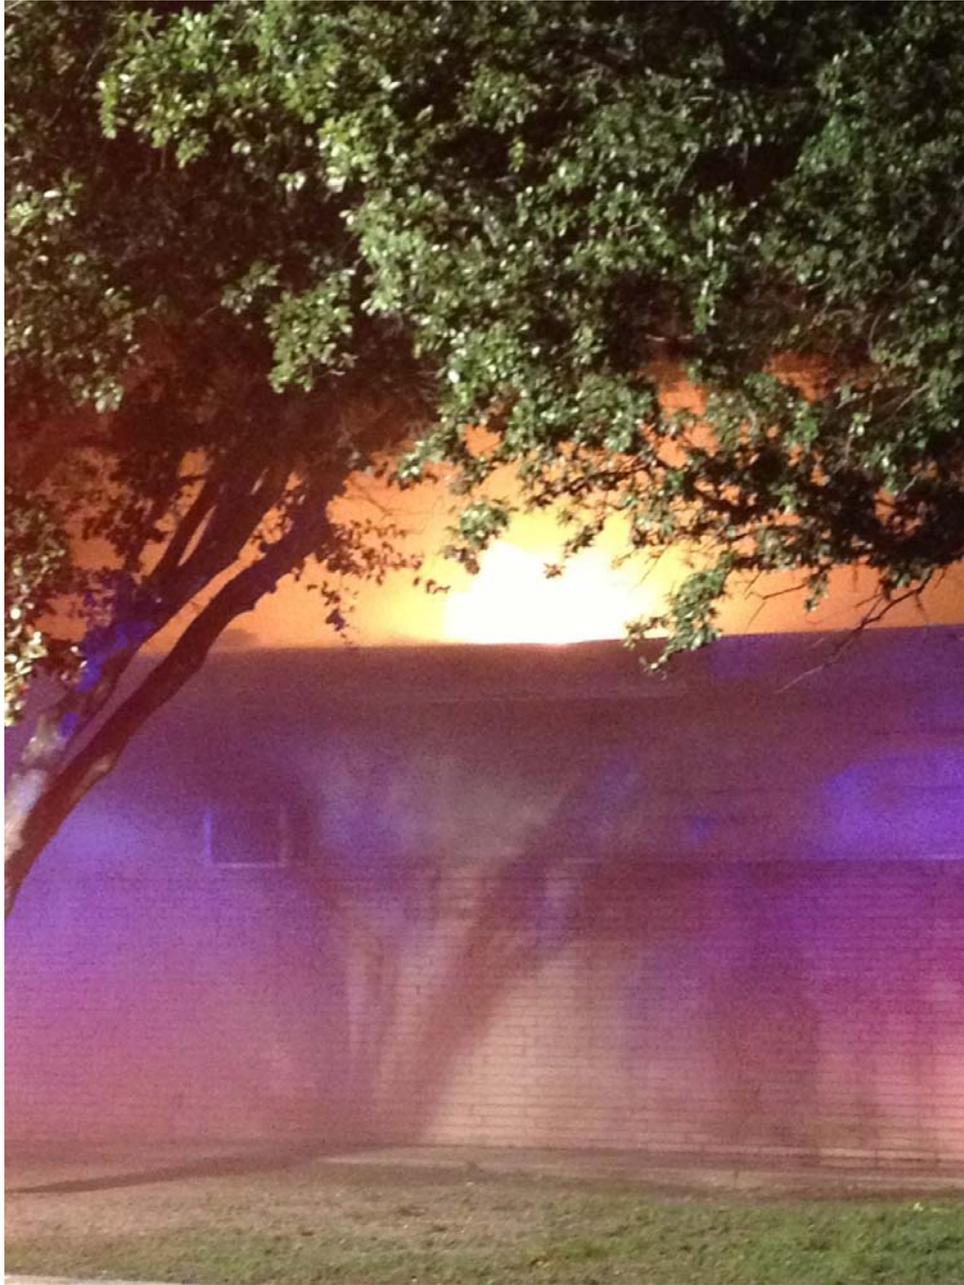
**23:31: Flames showing above the AB corner toward the center of the structure.**

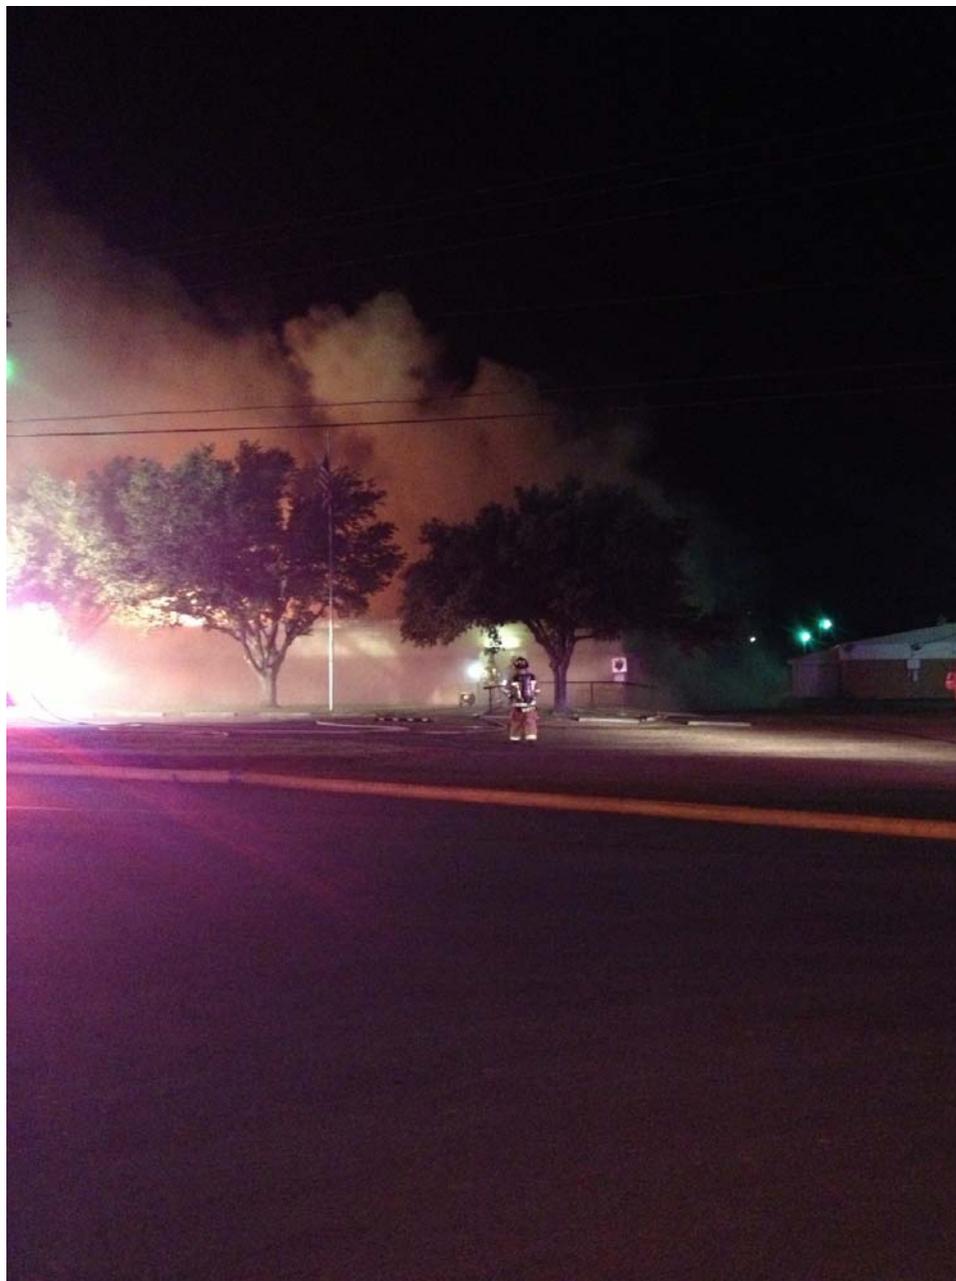
***23:35: View from the NE showing the fire above the roof. E2 to E1 supply hose line is established. (Photo by Bryan PD)***

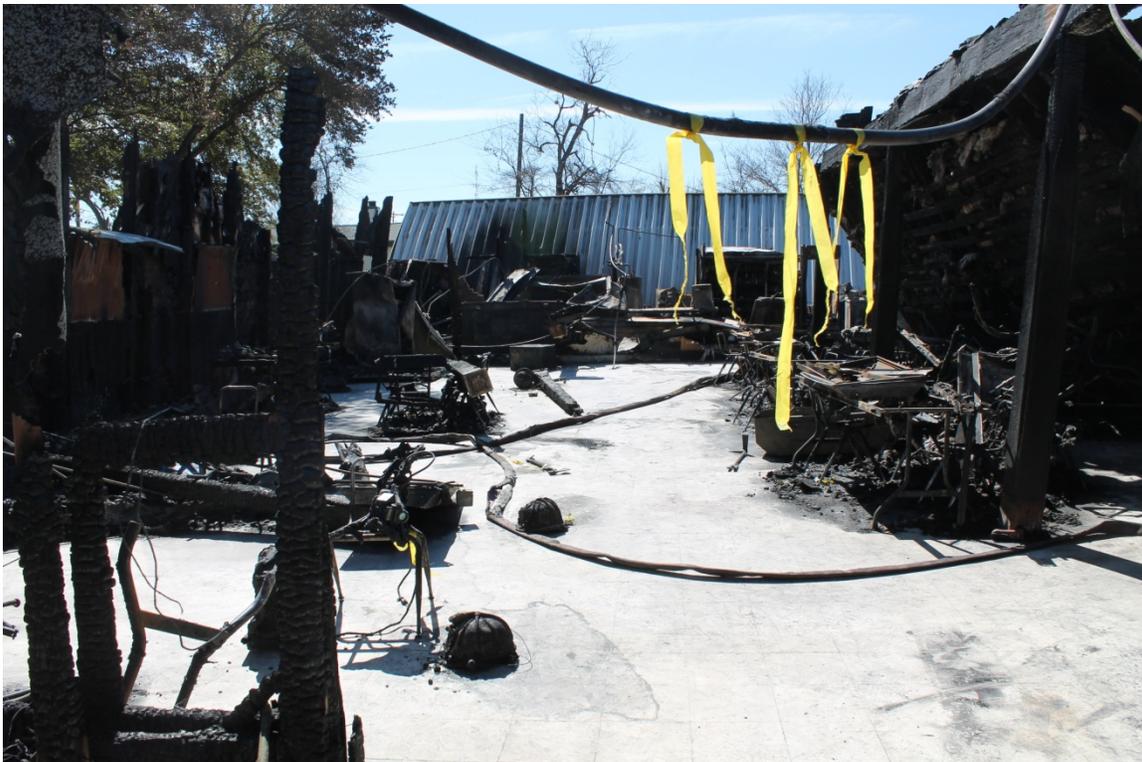
***View into the bingo room showing the looped E1 red hose line.  
(Photo by State Fire Marshal's Office)***

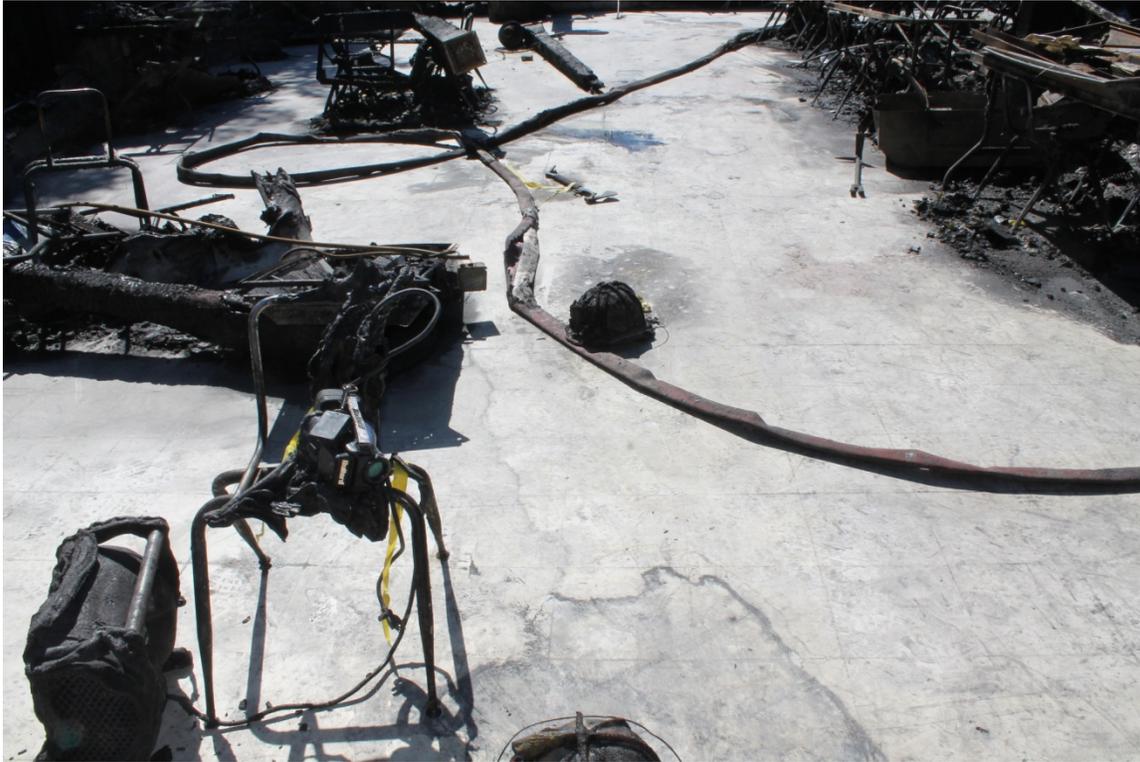
**Photo of the looped E1 red hose line in the bingo room. A TIC is melted to the chair in the foreground. (Photo by State Fire Marshal's Office)**

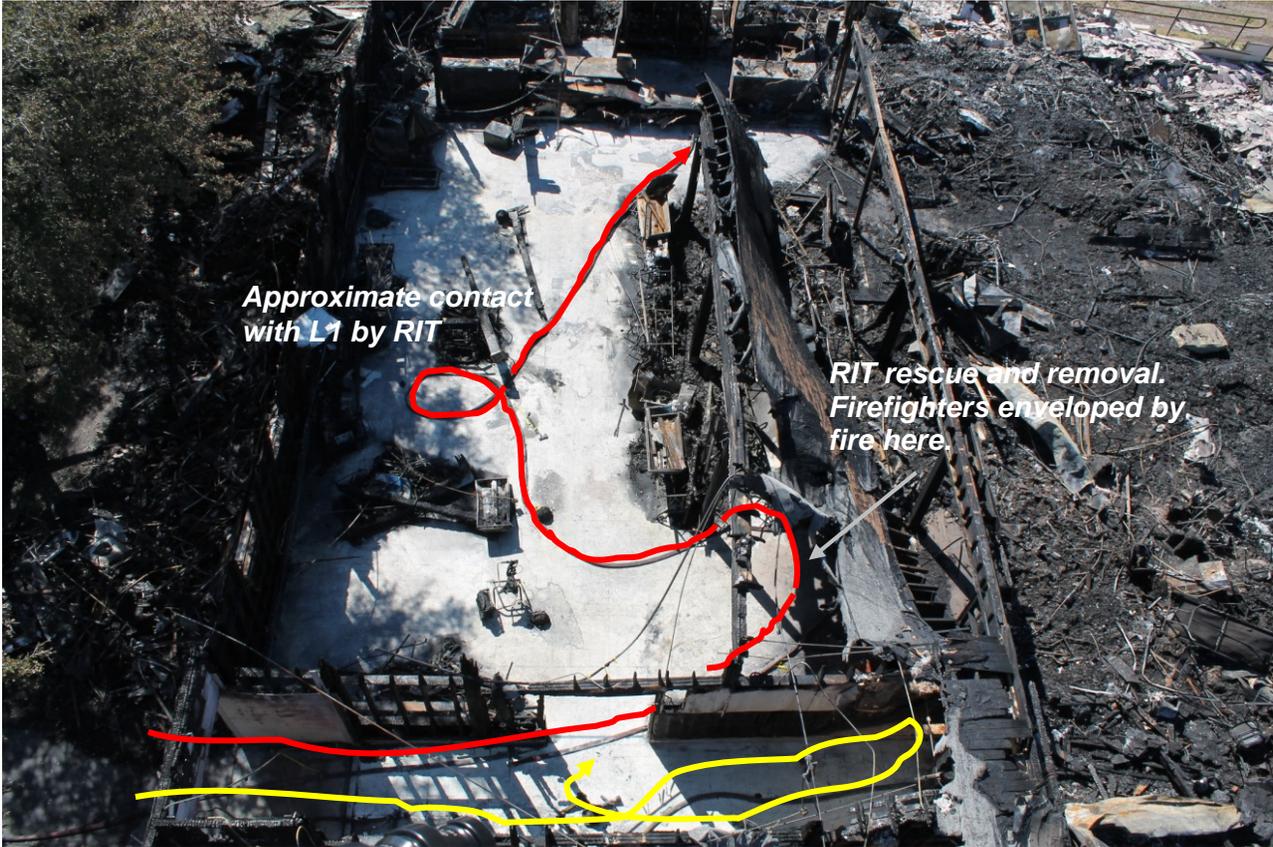
**Outline of E1 red and E2 yellow hose lines. Locations of firefighter contact and rescue. (Photo by State Fire Marshal's Office)**

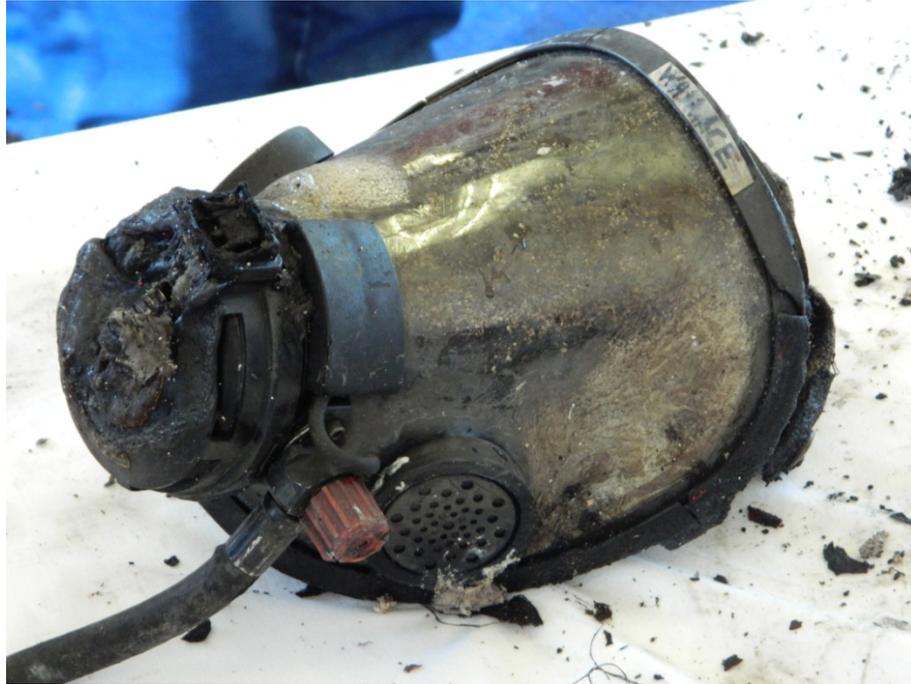
***Lt. Wallace's SCBA face mask with regulator melted. Thermal damage was attributed to flashover exposure and was secondary to running out of air.  
(Photo by State Fire Marshal's Office)***

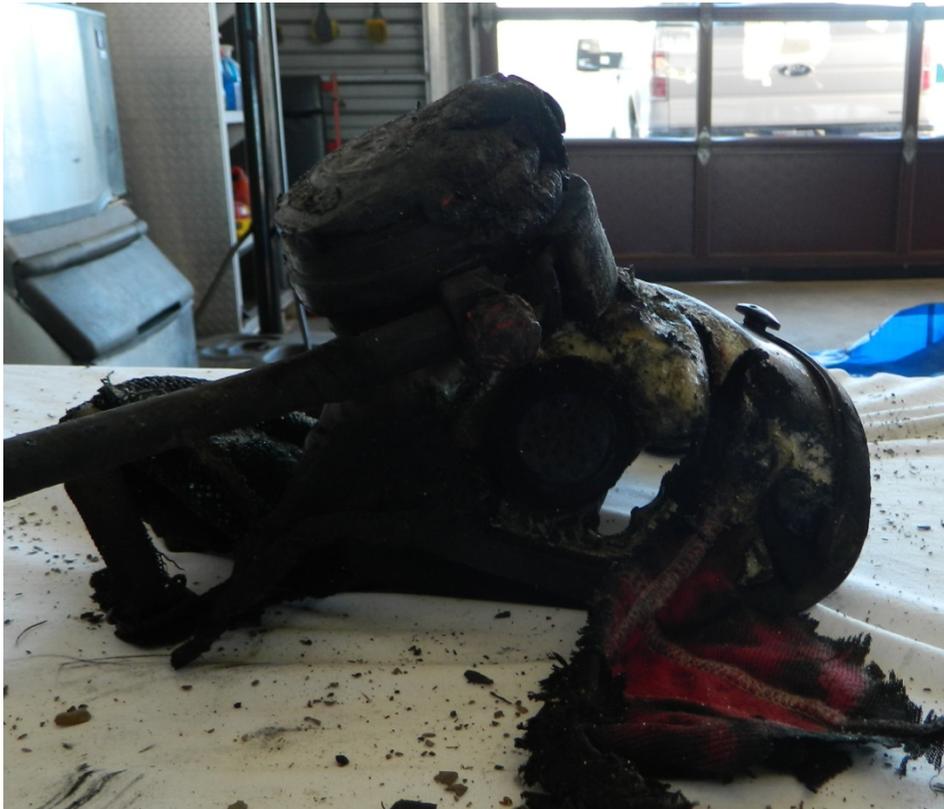
***Lt. Pickard's SCBA face mask with a hole melted through the lens. The mask was compromised and may have allowed for the inhalation of super-heated gases.  
(Photo by State Fire Marshal's Office)***
