CRASH RECONSTRUCTION MECHANICAL INSPECTION WISCONSIN STATE PATROL

STATE PATROL CFS NUMBER: 000221-2755
 MECHANICAL INSPECTOR: Insp. Ryan Schultz
 RECONSTRUCTIONIST: Trooper Trent Betley

Crash Location: USH 2 at entrance to Maslowski Beach	Date / Time of Inspection: 8/2/22 9:00 A.M.	Inspection Location: Pospychalla Towing
---	--	--

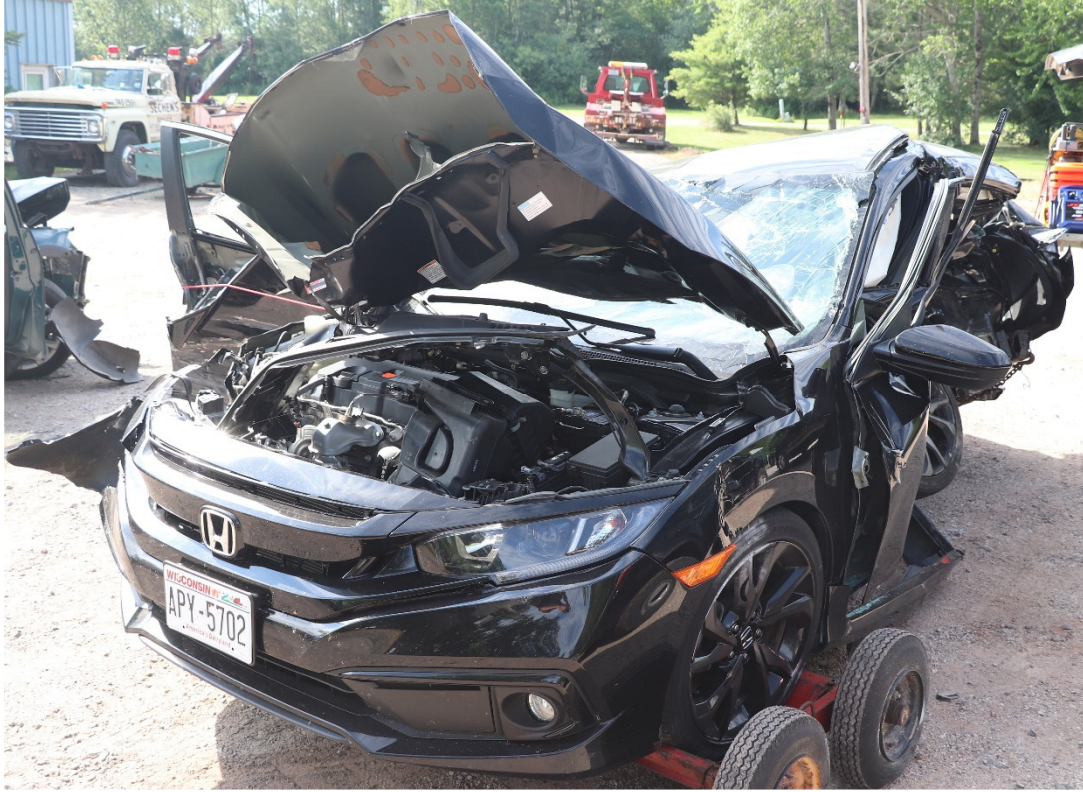
(Figure 1 Insp. Schultz-jpeg_9715)

On August 2, 2022, I went to Pospychalla Towing in Ashland, WI in reference to a mechanical inspection of a 2019 Honda Civic (Figure 1). The Civic had been involved in a fatality crash on U.S. Highway 2 near the entrance to Maslowski Beach. Upon arrival I met with Trooper Trent Betley. Trooper Betley had obtained consent to conduct the mechanical inspection. The Civic was stored in an indoor area at Pospychalla's. Mark Pospychalla moved the Civic outdoors and elevated it with a tow truck and wooden blocks so I may conduct my inspection.

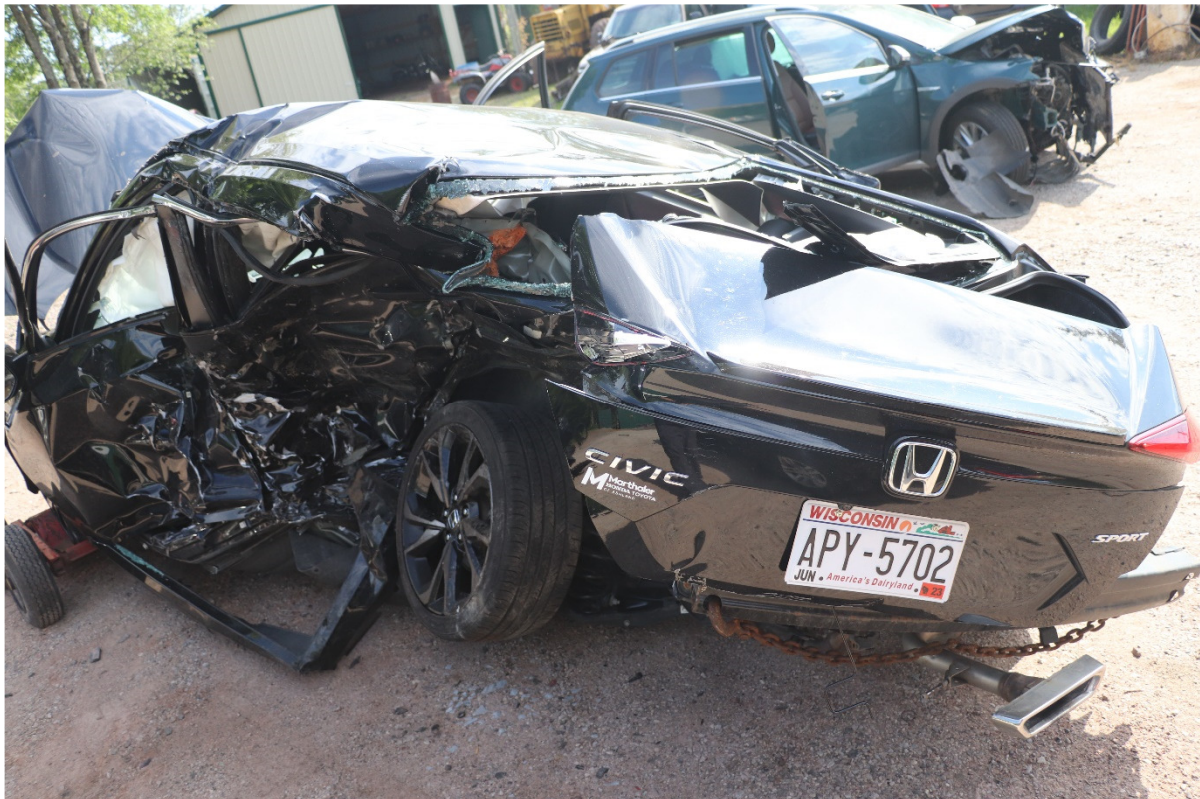
(Figure 2 Insp. Schultz-jpeg_9723)

I began my inspection with a walk around examination of the Civic. I was unable to access the Federal Certification Label in the Civic due to damage sustained in the crash. I verified the Civic's public vehicle identification number (VIN) (Figure 2). The Civic was a unibody construction. The Civic had sustained significant damage in the crash. Crash damage consisted of damage to the: All body panels, the cabin, front bumper, suspension, engine bay area, undercarriage, interior, and many other components. The driver's-front, both seat side, and both curtain side airbags were deployed.
