# Pre-Renovation Hazardous Materials Survey Report

**16 South Street  
Auburn, New York**

*CHA Project Number: 25810.1006.31000*

*January 24, 2013*

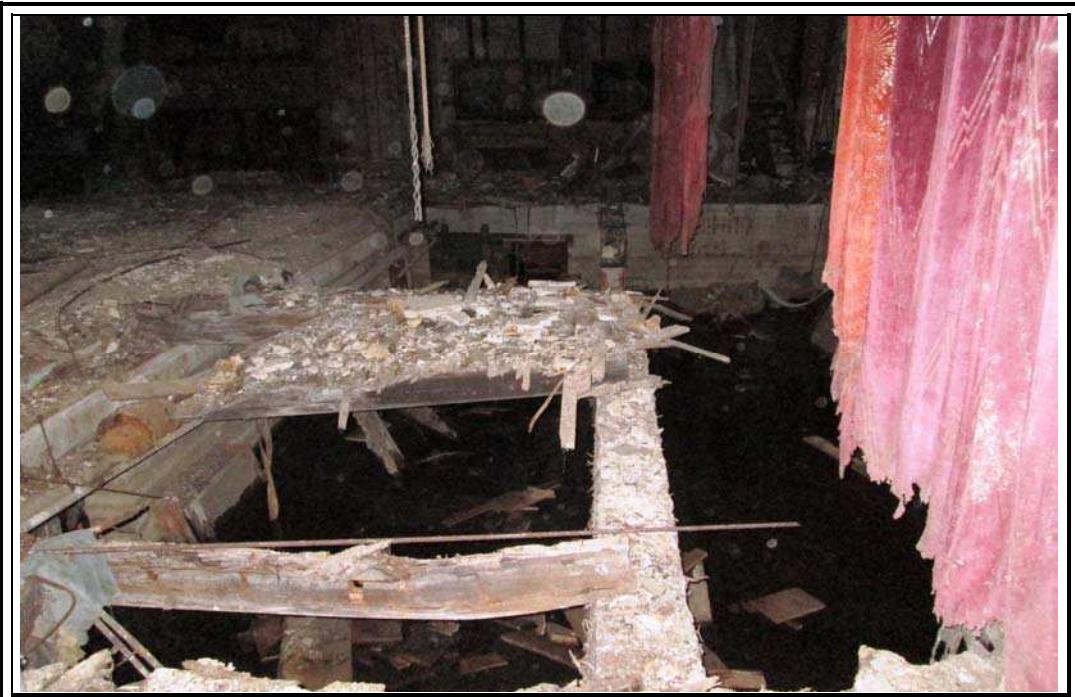
The backstage basement was inaccessible due to water infiltration/damage. Standing water was present in this area at the time of this inspection which prevented entry into this space.

- Asbestos-containing pipe insulation debris was observed floating on the water within the backstage basement. Based on field observations, it is likely that the boiler room is located in the backstage basement, although this was not confirmed.
- The dark green/grey paint and white/green paint wall paints have levels of lead exceeding 0.5% by weight therefore they are considered lead-based paint by EPA and HUD. Also, the seven remaining paints have detectable levels of lead below 0.5% by weight therefore they are not considered lead-based paint by EPA and HUD.

**Photo 4 – View of Backstage Basement**

- The water located in the backstage basement should be pumped and disposed of by a NYS licensed asbestos abatement contractor in accordance with all local, state, and federal

regulations. Following the water removal activities, the basement should be inspected for asbestos-containing materials.

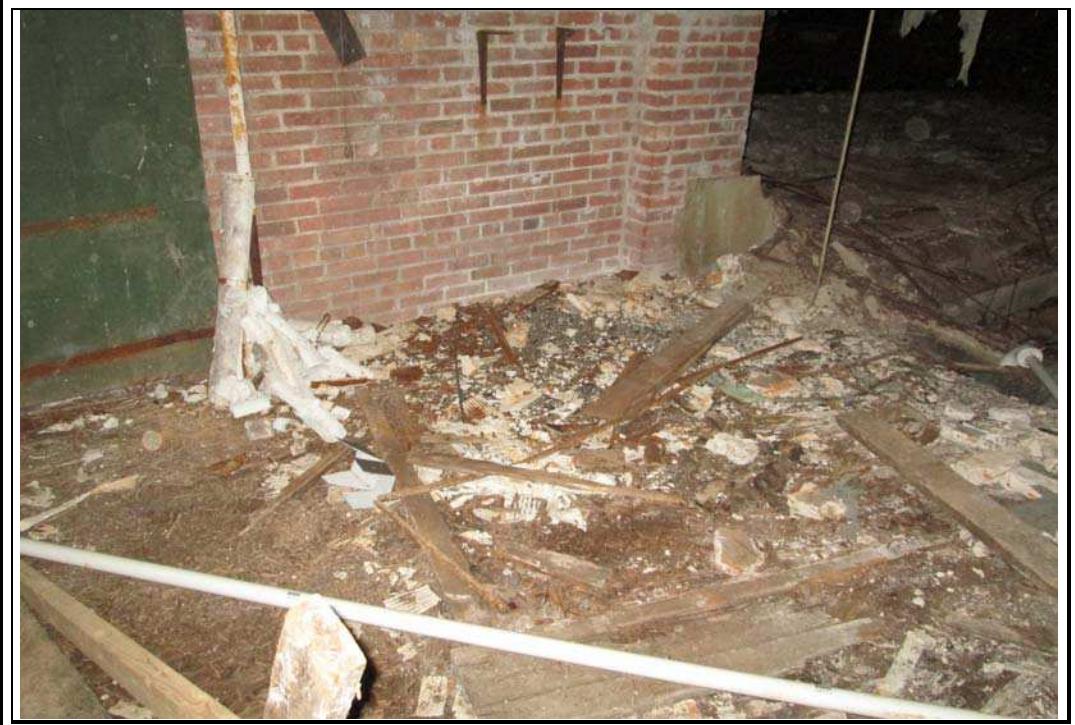
- 10 asbestos-containing materials were confirmed and 3 were assumed associated with the subject building. The confirmed and assumed asbestos-containing materials and asbestos debris throughout the building must be removed and legally disposed of in accordance with all local, state and federal regulations prior to any activities that could disturb them.
- Asbestos-containing pipe insulation debris was observed and quantified in the backstage area, the ceiling space above the projection room, and in the air handler room above the backstage dressing rooms, however, bulk debris samples and air samples were not collected to fully delineate the debris locations.

**Photo 5 – View of Backstage Aircell Insulation Debris**

- NYS Code Rule 56 Section 1.5 entitled “Responsibility for Cleanup of Uncontrolled Disturbance” states that “If there is an incidental disturbance or other disturbance (not as part of a controlled asbestos project) of ACM...at a building or structure, upon discovery of the disturbance, the property owner shall be responsible for contracting with a licensed asbestos abatement contractor for immediate isolation of the disturbance and cleanup in accordance with all provisions of this Part.” CHA hereby notifies the owner of the presence of asbestos debris observed in the backstage, the backstage basement, above the projection room, and in the air handler room above the backstage dressing rooms of the subject building and the requirements of NYS Code Rule 56. Due to the quantity of the asbestos debris present, a site specific variance to the NYSDOL Asbestos Control Bureau is required to set forth appropriate cleanup procedures prior to removal of the asbestos debris by a licensed asbestos abatement contractor.

- Bulk debris samples and air samples should be collected within and adjacent to contaminated areas to properly delineate the observed extent of contamination.

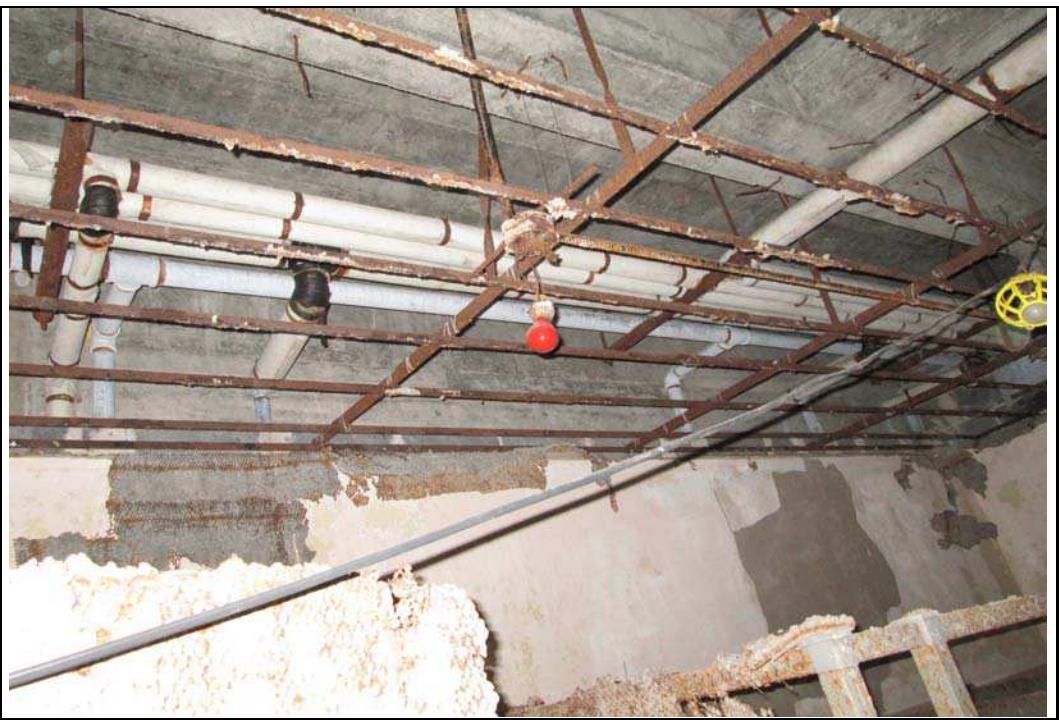
wood ceilings. The men's and women's bathrooms have suspect ceramic wall tiles and ceramic floor tiles with associated suspect bedding grout and seam grout. Suspect door insulation was observed in association with the utility room door. Also, suspect aircell pipe insulation was observed above and below the ceiling throughout the basement. In addition, a hatch access to the air plenum located adjacent to the women's bathroom room revealed suspect black wrap on three aircell insulated pipes.

**Photo 7 – View of Aircell Pipe Insulation in Women's Bathroom in Basement**

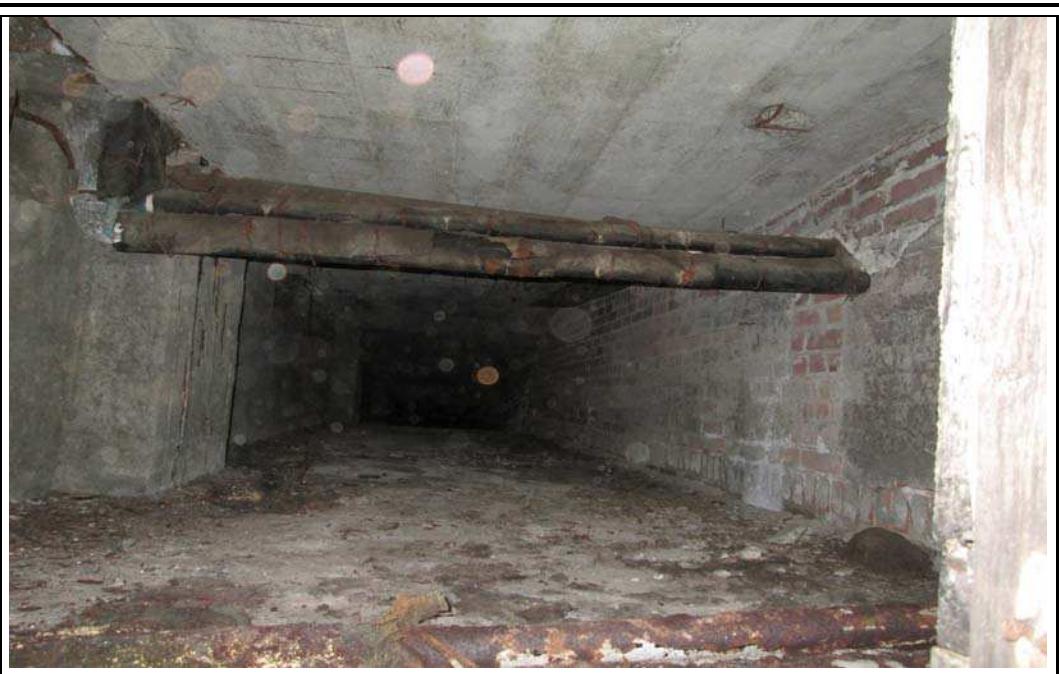
**Photo 8 – View of Aircell Insulated Pipes in Basement Air Plenum**

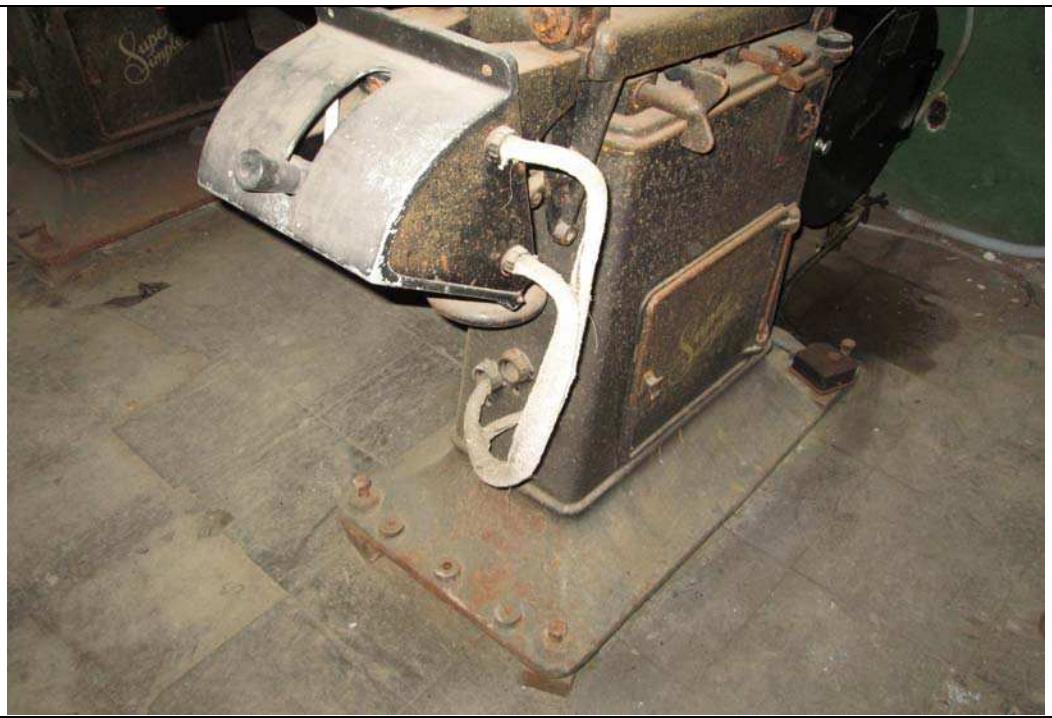
**Photo 11 – View of White Cord and 9" Black Floor Tile in Projection Room**

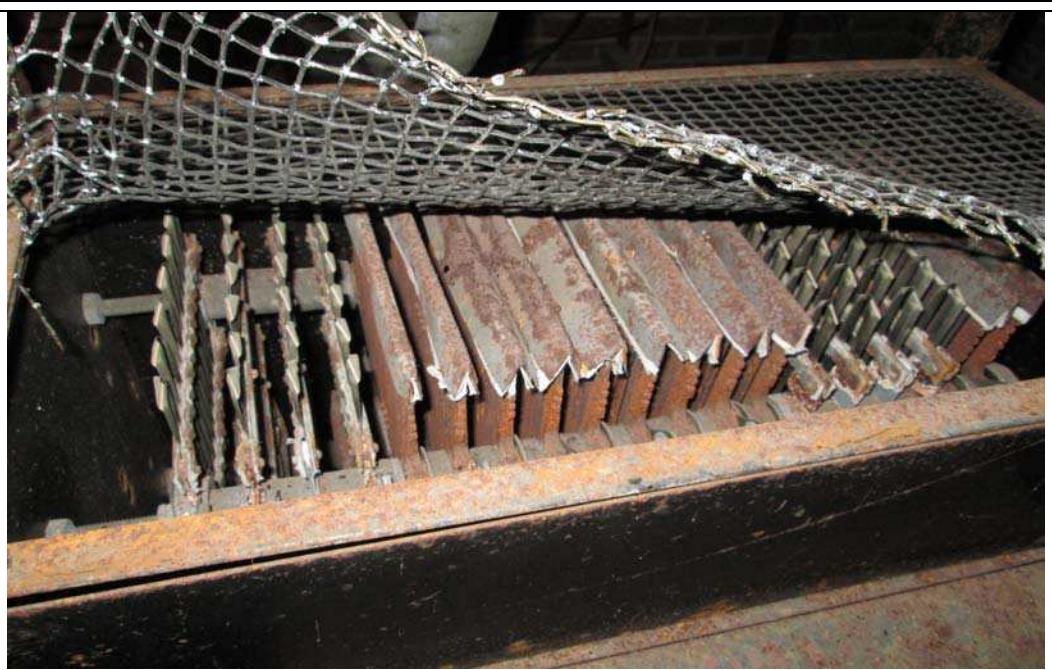
**Photo 12 – View of Motor Control Unit in Air Handler Room above Backstage Dressing Rm**
