Building Inspection Report
for
Flint House

Prepared for:
**Village of Scotia Historian
Beverly Clark**

Observation Date: April 4, 2025
Weather: 60's Partly Cloudy
Report Date: May 14, 2025
Observed by: Timothy Schroder, PE

As requested, Enginuity Engineering & Design has conducted an inspection of the Flint House building at 421 South Reynolds Street; Scotia, NY 12302.

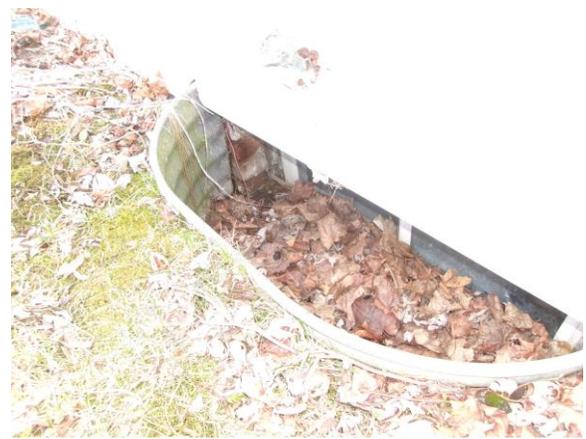
1. At the west side of the north wall there is a metal window well. The window well is full of debris above the window sill elevation.

Remove debris from window well and confirm grade elevation is 4-6" below the window sill.

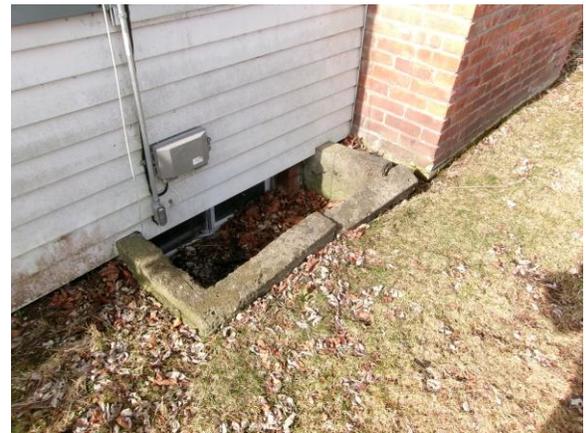
2. At the east end of the north wall there is a concrete window well. The concrete is broken and displaced. The window well is full of debris above the window sill elevation.

Remove debris from window well and confirm grade elevation is 4-6" below the window sill.

Repair or replace window well.

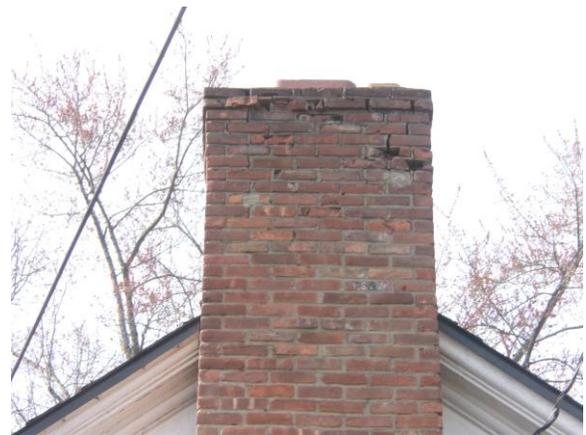
3. The masonry chimney on the D-side of the building has broken/missing bricks and mortar at several areas, especially the top.

Repair and repoint chimney as recommended by a qualified mason.

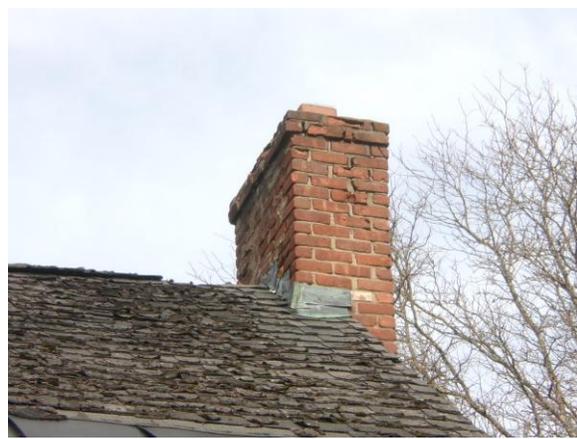
4. The masonry chimney on the D-side of the building has open flues and the roof flashing is in poor condition.
Open flues in a chimney can lead to premature failure of the flue liner.

***Have a qualified chimney sweep inspect the chimney prior to future use and remediate per their recommendation.
Install metal caps on the flues to prevent water infiltration and damage.***

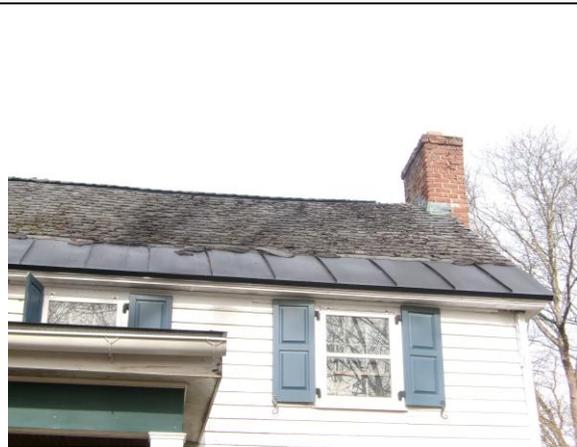
5. Existing asphalt shingle roof on entire house is in poor condition.

Replace all existing roofing and flashing to prevent water infiltration.

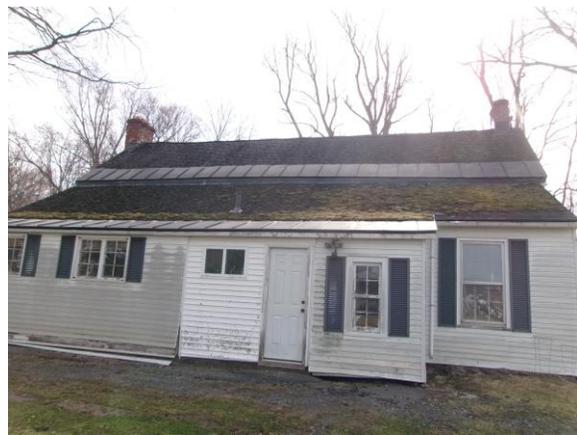
6. Moss growth was observed on several area of the roofing.
Growth of any organics on the building will lead to premature deterioration.

Remove organic growth from building and maintain surfaces free of future growth to minimize potential issues for building.

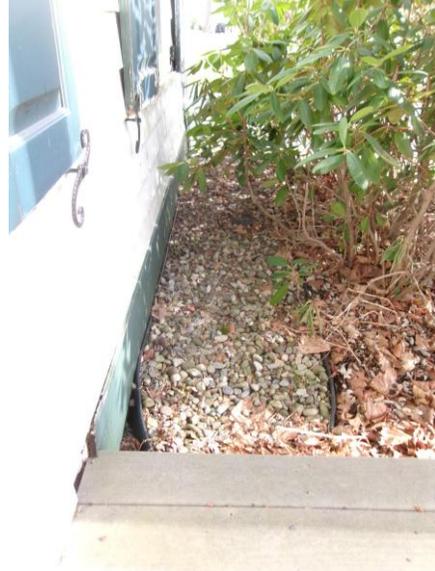
7. Bushes were noted to be close to the face of the building in multiple areas.

Trim bushes back and maintain a clear space of 18" to building to minimize moisture issues for the building.

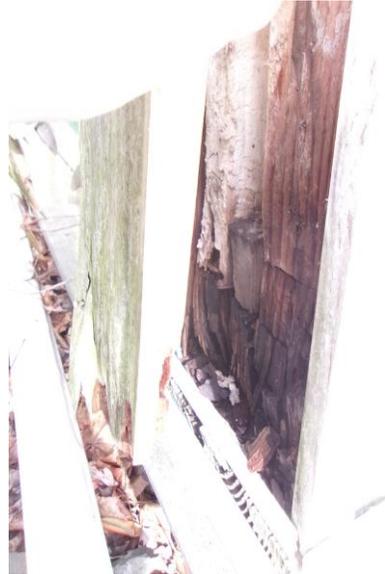
8. The base of the south column on the front porch was observed to have significant deterioration. The other column bases on the porch also were observed to have some moisture damage also.

Column bases should be repaired as required using deterioration resistant materials.

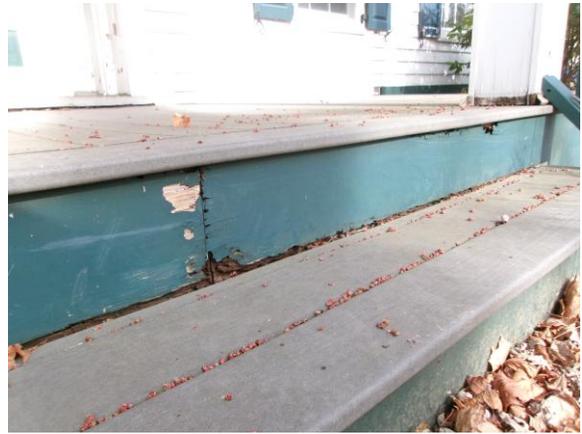
9. Finish trim boards around the porch and on the A-side of the building were noted to have some deterioration due to moisture.

Repair/Replace damaged trim boards with deterioration resistant materials.

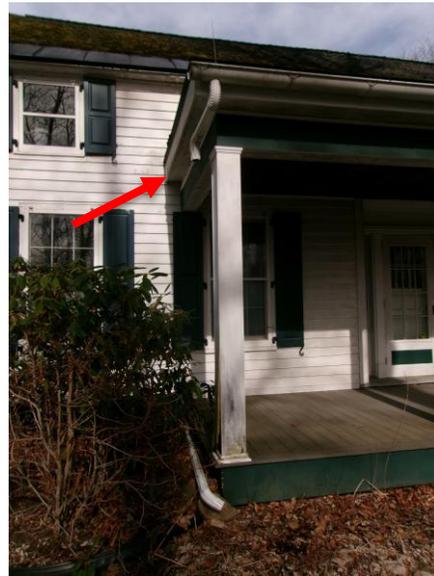
10. Roof leader on southeast corner of porch was noted to be disconnected and discharging water on the column accelerating deterioration.

Reinstall leader and discharge water way from building.

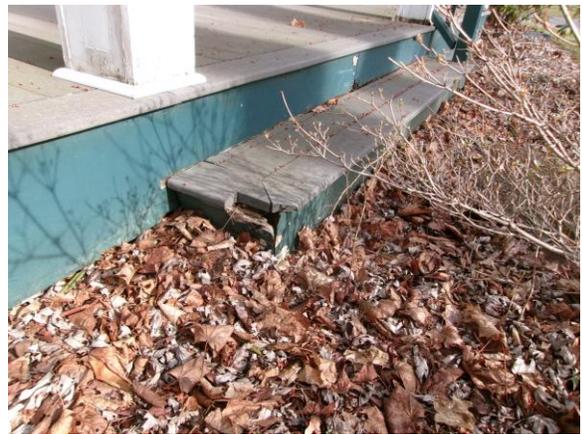
11. The south handrail for the front steps has been removed and the step wood framing is deteriorated.

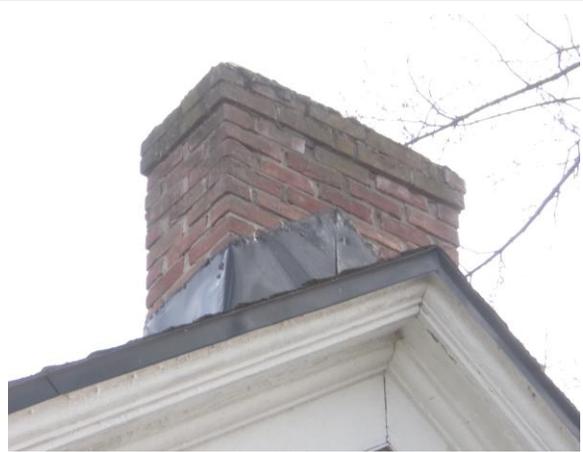
12. The south chimney needs repointing at the exposed top section.

Repoint masonry to prevent damage to masonry

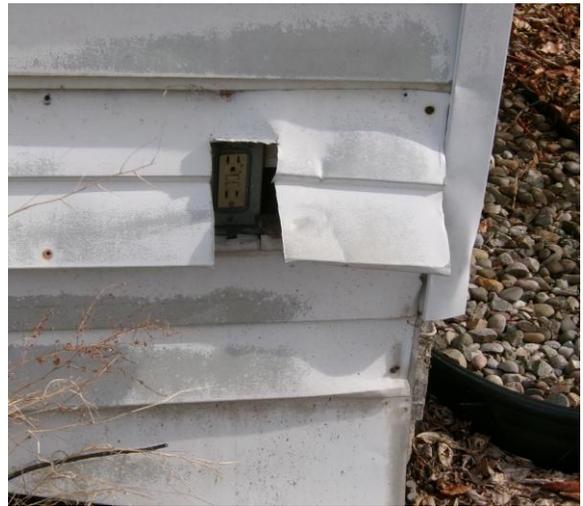
13. Exterior outlet on southeast corner of building does not have a weather proof cover.

Install weather proof covers on all exterior outlets

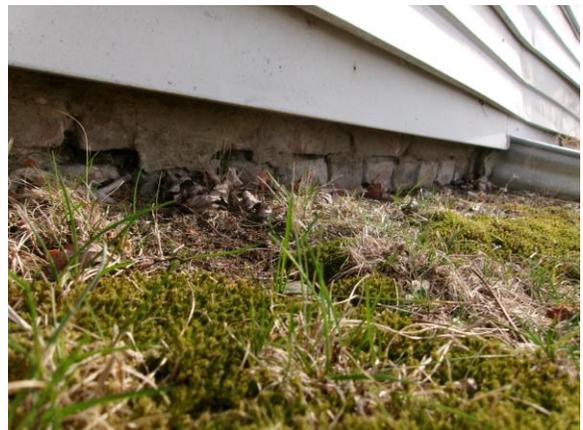
14. Exposed brick on B-side of main house is in poor condition and need to be repointed. It is unknown what the condition of the foundation brick is in other areas of the foundation due to being covered with finishes.

Repair/repoint foundation as required.

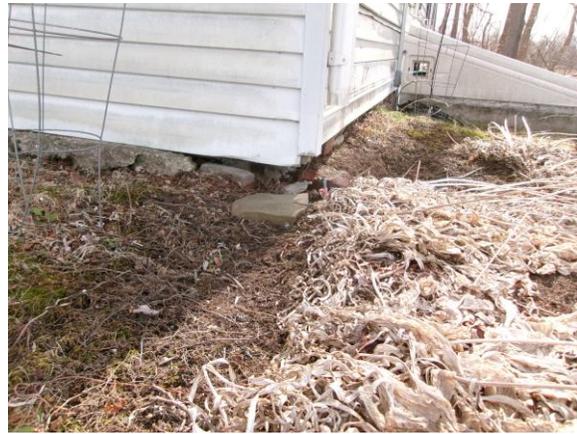
15. The foundation under the kitchen addition R105 is in poor condition on the south and west exposed sides.

Further review of the foundation is recommended.

Repair the foundation to prevent movement/damage to the foundation and addition.

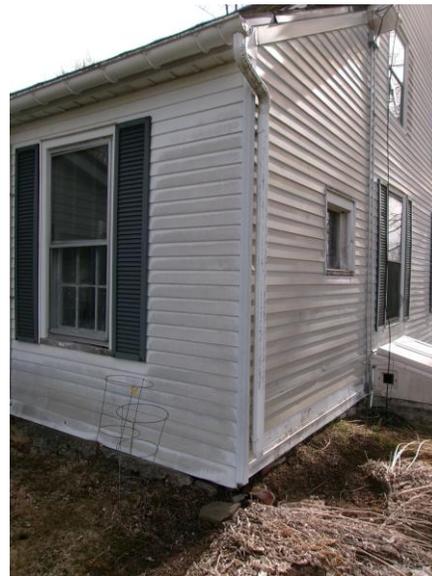
16. Roof leader on southwest corner of building discharges as face of building and the grading in the area is not directing water away from building.

Sill beam on the west wall shown was observed to have rotted out.

- Where sill plates were accessible during the inspection were checked (from the basement side) for deterioration. Some deterioration was noted but generally were in serviceable condition with the exception of the area noted in item 16 above.

Reinstall roof leader and extend away from building. Re-grade to slope away from building.

Deteriorated sill beam should be repaired with deterioration resistant materials and protected from moisture.

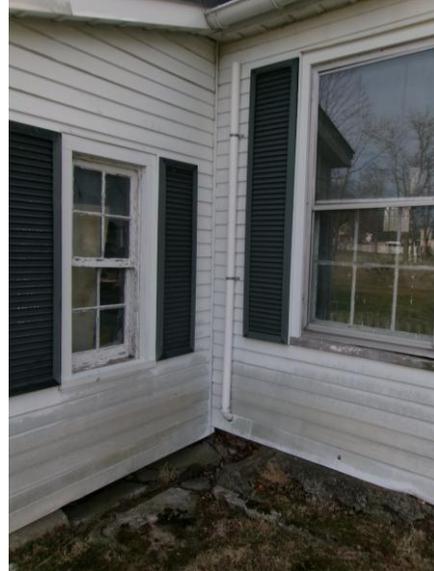
17. Plumbing vent from sanitary pump in basement discharges under eave of building adjacent to two windows.

Review vent location requirements for proper installation and remediate as required.

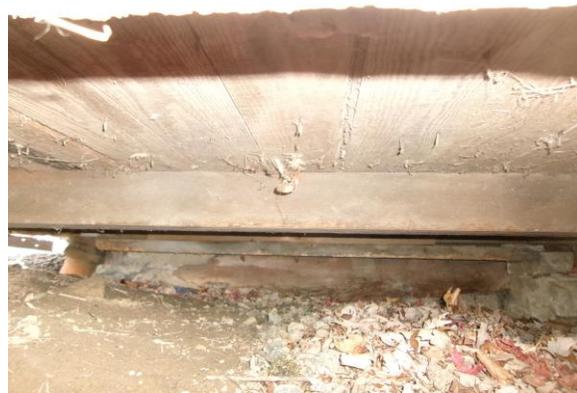
18. Roof R108 floor is less than 12" above grade and space is open to exterior. Grade appears to promote water entry into area and infiltration at foundation.

Remediate grading to prevent water entry and infiltration. Do not enclose crawl space without providing proper ventilation.

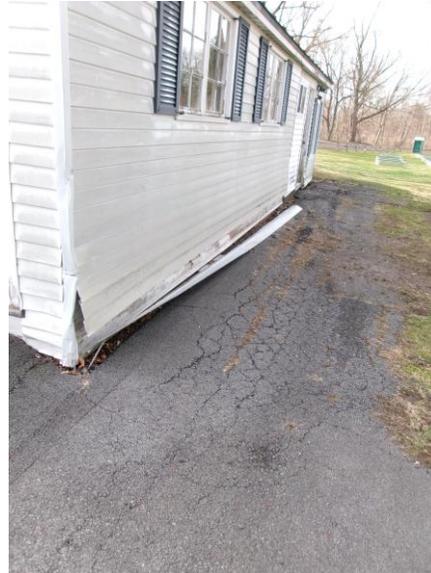
19. West addition roof does not have gutter and pavement is adjacent to building with a gully next to the building. The conditions may promote water infiltration into crawlspace. Water splashing on the building from the roof eave on to building will accelerate deterioration.

Remediate drainage issue. Installation of a gutter and proper drainage away from the building is recommended.

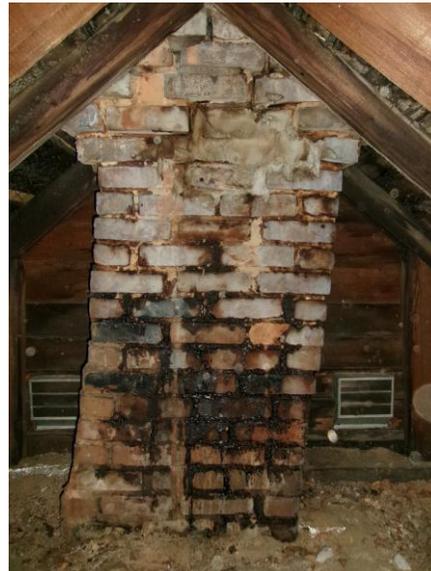
20. South chimney in attic is corbeled to center of roof and has an enlarged top penetrating roof.. Corbeled chimney has creosote on exterior of brick masonry.

Chimney not currently in use should be inspected by a qualified chimney sweep prior to any future use.

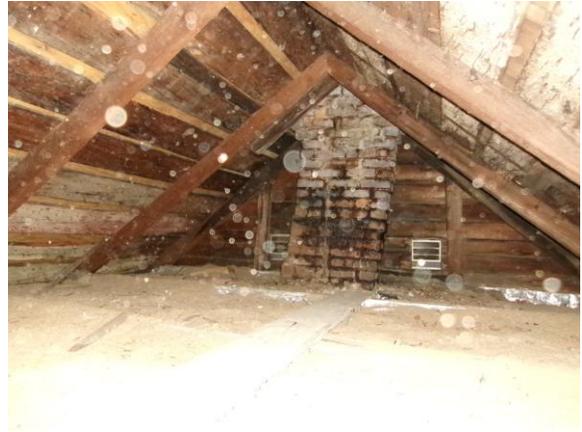
21. Attic insulation consists of foil draped over joist with loose insulation on top. Unknown insulation in cathedral roof section.

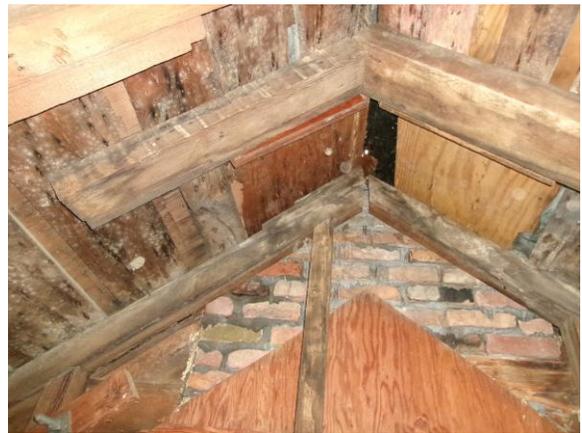
22. North chimney on exterior was previously relocated from the interior of the building.

Note: plywood roof sheathing installed over previous chimney opening.

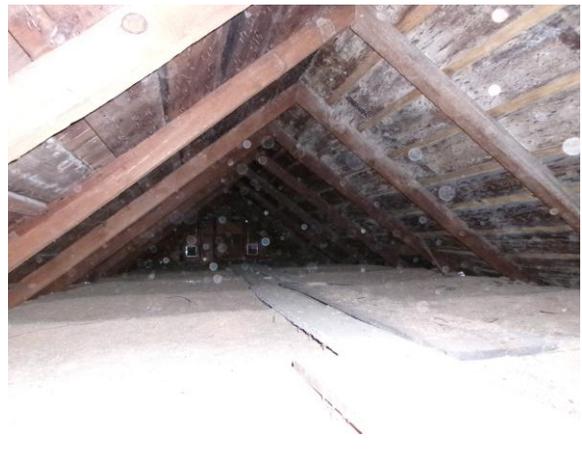
23. Attic ventilation is located on the two end gable walls. No ventilation was observed in cathedral section of roof from eaves. Mold was noted in several area of the roof indicating that the attic is not adequately ventilated.

Remove mold from attic space and provide proper ventilation.

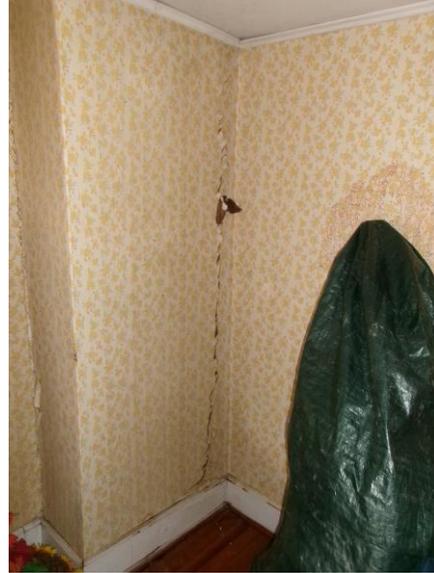
24. Differential movement was observed between the south chimney and wood framed walls in room R203. The wood framing was noted to be settling.

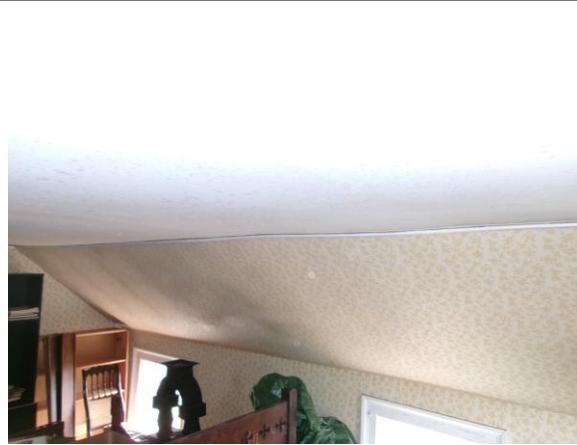
25. Ceiling levels through-out second floor were noted to have deflection movement.

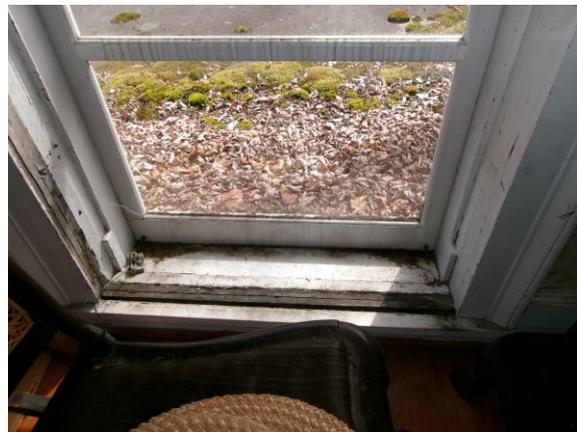
26. Windows on east side are close to porch roof elevation and have debris on roof. Window sash is missing and only storm window is installed (3 locations). It appears that water may be entering window opening from exterior.

***Patio roof should be cleared of debris and flashing to building inspected.
Window openings should be inspected for moisture damage are remediated as required.***

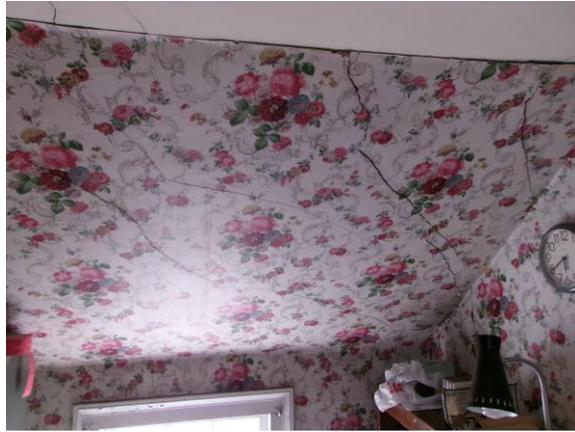
27. Room R202 ceiling has extensive cracking due to movement.

Damage to the plaster and wall paper finishes were particularly evident in room R202. It was noted an interior wall was previously removed in room R202. The wall, although intended to be non-load bearing, was contributing to the strength of the roof framing and acting as a load bearing wall. Removal of the wall has contributed to the increased damage to the finishes in this area.

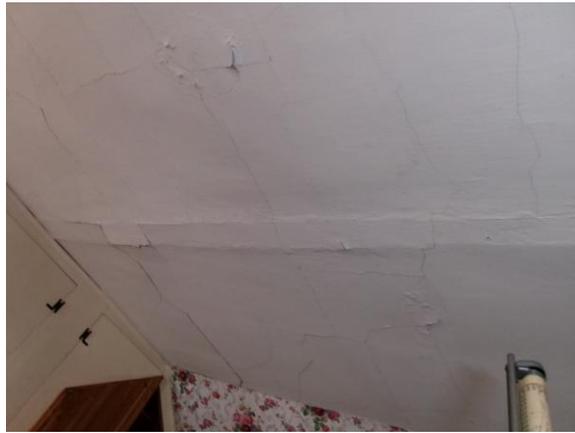
28. Interior wall was previously removed in room R202.

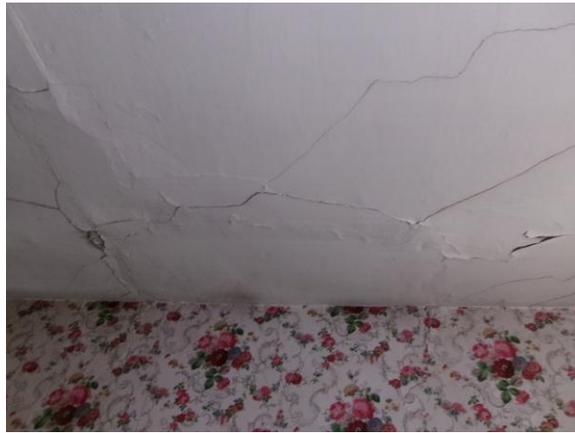
29. Ceiling repair at previously relocated north chimney

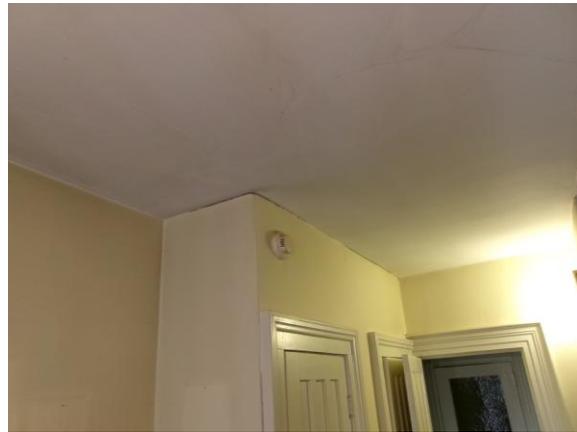
30. Added closets in room R101 appear to have settled separating from the ceiling. This indicates that the floor is deflecting below.

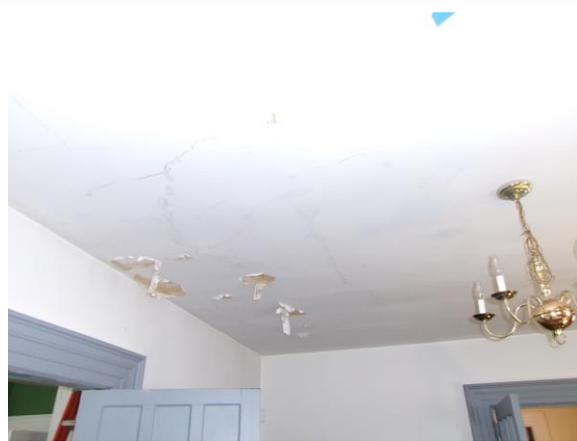
31. Ceiling of room R103 with damage reported from previous heating system failure.

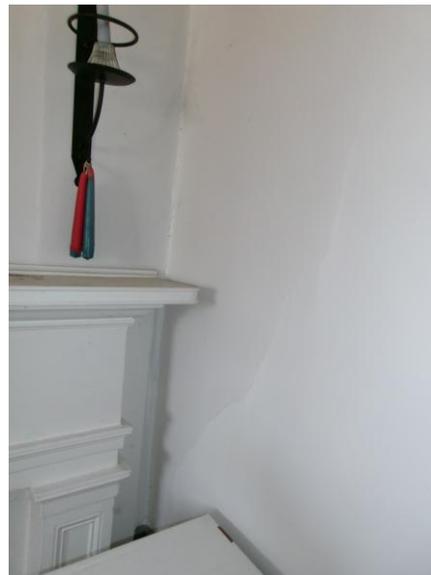
32. West wall of room R103 adjacent to chimney shows signs of movement.

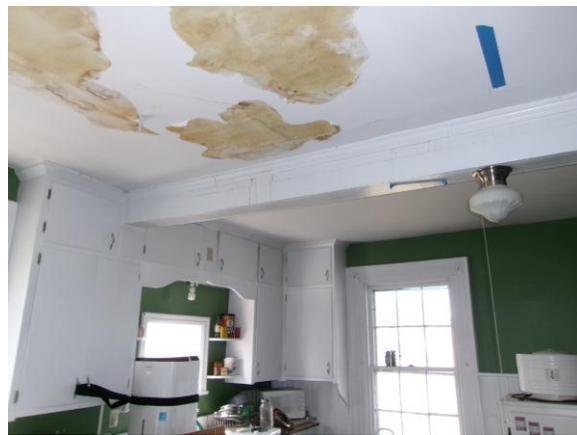
33. Ceiling of room R105 kitchen shows signs of previous water damage. Water staining was also noted on both sides of beam. It is unknown if the water damage is due to the plumbing system failure.

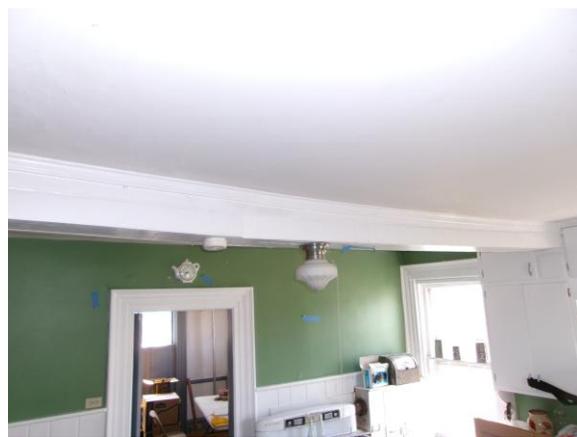
34. The support beam below the exterior wall above room R105 kitchen has a deflection of approx. 2"

The removal of a load-bearing wall in the kitchen space has telegraphed through the exterior wall, showing in the roof eave line. The deflection of the roof is clearly evident within the kitchen by the observed deflection of the support beam spanning the room. The deflection of the beam was measured to be approximately 2".

- 1) Repair of damaged first floor framing.
- 2) Evaluation and reinforcement of the beam over the kitchen space.
 - a) Reinforcement or replacement of this beam is recommended to prevent a more significant failure.

- b) It is recommended to install a temporary shoring post under the midspan of the beam until designing installation of the permanent remediations can be completed.

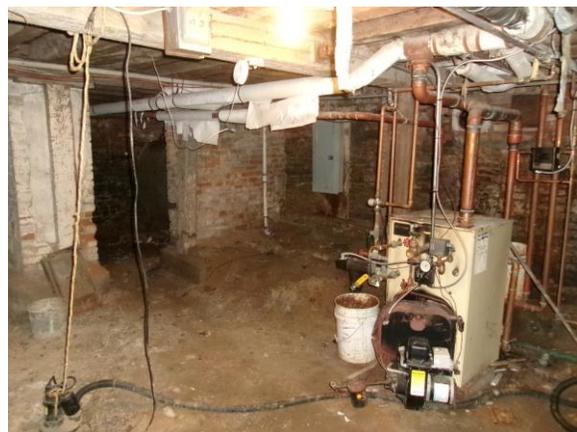
35. Steam boiler and heating piping system is deactivated after previous reported puffback. Note pipes throughout space have suspected ACM materials.

Recommend having an asbestos survey performed on the building and remediating per the survey recommendations prior to performing ANY work in the basement.

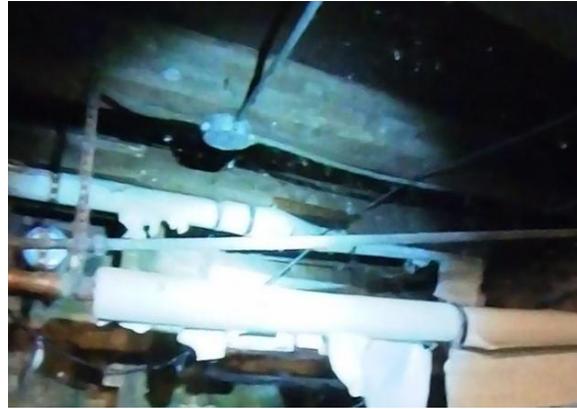
36. Several notches of the first floor joist were noted for the installation of the heating system.

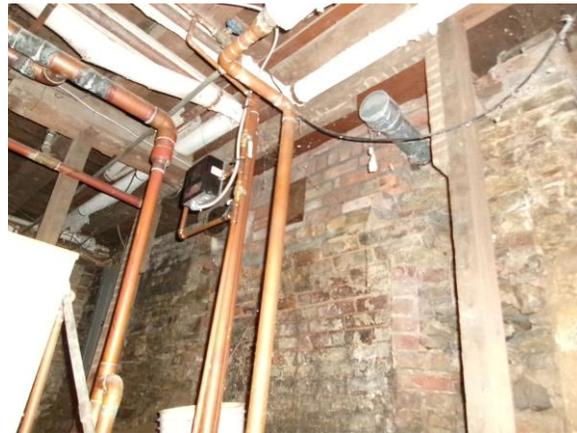
37. Center support beam over room B102 is supported on 2x4 posts. North end of beam end short of existing foundation. Likely was previously supported on removed north chimney. Beam was noted to have a deflection of approx.. 1 1/8"

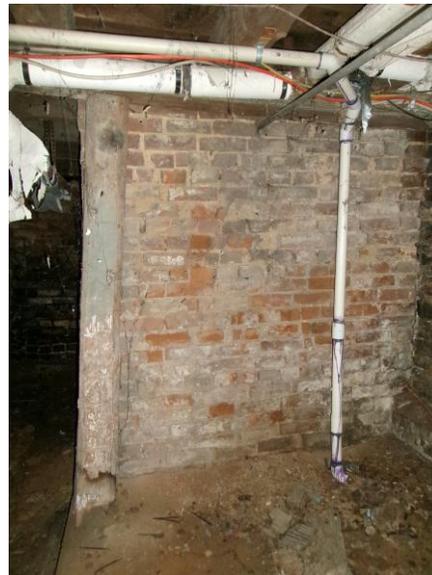
38. Foundation of main house in northwest corner of room B102 is in poor condition and has settled.

Repair/rebuild wall to support loads above.

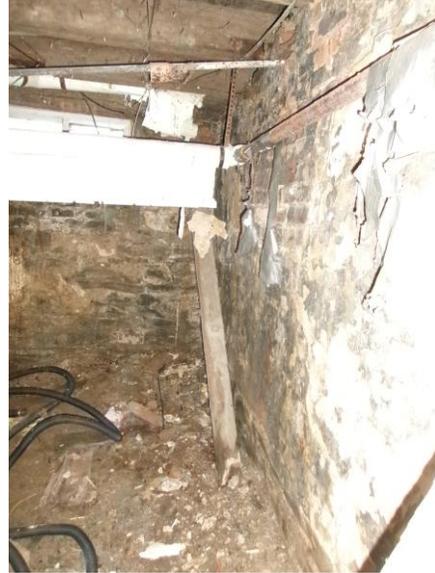
39. The east foundation wall of the building along its entire length is in poor condition and has signs of movement in several areas.

Reinforcement of the east wall is recommended to stabilize the wall and prevent further movement and potential failure.

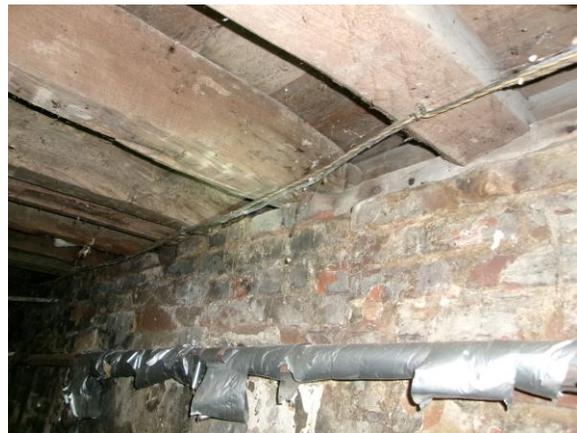
40. Several first floor joist were noted to extend to the exterior wall but not properly supported or connected.

Repair connections and/or support of joist as required for floor loads.

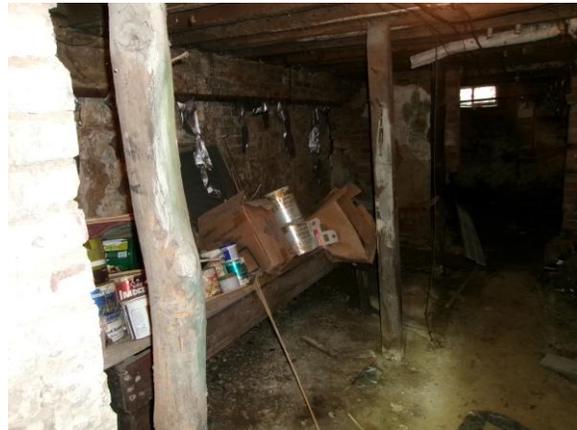
41. Supplement wood posts have been installed in throughout the basement over the service life of the building. It is suspected that the posts were added to address localized floor deflection. However the based of all the supplemental posts have deteriorated and in most cases are not supporting the floor.

Throughout the entire basement, several supplemental posts were previously installed to address localized concerns with floor settlement. These posts have since deteriorated at their base and are no longer supporting floor loads from above. All the observed posts in the basement were bearing on the dirt basement floor without footings or bases to prevent deterioration due to moisture infiltration from the soils.

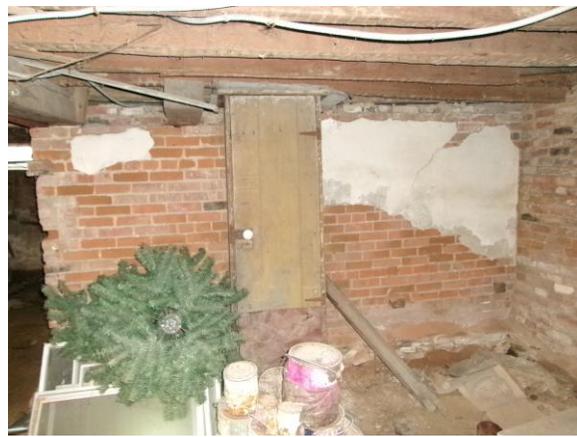
42. On the south side of room B101 a floor joist has broken and is bearing on a storage cabinet.

Additionally throughout the first-floor framing, several joists were observed to have significant splits, insect damage, and deterioration. On the south side of room B101 a joist has broken and is supported by a cabinet stored in the basement.

Replace or reinforce existing joist and remove cabinet.

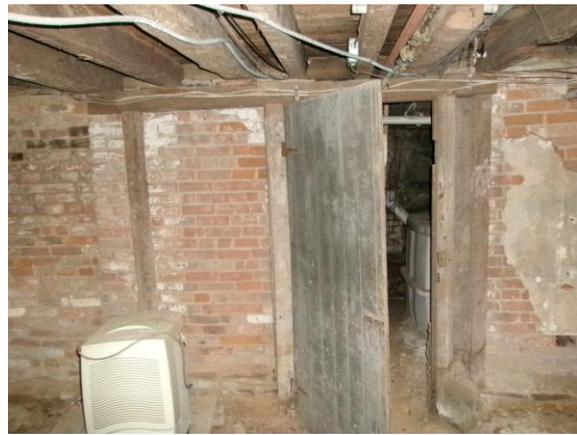
43. At the doors leading from the main basement to the west addition basement the door headers are serving as structural supports for the first floor framing and posts are bearing on the wall footing unsecured.

Further evaluation and remediation is recommended to stabilize the floor framing.

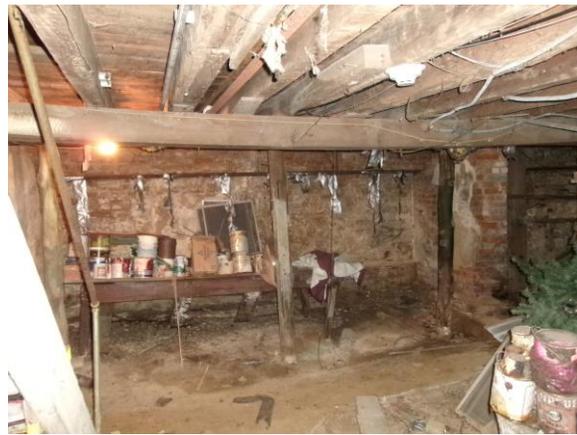
44. Beam across room B101 running north-south is deflected approx.. 1 7/8".

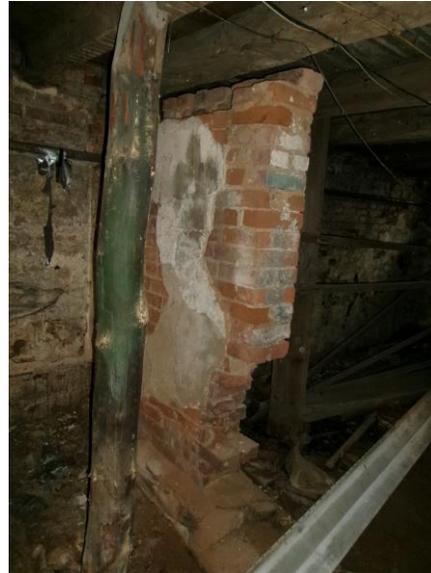
45. Load bearing wall in northeast corner of B103 is in poor condition and has settled and is no longer supporting the floor framing above.

Rebuild wall to support framing.

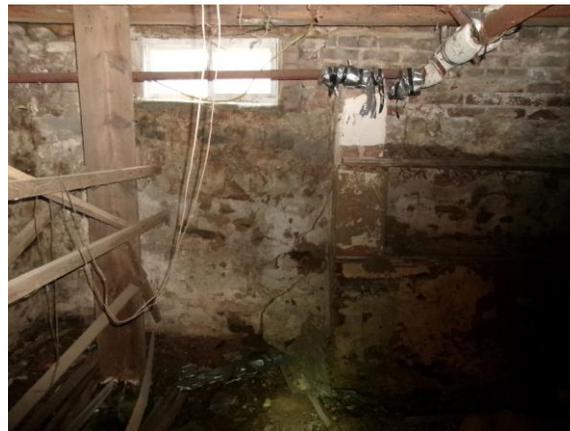
46. There is a crack in the foundation east of the south chimney.

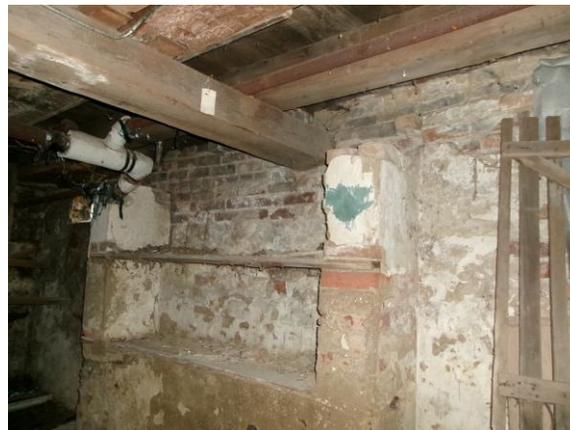
47. The Foundation enlargement supporting the south chimney and hearth was previously removed along with the hearth. The removal of the foundation previously supporting the hearth would generally not have a significant issue on the floor strength.

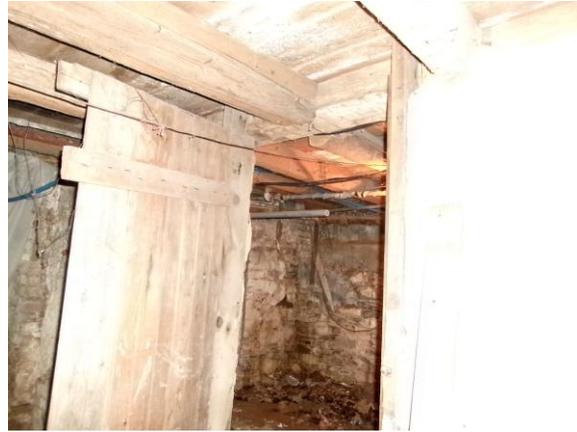
48. Floor joist over room B103 has split at the notched tenant connection to the west sill beam.

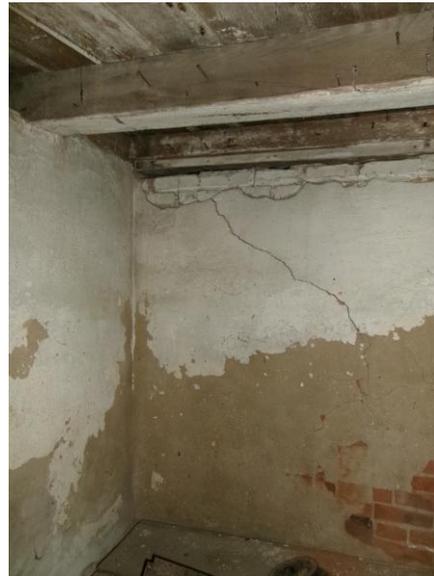
49. Wall between room B101 and B103 on the west end has a crack which appears to be due to settlement.

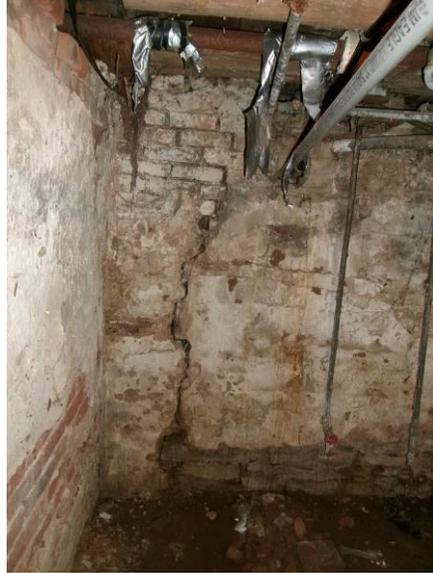
50. South foundation wall of room B104 has a large crack.

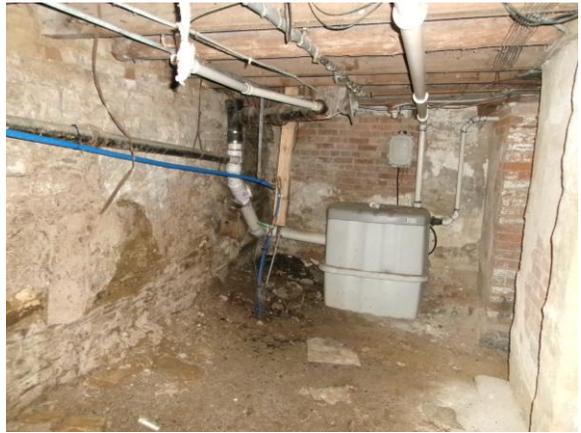
51. In north end of room B104 a sanitary grinder pump chamber has been installed. Previously noted vent under eave is from chamber and run directly overhead.

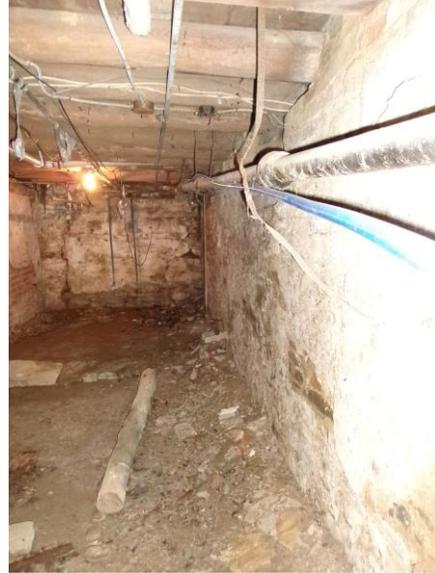
52. West foundation wall of room B104 was noted to be in poor condition.

Repair wall and/or provide stabilization bracing to prevent further movement and issues.

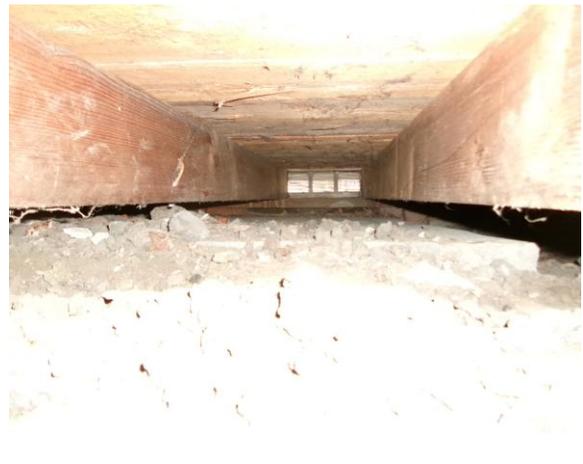
53. Crawl space under room R104 is close to grade. Floor framing in this area is 2x6. Note ventilation louver.

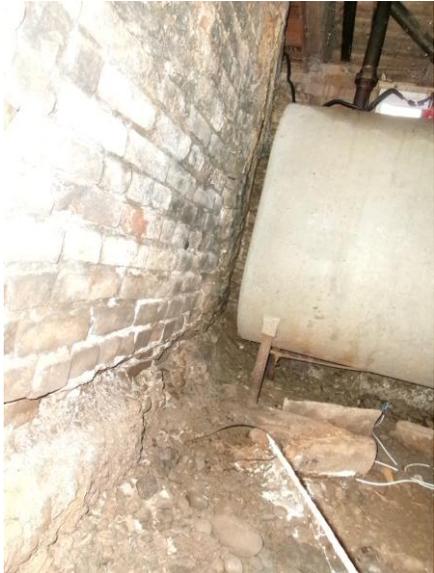
<p>54. West foundation wall of B102B is in poor condition. Note that the floor of the space has been lowered without addressing foundation bearing.</p> <p><i>Rebuild and/or brace wall to prevent failure.</i></p>
