RE: Structural Condition Assessment
20-22 Main Street, Amsterdam, Montgomery County, NY
Ambient Project No. 181107ENVA

**Re: Structural Condition Assessment 20-22 Main Street,
Amsterdam, New York**

20-22 Main Street

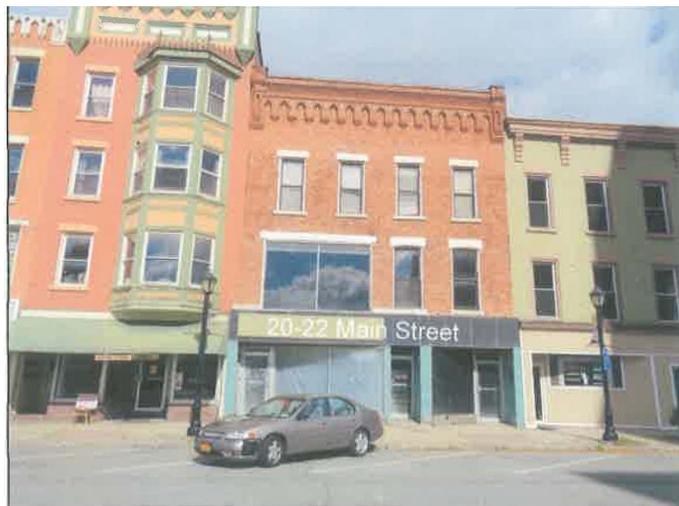
In order to understand the character and overall condition of the structure and associated skeletal framing members within this building, we made a site visit to 20-22 Main Street where Engineering Technician Barb Tozzi and I met with you and Mr. John Duchessi of the Amsterdam Industrial Development Agency. Photograph 1 shows the Southerly front elevation view of the building.

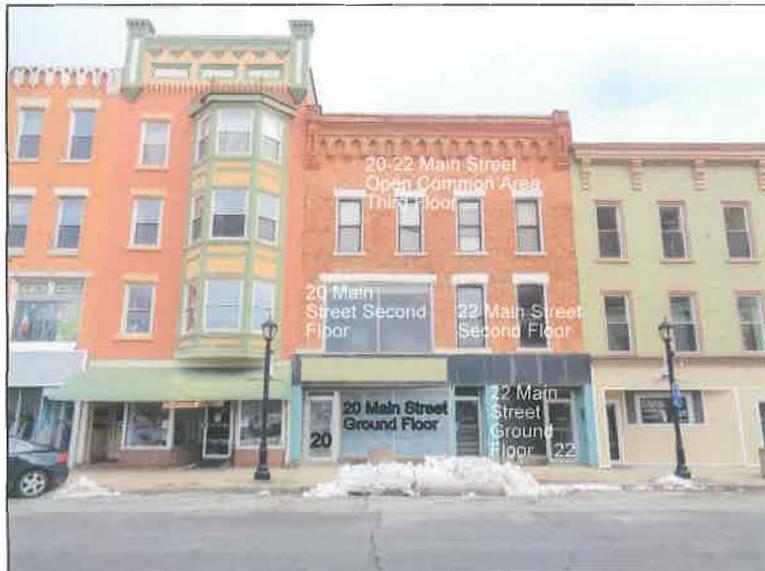
The existing structure is three stories in height and has a foot print of 32' x 65' (2,080 sq ft foot print or approximately 6,240 sq ft net total for three stories). In referring to Photograph 2, 22 Main Street is situated to the right of the photo. The entrance door to the ground floor office is seen on the right side of the building and is labeled 22 on the door (22 Main Street). This interior work space is more specifically shown in Photograph 3.

The center door shown on Photograph 2 accesses the second floor level of both 22 Main Street to the right (East side) of the building and 20 Main Street.

A stair case situated in the front portion of the structure on the second floor accesses the third floor area which is an open and common space. The ground floor level office space of 20 Main Street is located on the West side of the building and is also depicted in Photograph 2.

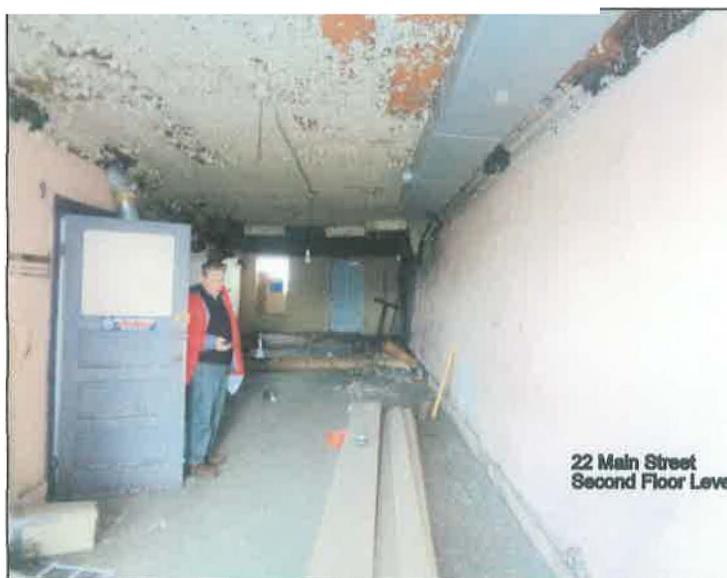
Photograph 4 shows a typical view at the second floor level of 22 Main Street (the Westerly office space). Although difficult to see in this photograph, this area has experienced extensive water damage. This is specifically occurring in the Northerly one third portion of the floor system and occurs in both the first, second and third floor levels and the roof framing. It shall be pointed out that we had noted that a previous fire had transmitted through the floor system as seen in the basement area of 20 Main Street and in each floor and roof system on both sides of the structure.

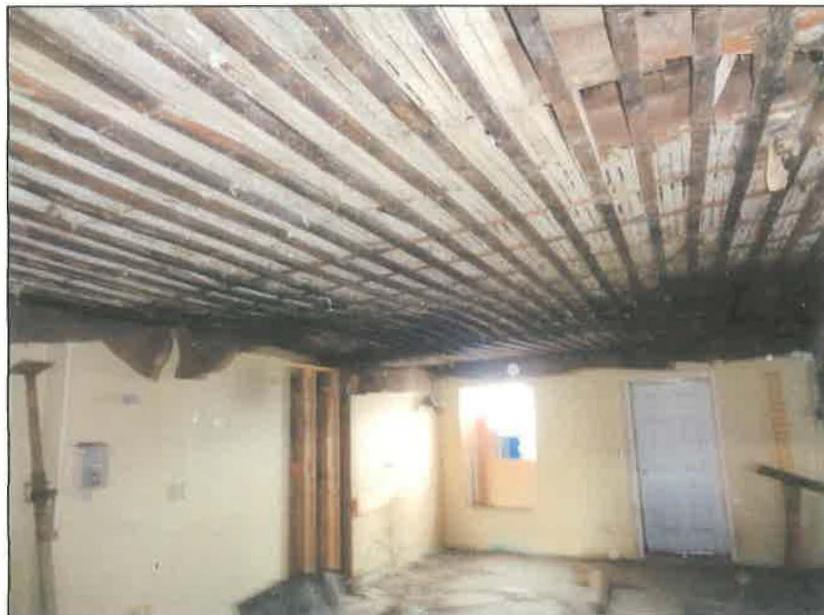
Photograph 5 shows the Northerly rear one third of the third level floor framing (as seen from the second floor), this exhibits gross deflection and heavy water damage. Floor joists have longitudinal fracture cracks through these members due to horizontal shear from being overstressed because of the deteriorated nature of the floor joists and being unable to adequately support the dead loads associated with the third floor level framing. This is unstable and a high hazard condition. The third floor should not be accessed by any personnel. In addition, the third floor is incapable of supporting any live loads. It shall be noted that the third floor level framing is failing as depicted in Photograph 6. A collapse of approximately $\frac{1}{2}$ of this floor system is considered imminent at this time. This will induce a partial collapse of temporary timber column

supports that were installed at the third floor level. These timber column supports and transverse bearing beams placed across the third level floor joists were used to provide supplemental support to the large roof truss members which are failing due to gross water damage and past fire damage.

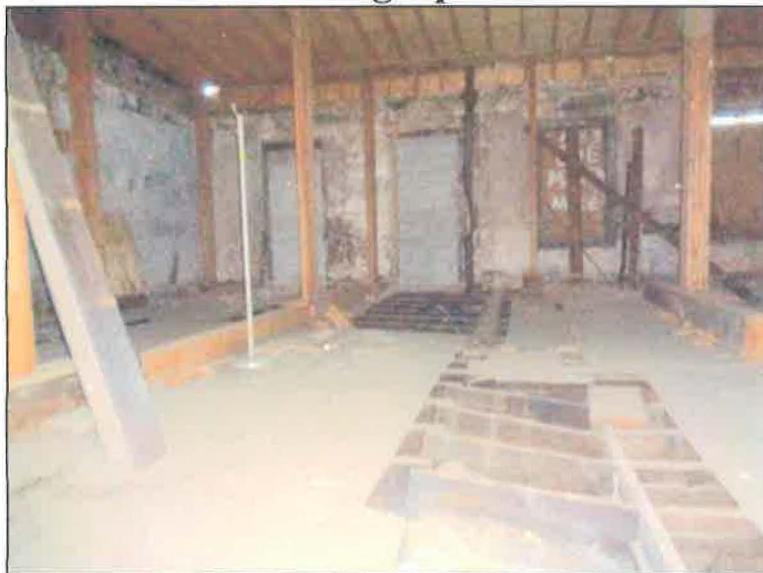
We were able to gain access to the third floor level through the center staircase in the front portion of the building at the second floor. This area is highly unstable. Photograph 7 shows a typical view of a portion of this space on the third floor level looking at the rear Northerly brick

masonry wall. Lighting in this area and throughout the building is poor and is reflective in the quality of some of the photographs within this report.

Although difficult to see in the photograph, there is substantial deflection in the third level floor system. At one point, supplemental sections of floor joists were installed and nailed to the ends of 3" x 10" floor joists in order to achieve end bearing on the Easterly wall section. This was inadequate and is contributing to the failure of the third floor framing. This is more specifically shown in the lower portion of Photograph 7.

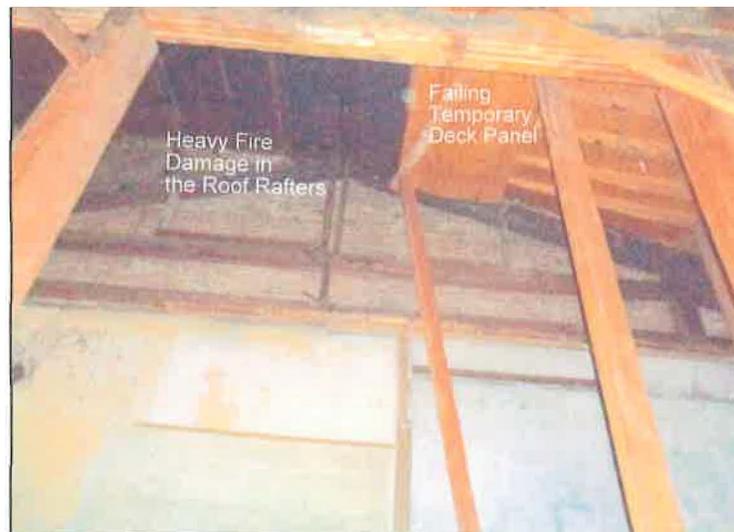
Photograph 8

Large sections of the roof joists have significant fire damage. A temporary repair was made by installing a plywood deck panel and 2" x 6" studding in an attempt to provide supplemental support to the damaged floor joists and roof decking. This is shown in Photograph 8. This plywood deck panel is now failing under the weight of the roof framing and the 2" x 6" column support is no longer plumb and is deflecting under the eccentric loads imposed to the column from the partial collapsing of this part of the roof. A collapse of portions of the roof section in numerous areas of the building on both sides of the structure is considered imminent at this time.

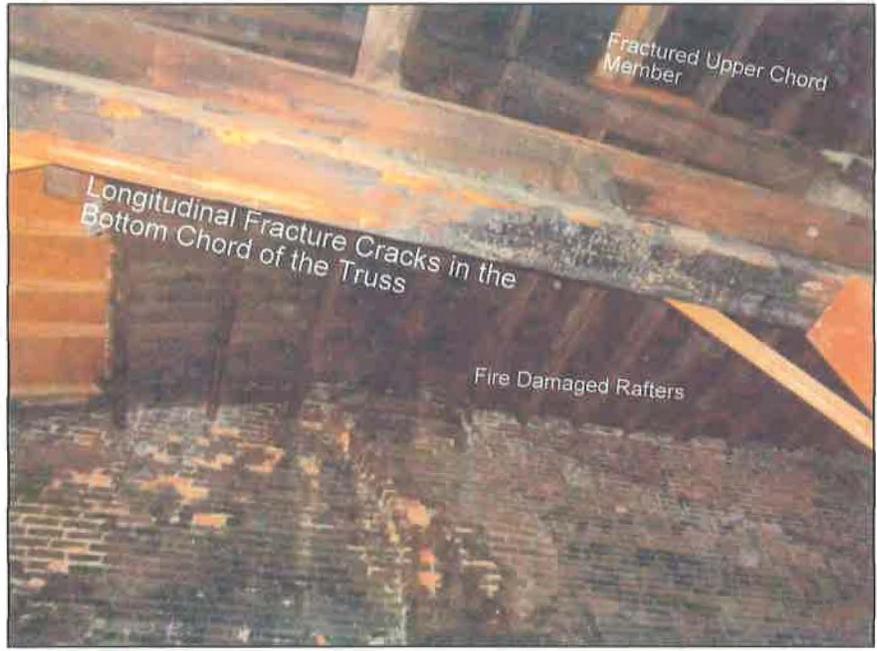
Photograph 9

When we entered the third floor common space, we found new fracture cracks that have opened up in the upper chord members and bottom chord members of the large timber trusses. Although difficult to see in the photograph, these fracture cracks are more specifically shown in Photograph 9. Also shown is some of the fire damaged roof rafters and underlayment. Photograph 10 shows gross floor deflection and

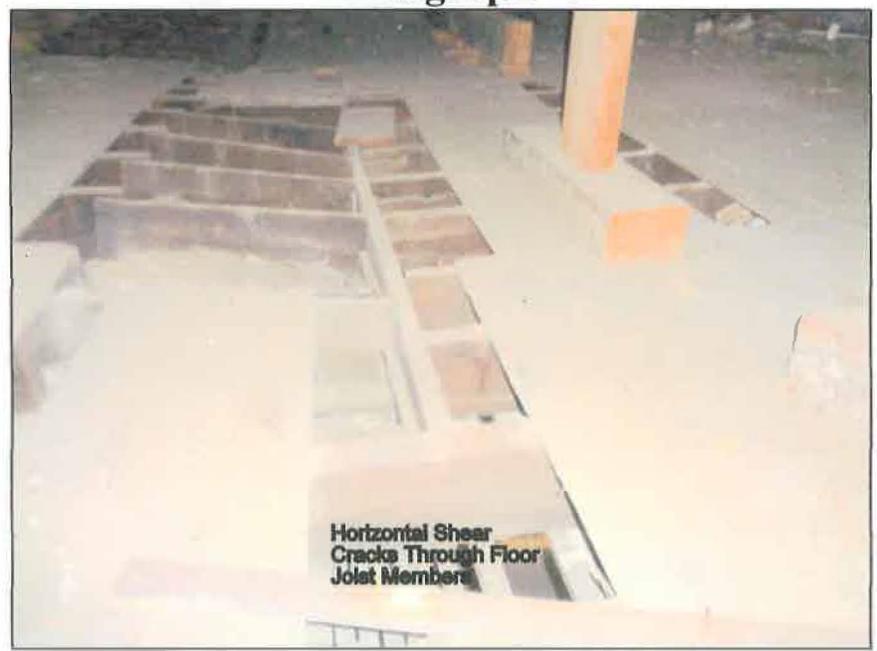
Photograph 10

horizontal fracture cracks through portions of the third level floor framing which are producing a highly unstable condition.

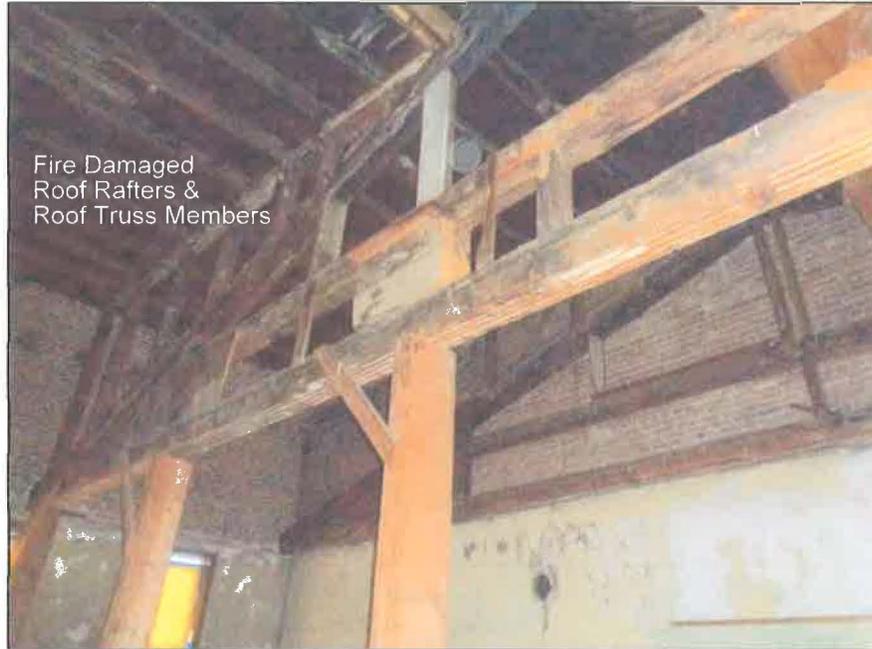
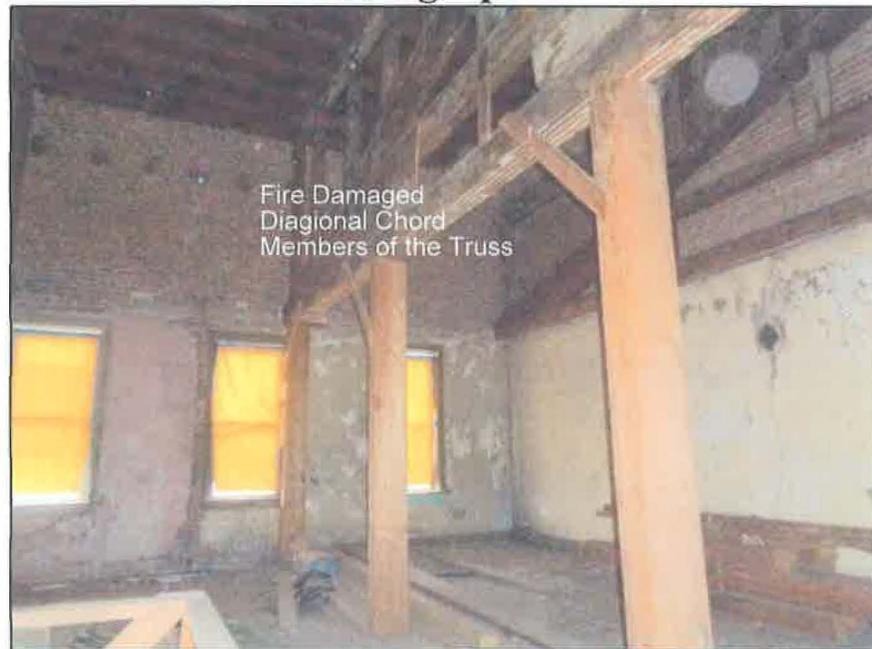
Photographs 11 and 12 show a deep timber truss section that bears directly on the front Southerly masonry wall. There is fire damage to both roof rafters and roof truss members in this area. Supplemental framing has been installed in an attempt to support the failing truss

sections. These elements are now considered highly unstable. It shall be noted that diagonal chord members are failing due to the aforementioned fire and water damage. Some deflection in these trusses are causing fracture cracking through the front and rear masonry walls.

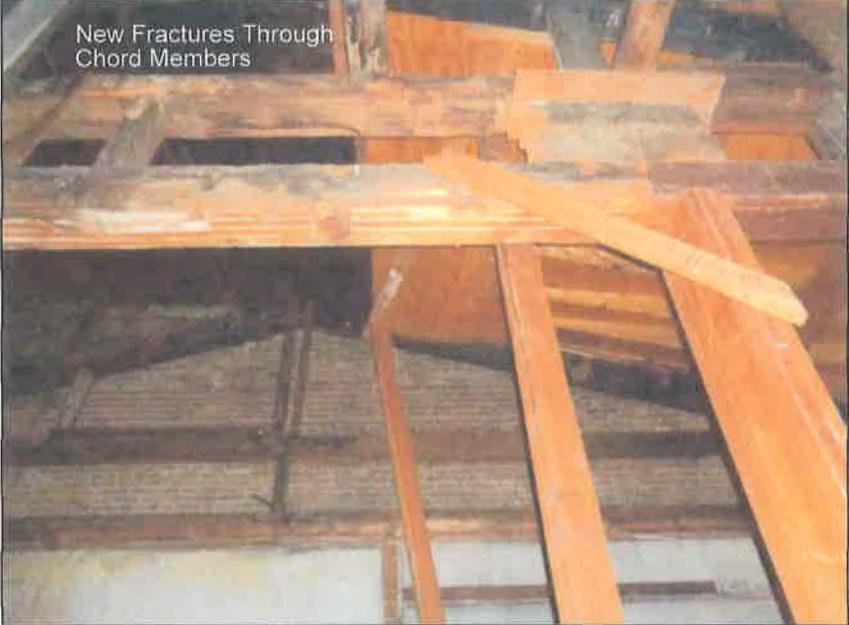
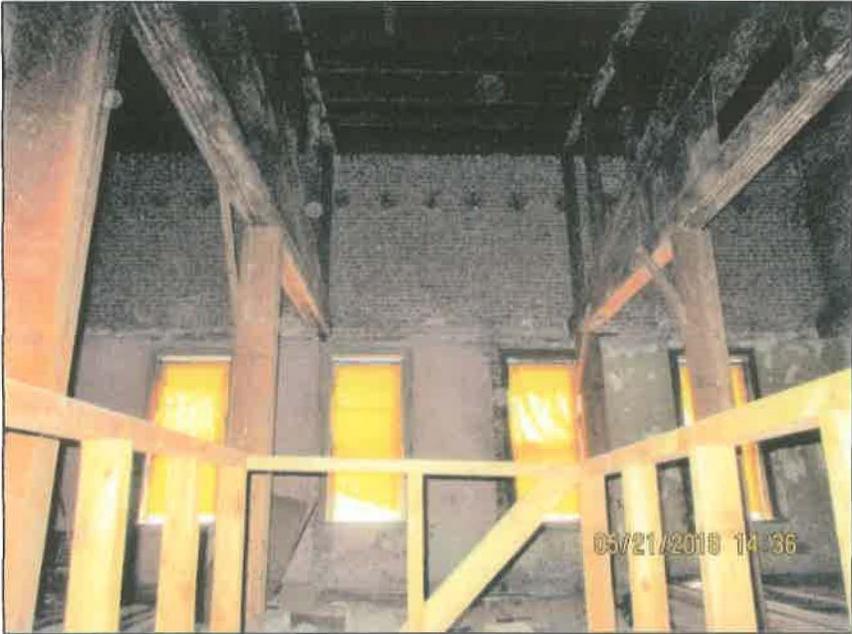
Photographs 13 and 14 show some of the blocking and column supports under truss members in an attempt to maintain load paths of support to the roof framing and trusses thus transferring these loads down through

subsequent floor levels and finally to the foundation. Maintaining the load paths was not properly achieved due to the failure condition that we encountered in the roof section, trusses and subsequent floor systems at each level thus making the building highly unstable. Access into the first and second floor levels of 20-22-Main Street shall be restricted. There shall be no access to the third floor level.

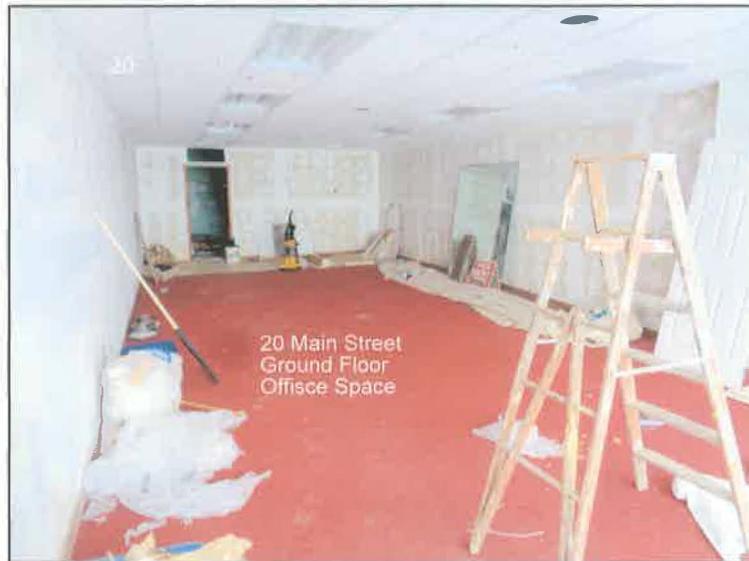
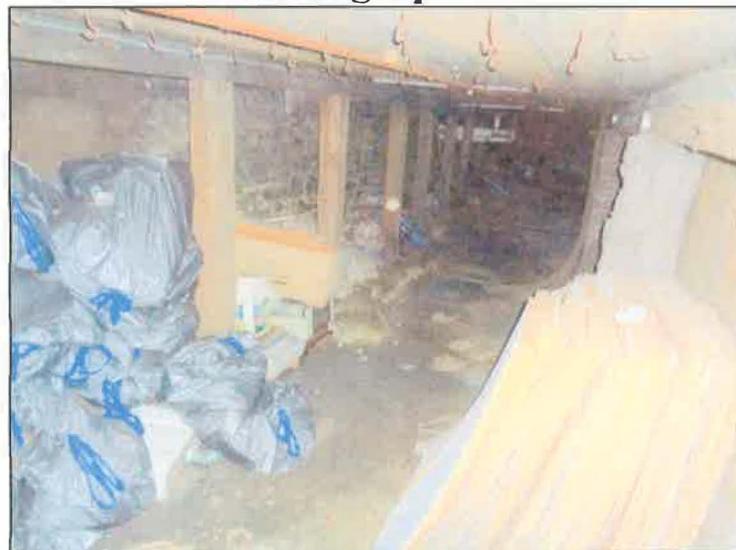
Photographs 15 and 16 show a typical view of the ground floor level office space of 20 Main Street which is on the Westerly side of the building and the basement area directly below this space respectively.

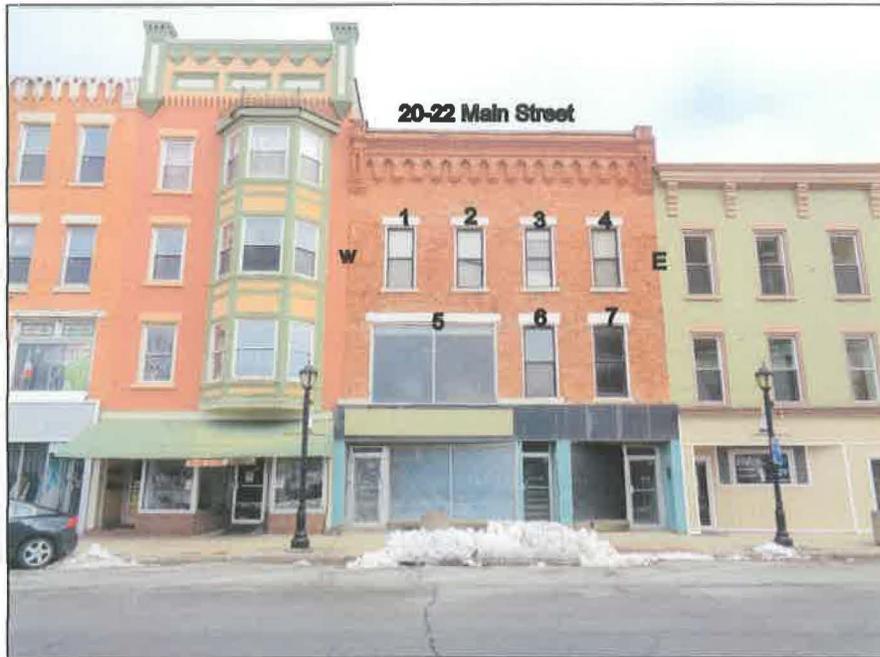
failure of any one of these structural systems will result in a partial and localized collapse of portions of the front and rear masonry bearing walls into the City Right-of-Way. This represents a substantial hazard to public safety. During the course of our evaluation, we observed numerous fracture cracks through the front and rear laid-up brick masonry bearing walls. This condition was due to the deflection and movement in the large truss sections which are structurally deficient and are now in a dynamic state due to inadequate support and failure in the third level floor framing and deficiencies in lower framing systems. Load paths at each floor level have been disrupted.

Photograph 20 shows the front elevation view of the building where we numbered the masonry stone lintels over each window opening where fracture cracking has occurred. Photographs 21 and 22 show an enlarged view of some of these areas.

The present condition of the building is considered a high hazard to public safety and shall be removed as soon as practicable under the City of Amsterdam's Emergency Condemnation Procedures. Any heavy wet snow loads will advance this condition.

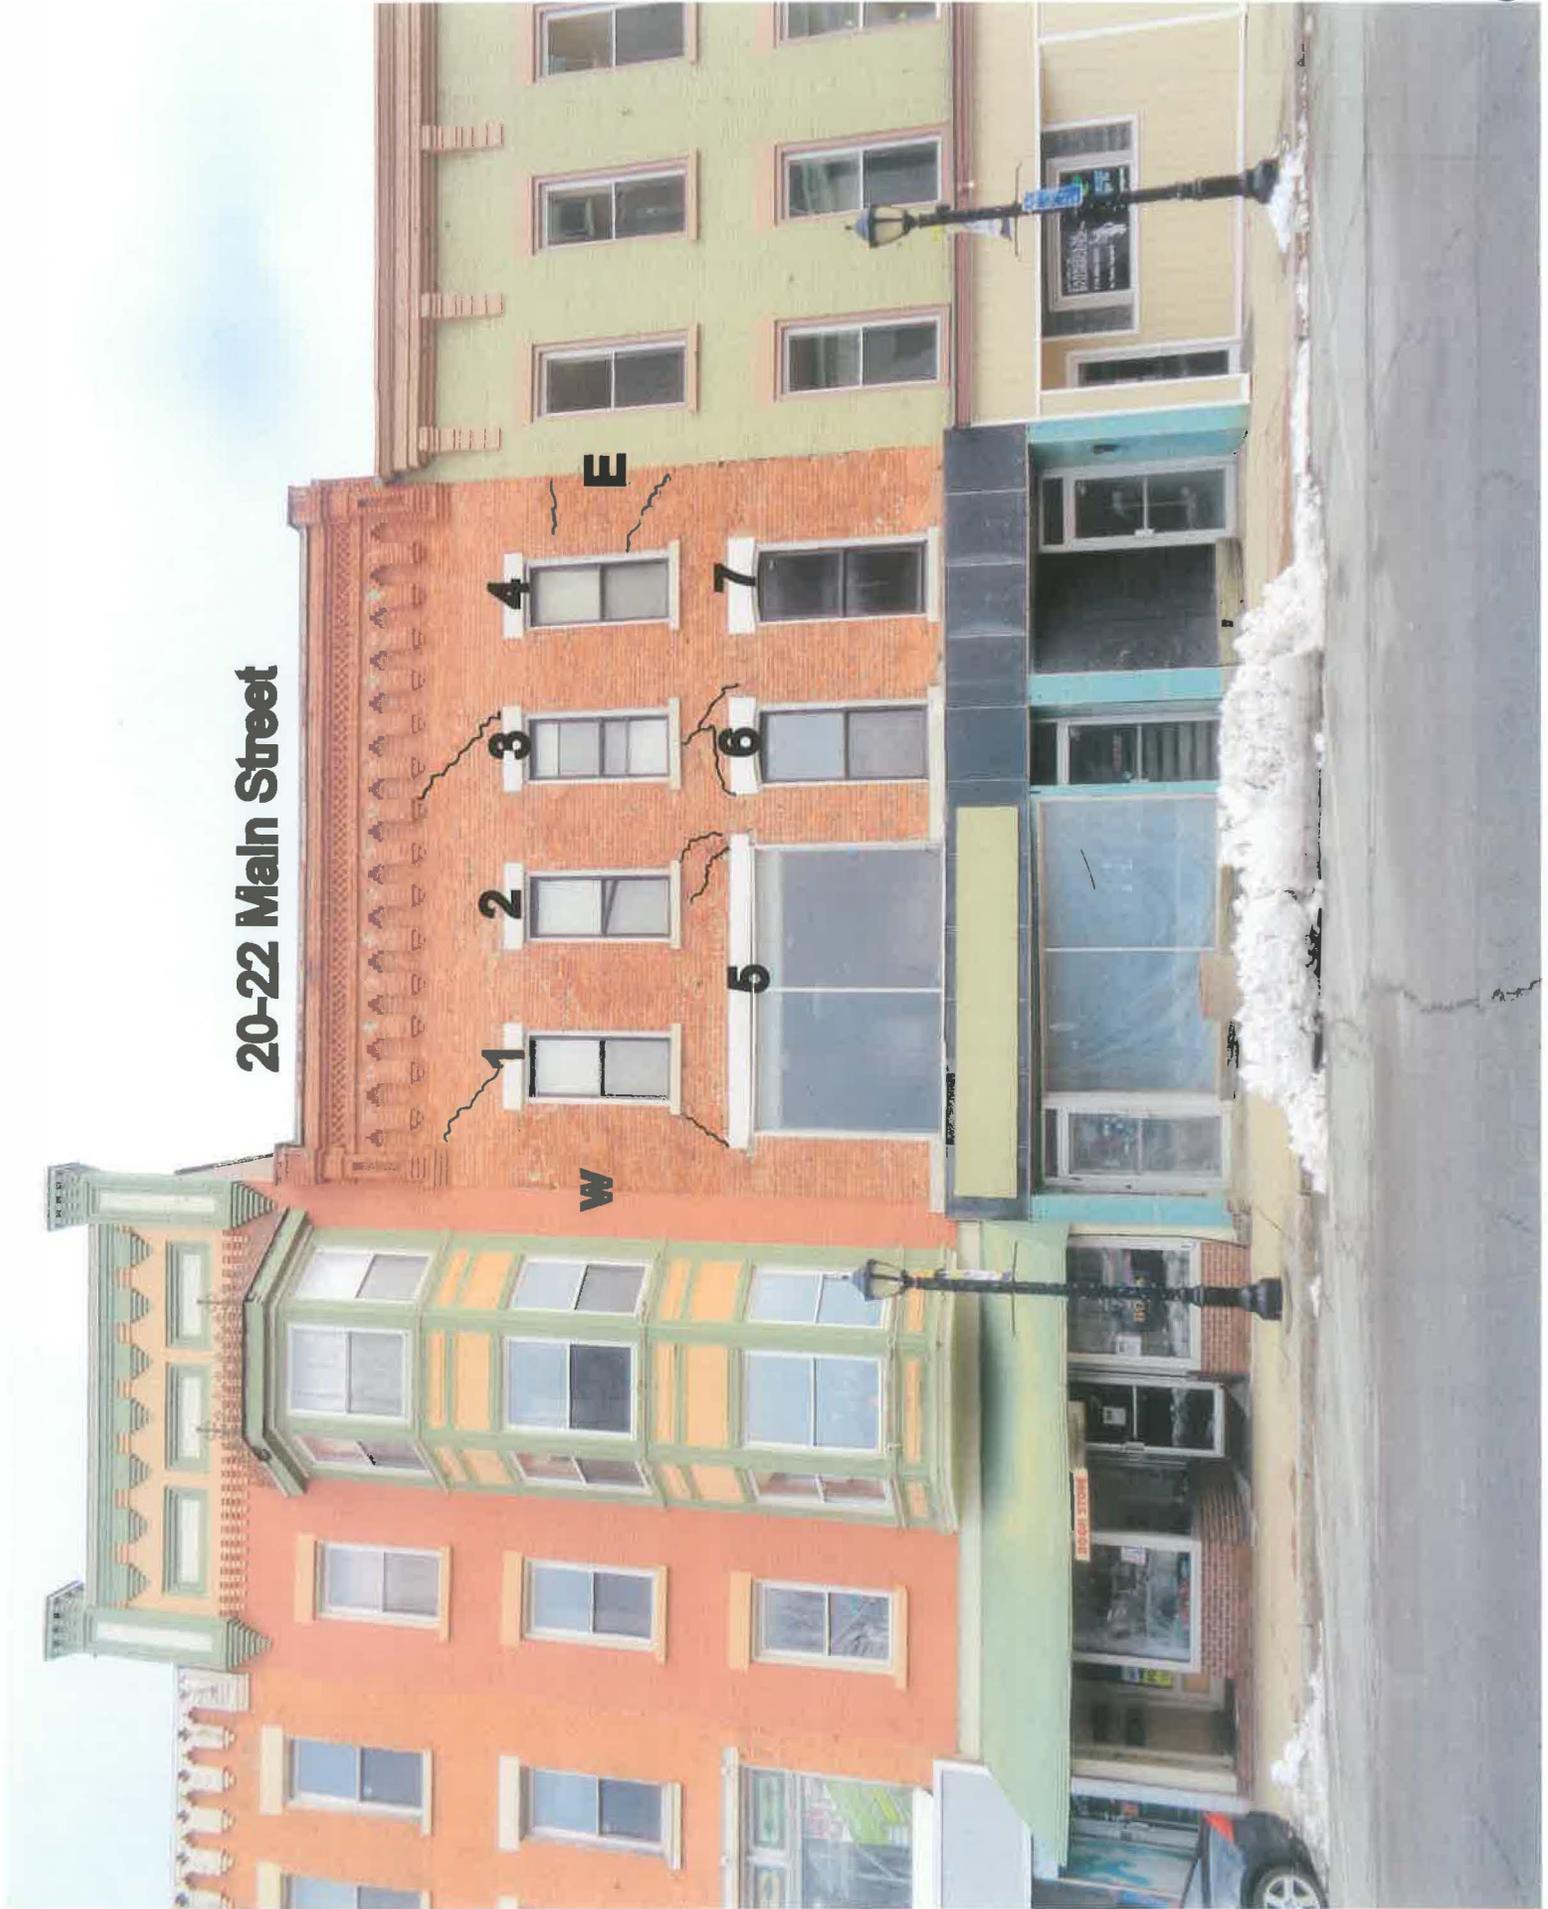
In order to understand the extent of the fracture cracking, we provide a subsequent photograph (at the back of this report) graphically depicting fractures throughout the masonry wall assembly which represent discontinuities in the front masonry bearing wall. This is producing a condition of instability in the wall and hence a hazard to public safety.
