# Cedaredge Golf Club Irrigation System Assessment

Prepared for:

**Mr. Adam Conway  
Golf Course Superintendent  
500 SE Jay Avenue  
Cedaredge, CO 81413**

# **Cedaredge Golf Club Irrigation System Master Plan**

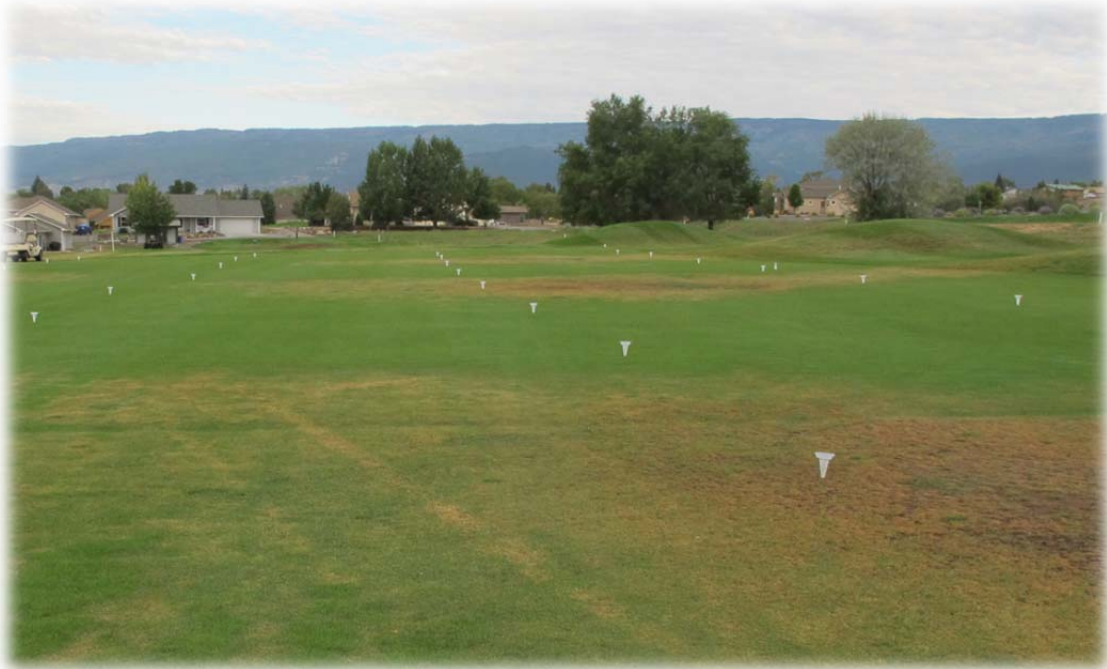
*Picture 1. Catch Can Collection Setup - 5 Fairway*

During the data collection process, two (2) areas had the sprinkler application performance tested (picture 1). A number of catch cans were placed in the fairway area and the sprinklers were operated during a normal overnight irrigation cycle. The sprinklers in the test area were GPS mapped and the water collected in the catch cans was noted during (see pictures 2 &3).

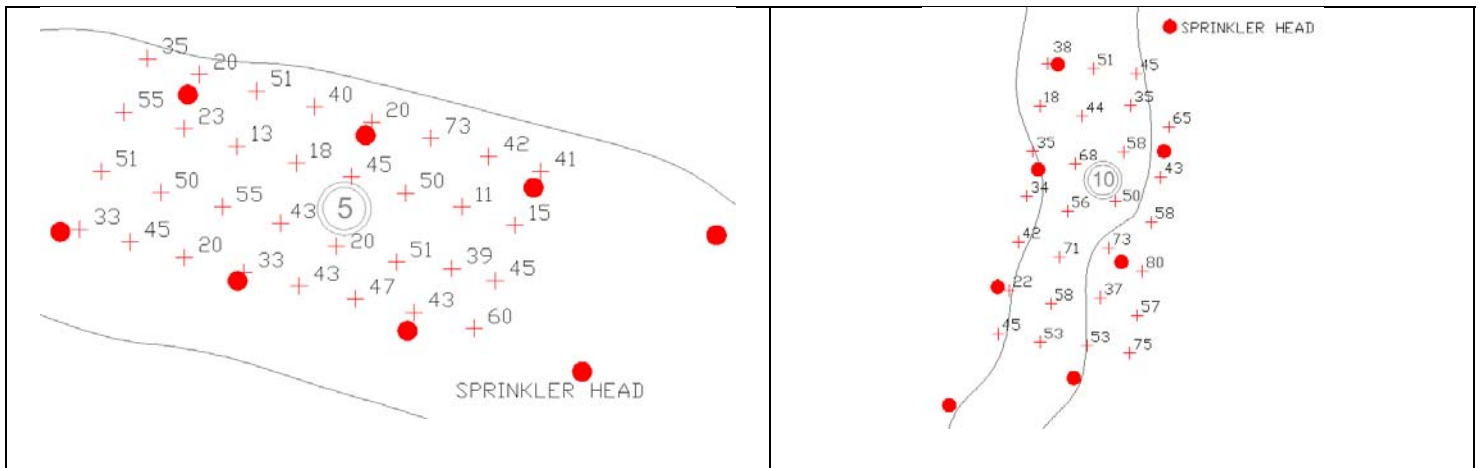
Picture 2 & 3. Collected volumes of water in the catch cans. Volumes shown are in ml.

Sprinkler application performance is defined by a sprinklers ability to apply a uniform amount of water across its range of throw. This is termed Distribution Uniformity or DU. A sprinklers DU is expressed as a percentage. 80% and greater is considered excellent, 70% good, 60% fair and 50% or lower is poor. The two test areas, 5 fairway and 10 fairway performed at 48% DU and 66% DU respectively. To help understand why the areas tested as they did, additional data collection occurred.

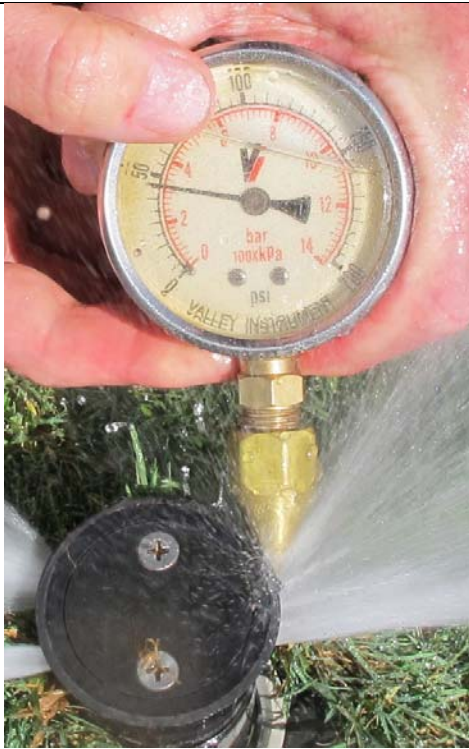
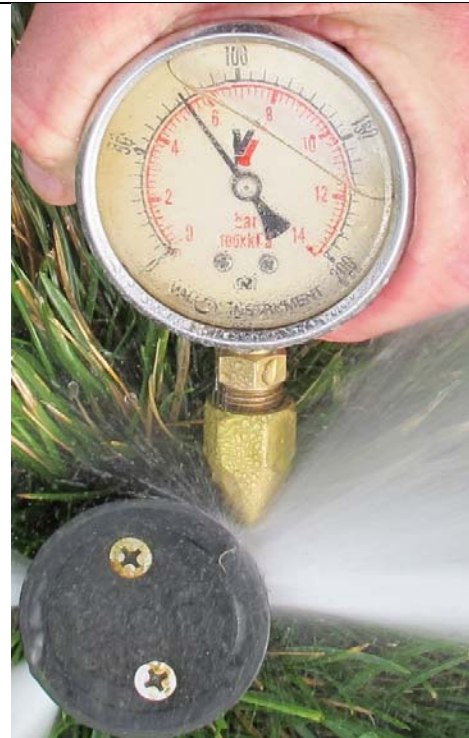
The operating pressure of several of the sprinklers was checked and the average pressure for the heads on 5 fairway is 45-48 pounds per square inch (psi). The pressure of the heads on hole 10 was in the 75-78 psi range (see pictures 4 &5). The sprinkler heads must have a discharge pressure of 80psi to attain the 65' radius of throw that matches the sprinkler head spacing. The sprinklers on 5 fairway are not performing at an acceptable level due to lack of pressure. The heads on hole 10 have adequate pressure.

Pictures 4 & 5 Sprinkler head pressure testing during operation. The sprinkler on the left is on hole 5 and has an operational pressure of less than 50 psi. The picture on the right is a sprinkler between the driving range and hole 10, with an operational pressure of 78psi. Optimal operating pressure is 80 psi.

- Adjust sprinklers to the same pressure discharge.
- Install the same nozzle in the same model sprinkler. Select a nozzle that will provide a minimum throw of 65' with the pressure available at the sprinkler head.
- It is important to note that sprinkler heads need to have the same nozzle, pressure, and spacing to apply a uniform application of water.
- Replace worn nozzles with new.

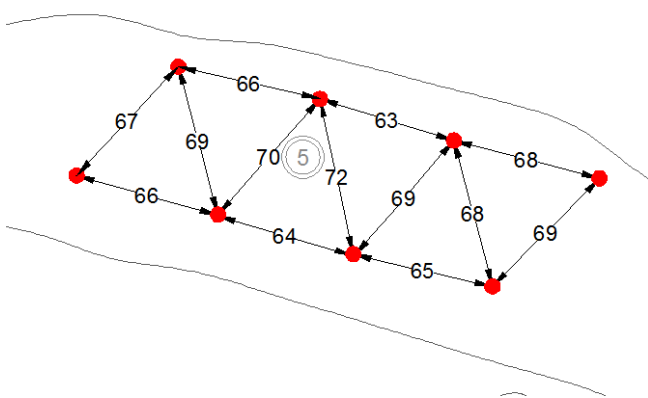
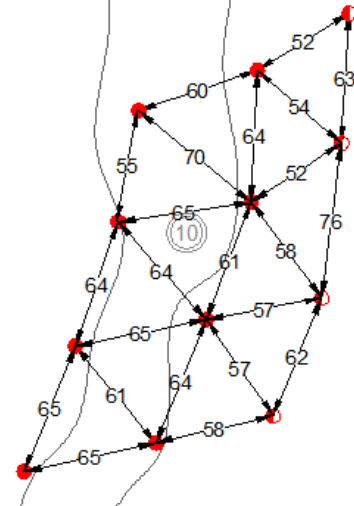
Pictures 6 & 7 – Head spacing on 5 fairway and 10 fairway. Spacing is relatively uniform and is not limiting the performance of the sprinklers. The ideal spacing is 65'.

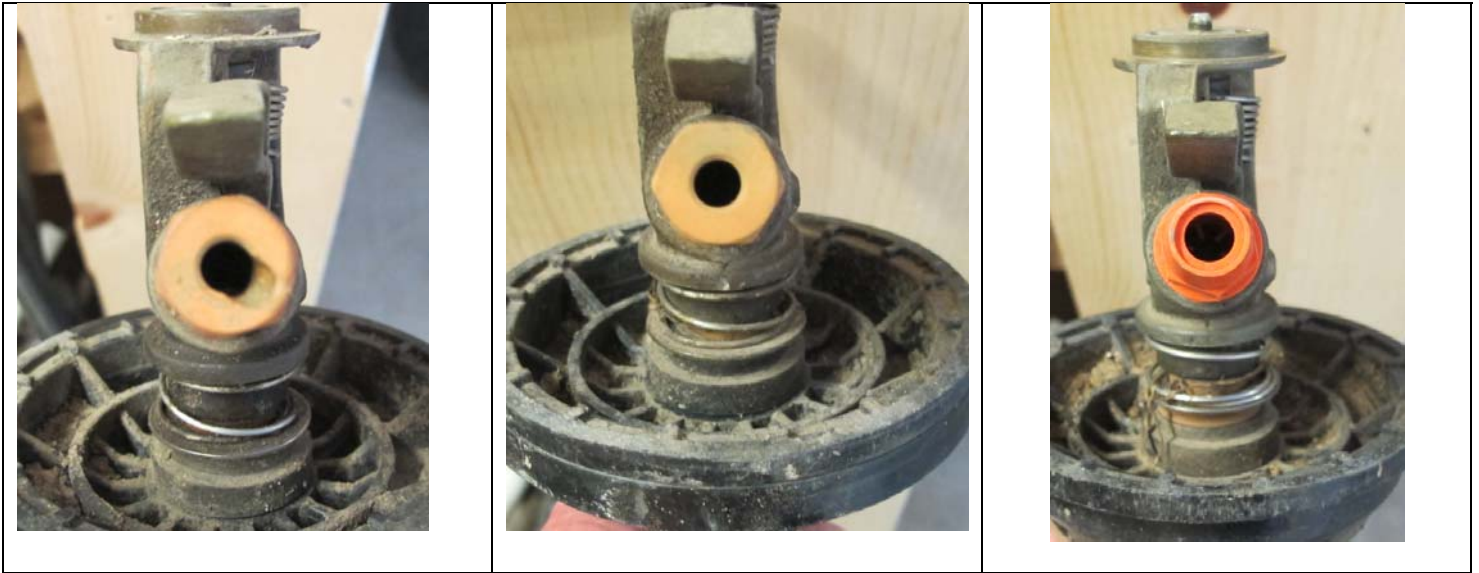
*Pictures 8,9,10 – All three heads shown are the same Rainbird model 51 sprinkler. Note the nozzle wear in the left picture at the 4 o'clock position. A non-visibly worn nozzle appears in the middle picture. The picture on the right shows a plastic nozzle in the same model. Three of the same head, three different nozzle conditions/types.*

There is a wide variety of nozzles in the sprinklers at Cedaredge. Different nozzles apply different amounts of water and can have a different radius of throw. To maximize sprinkler uniformity performance, the same nozzle needs to be in the same model sprinkler. It is important that the sprinkler flow rate noted in the central computer database match as closely as possible the flow rate of the nozzle. This allows for accurate water use and application data.

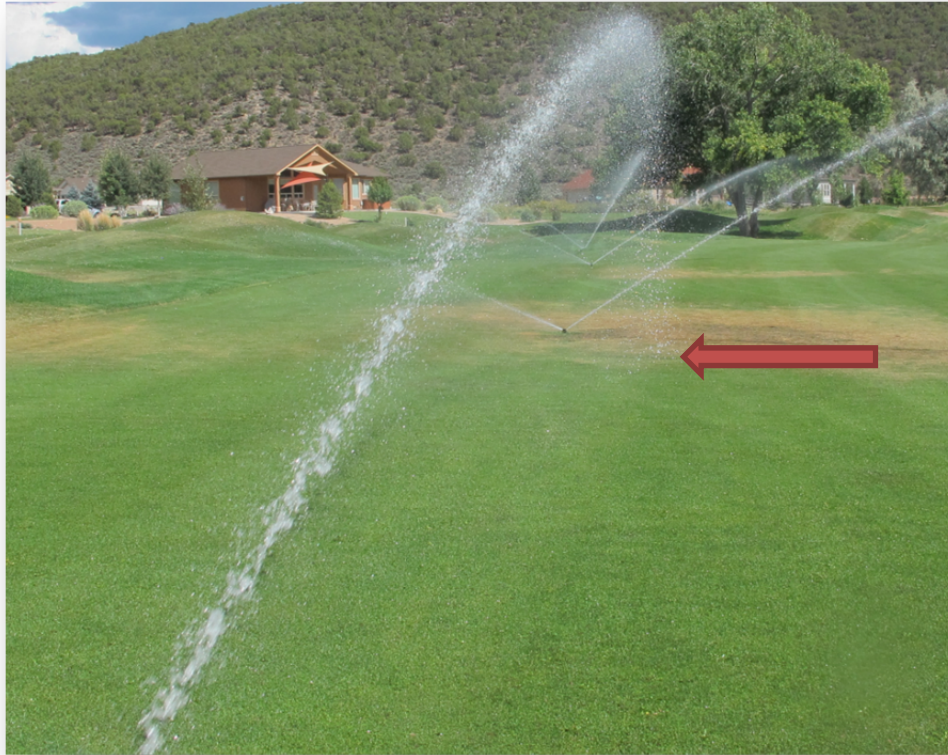
The sprinklers are designed to have a radius of throw that will reach other surrounding sprinklers. This is referred to as 'head to head coverage'. Because of the low pressure on the front 9 holes, very few of the sprinklers have the necessary head to head coverage. Without the head to head coverage, the sprinklers need to run longer to help mask the inefficient application of water, and in some cases thin turf will result (see picture 11).

*Picture 11. Hole 5 fairway, inadequate sprinkler pressure is the leading cause of the thin/brown turf. The other heads that help irrigate this area do not have 'head to head' coverage and also contribute to the poor turf condition. Note the nozzle stream is only irrigating to the near edge of the brown turf (see arrow).*

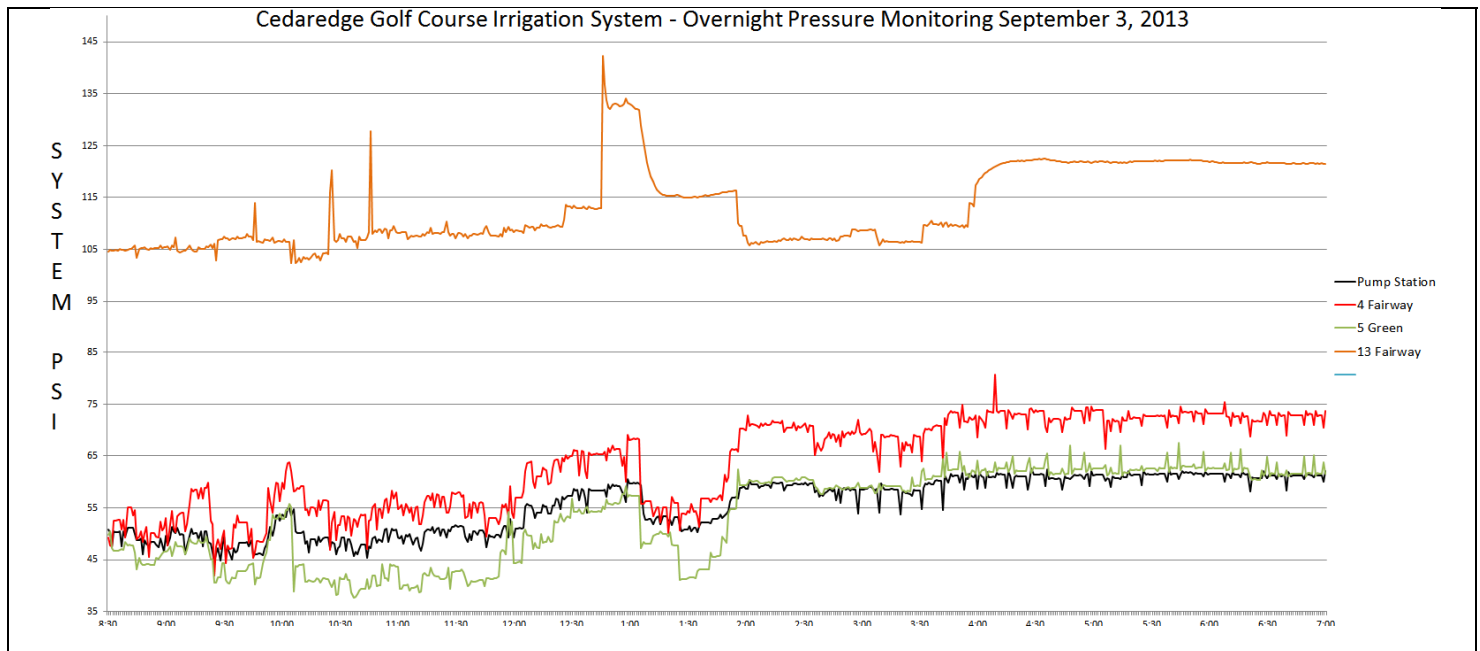
To understand the pressure that is available during the irrigation cycle, (4) pressure monitoring devices were installed during an overnight irrigation cycle. Devices were installed at the pump station, 4 fairway, 5 green, and 13 fairway (see graph 1). The pressure at the pump station, 4 fairway and 5 green is very low, between 38-75 psi. Keep in mind that the sprinklers perform best with 80 psi at the head. The pressure at 13 fairway is actually higher than it needs to be and could be reduced at the existing pressure reducing valve (PRV) located near 11 green. The PRV was examined during the site visit and was found to be covered with soil inside the

valve box. The PRV should be cleaned and checked at the beginning of every season to verify that it is operating as designed. Based on the collected pressure data the PRV is working, but a pressure spike that occurred around 1:00am and another around 4:00am raise some concern that the valve should be looked at and adjusted as needed.

Graph 1. Pressure monitoring at the four locations around the course (full size graph in appendices).

- Improve the pressure for the heads on the front 9.
- Clean out the valve box that contains the pressure reducing valve. Install a pressure gauge on the upstream side and downstream side of the valve. That will allow for a quick check to see if the valve is functioning properly.
- Have the PRV checked for proper operation as soon as possible and at the start of each irrigation season. The suggested maximum operating pressure for Class 200 PVC pipe is 160 psi. If the PRV valve is not operating properly some portions of the pipe network could be subject to pressure in excess of 160psi.

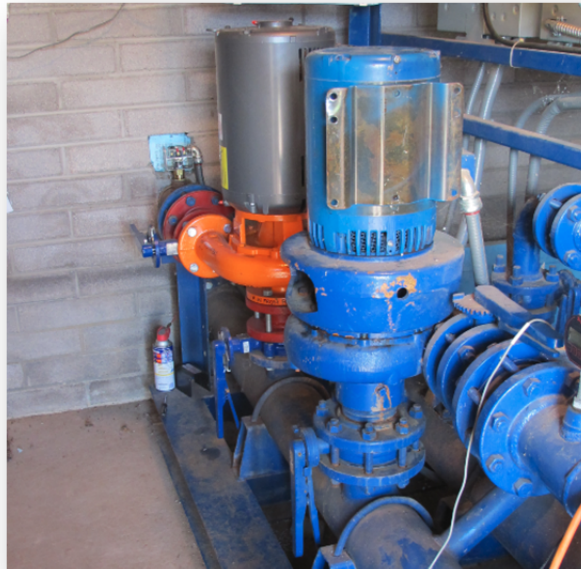
The pump station near 4 green contains two (2) pumps. One of the pumps is a 15hp pump that supplies water to the cemetery. The second pump is a variable frequency drive (VFD) controlled 10 hp pump that can provide water to the holes on the front 9. The pump is supplied water from an off-site pond located at E Main Street and NE 4<sup>th</sup>. The source pond is located approximately 130' higher than the pump station. The difference in elevation provides approximately 56 pounds of static pressure to the pump station. At the current time the pump is not operational. During the data collection process, it was determined that even if the pump was operational it is not sized properly to provide the necessary volume or pressure for the front 9 holes. An initial design analysis identified that a properly selected 40hp pump and motor would be able to supply 800 GPM flow rate with a 50 psi boost. The boost would allow the sprinklers on the front 9 to operate at 80 psi and greatly improve the performance of the irrigation system.

*Picture 12. Pump station. The 10hp motor is in the foreground part of the picture.*

- Contact a pump company to examine the existing pump components and start the station. Identify the flow rate and pressure that the 10 hp pump will supply.
- Replace the pump and motor if it does not provide 800GPM with a 50psi boost, for a station discharge pressure of 90 psi.
- Consider replacing the pump station with a pre-fabricated pump station from Rainbird, Flowtronex or Watertronics. These companies specialize in building pumping stations for golf course applications.
- Install a simple and inexpensive wye strainer type filter to prevent debris from entering the mainline pipe network.

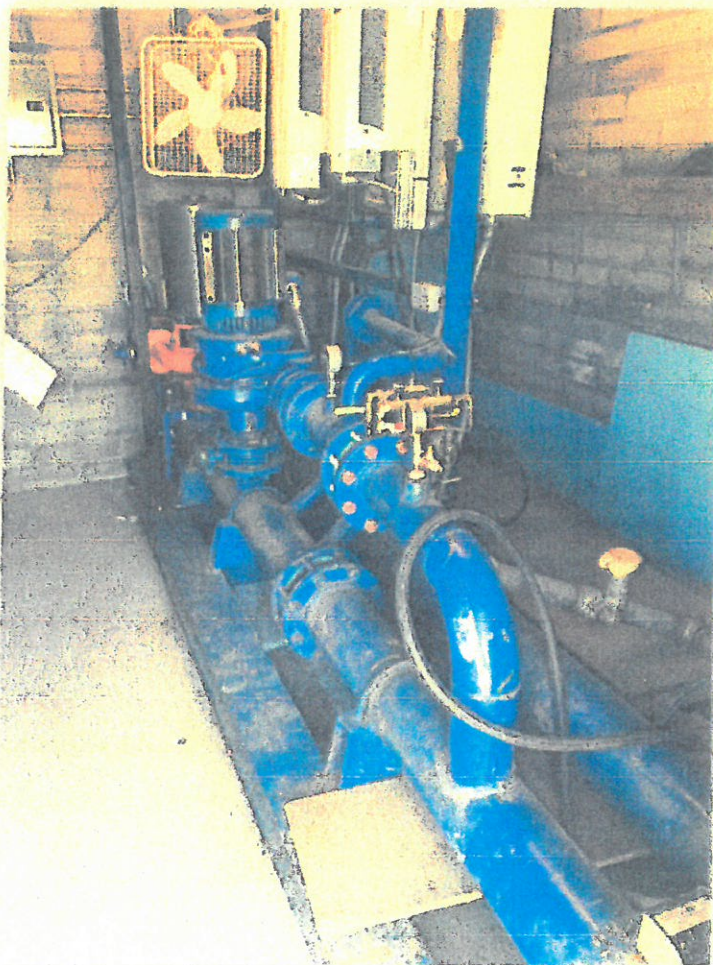
*Picture 1. Current Golf and Cemetery Pump Station Configuration*

The current pump station configuration supplies water to the cemetery and golf course from one pump station unit. The pump does not have any filtration. The current status has the cemetery pump working but the golf course side of the pump is not working. The golf course irrigation system is irrigated by gravity pressure from an off-site pond. Replacing the pump station is an absolute top priority along with an inline filtration device. The 56 pounds of pressure coming from the pond source is about half the pressure needed to properly irrigate the front nine holes and holes 16, 17 and 18 on the back nine. Holes 10-15 and the driving range have adequate pressure supplied from the gravity supply side of the irrigation system.

Replacing the pump station with two separate pump stations would allow for a complete separation of the golf course and cemetery irrigation operation. Each pump station would be enclosed in a steel, lockable enclosure and have separate electric meters to allow for separate billing.

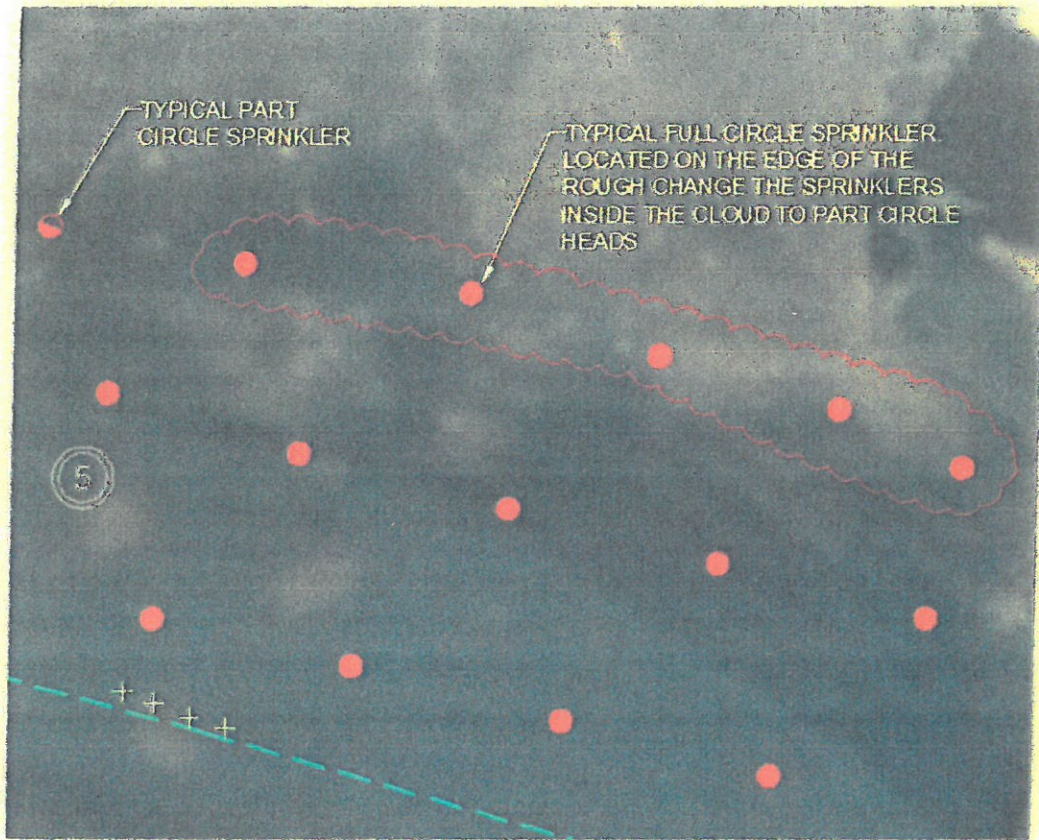
Picture 5. Full circle sprinklers that can be changed to part circle heads. There are approximately 70 full circle sprinkler heads that heads that are in similar areas relative to the edge of the grass line that can be changed.

Using the 2002 irrigation as-built as a guide and looking the sprinkler arcs relative to the limits of irrigation, there are several areas where full circle arc sprinklers can be changed to a part circle arc sprinklers. By changing the sprinkler from a full circle to a part circle the sprinkler run time can be reduced by 50%. The reason is that if a full circle sprinkler needs 3 minutes to complete a revolution, the part circle will need only half the amount of time to apply the same amount of water for half of the area. The downside to changing from a full circle to a part circle is that the area behind the sprinkler no longer receives water. About 70 heads have been identified that can be changed. Changing the 70 heads would allow for the run time on those sprinkler zones to be reduced from 15 minutes to 8 minutes. Each sprinkler applies about 20 gallons per minute. Water savings would be about 9,800 gallons per irrigation cycle, (based on a 15 minute full circle sprinkler run time).

The estimated cost to convert the sprinkler from a full circle to a part circle is \$150/ sprinkler.

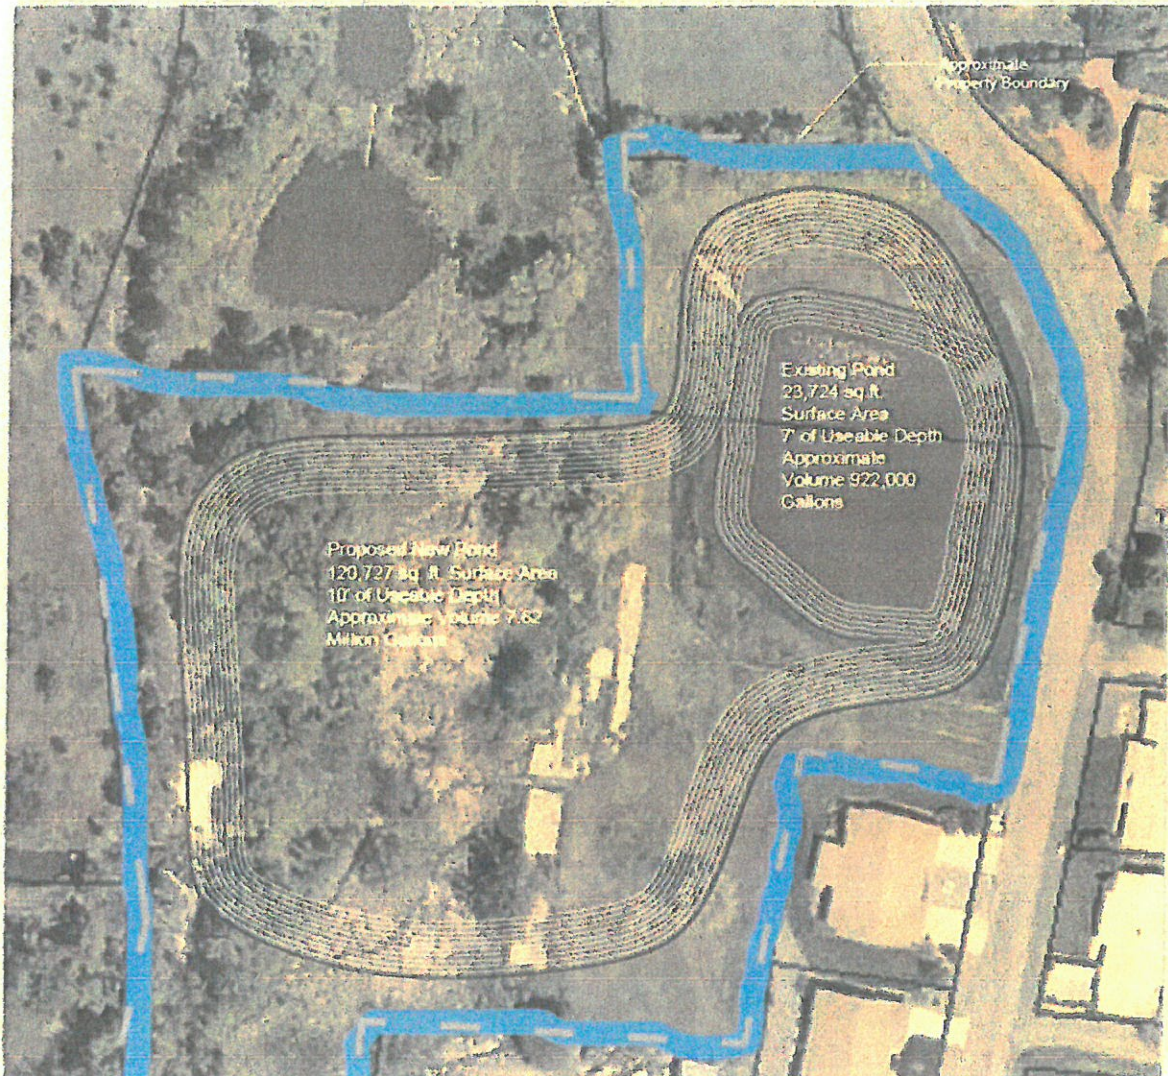
Picture 6. Existing Pond at the upper right side of picture, possible new pond shown in the center of picture

The current pond has a useable depth of about 7' and capacity of about 922,000 gallons, lacks a liner and has had the dam face leak in past years. During the peak irrigation, the golf course requires 700,000 gallons for one irrigation cycle. To refill the pond within a 24 hour period, an inflow of 486 gallons per minute is needed. Relying on a high inflow rate for the entire peak season is not a reliable mechanism. A better option would be

The town owns a sizable amount of land at the existing pond location and with some engineering thought a larger pond could be constructed. A very basic conceptual layout of a larger pond is shown in picture 6. The proposed pond has a useable depth of 10' and a capacity of 7.62 million gallons, nearly 11 nights of peak use storage. Building the new pond with a geomembrane liner will ensure that no water will be lost due to seepage. Piping the existing open ditch delivery system would also reduce water loss due to seepage through the ditch.
