PRELIMINARY REPORT

Pipeline

Over-pressure of a Columbia Gas of Massachusetts Low-pressure Natural Gas Distribution System

PLD18MR003

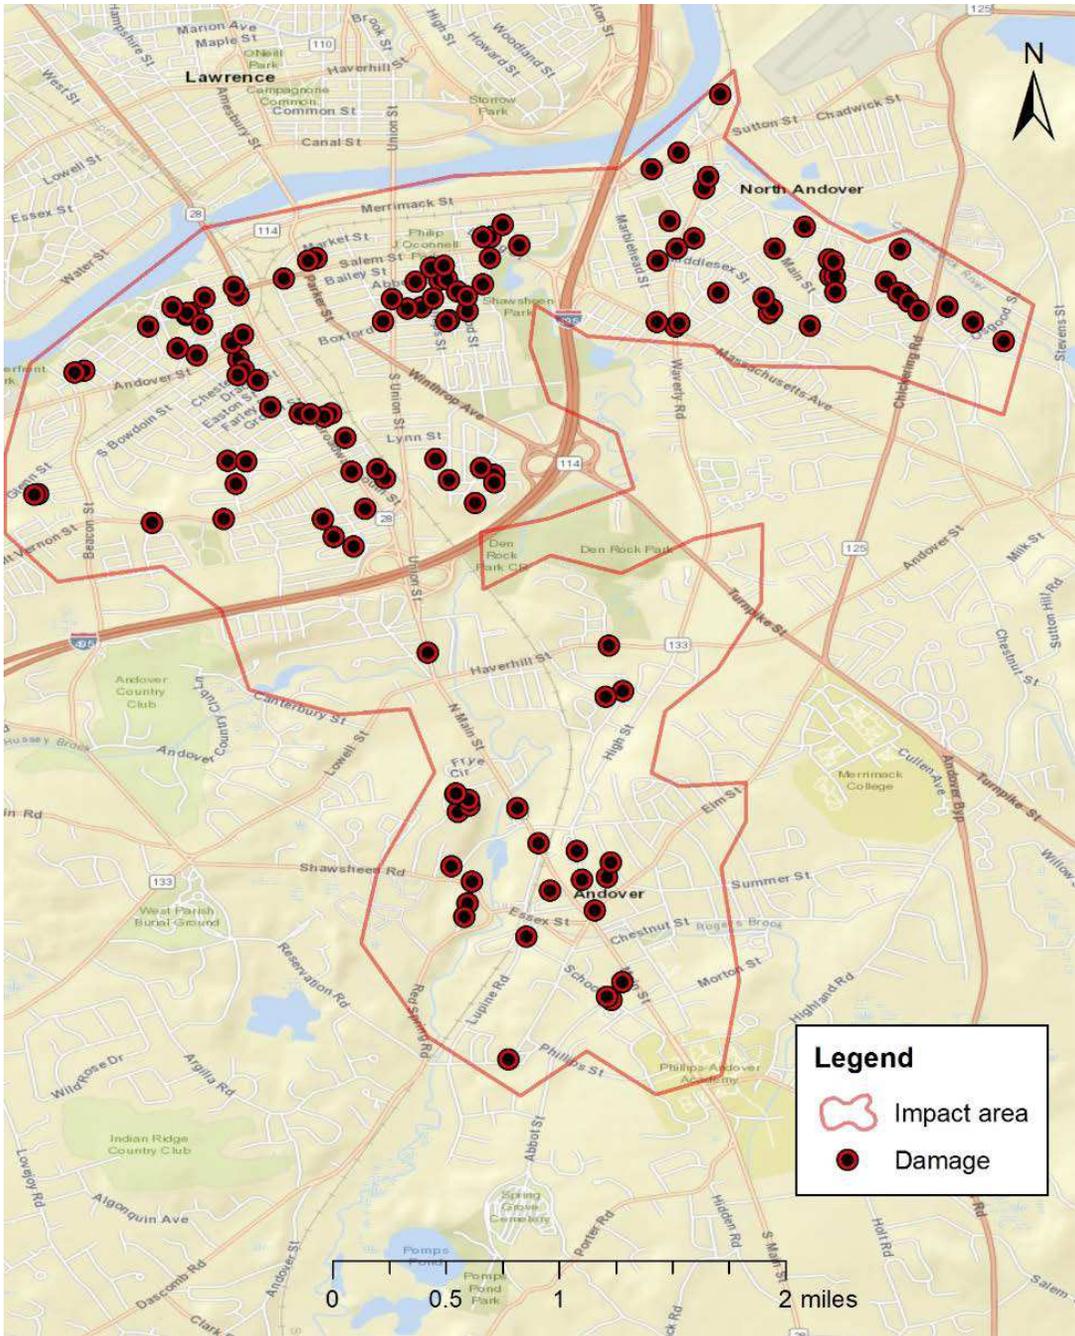
Figure 1. Area impacted by accident depicting structures that were damaged.

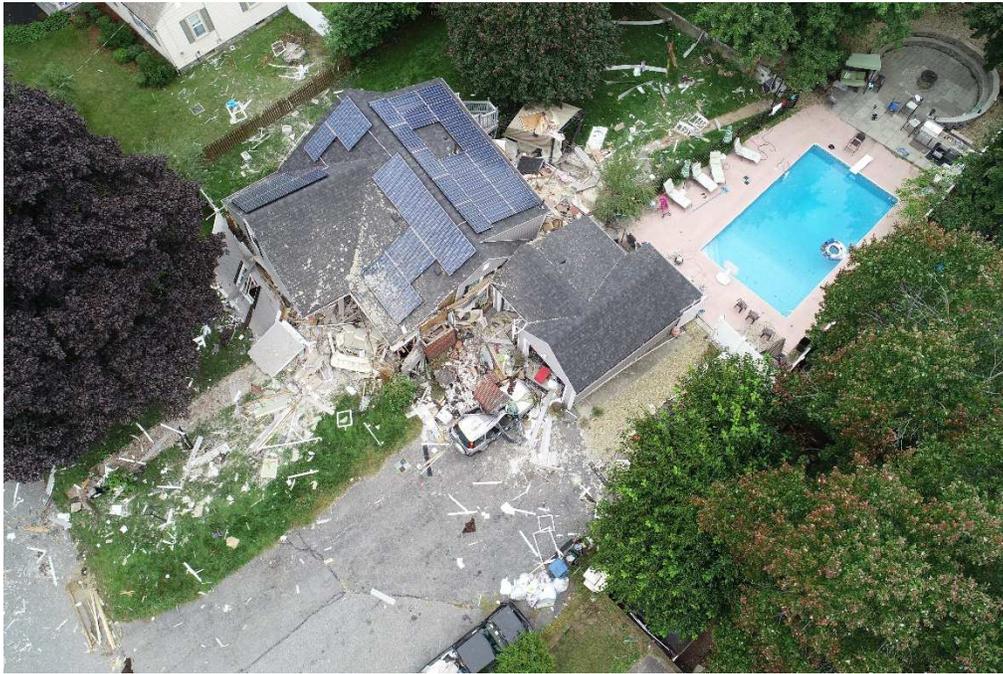
Figure 2. Aerial view of damaged home where a fatality occurred after the chimney collapsed on vehicle in the driveway.

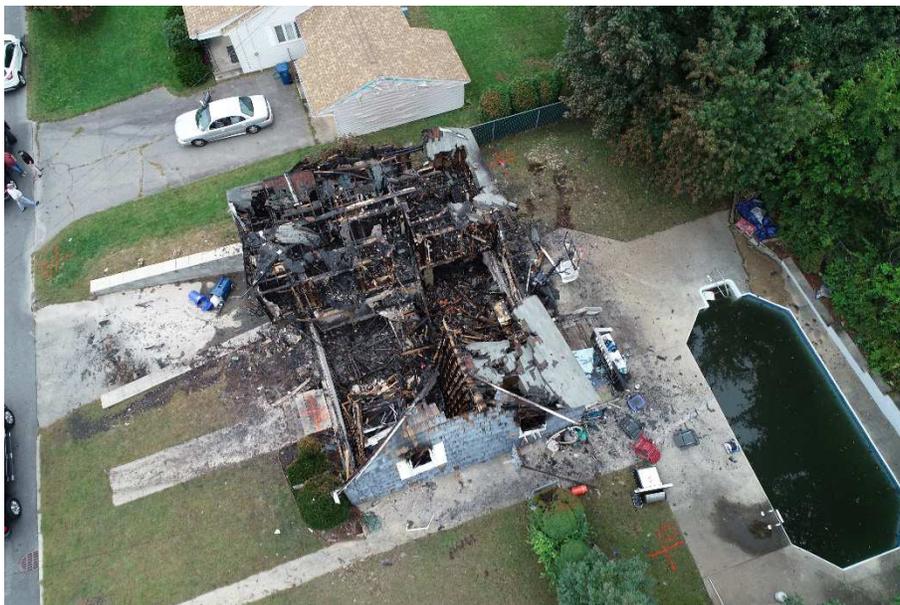
Figure 3. Aerial view of burned-out home impacted by the event.
