# Bridger Foothills Entrapment and Shelter Deployment

Facilitated Learning Analysis

**September 5<sup>th</sup>, 2020**

Montana Department of Natural Resources and Conservation  
USDA Forest Service, Region 1/ Custer-Gallatin National Forest

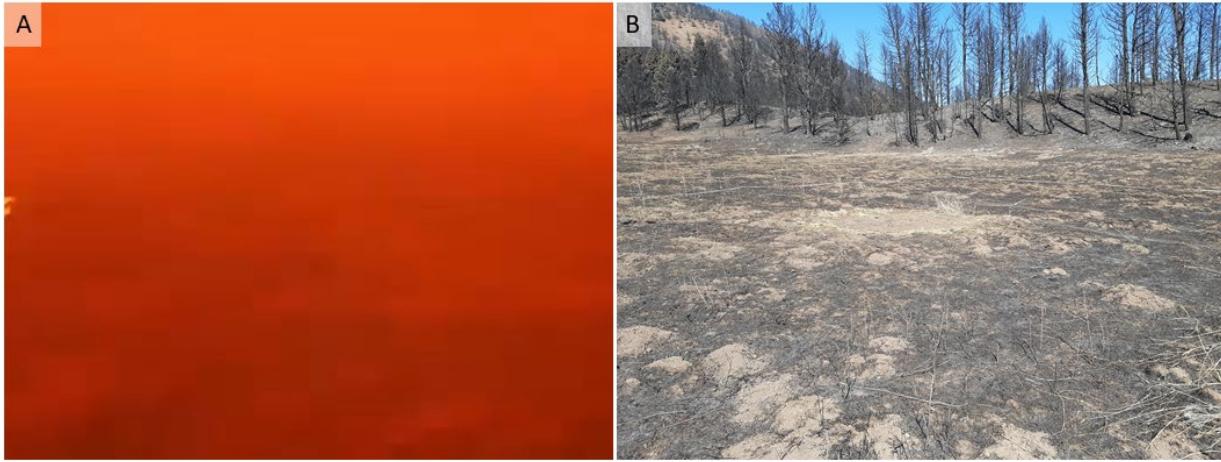
Figure 2A: Picture taken from the deployment site, when Casey and Charlie first emerged from their shared shelter and 2B: picture of the deployment site, taken a week after the incident.

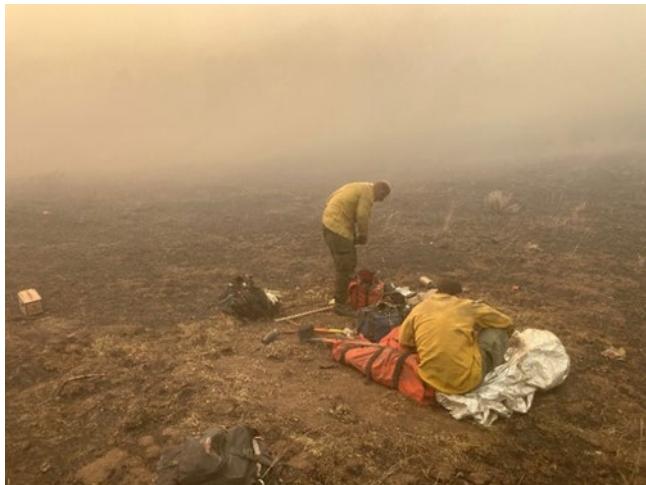
Figure 12: Photo taken by one of the crew members, immediately post-deployment.

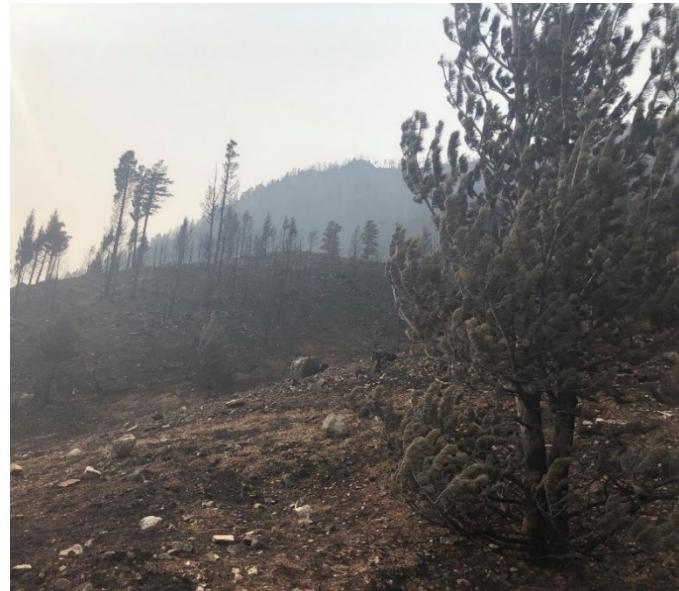
*Figure 13: A tree “frozen” in place by wind from the fire event. This picture was taken over a week after the deployment, near the fork in the two-track where the Helitack Crew waited for possible extraction before returning to the helispot.*

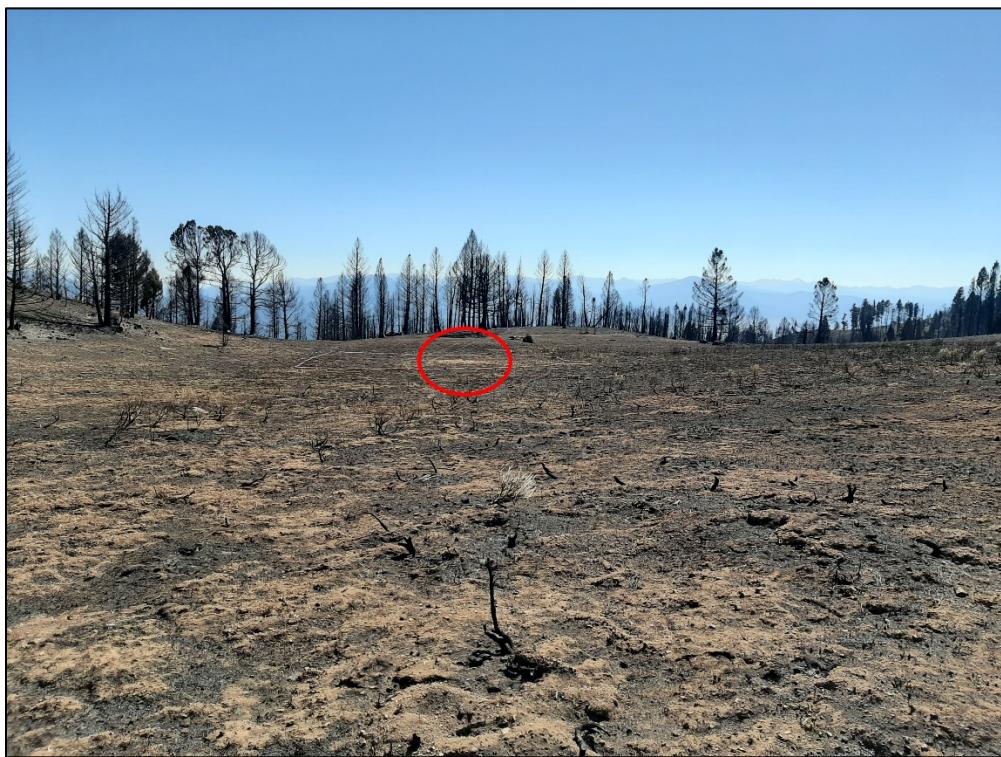
The shelter deployment site was located near the edge of a 12-acre, flat bench that dropped off into the valley below. The opposite end of the bench transitioned into rising terrain. The fuels around the deployment site consisted of 18- to 24-inch tall grass, sagebrush, and adjacent mixed conifers. The firefighters estimated that the winds were 35 to 40 miles per hour (mph), which shifted in many directions and gusted to higher wind speeds as the flame front passed over them. See figures 1 and 2.

*Figure 1: The area surrounding the deployment site looking towards the edge of the bench that drops into the valley below. The deployment site is circled in red.*

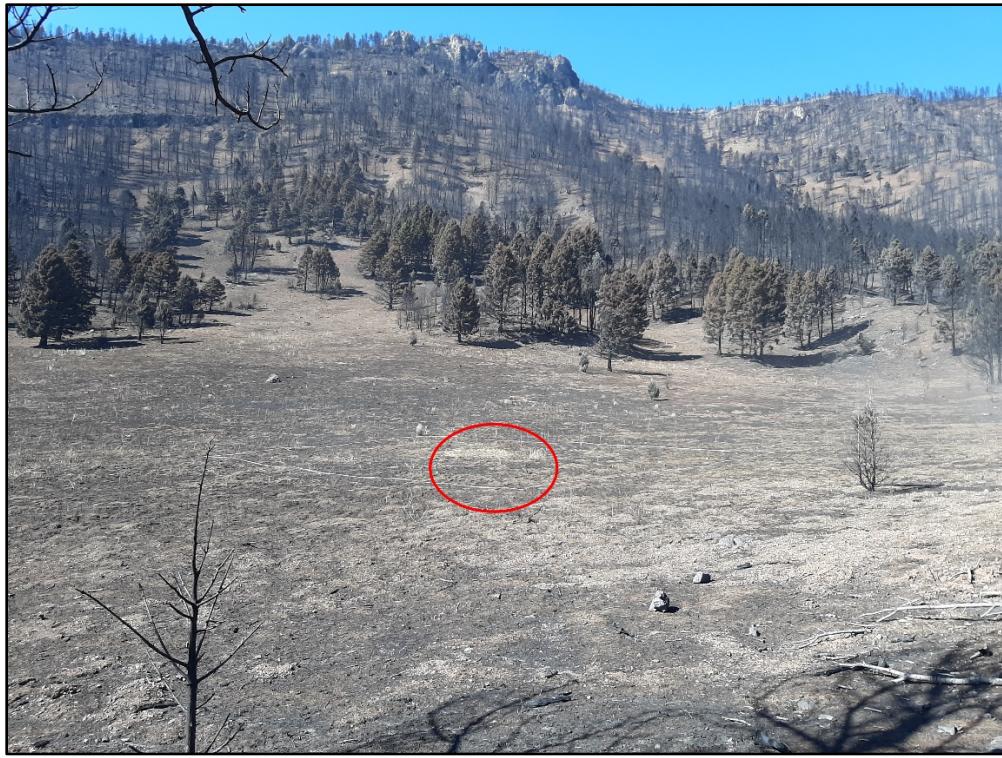
*Figure 2: The area surrounding the deployment site looking towards the rising terrain. The deployment site is circled in red.*

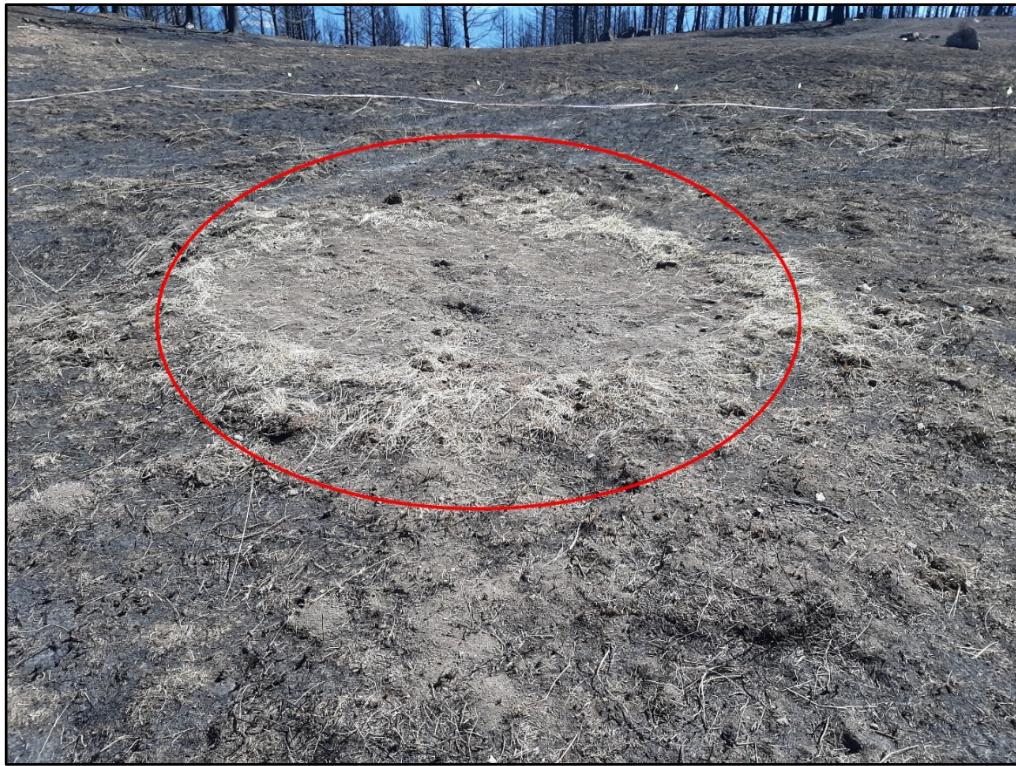
The shelter deployment site was an 8- by 10-foot oval that the firefighters had previously lined and scraped down to mineral soil. The firefighters used this area of bare ground to stage their extra equipment (food, water, flight helmets, overnight gear, etc.) during the shift. See figure 3.

Figure 3: A close-up of the deployment site. The deployment site is circled in red.

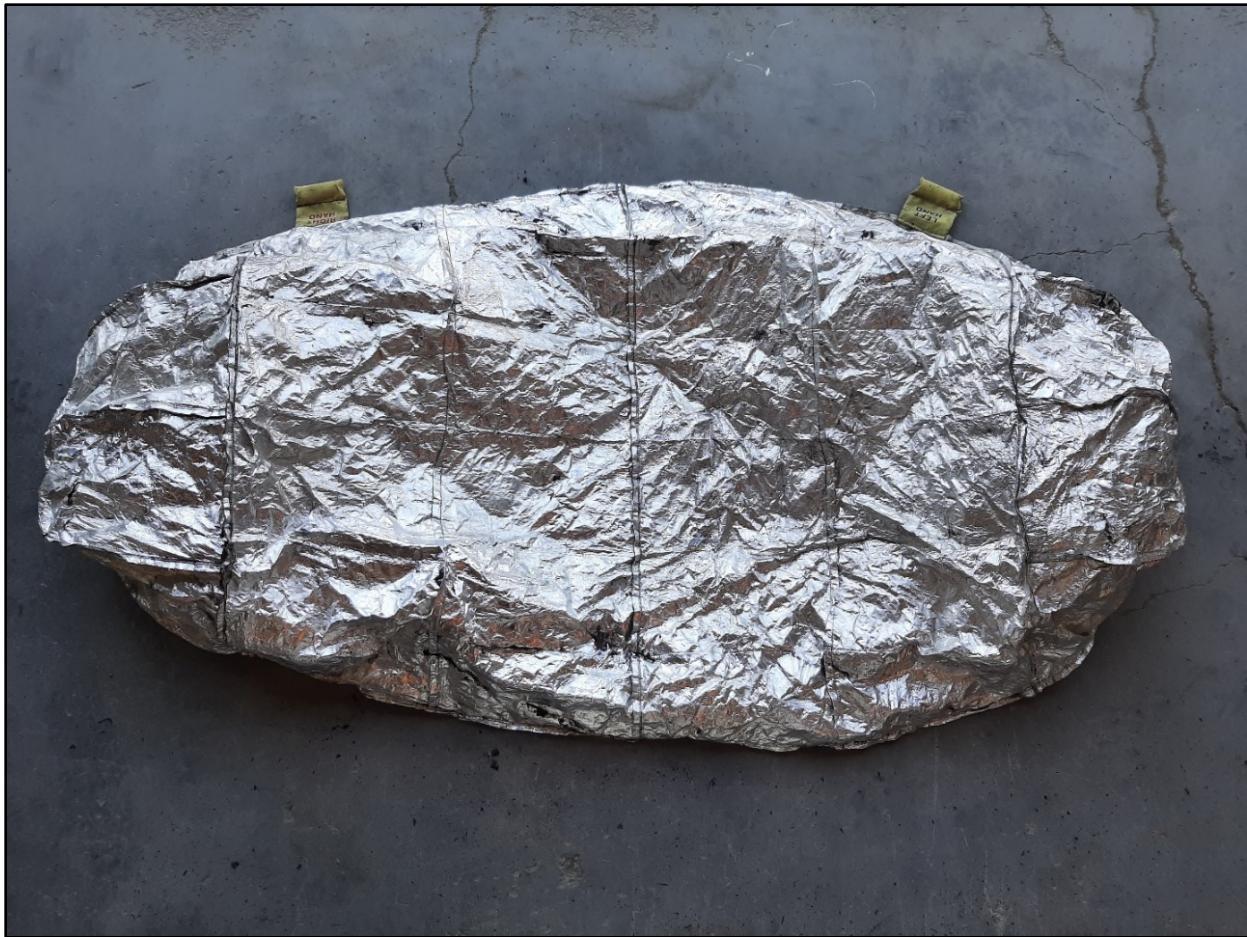
- Shell outer laminate: The foil had visible evidence of exposure to heat and delamination. The foil had 4-inch tears in two spots on the end cap. See figures 5 and 6.

Figure 5: The fire shelter used by firefighter 1 (FF1) showing the conditions of the shell outer laminate and two (2) yellow shake handles.

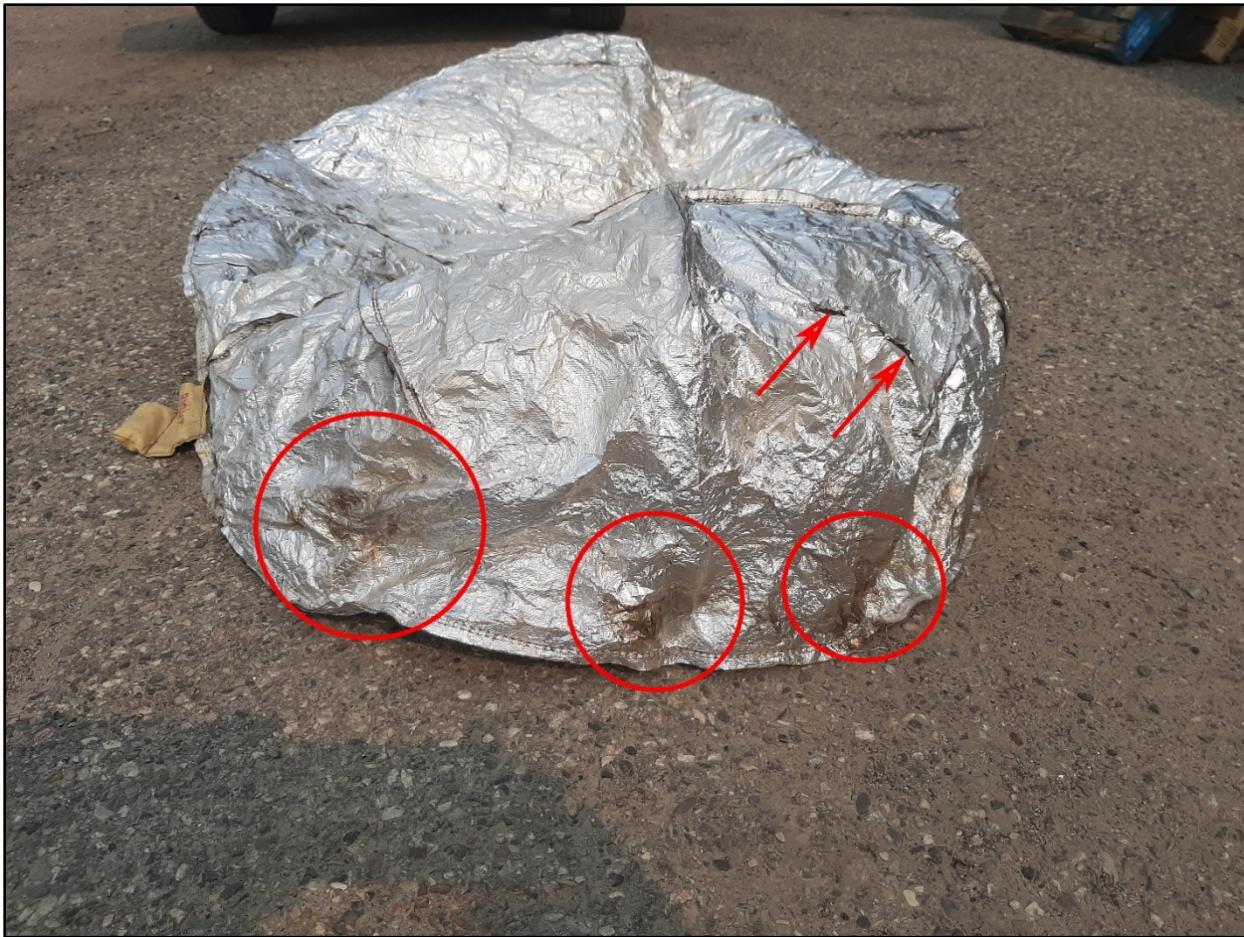
Figure 6: The fire shelter used by firefighter 1 (FF1) showing the conditions of the end cap portion of the shell outer laminate. The foil shows visible signs of heat in three (3) areas that are circled in red. Two (2) red arrows point to the torn foil.

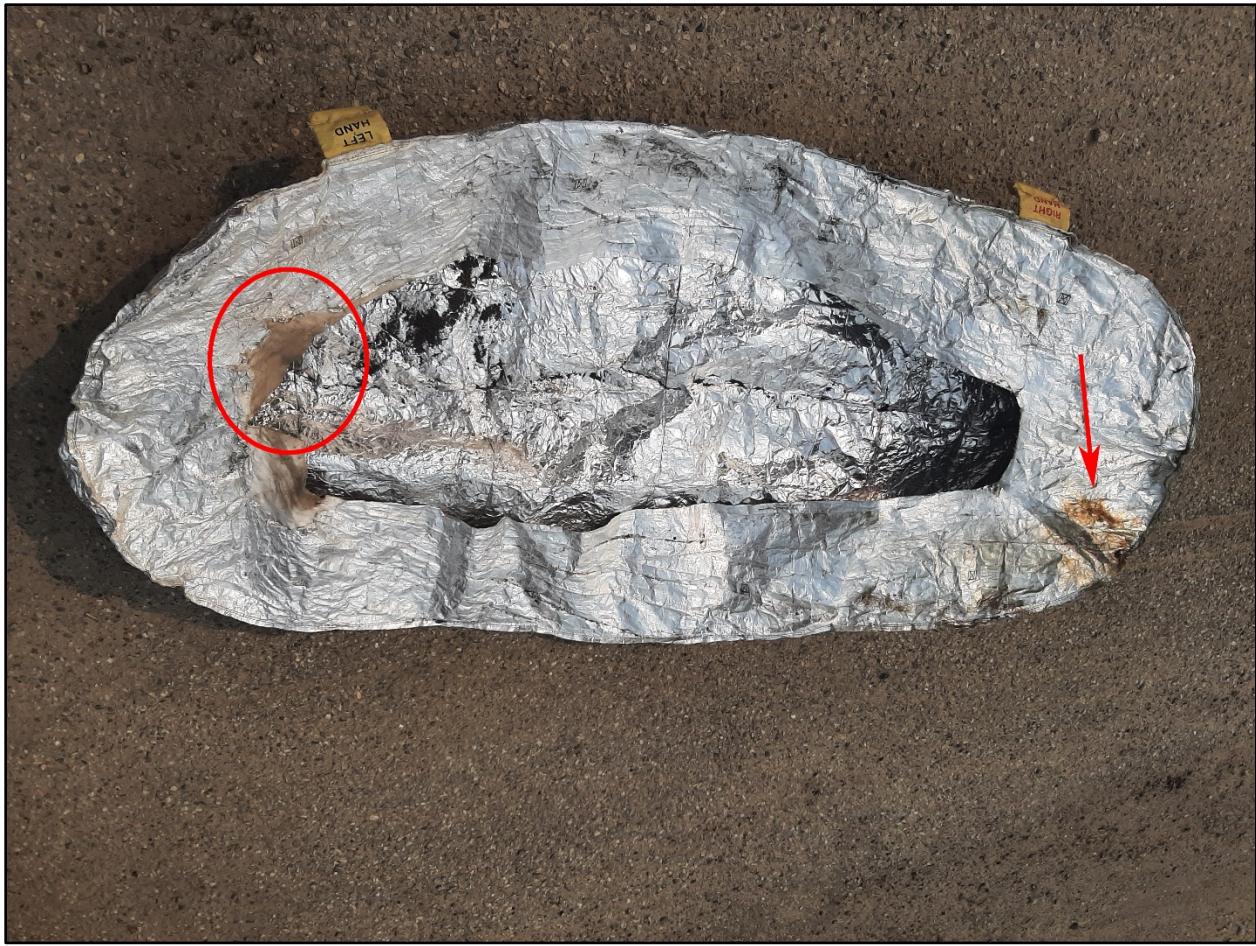
- Shell inner laminate: Nothing to note.
- Seams: Nothing to note.
- Hold-down straps: Nothing to note.
- Floor laminate: The foil had visible evidence of exposure to heat on the floor of one end cap. The opposite end cap had a 4-inch tear and visible evidence of physical abrasion. See figure 7.

Figure 7: The fire shelter used by firefighter 1 (FF1) showing the conditions of the shell inner laminate, floor laminate, and shake handles. The physically abraded and torn laminate is circled in red. A red arrow points to the visible signs of heat on the foil.

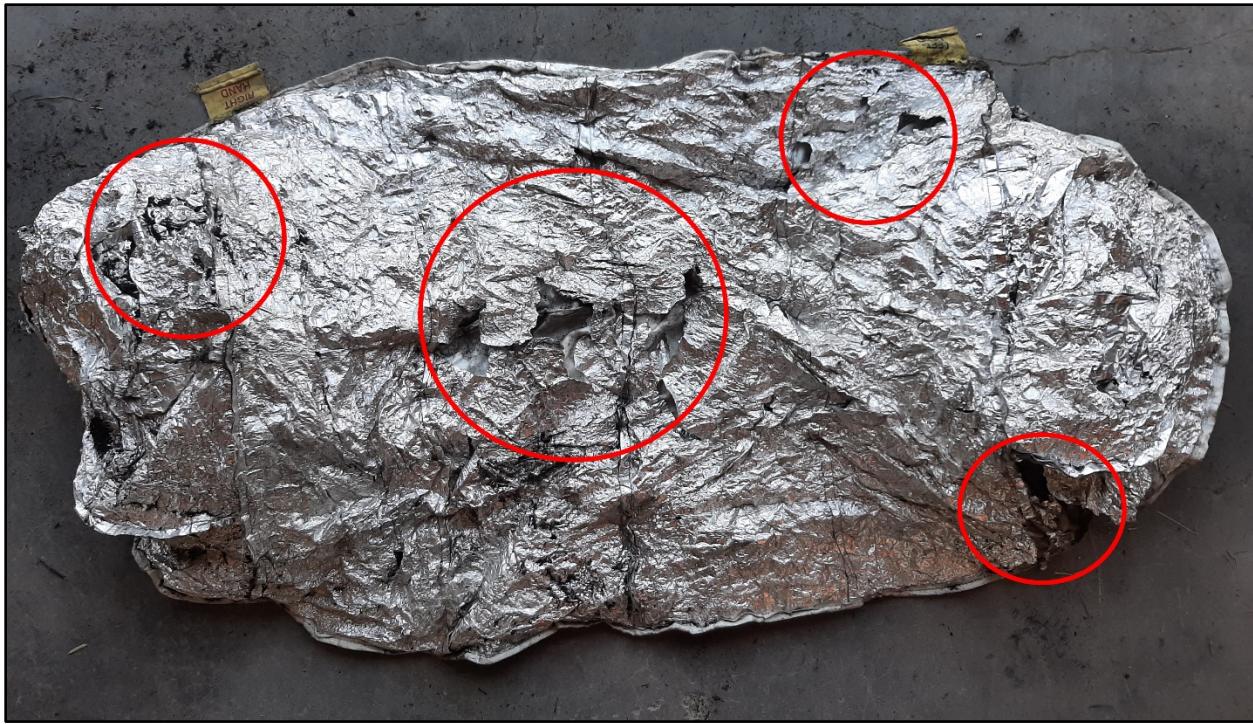
- Firefighter information: FF2 was 74 inches (6 foot 2 inches) tall and weighed 225 pounds. FF3 was 72 inches (6 foot) tall and weighed 190 pounds.
- Fire shelter information: The regular-sized fire shelter was manufactured according to Forest Service Specification 5100-606 in February of 2005.
- Post-deployment fire shelter inspection observations:
  - Shell outer laminate: The foil on the main body and end cap had visible evidence of exposure to heat, physical abrasion, numerous tears, and delamination. See figure 8.

Figure 8: The fire shelter shared by firefighter 2 (FF2) and firefighter 3 (FF3) showing the conditions of the shell outer laminate and shake handles. There were several areas where the foil is delaminated and abraded away, circled in red.

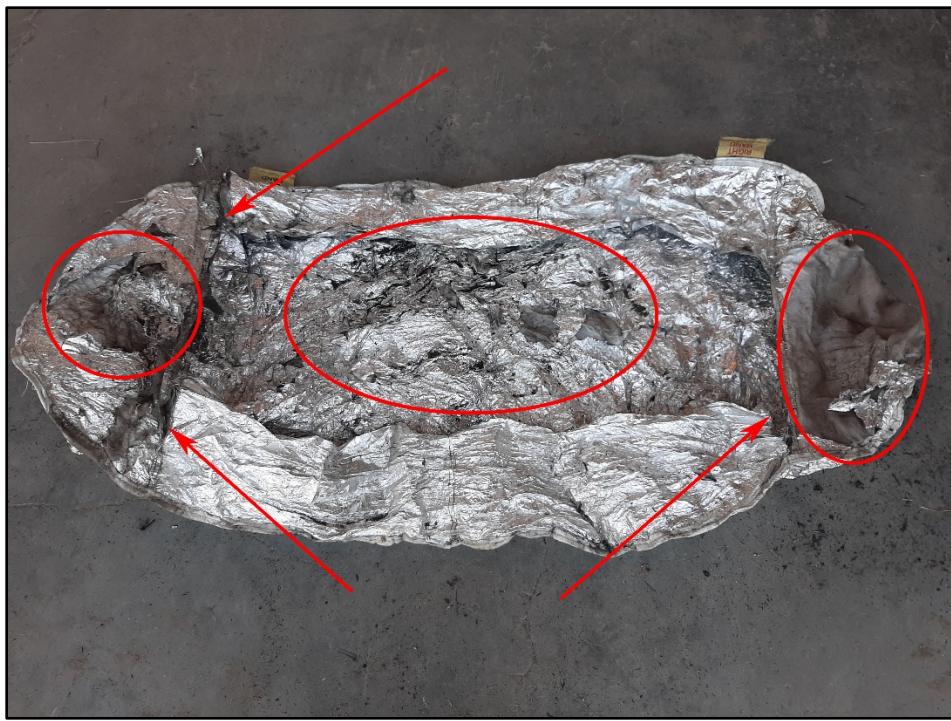
- Hold-down straps: Nothing to note.
- Shell inner laminate: The foil of the main body had visible evidence of delamination and was abraded away.
- Seams: Two of the floor seams had 8-inch tears. One of the floor seams had a 6-inch tear.
- Floor laminate: The foil of both end caps had visible evidence of delamination and was abraded away. The silica cloth on one of the end caps showed signs of heat and embrittlement. The laminate had two circular abrasion holes. See figures 9 and 10.

Figure 9: The fire shelter shared by firefighter 2 (FF2) and firefighter 3 (FF3) showing the conditions of the shell inner laminate, floor laminate, and two (2) shake handles. There were several areas where the foil was abraded away, circled in red. Red arrows point to torn floor seams.

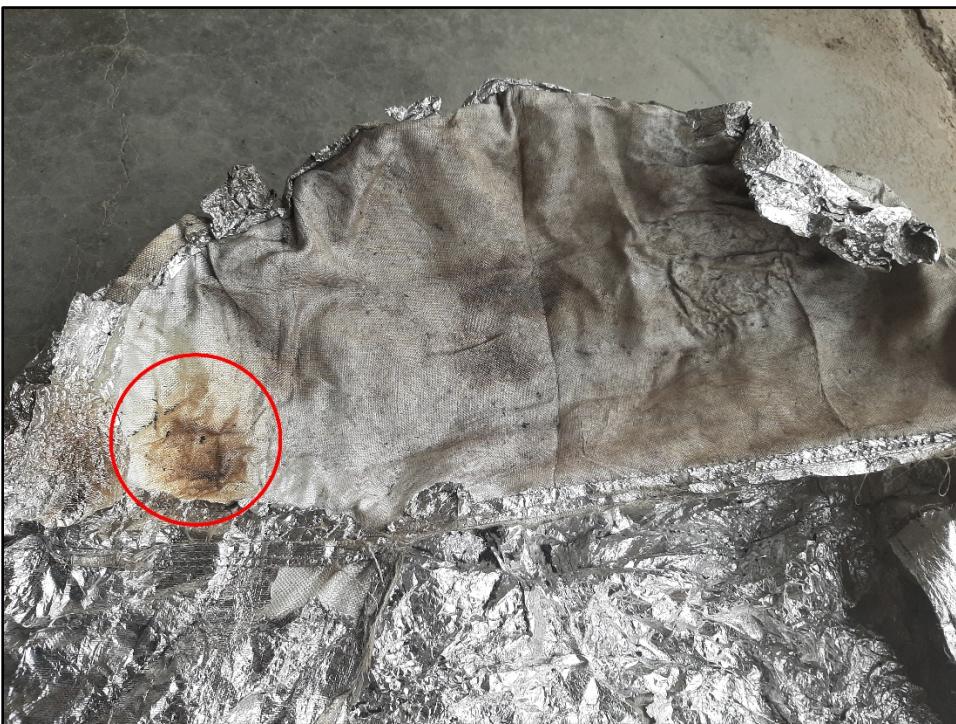
Figure 10: The floor laminate portion of the end cap. The heat-embrittled silica cloth is circled in red.
