REPORT ON THE COLLISION BETWEEN USS JOHN S MCCAIN (DDG 56)  
AND MOTOR VESSEL ALNIC MC

23 OCT 2017

## **1. EXECUTIVE SUMMARY - USS JOHN S MCCAIN**

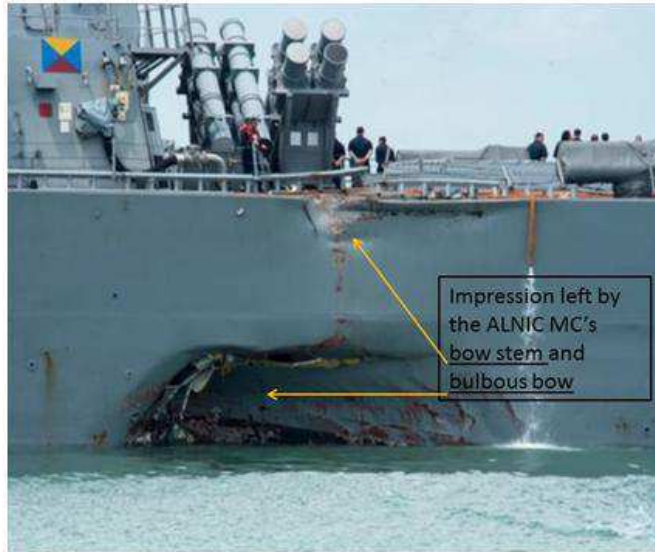
**Figure 9 – Point of impact on JOHN S MCCAIN from ALINIC MC**

The point of impact was centered on Berthings 3 and 5 as noted in Figure 9. All significant injuries occurred to Sailors that were in Berthing 3 at the time of the impact. All ten of the fallen Sailors were in Berthing 5 at the time of impact.

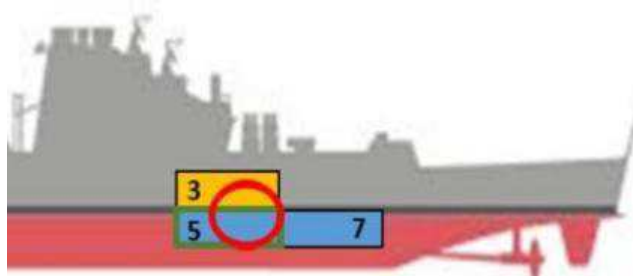
**Figure 11 - Relative Positions of Berthings 3, 5 (in green), and 7, and point of impact**

Berthing 5 is located aft (near the back of the ship) on the port side. See Figure 10. It is approximately 25 feet by 15 feet and has 18 racks, stacked as bunk beds three-high. Each row of racks has a locker for Sailors' belongings. There is a lounge with seats, a small table, and a wall-mounted television. There is a head with one toilet, one shower stall, and one sink.

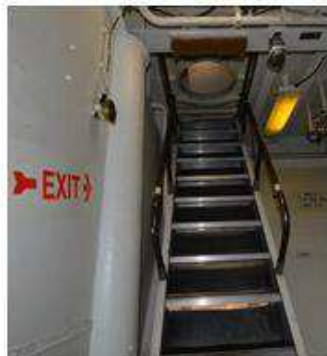
**Figure 12 – Primary egress from Berthing 5**  
**Left: from within Berthing 5**  
**Right: Above on the deck outside Berthing 5**

There are two means to exit Berthing 5: the primary egress (ladderwell) through a hatch with a scuttle (Figure 11) and an escape scuttle into Berthing 3 on the deck above (Figure 12).

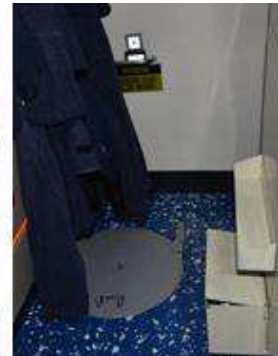
**Figure 13 – Escape Scuttle from Berthing 5**  
**Left: From within Berthing 5**  
**Right: Above in Berthing 3**

During Modified ZEBRA, the hatch is closed, but the scuttle is open for ease of access. The escape scuttle is normally closed at all times, as it was at the time of the impact. The collision knocked debris in Berthing 3 on top of the escape scuttle connecting Berthing 3 to Berthing 5 below it. This would have made any attempts to open and exit through the escape scuttle very difficult.

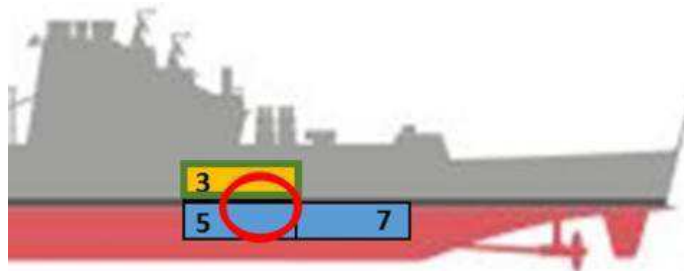
**Figure 14 - Relative Positions of Berthings 3, 5, and 7 and point of impact**

At 0530, the DCA began receiving reports of a ruptured fire main and water and fuel flooding into Berthing 3. The port side of Berthing 3 suffered substantial damage, including a large hole in the bulkhead. See Figure 13. Racks and lockers detached from the walls and were thrown about, leaving jagged metal throughout the space. Cables and debris hung from the ceiling.

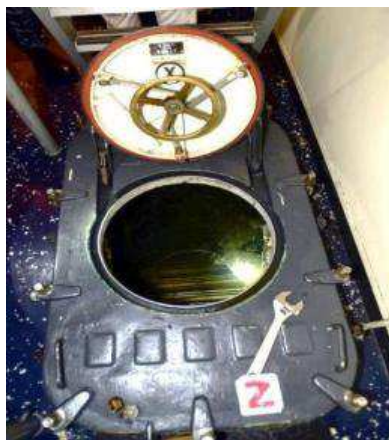
**Figure 17—Scuttle and hatch into Berthing 4 showing the space completely flooded**

All Sailors in Berthing 4 were able to evacuate. At 0544, Sailors reported 4 inches of water on the deck in Berthing 4. Sailors in Berthing 4 were thrown about their racks by the force of the collision. By 0627, the berthing space was lost. See Figures 16 and 17.

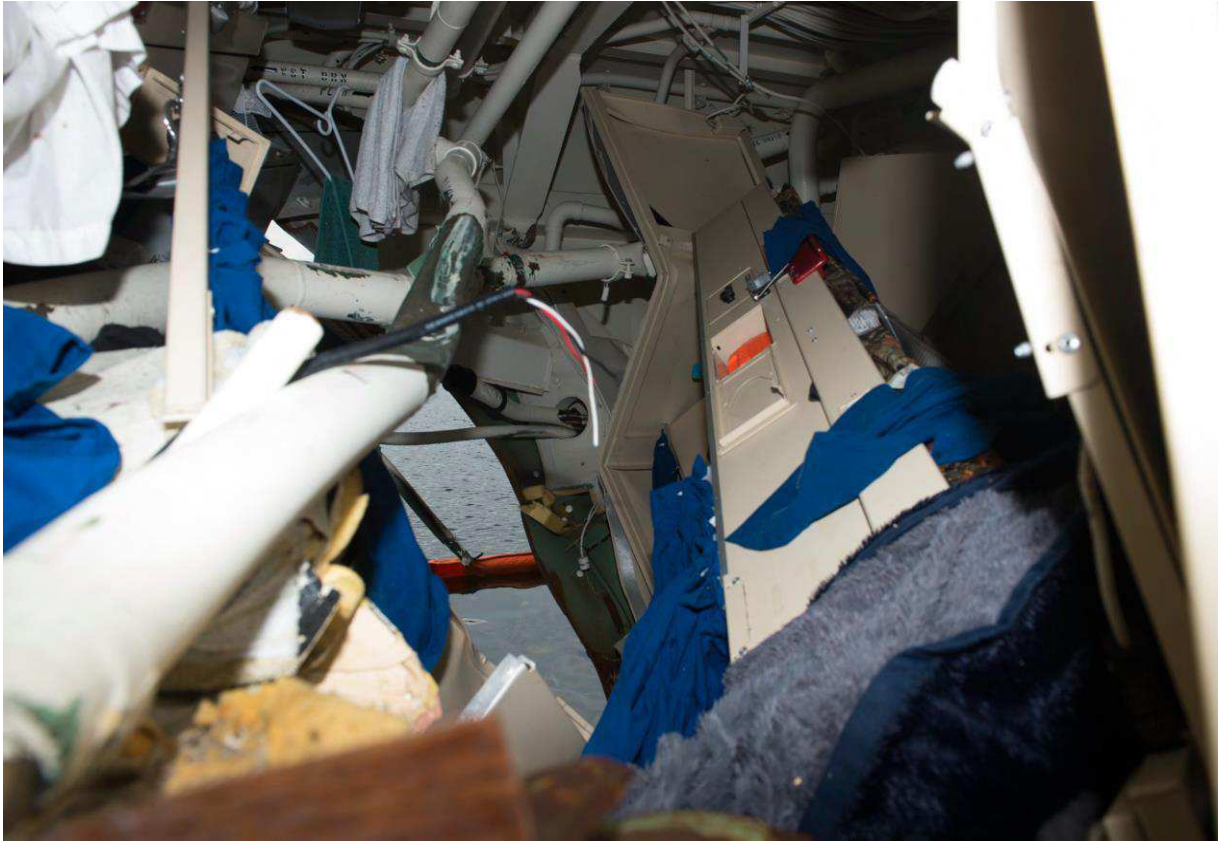
Internal view through Berthing 3 to point of impact; ocean visible

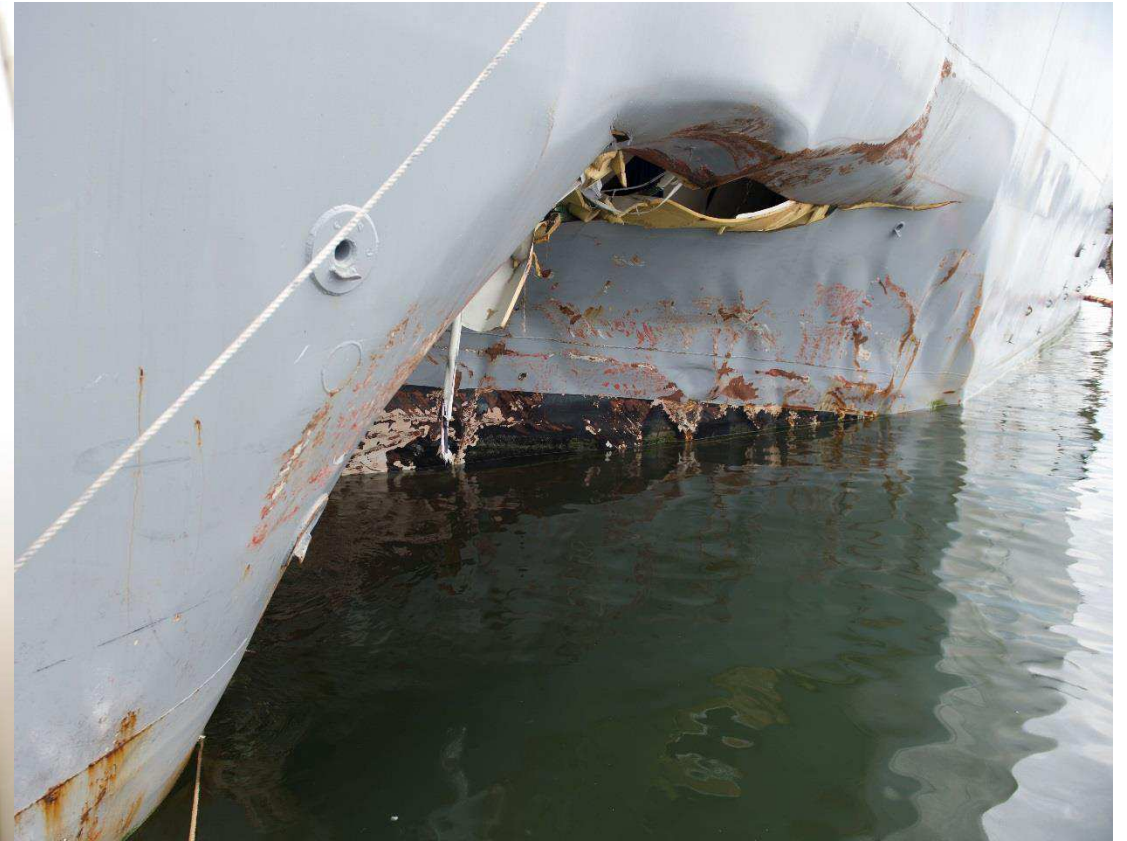
External view of point of impact; rupture in hull of the ship visible

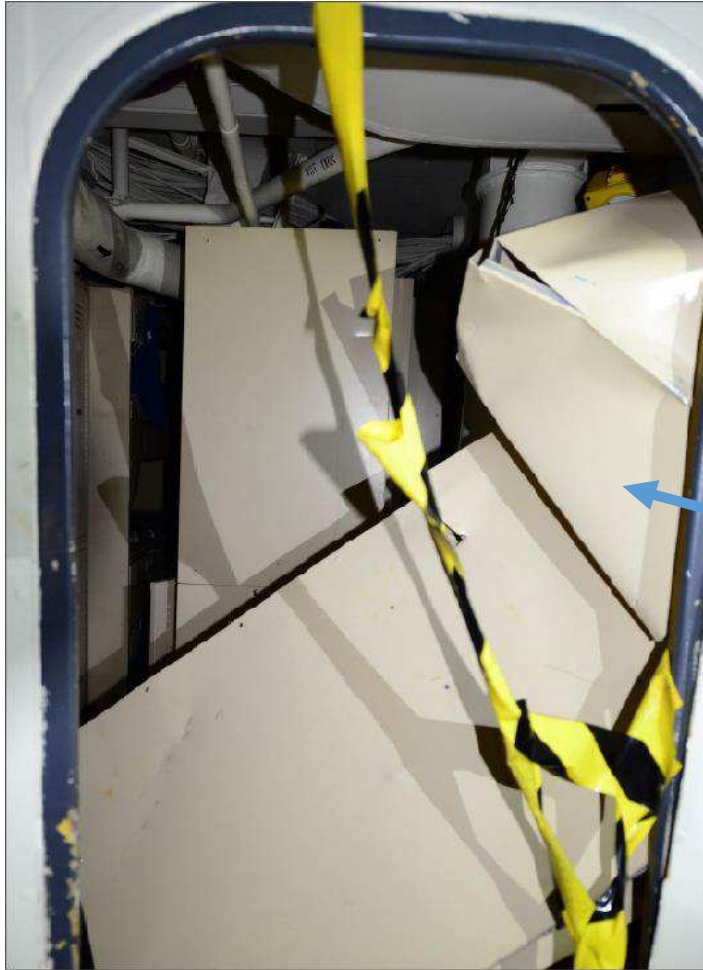
View through hatch into Berthing 3

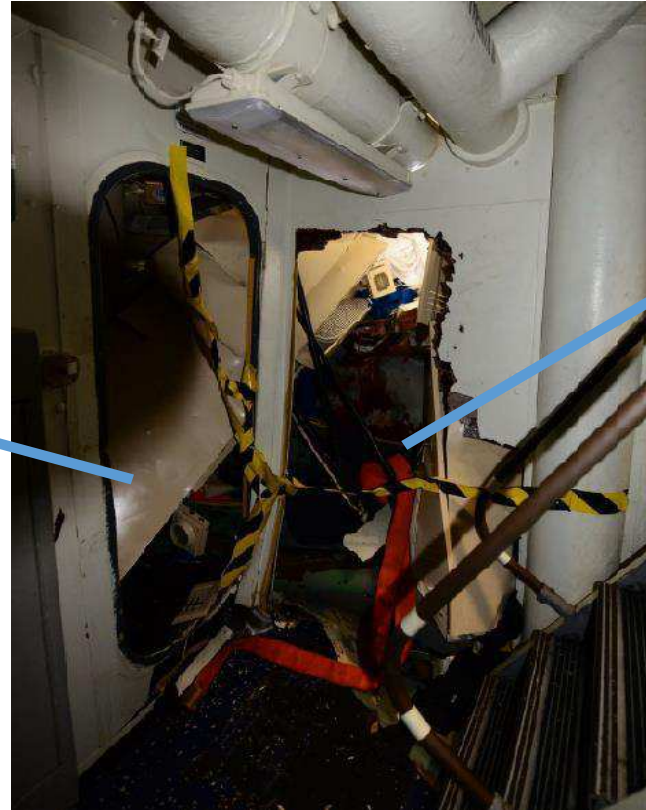
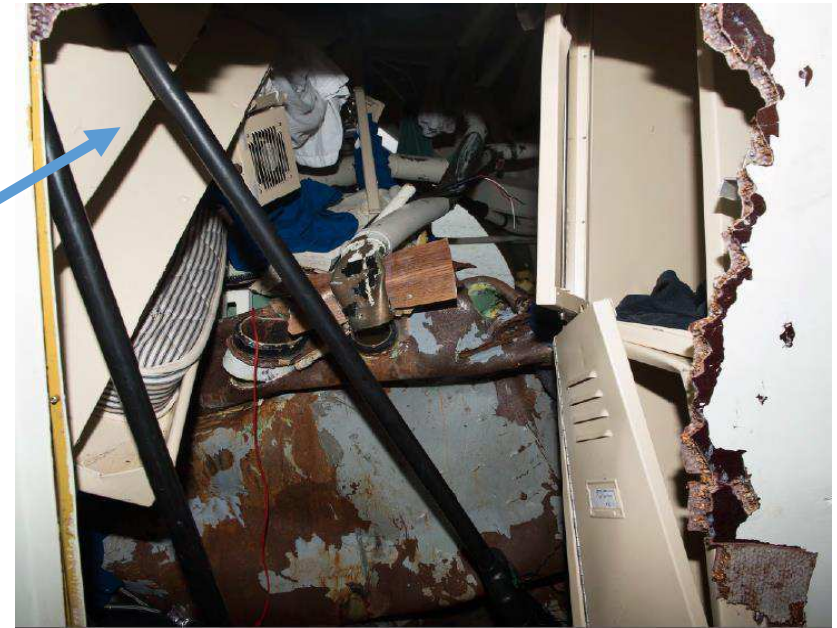
View through hole cut into bulkhead (wall)

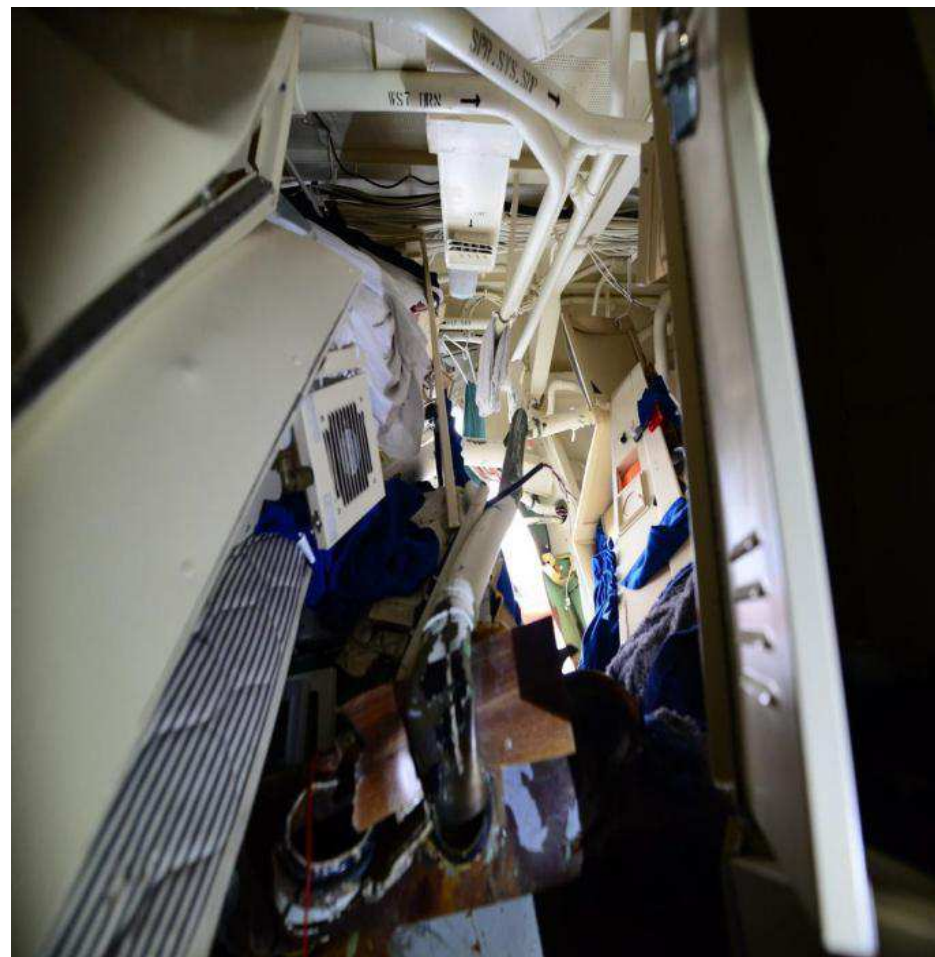
JOHN S MCCAIN, post-collision
