# Pavement Evaluation Report

**West Klein Road**

**New Braunfels, Texas**

Terracon Project No. 90201363

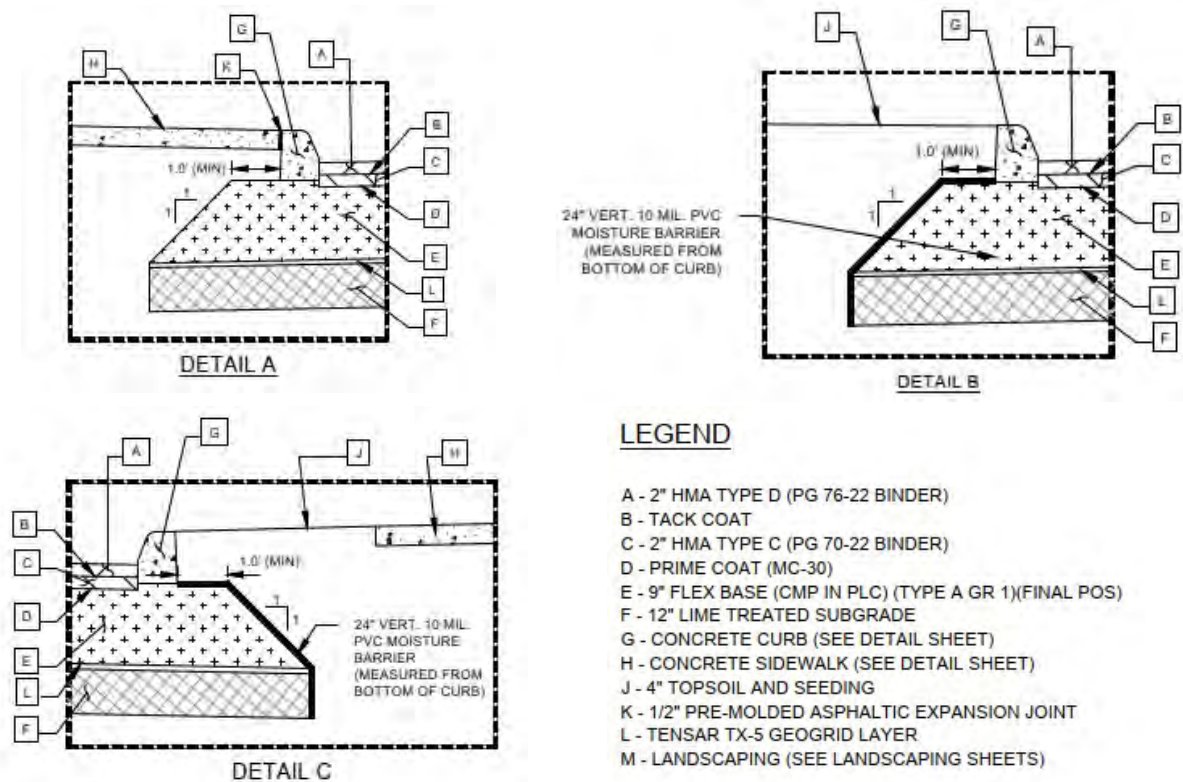
Figure 1. Pavement Cross Section – Plan Sheet No. 34

In cases where a sidewalk is constructed adjacent to the edge of the pavement, the 10 mil PVC moisture barrier is not specified.

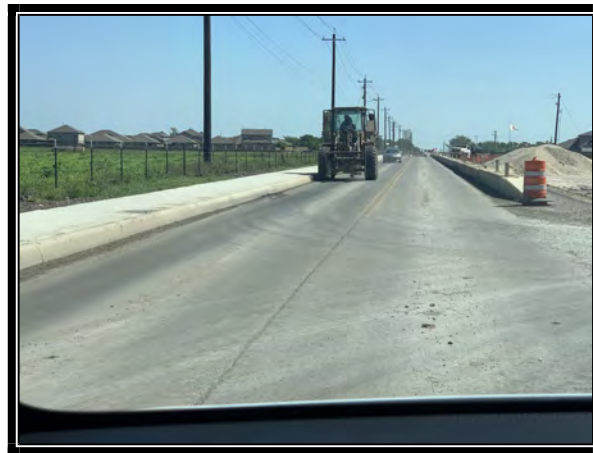
Figure 2: Loader wheel path (Phase III)

The construction traffic was rerouted to only one side of the pavement which perhaps resulted in more traffic in each lane than anticipated. Narrow lanes due to construction also change the wheel paths of the traffic. The pavement edges disintegrate from the curb as the wheels are much closer and weakens the bond between the curb and hot mix asphalt. In addition, frequent construction traffic including loaders, trailers and trucks were observed with their wheel paths rubbing against the curb as shown in the Figure 2. This created high edge stresses resulting in weakening and most likely opening of the joint between pavement and the adjacent curb.
