The following is an existing conditions study focusing on the old grocery store property located adjacent to the Greenville City Hall. The site of focus is located on roughly a city block bounded by Washington Street, Oak Street, Pickett Street, and King Street in Greenville, Texas. KSA has provided this report upon request of the City of Greenville, Texas for informational purposes only. This study is based solely on site observations, photographic documentation, and digital information available online. Potential adaptive reuse functions for the building include Fire Administration Offices, Emergency Operations Center/Training Room, Council Chambers, Finance Department, City Manager, City Secretary, and Human Resources.

November 8, 2018

City Annex Johnson SA - : also call Suann Hardin  
Steve Methin / Brandon Jamison

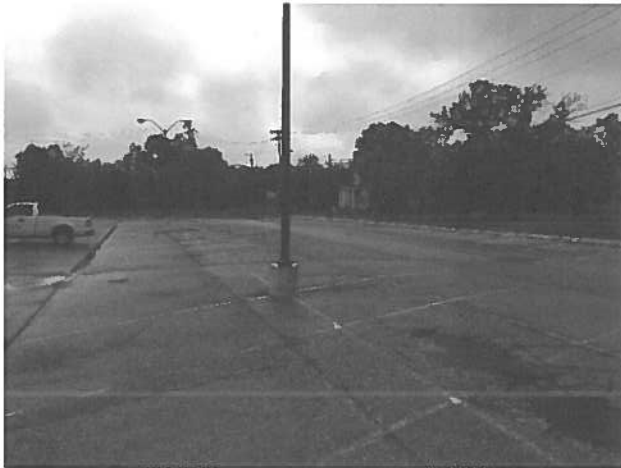
The existing parking lot does require some attention and corrective work. The existing asphaltic concrete paving does show signs of age and multiple repairs through the years. It is serviceable at this point in time; however, repairs will be required in the near future. In addition the existing pavement striping and markings show significant signs of add and should be updated.

General Condition of the Parking

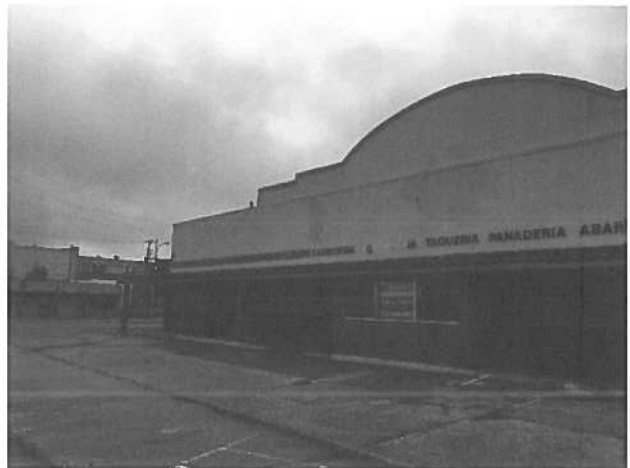
Inadequate handicap accessibility

Currently there is no handicap accessibility provided to the front entrance of the building. This will be an initial expense to immediately provide corrective measures to address and implement to ensure compliance with the Texas Accessibility Standards 2012.

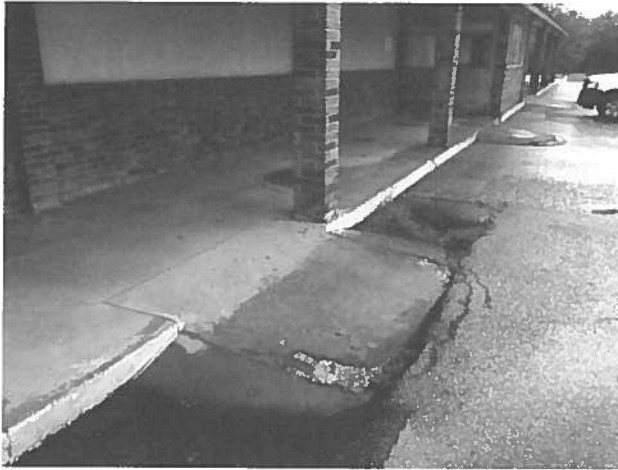
Ponding at inadequate accessible locations

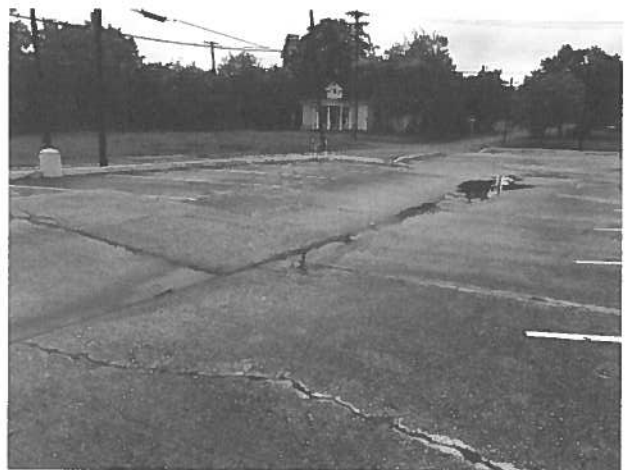
There are potential site grading issues around the site as well. At previously repaired areas of the asphaltic concrete paving, the patches were not properly grading to prevent ponding. These spot areas can be reviewed and replaced/repaired at some appropriate time in the future. The north side of the

Ponding with parking, drive areas

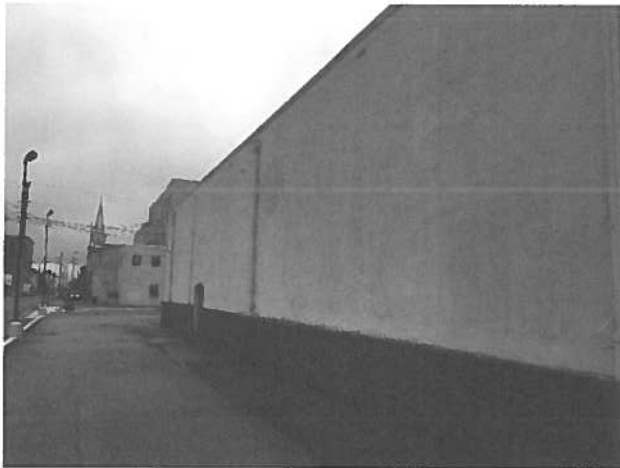
building facing Washington Street does present concern do to the lack of positive drainage away from the face of the building. At the time of this site visit, there was actually standing water at the base of the masonry veneer and the adjacent paving with no option for removal other than evaporation.

Ponding along north elevation due to lack of positive drainage away from building

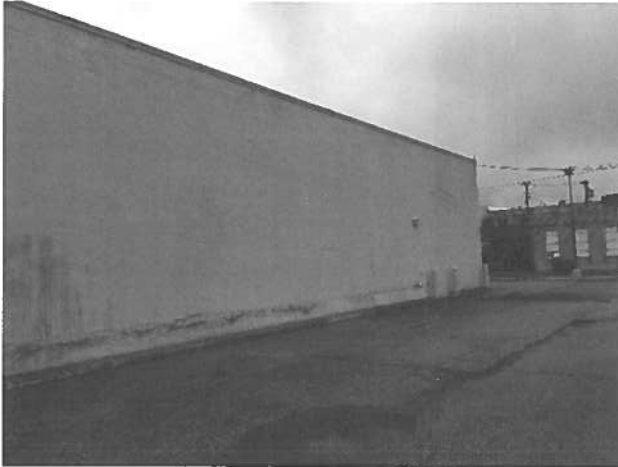
Typical painted masonry veneer (east)

The east elevation does appear to be a full height masonry veneer; however, the surface has been fully painted and/or skim coated with a thin stucco layer. This elevation faces directly to the Municipal Building. There is an existing loading dock and overhead door (with adjacent man door) near the southeast corner of the building. There does not appear to be any obvious or visible signs of construction issues with this wall. The exterior door and overhead need to be reviewed for water-tightness.

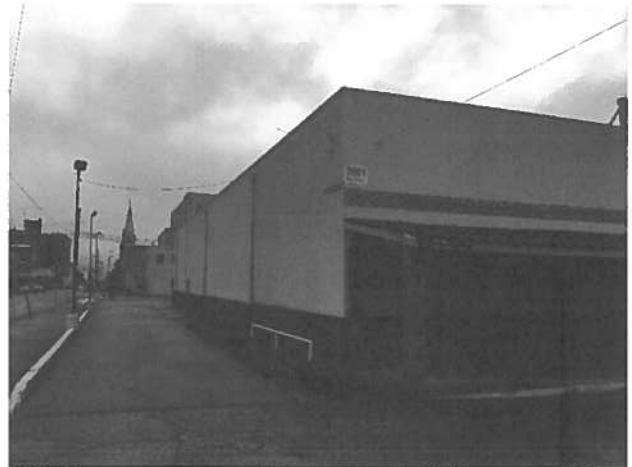
Exposed masonry wainscot (nw)

The north elevation is composed of similar construction, except it appears that an additional wythe of brick was installed to a height of approximately 3'-4" with a rowlock cap at the top of the masonry. The cap brick is not installed with a slope to drain surface water from above and visible signs of standing water and deterioration are evident above the masonry. This elevation does have new and existing scuppers through the roof parapet for water discharge. Some of the scuppers feed directly into conductors and downspouts while others do not. This does present some concern for the presence of water within the wall due to the roof condition. This will be further discussed in Section 6 – Existing Roof.

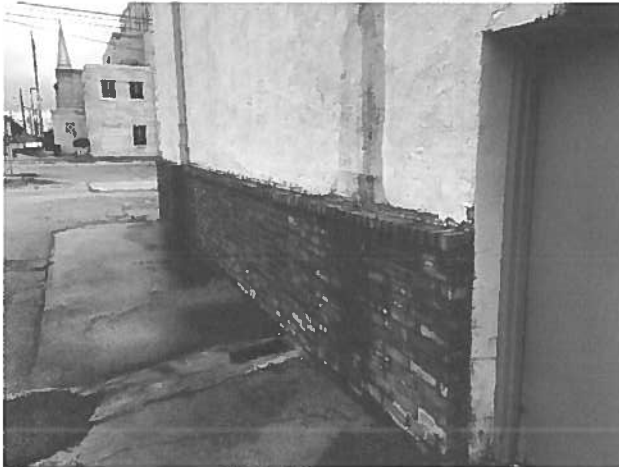
Roof runoff damaging wall surface

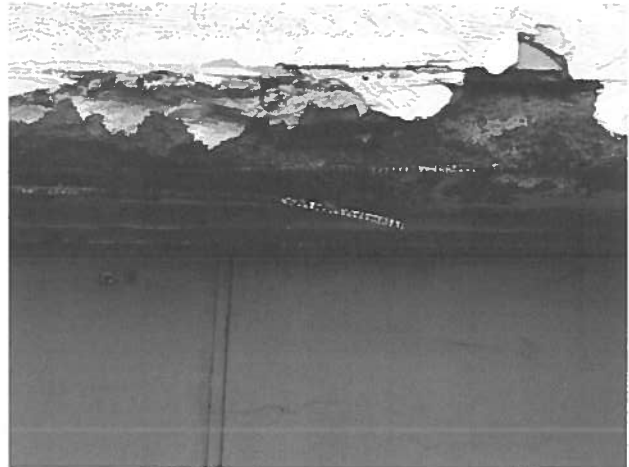
There are significant water and damage issues at the head of the double door in the northeast corner of the building. There is also a missing brick at the jamb of the door. The double door needs attention due to multiple dents in the door and hollow metal frame and to ensure water-tightness. At the areas where the existing scuppers are not tied to downspouts, there is staining on the wall from the water discharge and the coating over the masonry is peeling away from the surface of the brick.

Damage at head of door

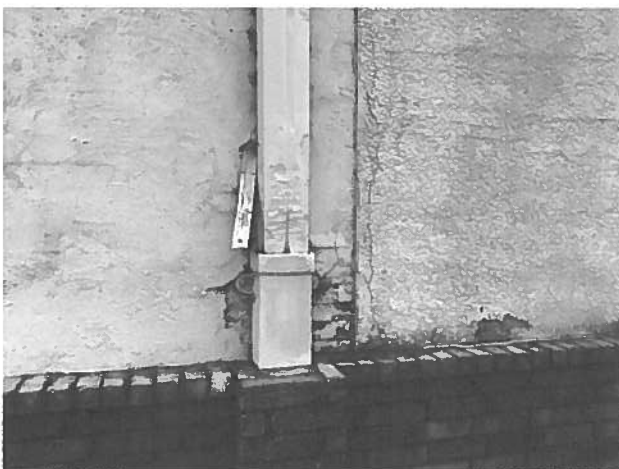
Surface damage at top of brick

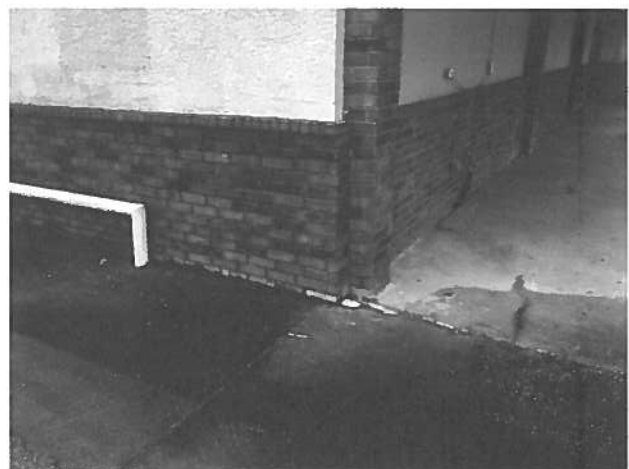
As previously mentioned, this elevation is the area of concern due to lack of positive drainage away from the building due to the adjacent paving. The paving elevation was limited so as not to cover the weeps in the masonry; however, at its current installed height the ponding water has the opportunity to actually penetrate the veneer through the weep holes on the exterior.

Ponding along north elevation

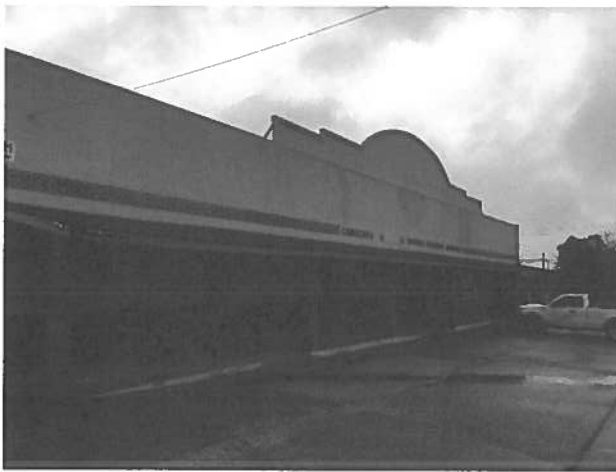
The west elevation provides similar construction to that of the north elevation with the addition of a sloped porch the length of this elevation. The roof of the porch is wood framed with multiple signs of water damage and age due to original construction methods. The framing members appear to be inadequately sized for some of the span and there is noticeable deflection between the column supports. As part of the new renovation project, it would be highly recommended to remove this porch system in its entirety.

Existing porch condition

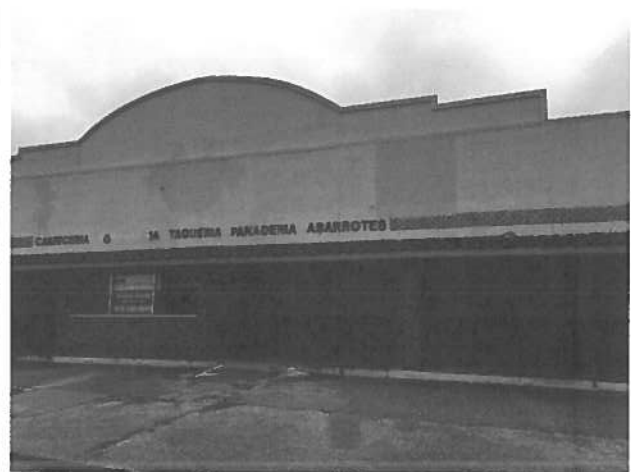
The existing entry system has window damage and is not suited for the proposed new use of the building. It would also be suggested to remove the entry as well. The tall parapet added above the masonry wall is insufficiently constructed. This will need to be removed due to its poor condition.

Top parapet should be removed

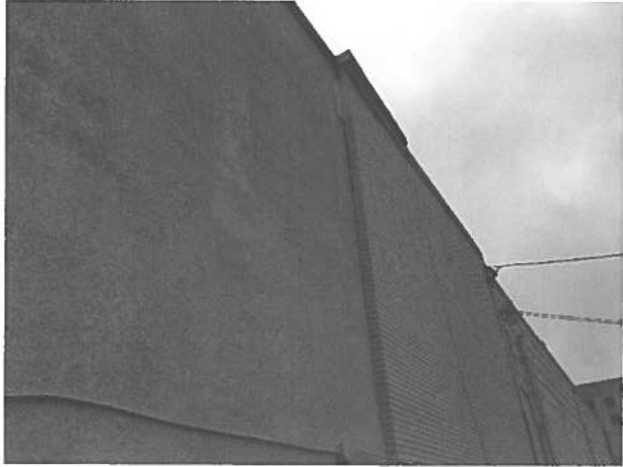
The south elevation is similar in construction to the east wall with some deviations. A single wythe of brick has been installed from an elevated height of roughly 3'-0" above grade up to the top of the parapet. This brick veneer shows signs of pulling away from the face of the building. Previously a metal bracket was installed to hold the top of the masonry to the face of the building but there is evidence that the added panel is still pulling away from the original exterior wall.

Added wythe of brick (south)

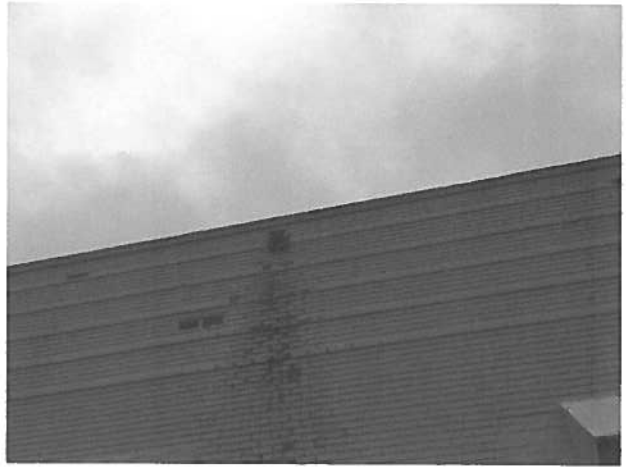
There are additional locations along this elevation where scupper through the parapet are not tied to downspouts. At these areas, the roof water runoff is staining the masonry veneer. There are multiple louvers/fans installed in this wall that will need to be removed. Currently there are water penetration issues attributable to these louvers. The lean-to addition in the southeast corner has water penetration issues at the roof and the walls.

Water runoff through scupper

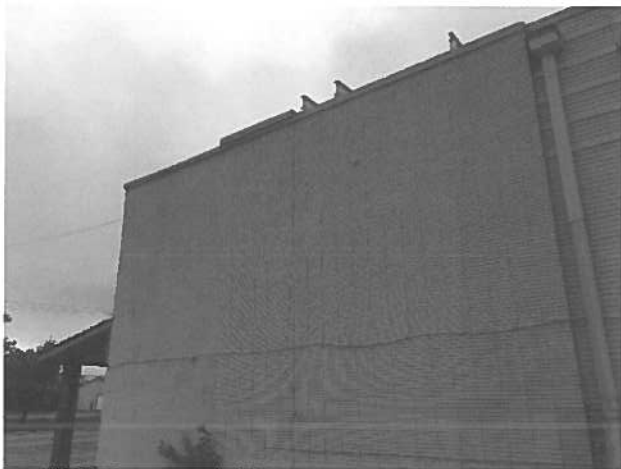
Added wythe of brick (south)

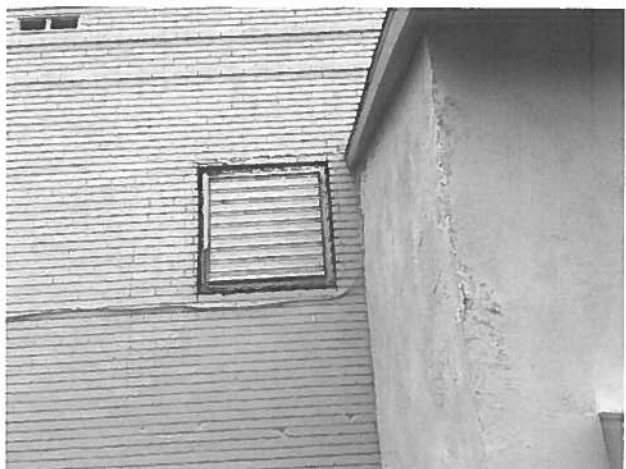
Water penetration at louver

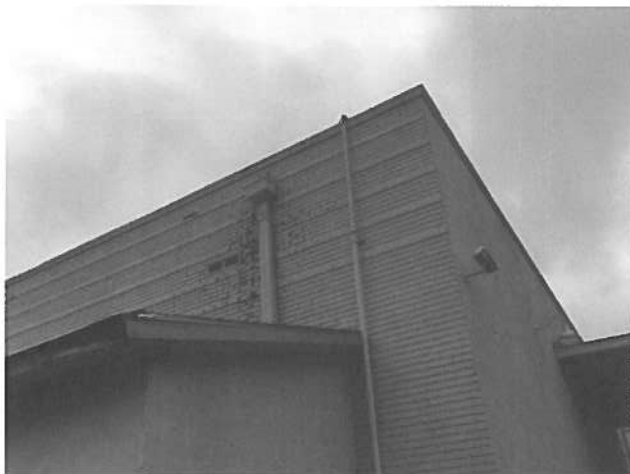
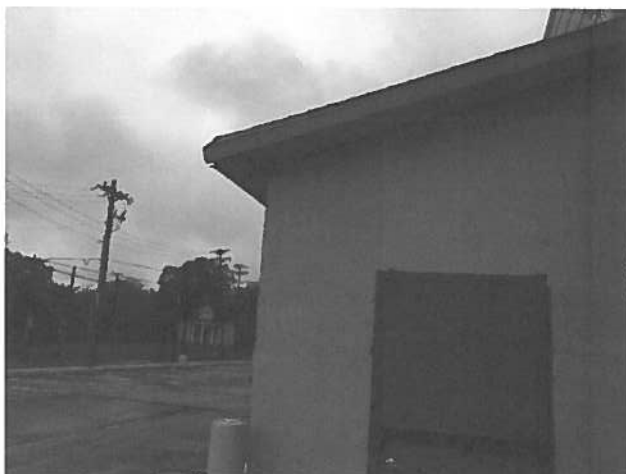
Water issues at lean-to roof and wall in southeast corner of building

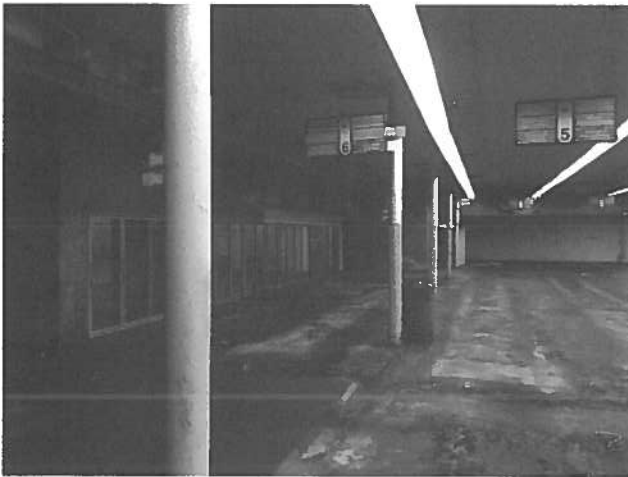
Unprotected steel tubes

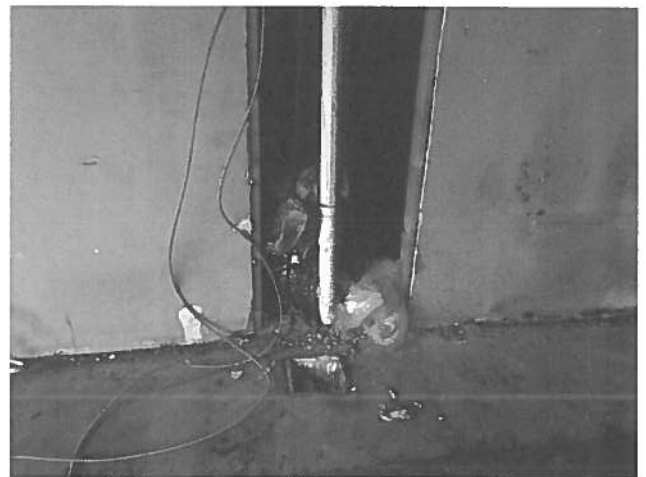
Wood exterior wall framing

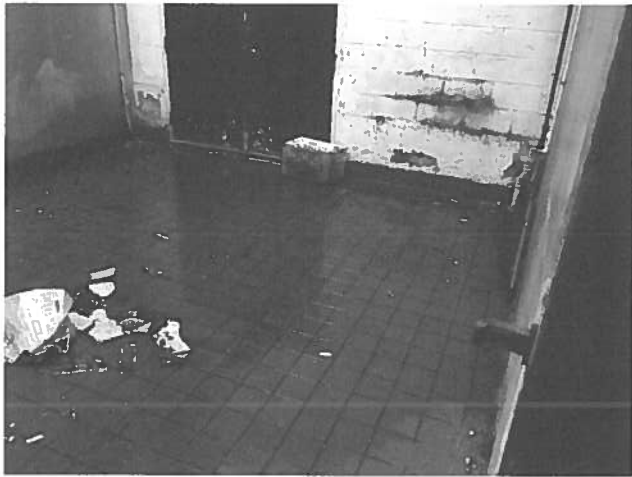
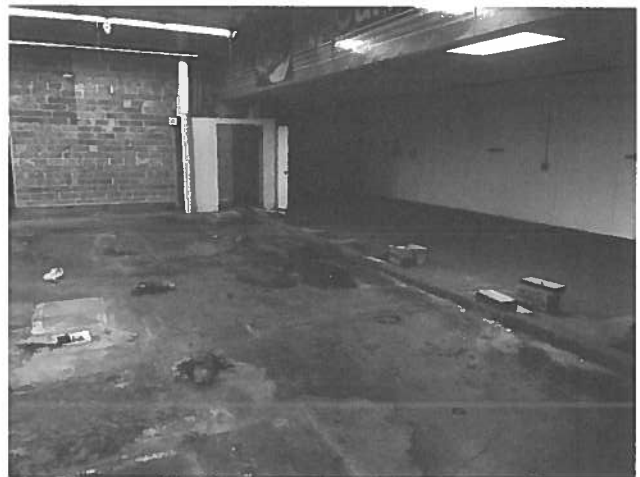
It is obvious from the review of the building interior that the roof has major issues. There are multiple roof leaks and the roof itself is suggested to be removed completely including the structural framing and decking. This will be discussed in detail in the following section.

Numerous signs of leaks through roof membrane, deck and down to slab

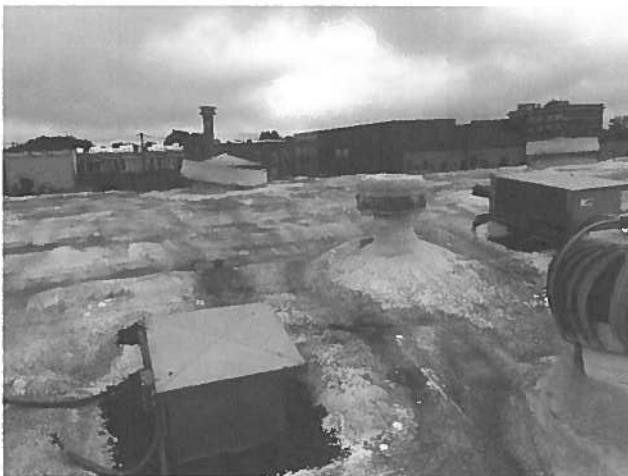
It is unclear what the actual, current roof system is. However, the current condition has an added layer of closed cell spray foam with an elastomeric coating. Upon visual inspection of the current roofing conditions, major defects can be found in the elastomeric coating system throughout the entirety of the roofing system. The defects are significant and numerous leaks are evident on the inside of the building. Multiple patches have been applied by various systems and none of resulted in a sealed, watertight roof condition.

Multiple patches in various roof systems

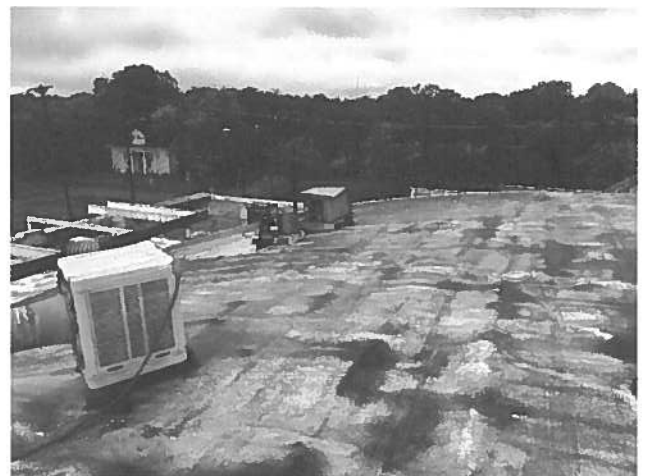
Foamed material causes ponding

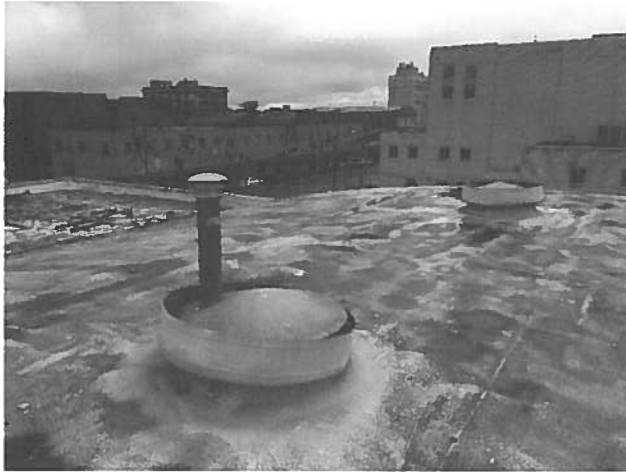
Vent covered not properly sealed

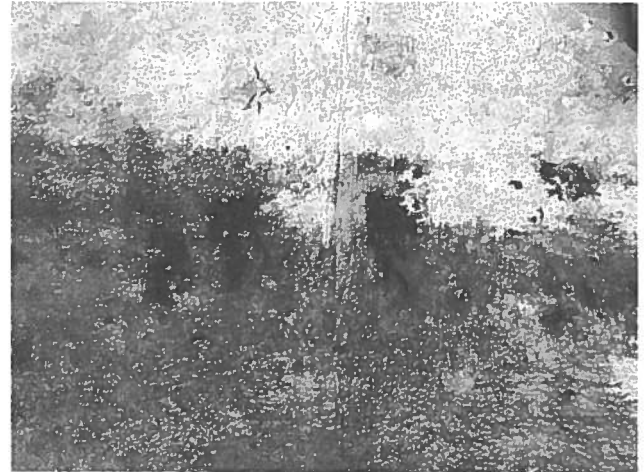
Numerous defects in roofing

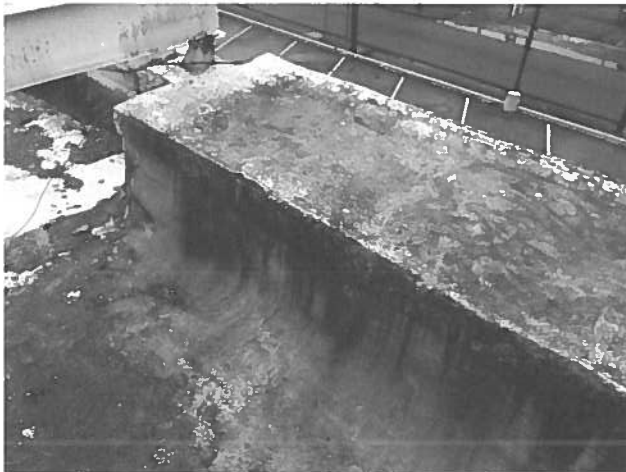
Build up at parapet and cap

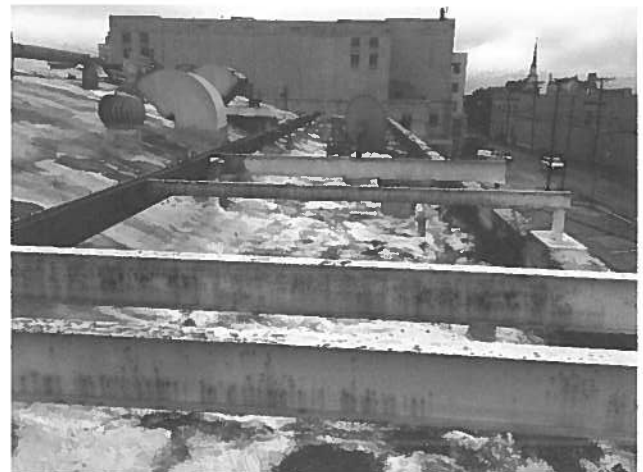
Exposed steel on low roof sides

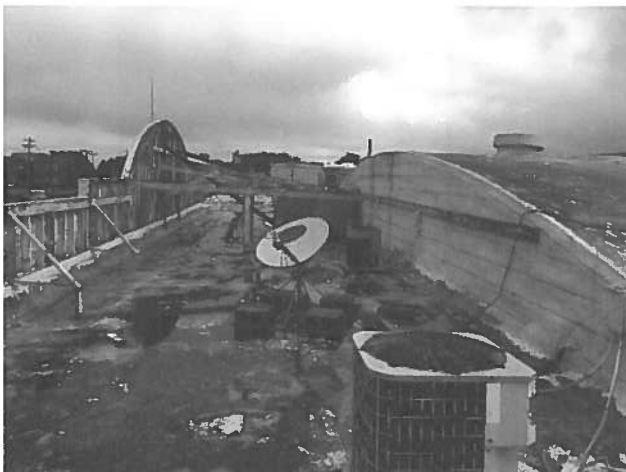
Ponding on flat roof area

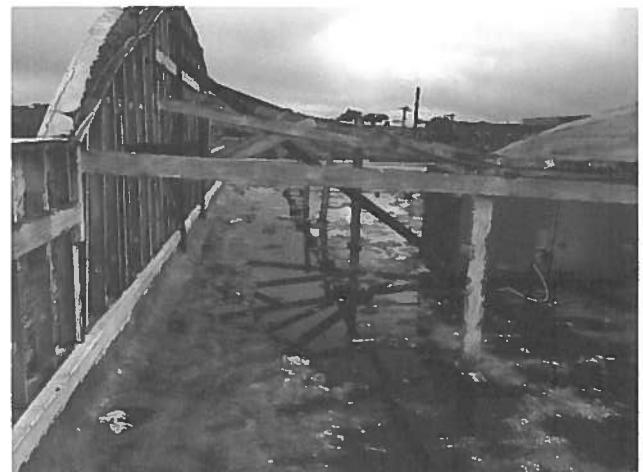
Poor bracing at parapet

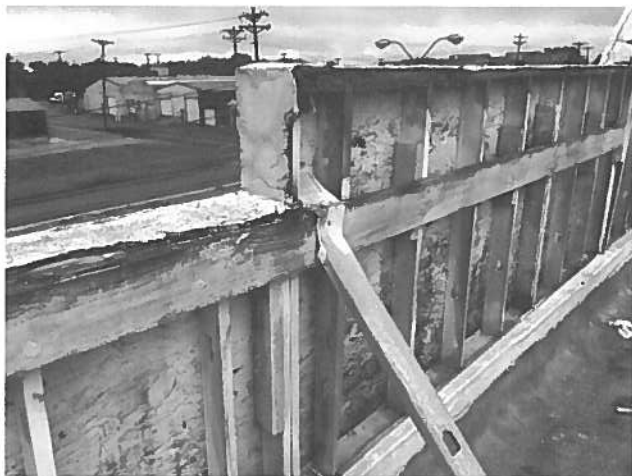
Inappropriate construction at parapet

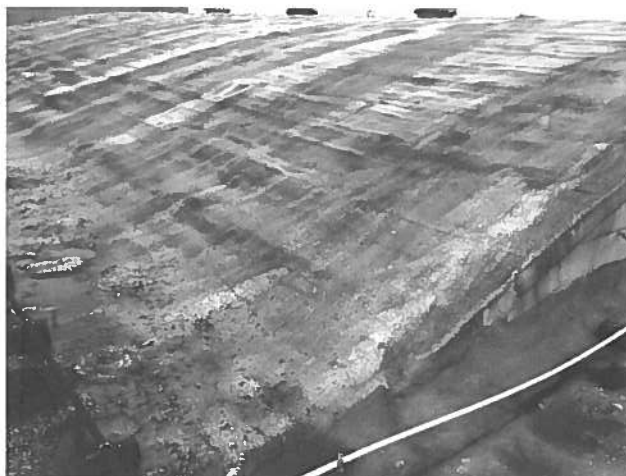
Open blisters on roof

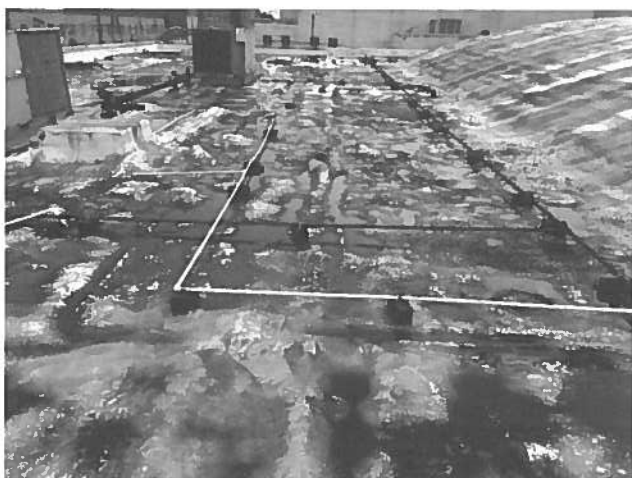
Condensate drains not connected

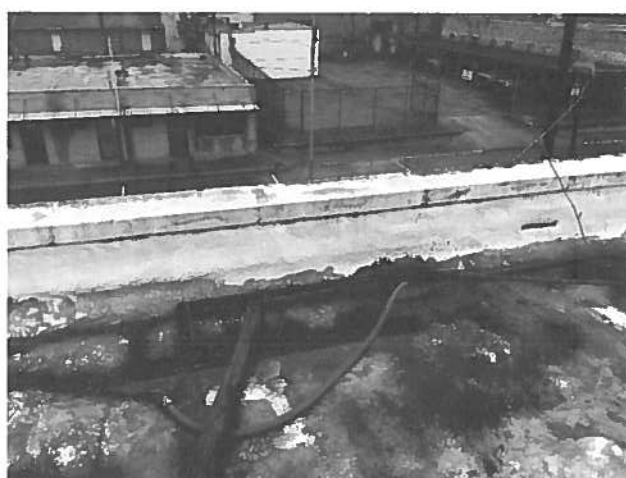
Exposed wiring through roof

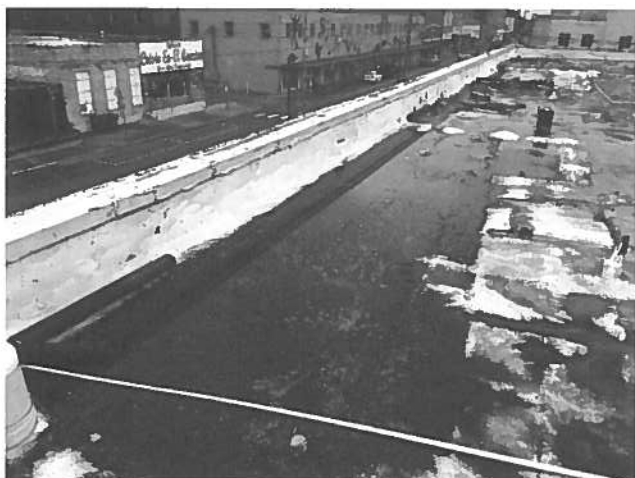
Massive ponding along north side

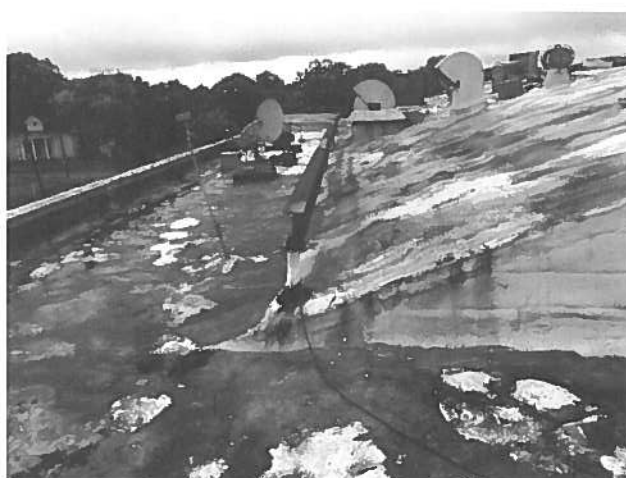
Numerous openings in surface

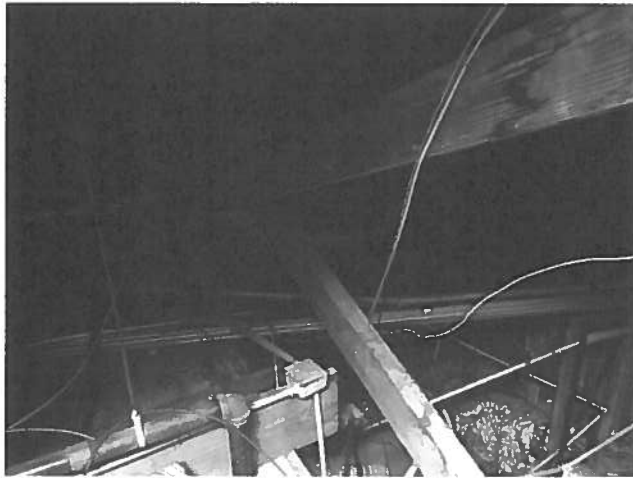
Evidence of moisture through roof

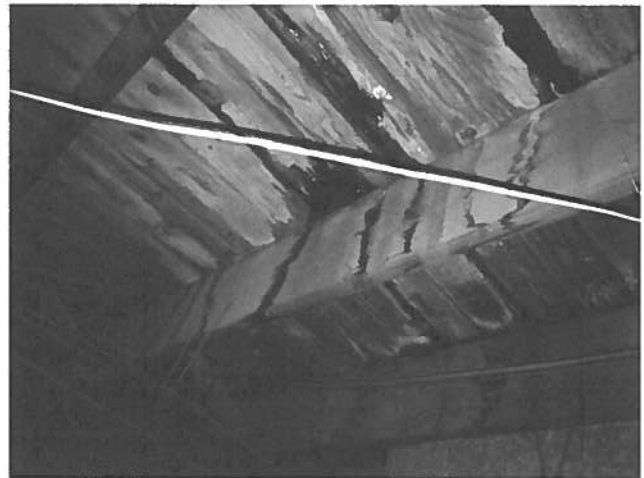
Water damage under roof

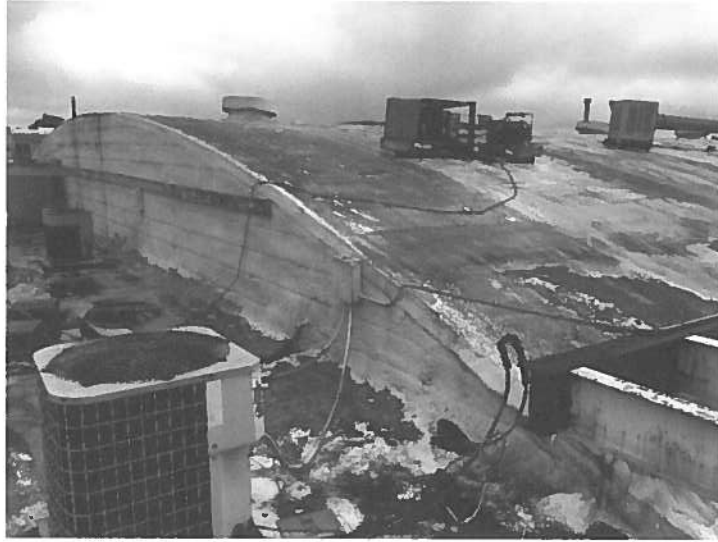
Existing roof top mechanical equipment

Many of the existing building systems appear to be original to the building. Given current lack of use and age, it is recommended that all existing building systems will be replaced in conjunction with the renovation project.
