FIRE INVESTIGATION REPORT

Case Name: 68 Highland High School

Case Number: 04212368

Date of Fire: April 21, 2023

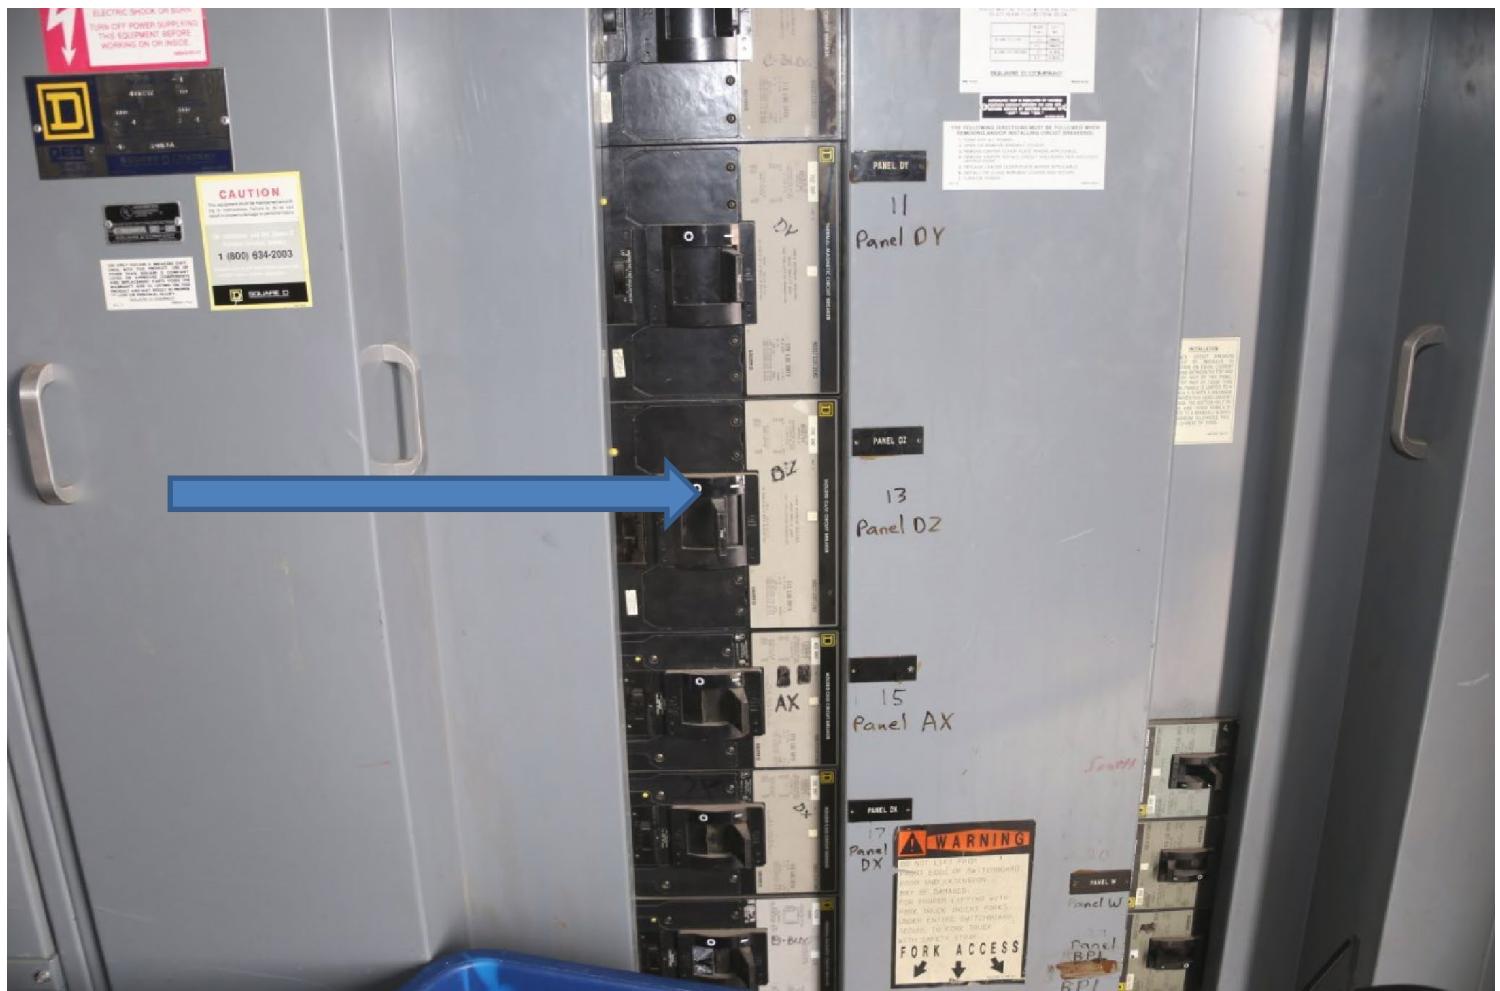
Examinations of the main service panel's interior and exterior areas revealed no fire or heat-related damage. The main breaker within the service panel was in the "on" position. Examinations of the main service panel's remaining breakers revealed that some were in the "tripped" position.

Blue arrow showing a trip on the main service panel. Picture is from file IMG_0313.CR2. A copy of this image is included in the addenda/held in the case file.

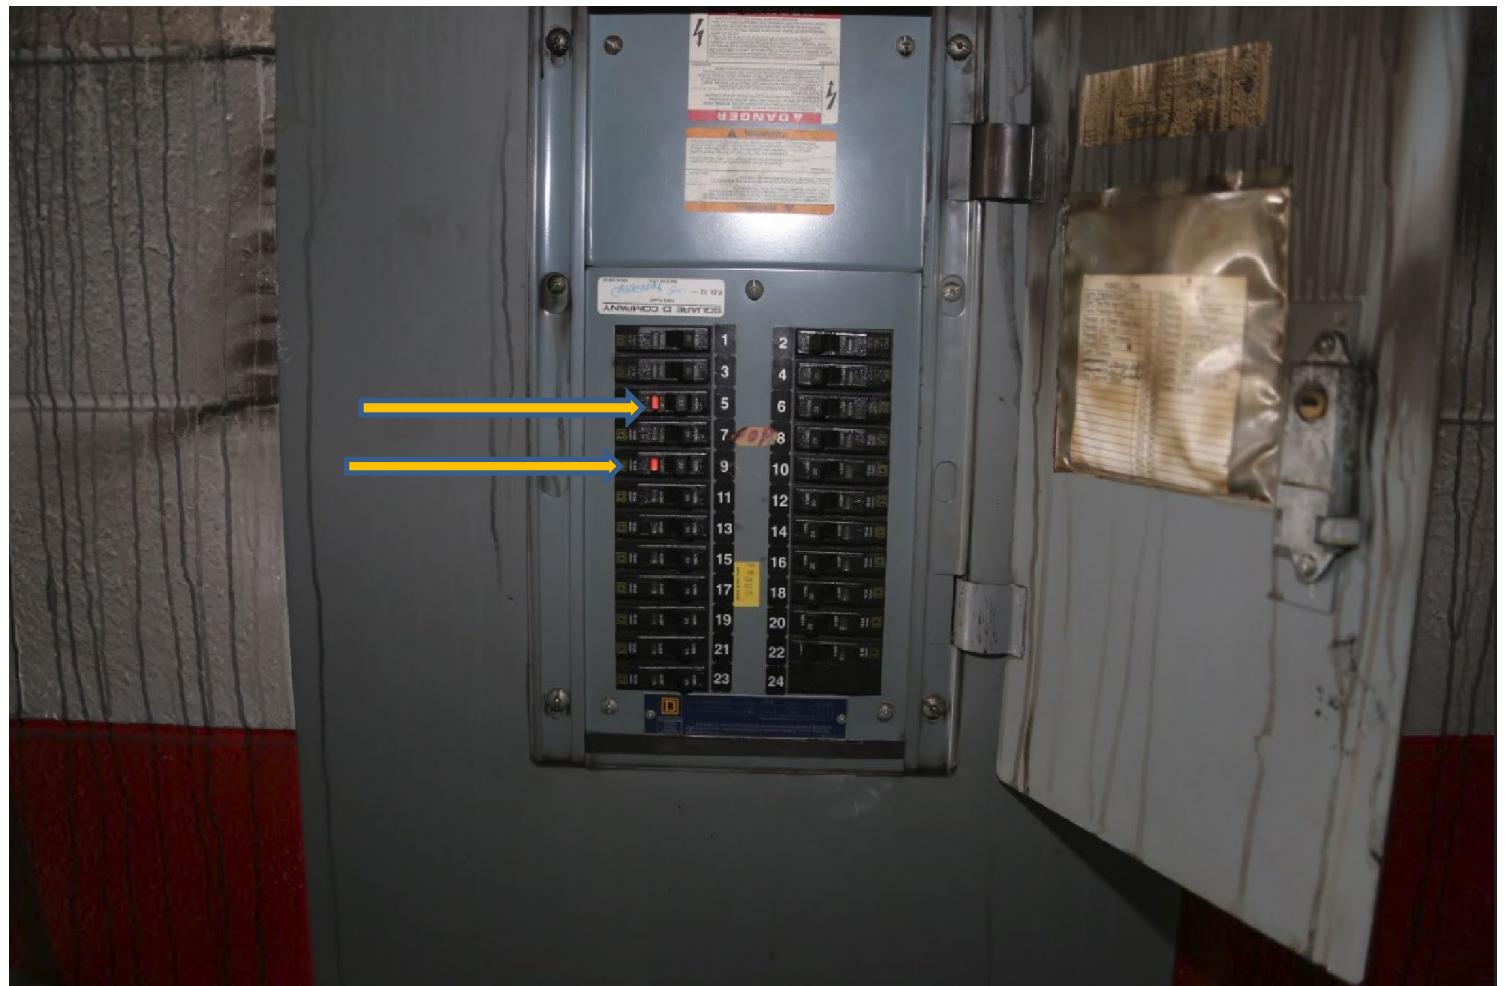
Examinations of the interior and exterior areas of the structure revealed a separate subpanel existed from the main service panel. The subpanel was located in the hallway of the D wing between the cafeteria and old gym. Examinations of the subpanel's interior and exterior areas revealed heat-related damage.

Panel D-2 located in the hallway of the D wing between the cafeteria and old gym. Orange arrows show breakers 5 and 9 tripped. Breaker 5 is connected to the fans in the practice room. Breaker 9 is connected to the receptacle on the stage lights. Picture is from file IMG_0316.CR2. A copy of this image is included in the addenda/held in the case file.

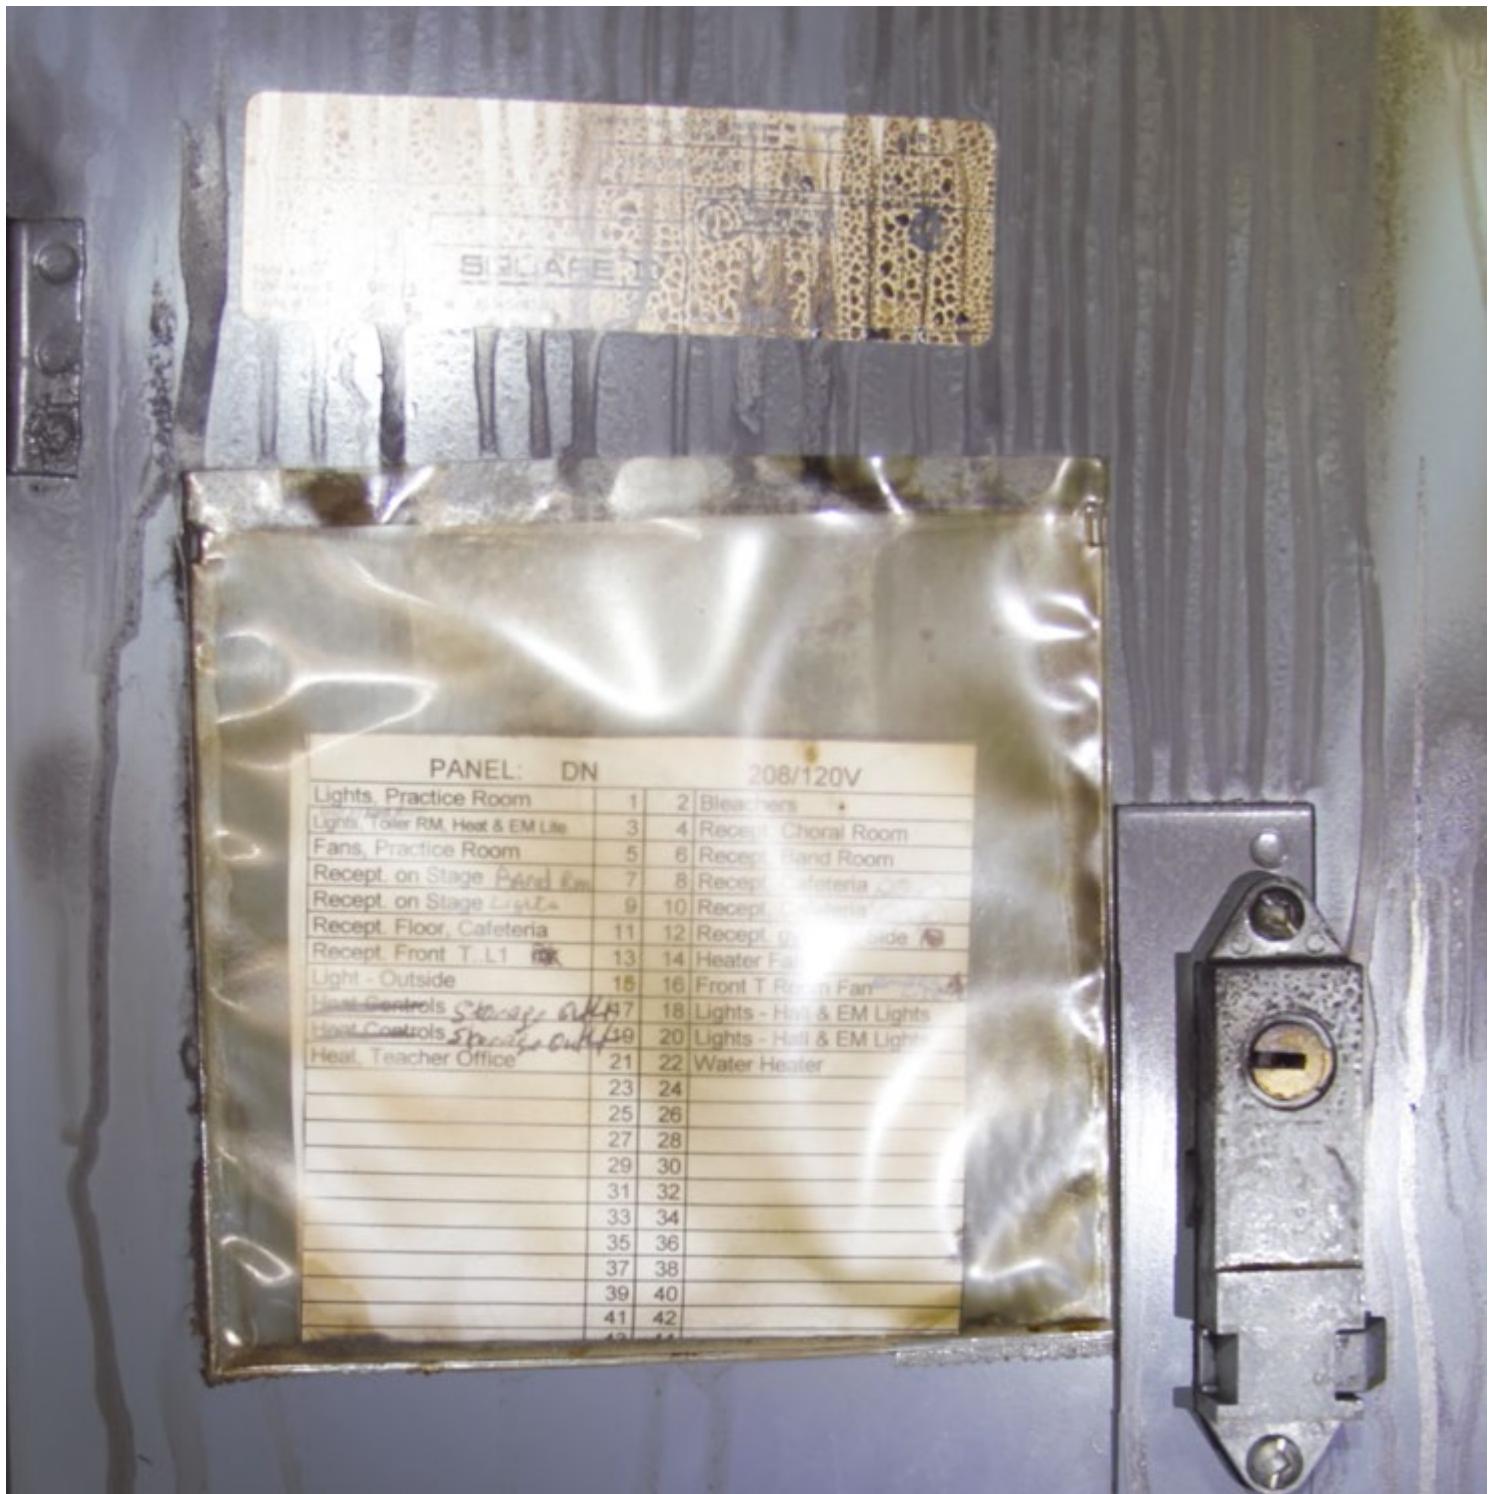
Labeling of Panel D2. Picture is from file IMG_0317.CR2. A copy of this image is included in the addenda/held in the case file.

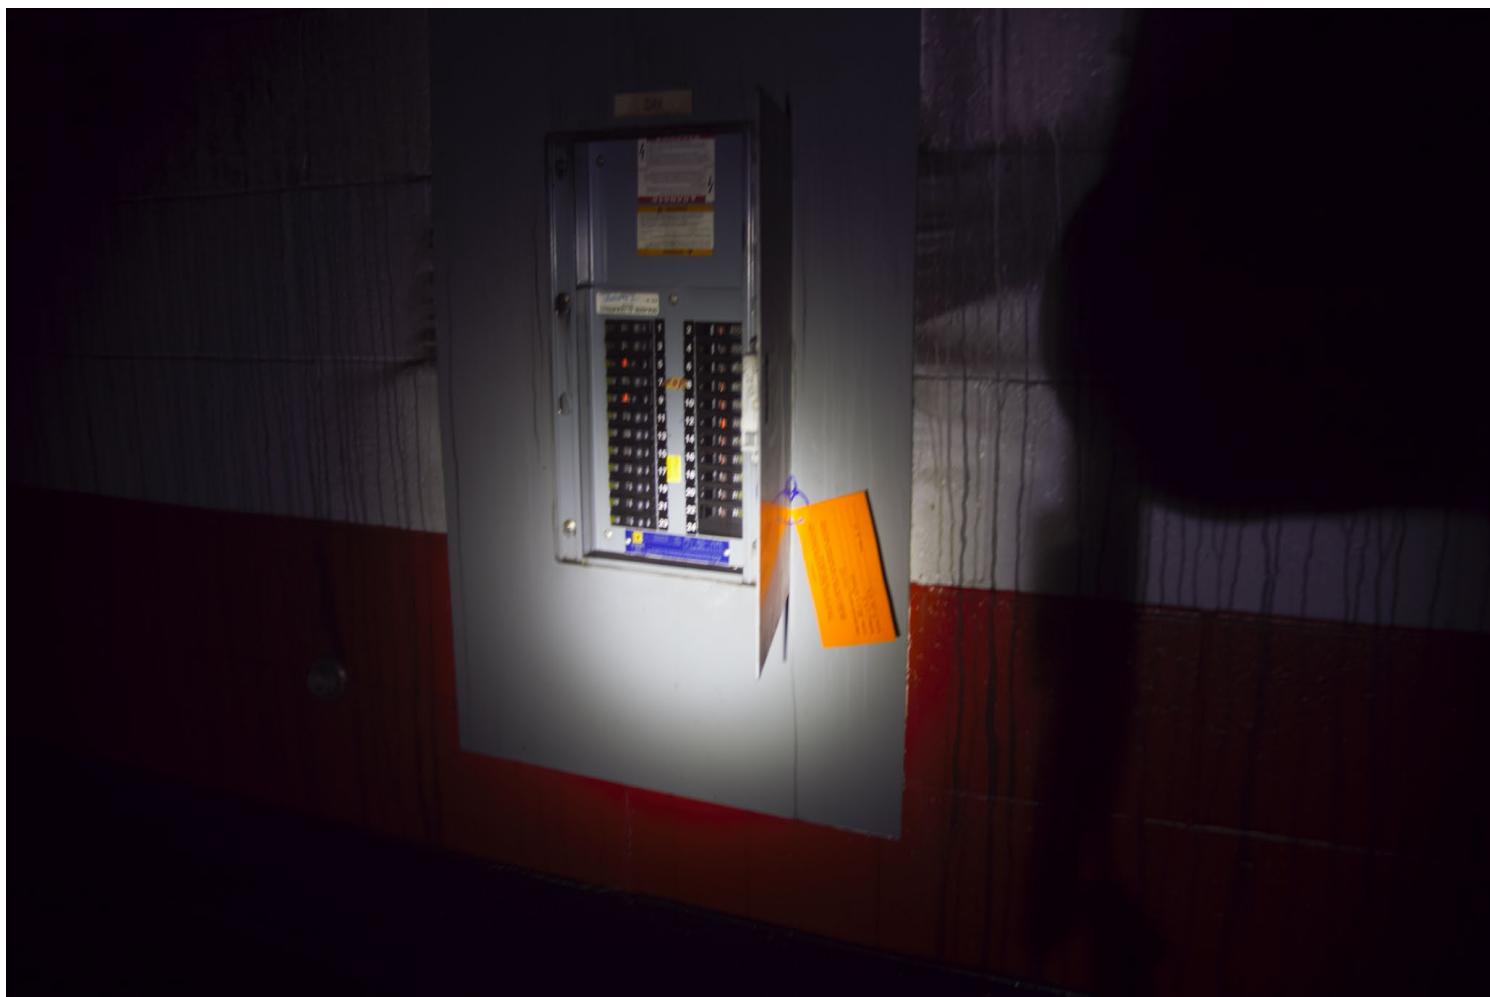
Panel D-2 located in the hallway of the D wing between the cafeteria and old gym marked as evidence. Picture is from file IMG_0364.CR2. A copy of this image is included in the addenda/held in the case file.

Analysis of the fire and heat-related patterns by their movement and intensity concludes the fire propagated to the panel.

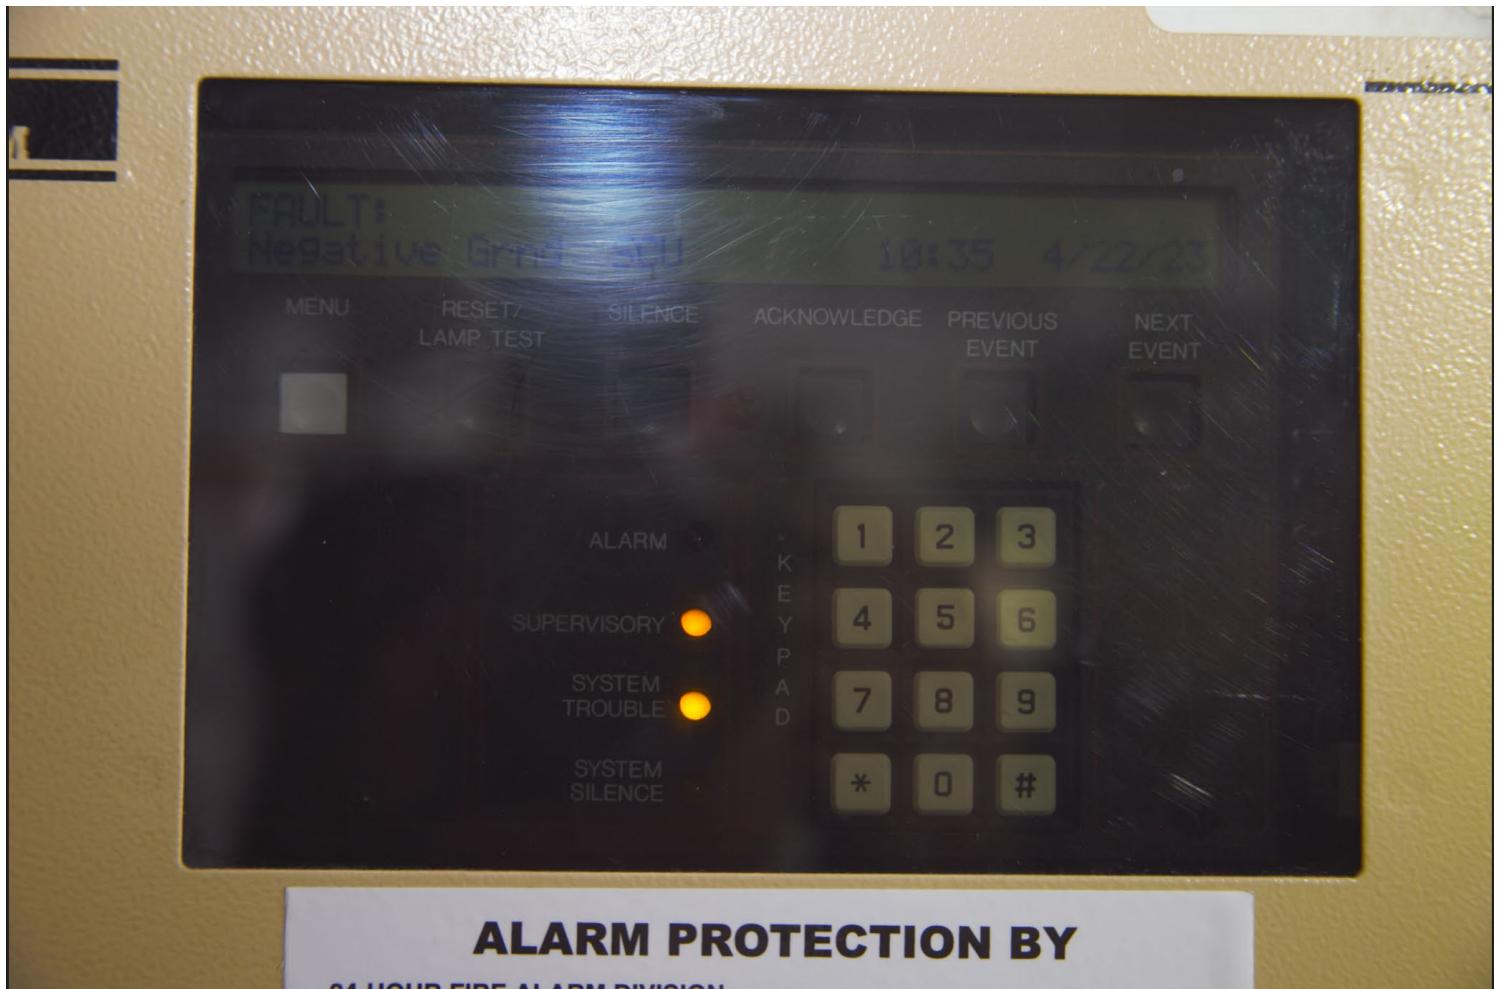
Alarm Panel reading Fault, Supervisory, and System Trouble on the day of the fire.

Pocatello Fire Department Inspection Report notes from November 28, 2022: Fire Alarm Panel in trouble mode (fail). The Inspection Report is included in the addenda/held in the case file.

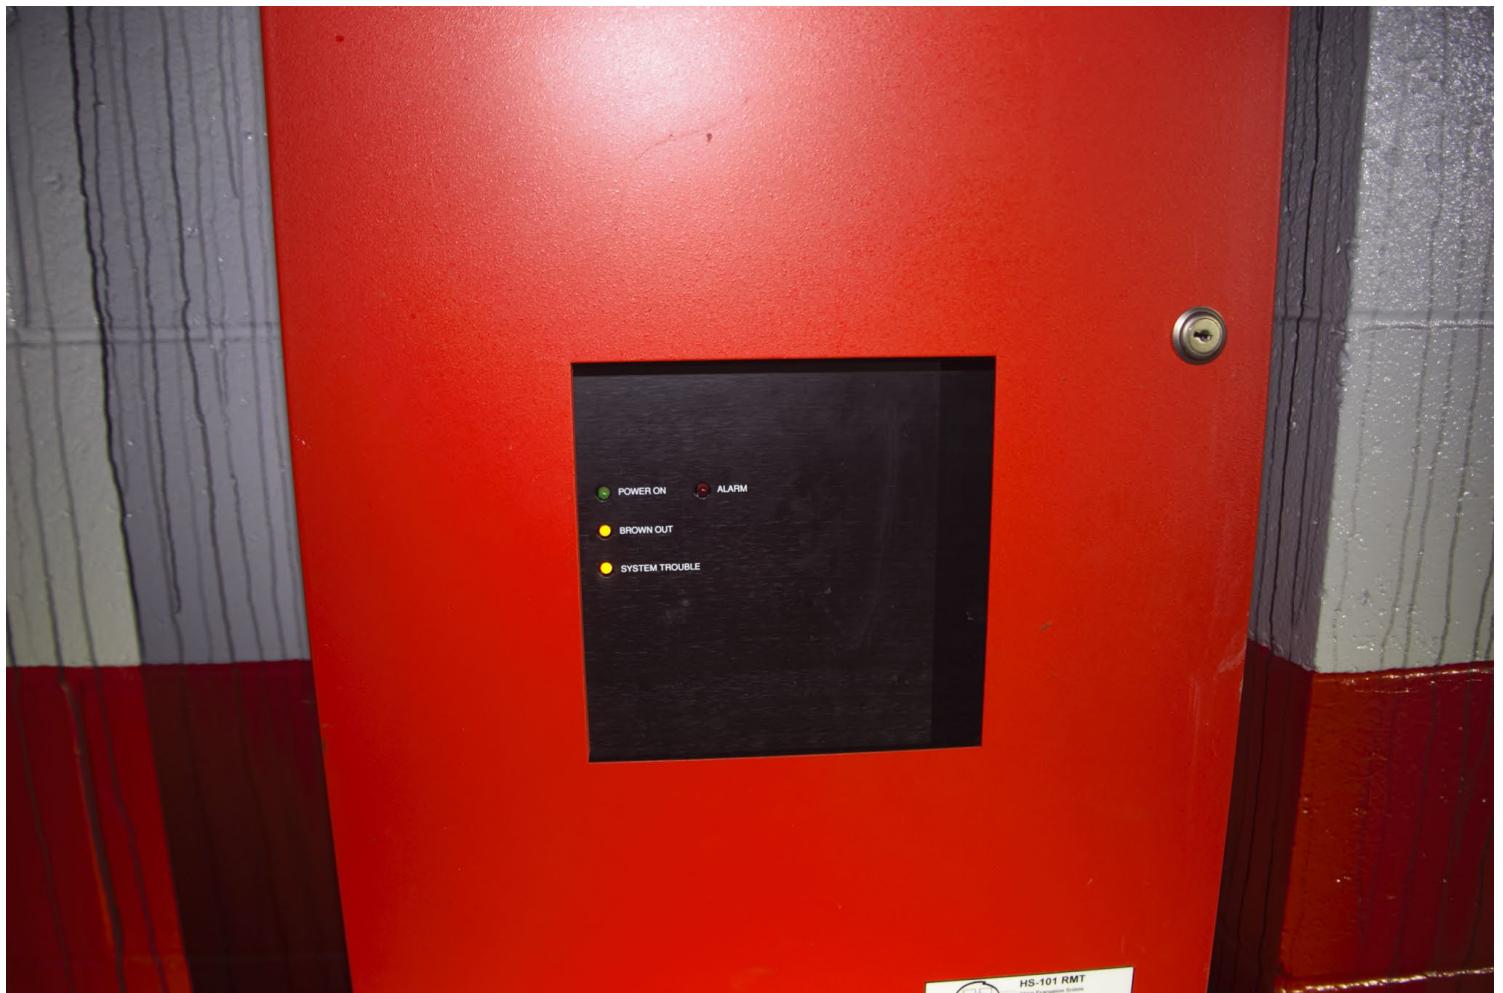
Main Alarm Panel showing Brown Out system trouble. Picture is from file IMG_0197.CR2. A copy of this image is included in the addenda/held in the case file.

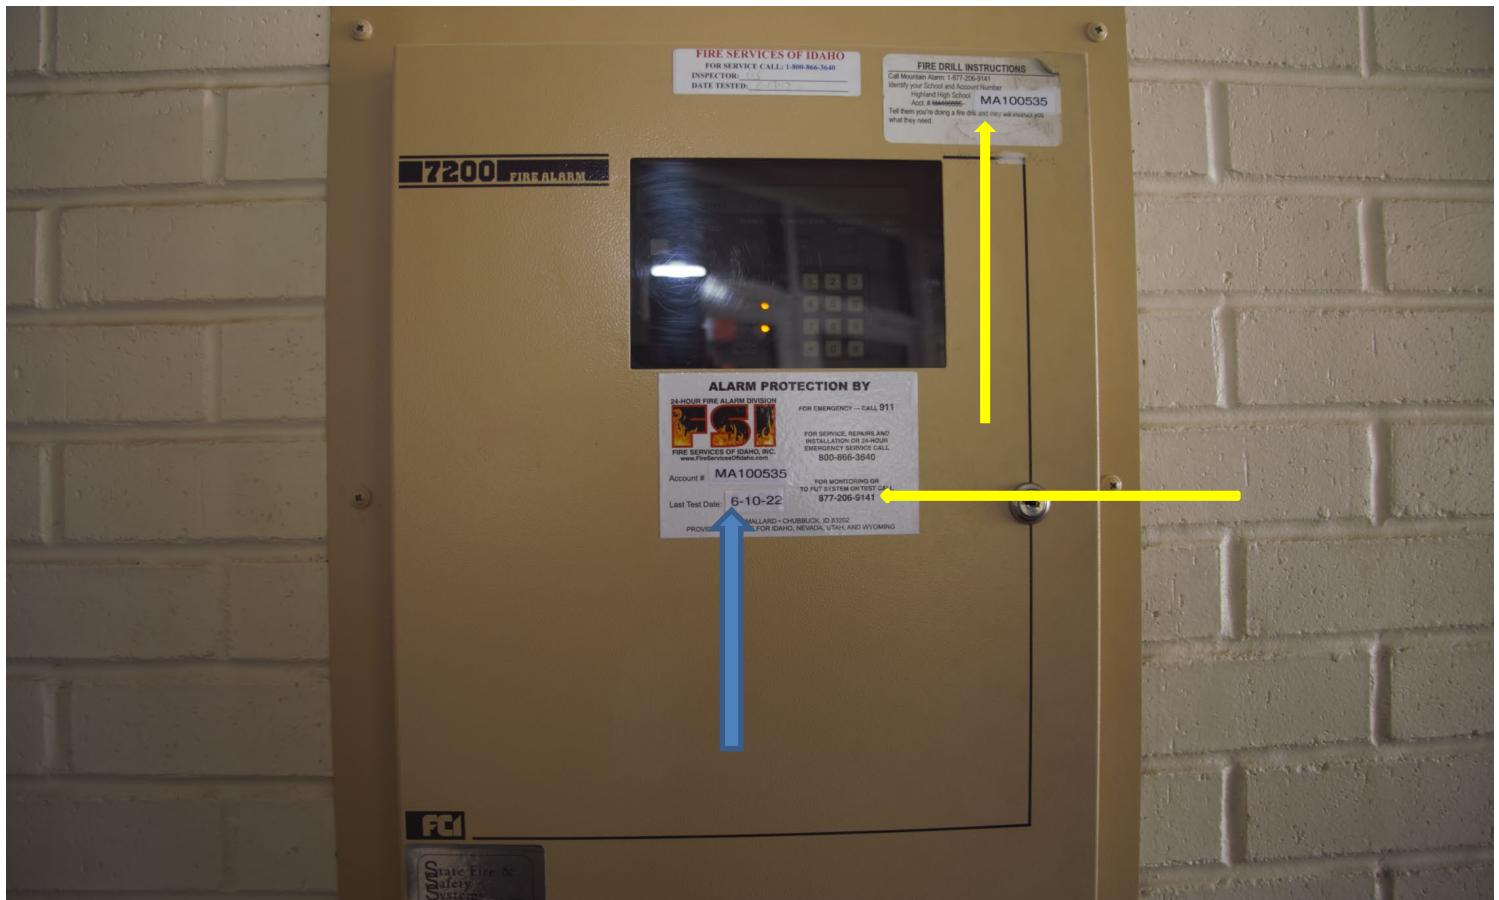
Blue arrow shows last inspection and test date by FSI. Yellow arrows show monitoring contacts. Picture is from file IMG_0193.CR2. A copy of this image is included in the addenda/held in the case file.

Specific Violation Identified, fire alarm panel in trouble:

901.6 Inspection, testing and maintenance. Fire detection and alarm systems, emergency alarm systems, gas detection systems, fire-extinguishing systems, mechanical smoke exhaust systems and smoke and heat vents shall be maintained in an operative condition at all times and shall be replaced or repaired where defective. Nonrequired *fire protection systems* and equipment shall be inspected, tested, and maintained or removed. IFC-2018 Chapter 9

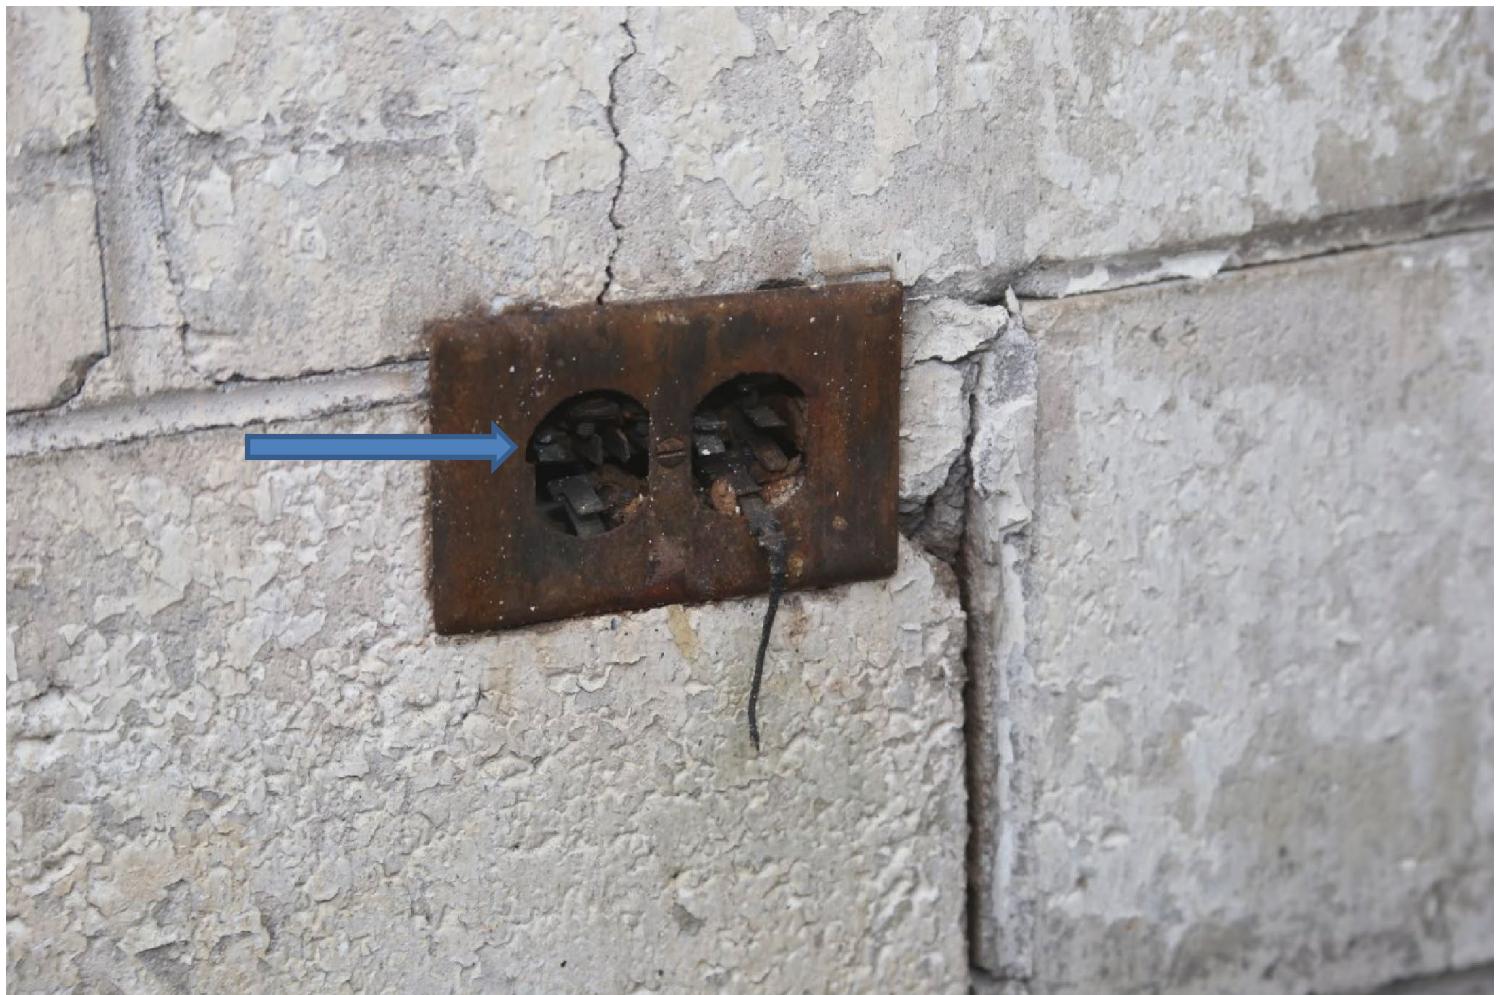
In-field investigation and examination provided evidence or information indicating the cause of the fire is most probably a component used in the construction of the audio power amplifier or the Tomcat floor scrubber.

Blue arrow showing arcing on outlet cover that the audio power amplifier was plugged into. Picture is from file IMG_0345.CR2. A copy of this image is included in the addenda/hold in the case file.

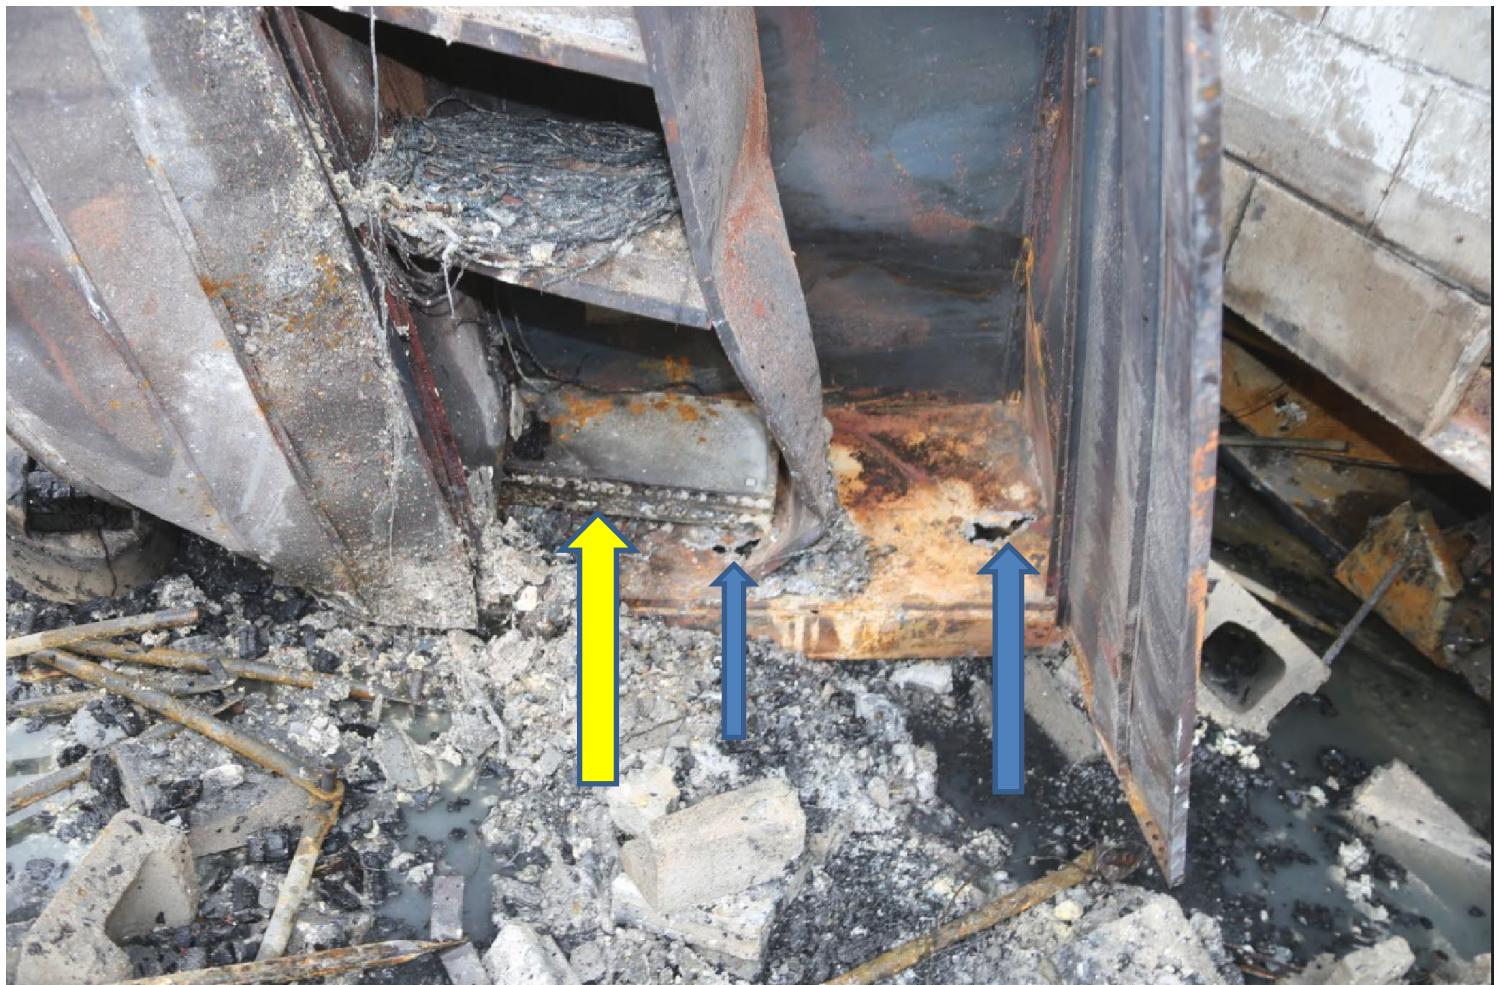
Yellow arrow showing equipment located in the cabinet on the northside of the stage area. Blue arrows show arcing inside the cabinet. Picture is from file IMG_0360.CR2. A copy of this image is included in the addenda/held in the case file.

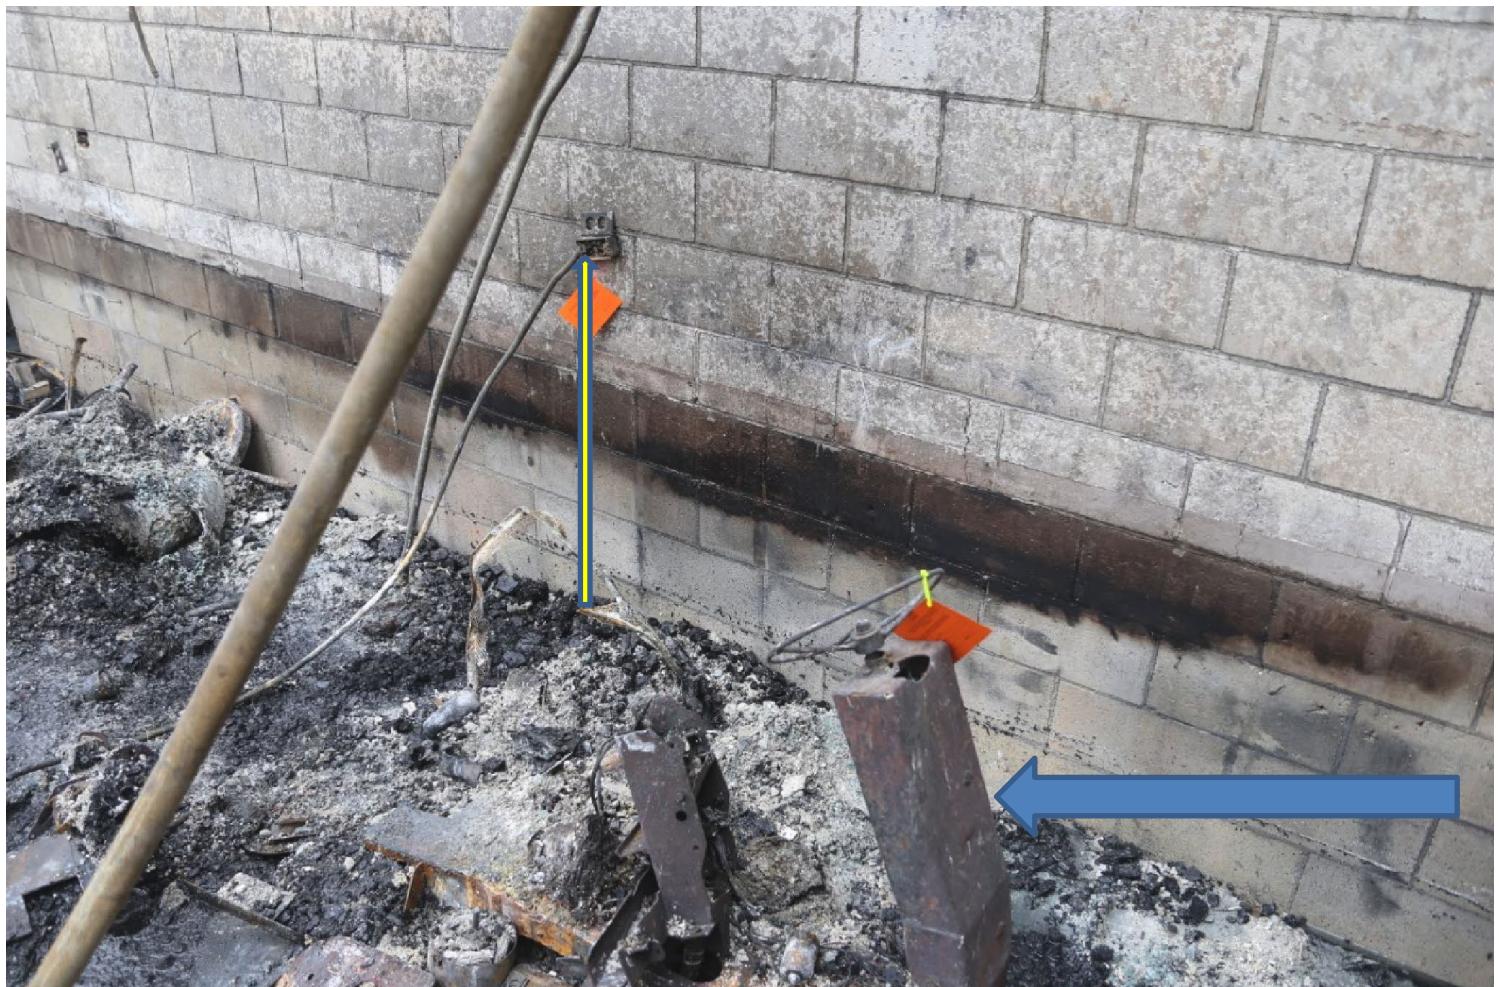
Blue arrow shows Tomcat floor scrubber located on the northside of the stage. Yellow arrow showing power cord for the Tomcat floor scrubber. Picture is from file IMG_0365.CR2. A copy of this image is included in the addenda/hold in the case file.
