MEMORANDUM

DATE: January 24, 2022

SUBJECT: Inspection of Generally Hauling Sanitary Landfill (aka Interstate Disposal Systems Inc. Sanitary Landfill), Permit #107104

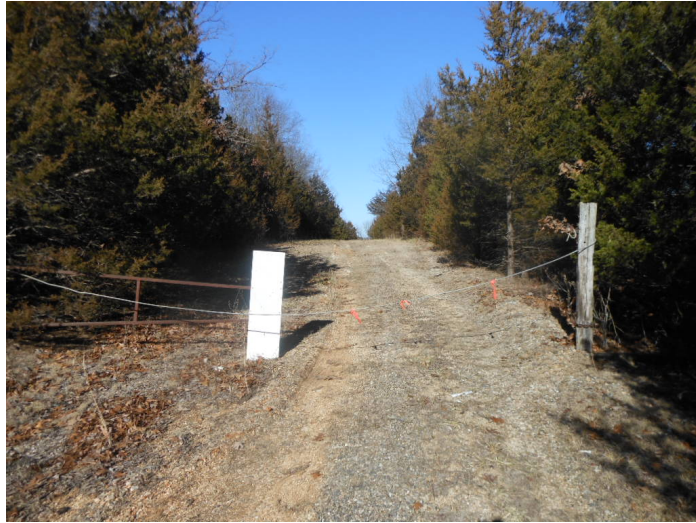
**Photograph: # 1.**  
**Taken By:** Joe Trunko  
**Date Taken:** January 13, 2022  
**Program:** WMP-RCRA D

5. Access into the site is partially restricted by a gate/cable located on the access road and a gate located at the entrance to the landfill. The gates are not locked and there are no "No Trespassing" signs posted.

**Entity:** Generally Hauling Sanitary Landfill  
**Permit:** 107104  
**Location:** Access road  
**Description:** Unlocked gate and cable on access road. Gate is located just past a mobile home that is on the right. Mr. Rick Generally currently lives in the mobile home.

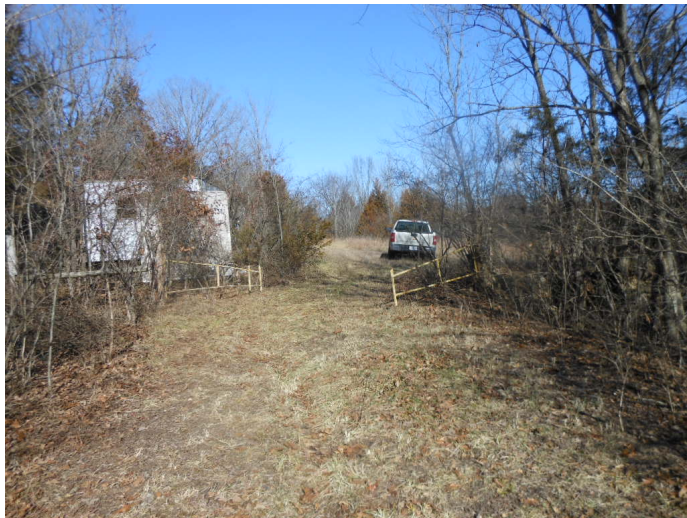
**Photograph: # 2.**  
**Taken By:** Joe Trunko  
**Date Taken:** January 13, 2022  
**Program:** WMP-RCRA D

**Entity:** Generally Hauling Sanitary Landfill  
**Permit:** 107104  
**Location:** Entrance  
**Description:** Unlocked gate at landfill entrance.

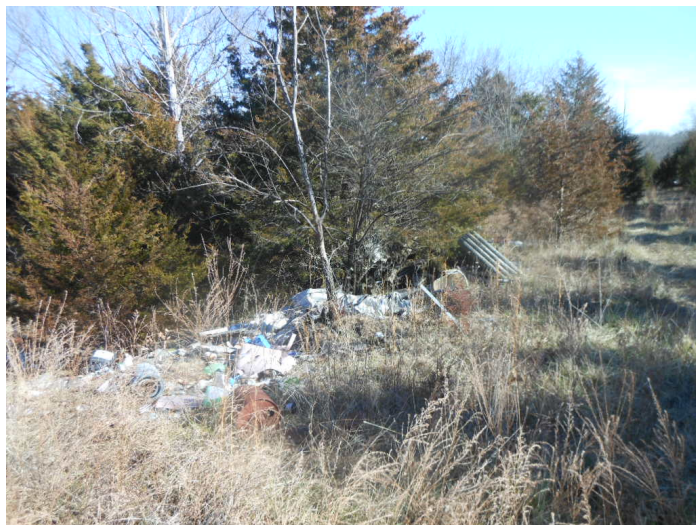
**Photograph: # 3.**  
**Taken By:** Joe Trunko  
**Date Taken:** January 13, 2022  
**Program:** WMP-RCRA D

**Entity:** Generally Hauling Sanitary Landfill  
**Permit:** 107104  
**Location:** SW area of Landfill  
**Description:** Promiscuously dumped waste along south side of depressed/excavated area.

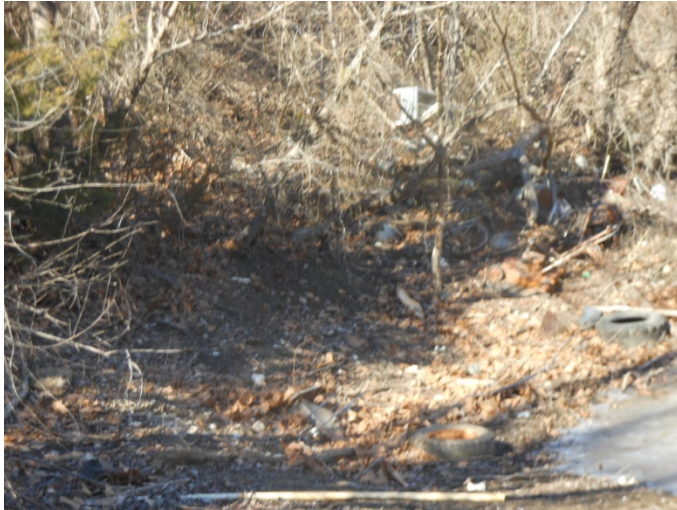
**Photograph: # 4.**  
**Taken By:** Joe Trunko  
**Date Taken:** January 13, 2022  
**Program:** WMP-RCRA D

**Entity:** Generally Hauling Sanitary Landfill  
**Permit:** 107104  
**Location:** SW area of Landfill  
**Description:** Water accumulated in depressed/excavated area; miscellaneous debris located in water.

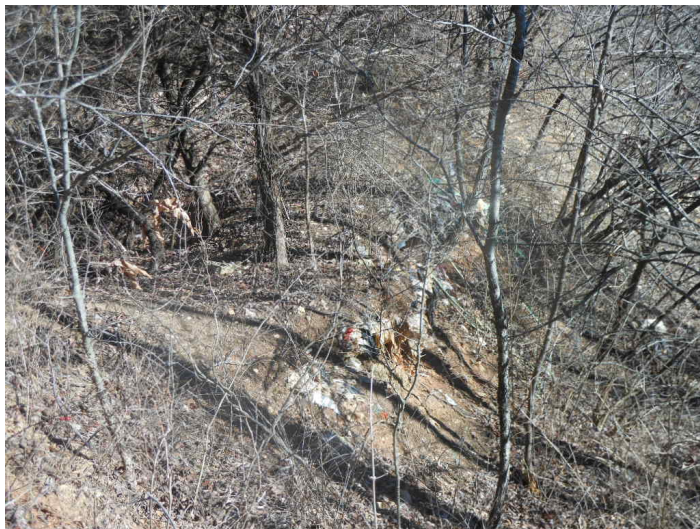
**Photograph: # 5.**  
**Taken By:** Joe Trunko  
**Date Taken:** January 13, 2022  
**Program:** WMP-RCRA D

**Entity:** Generally Hauling Sanitary Landfill  
**Permit:** 107104  
**Location:** SW area of Landfill  
**Description:** Exposed waste in north bank of depressed/excavated area.

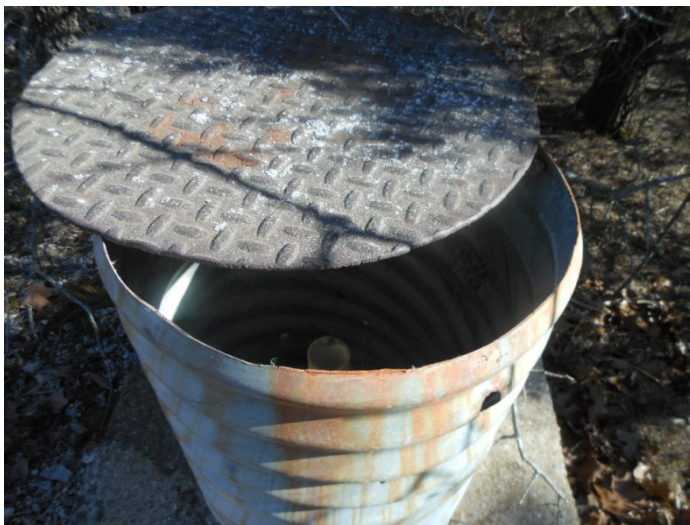
**Photograph: # 6.**  
**Taken By:** Joe Trunko  
**Date Taken:** January 13, 2022  
**Program:** WMP-RCRA D

11. There is one piezometer located at the southeast corner of the landfill and another located along the west property line. Neither piezometer has been properly decommissioned in accordance with 10 CSR 23-4. Access into the piezometers is not restricted (i.e. there is no locked cap). The west piezometer does not have any sort of cap/lid, and rainwater had accumulated in it to just below the PVC riser pipe. This condition results in a potential direct conduit for contaminants to enter the groundwater system.

**Entity:** Generally Hauling Sanitary Landfill  
**Permit:** 107104  
**Location:** SE corner of Landfill  
**Description:** Piezometer

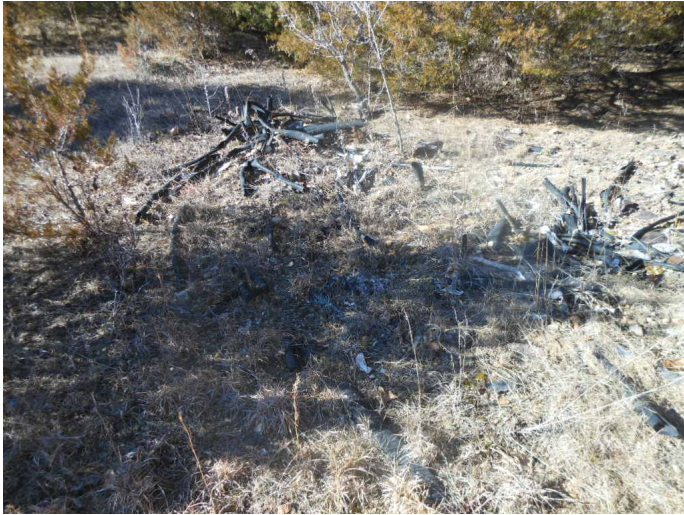
**Photograph: # 7.**  
**Taken By:** Joe Trunko  
**Date Taken:** January 13, 2022  
**Program:** WMP-RCRA D

**Entity:** Generally Hauling Sanitary Landfill  
**Permit:** 107104  
**Location:** SE area of Landfill  
**Description:** Rubber hose and misc. waste sticking out of the ground surface.

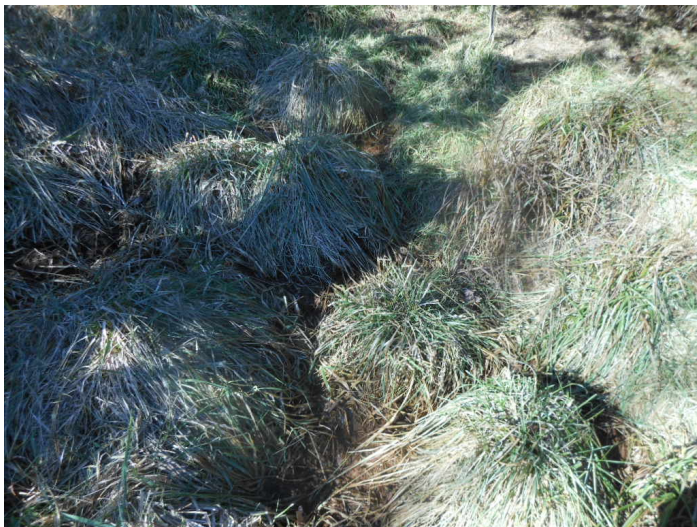
**Photograph: # 8.**  
**Taken By:** Joe Trunko  
**Date Taken:** January 13, 2022  
**Program:** WMP-RCRA D

8. Several leachate outbreaks were observed in the central south section of the landfill. The leachate flowed for several feet and then dried up. During past inspections, leachate from this area has been observed flowing into an erosion ditch towards the southeast corner of the site and discharging off the property to the east into an unnamed tributary to the Meramec River.

**Entity:** Generally Hauling Sanitary Landfill  
**Permit:** 107104  
**Location:** Central south area of landfill  
**Description:** Leachate outbreak area.

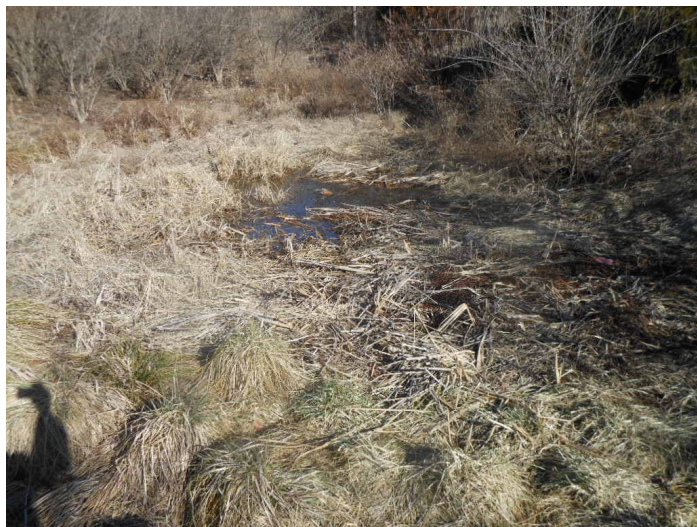
**Photograph: # 9.**  
**Taken By:** Joe Trunko  
**Date Taken:** January 13, 2022  
**Program:** WMP-RCRA D

**Entity:** Generally Hauling Sanitary Landfill  
**Permit:** 107104  
**Location:** West central area of landfill  
**Description:** Subsided area containing ponded water.

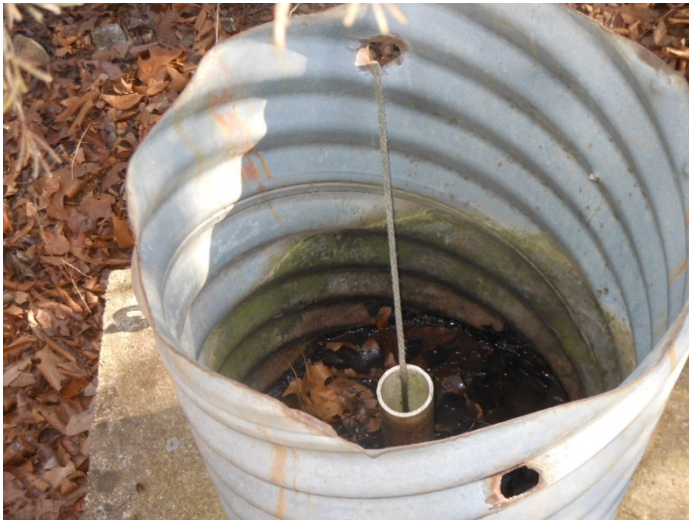
**Photograph: # 10.**  
**Taken By:** Joe Trunko  
**Date Taken:** January 13, 2022  
**Program:** WMP-RCRA D

**Entity:** Generally Hauling Sanitary Landfill  
**Permit:** 107104  
**Location:** West side of landfill  
**Description:** Uncovered piezometer; water accumulated in casing.

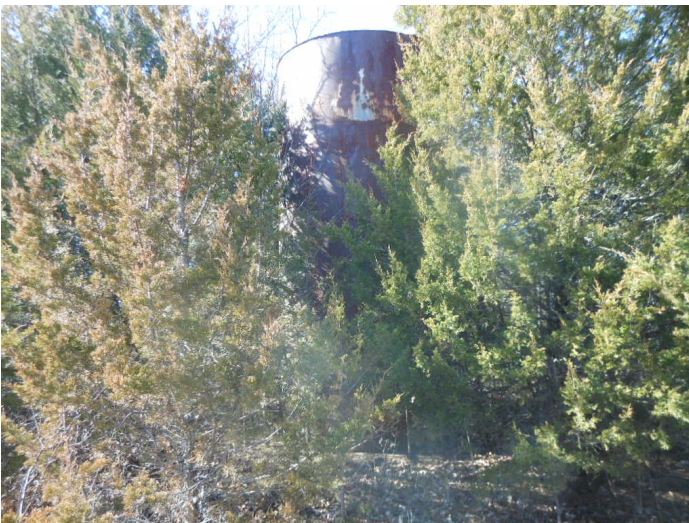
**Photograph: # 11.**  
**Taken By:** Joe Trunko  
**Date Taken:** January 13, 2022  
**Program:** WMP-RCRA D

**Entity:** Generally Hauling Sanitary Landfill  
**Permit:** 107104  
**Location:** West side of landfill  
**Description:** Leachate storage tank.

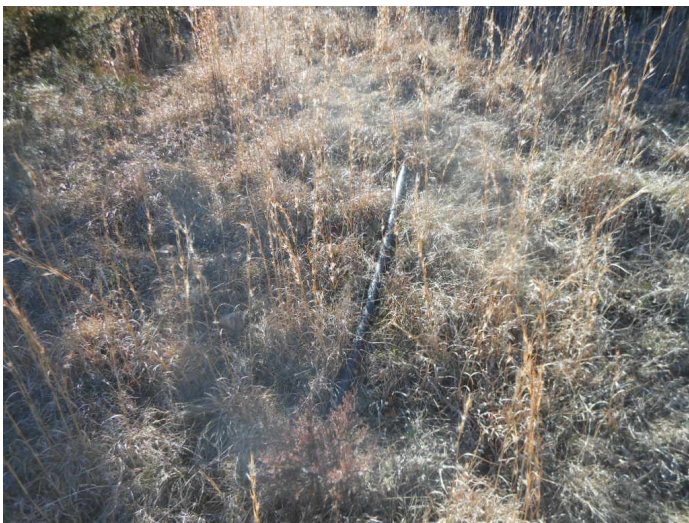
**Photograph: # 12.**  
**Taken By:** Joe Trunko  
**Date Taken:** January 13, 2022  
**Program:** WMP-RCRA D

**Entity:** Generally Hauling Sanitary Landfill  
**Permit:** 107104  
**Location:** North area of landfill  
**Description:** Hose formerly used to pump leachate from the leachate collection sump to the leachate tank.

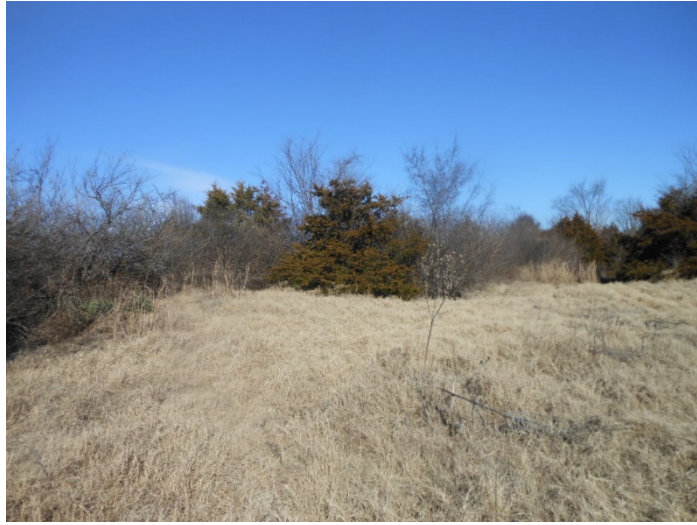
**Photograph:** # 13.  
**Taken By:** Joe Trunko  
**Date Taken:** January 13, 2022  
**Program:** WMP-RCRA D  
**Entity:** Generally Hauling Sanitary Landfill  
**Permit:** 107104  
**Location:** Central west side of landfill  
**Description:** Central west side of landfill; looking northeast.

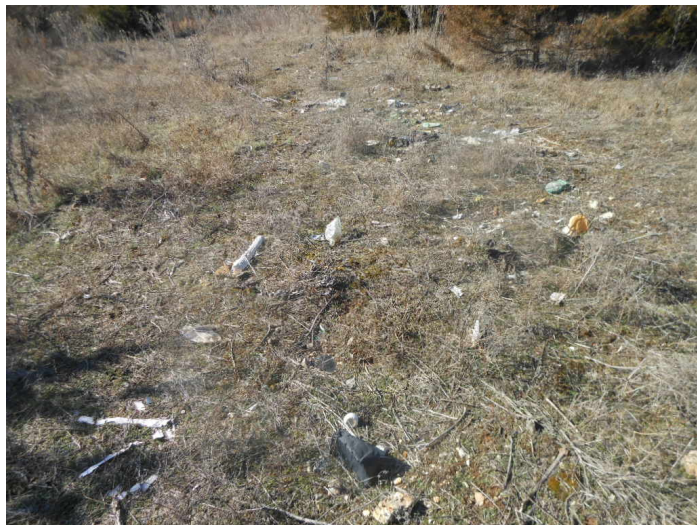
7. The landfill was never properly closed and adequate final cover was never applied. The cover material that had been utilized consisted of a significant amount of rock. A significant amount of exposed waste was observed sticking through the cover throughout the landfill. A large erosion

**Photograph:** # 14.  
**Taken By:** Joe Trunko  
**Date Taken:** January 13, 2022  
**Program:** WMP-RCRA D  
**Entity:** Generally Hauling Sanitary Landfill  
**Permit:** 107104  
**Location:** Central area of landfill  
**Description:** Exposed waste sticking out from cover.

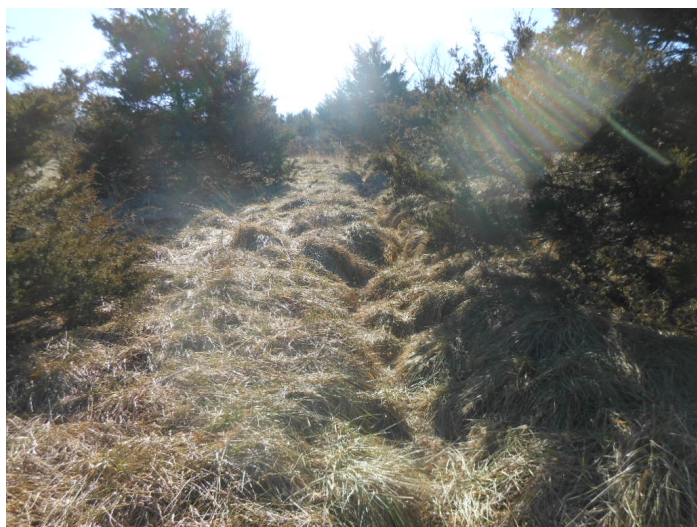
**Photograph:** # 15.  
**Taken By:** Joe Trunko  
**Date Taken:** January 13, 2022  
**Program:** WMP-RCRA D  
**Entity:** Generally Hauling Sanitary Landfill  
**Permit:** 107104  
**Location:** East side of North slopr  
**Description:** Erosion ditch located in the central section of the east side of the north slope; looking south upslope.

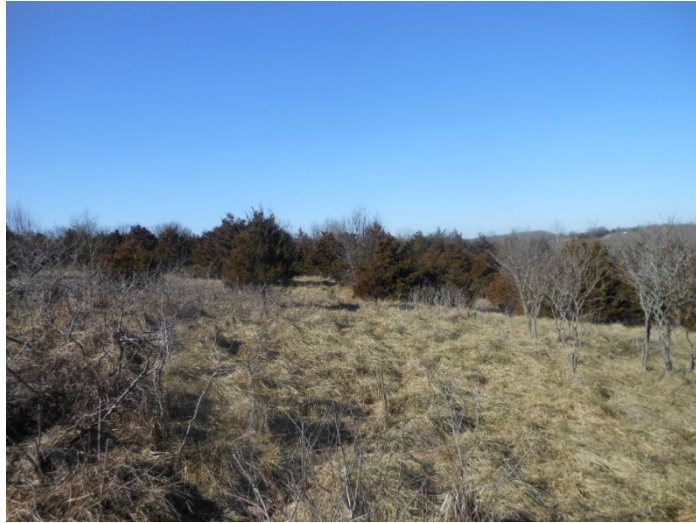
**Photograph:** # 16.  
**Taken By:** Joe Trunko  
**Date Taken:** January 13, 2022  
**Program:** WMP-RCRA D  
**Entity:** Generally Hauling Sanitary Landfill  
**Permit:** 107104  
**Location:** North slope  
**Description:** Upper section of North slope; looking west.

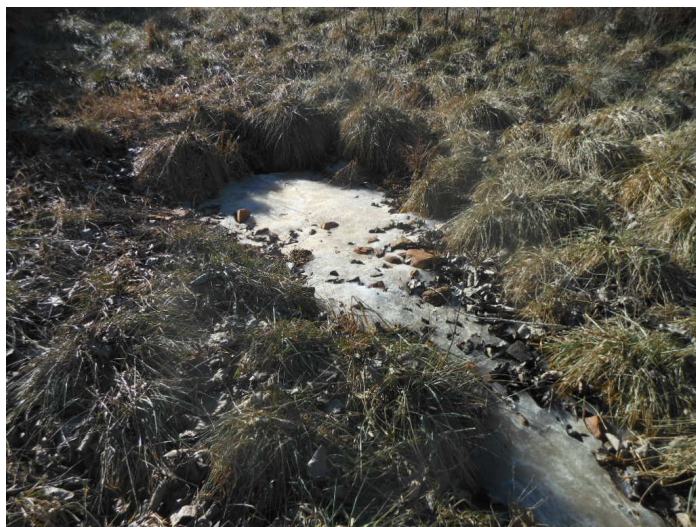
9. Several large leachate outbreaks were observed near the base of the west side of the north slope. The leachate was partially frozen and only flowed for a few feet. At the time of the previous inspection however, leachate from these outbreaks was observed entering a drainage ditch located just west of the leachate collection manhole, flowing into the railroad culvert, and discharging from the culvert to the north into an unnamed tributary to the Meramec River.

**Photograph:** # 17.  
**Taken By:** Joe Trunko  
**Date Taken:** January 13, 2022  
**Program:** WMP-RCRA D  
**Entity:** Generally Hauling Sanitary Landfill  
**Permit:** 107104  
**Location:** North slope of landfill  
**Description:** Leachate outbreak on lower west side of north slope.

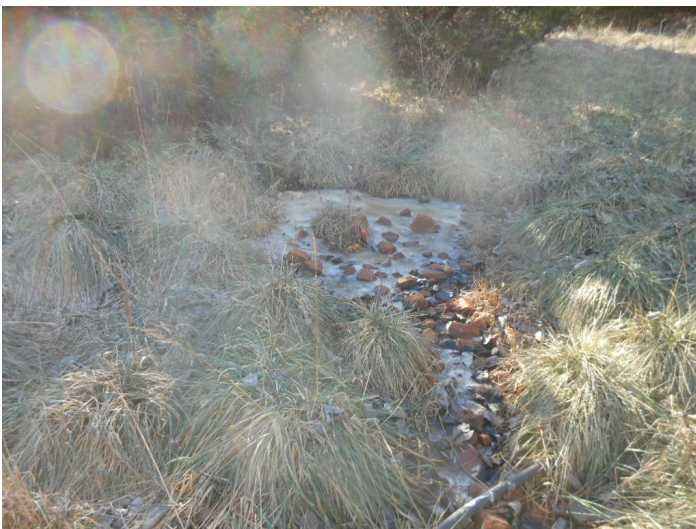
**Photograph:** # 18.  
**Taken By:** Joe Trunko  
**Date Taken:** January 13, 2022  
**Program:** WMP-RCRA D  
**Entity:** Generally Hauling Sanitary Landfill  
**Permit:** 107104  
**Location:** North slope of landfill  
**Description:** Leachate outbreak on lower west side of north slope.

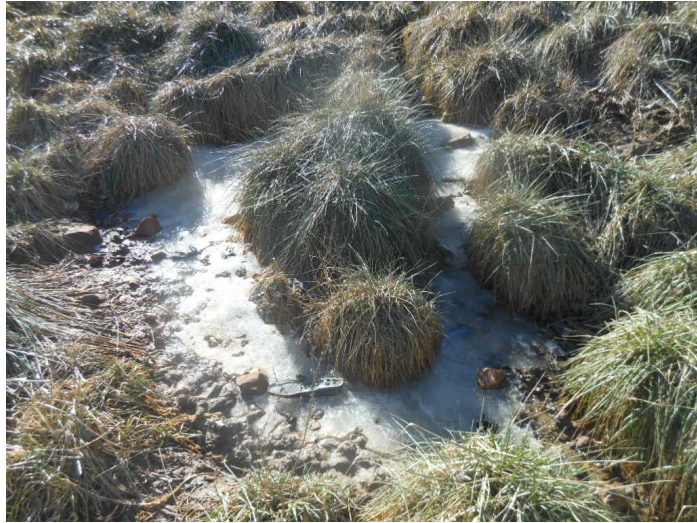
**Photograph:** # 19.  
**Taken By:** Joe Trunko  
**Date Taken:** January 13, 2022  
**Program:** WMP-RCRA D

**Entity:** Generally Hauling Sanitary Landfill  
**Permit:** 107104  
**Location:** North slope of landfill  
**Description:** Leachate outbreak on lower west side of north slope.

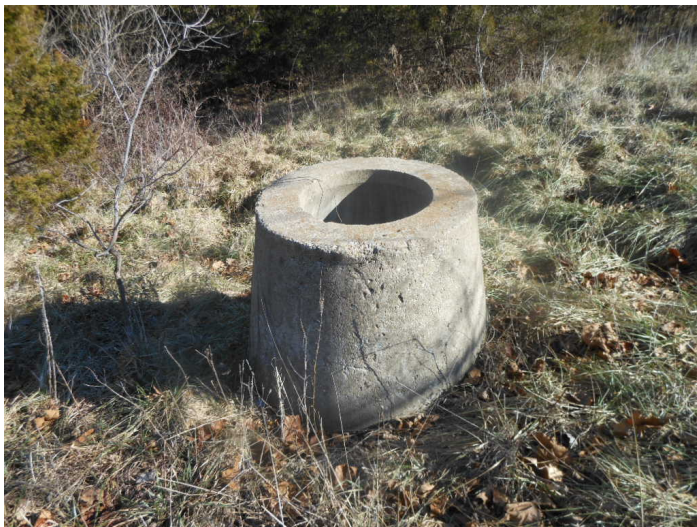
**Photograph:** # 20.  
**Taken By:** Joe Trunko  
**Date Taken:** January 13, 2022  
**Program:** WMP-RCRA D

10. There is a leachate collection sump located at the base of the north slope just south of the railroad culvert. The depth of liquid in the sump was not determined, but it appeared to be similar to the depth observed during previous inspections. It could not be determined if the leachate collection system was still functional. When the landfill was operating, leachate used to be pumped from the sump to a storage tank located on the west side of the landfill. The tank is rusted and in poor condition. I tapped on the tank and it appeared to be empty, however it could not be confirmed if there was any residual leachate in the tank.

**Entity:** Generally Hauling Sanitary Landfill  
**Permit:** 107104  
**Location:** North slope of landfill  
**Description:** Leachate collection sump at base of north slope.

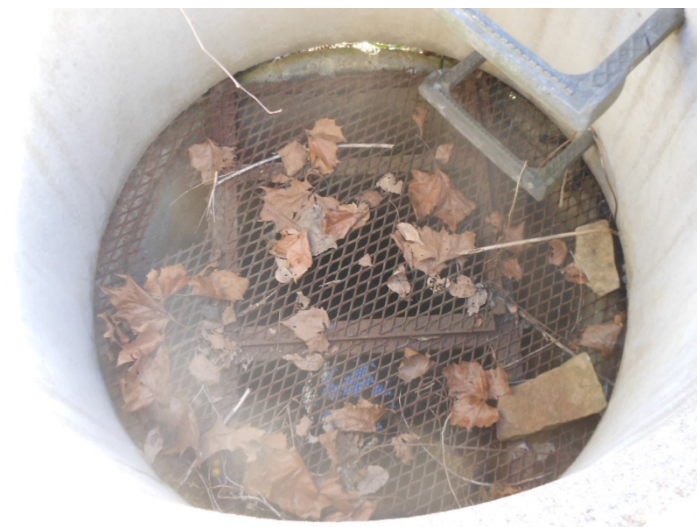
**Photograph:** # 21.  
**Taken By:** Joe Trunko  
**Date Taken:** January 13, 2022  
**Program:** WMP-RCRA D

**Entity:** Generally Hauling Sanitary Landfill  
**Permit:** 107104  
**Location:** North slope of landfill  
**Description:** Inside the leachate collection sump at base of north slope.

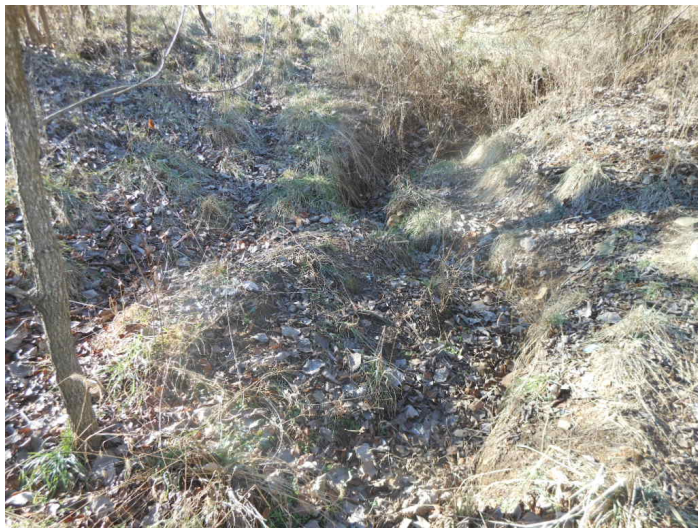
**Photograph:** # 22.  
**Taken By:** Joe Trunko  
**Date Taken:** January 13, 2022  
**Program:** WMP-RCRA D

**Entity:** Generally Hauling Sanitary Landfill  
**Permit:** 107104  
**Location:** North side of landfill  
**Description:** Erosion at base of North slope; leachate was observed flowing in this ditch towards the railroad culvert pipe inlet during the previous inspection.

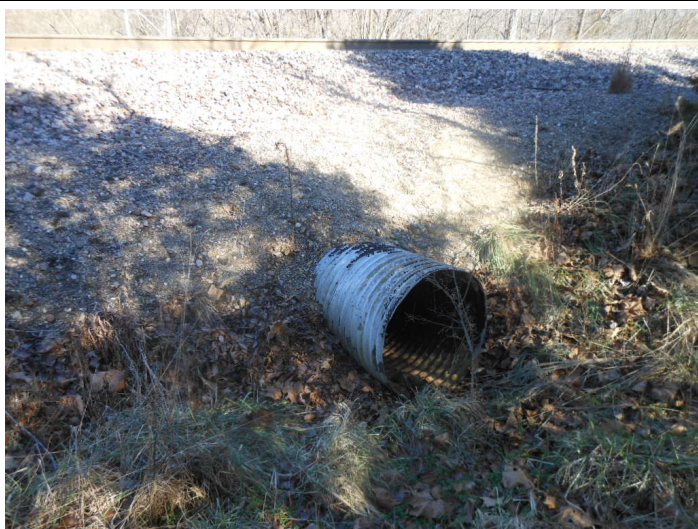
**Photograph:** # 23.  
**Taken By:** Joe Trunko  
**Date Taken:** January 13, 2022  
**Program:** WMP-RCRA D

**Entity:** Generally Hauling Sanitary Landfill  
**Permit:** 107104  
**Location:** North side of landfill  
**Description:** Railroad culvert pipe inlet.

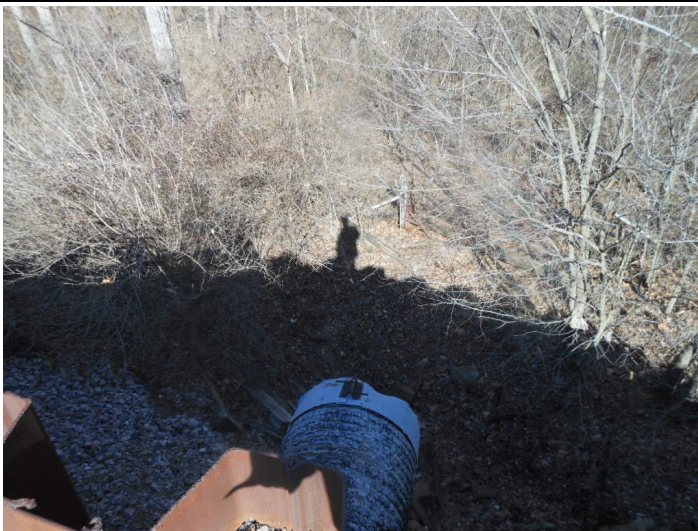
**Photograph:** # 24.  
**Taken By:** Joe Trunko  
**Date Taken:** January 13, 2022  
**Program:** WMP-RCRA D

**Entity:** Generally Hauling Sanitary Landfill  
**Permit:** 107104  
**Location:** North side of landfill  
**Description:** Outlet of railroad culvert pipe.
