## **INVESTIGATION REPORT**

**CASE NUMBER:** 20CALNU015947

**CASE NAME:** Glass

**INCIDENT TYPE:** Wildland Fire

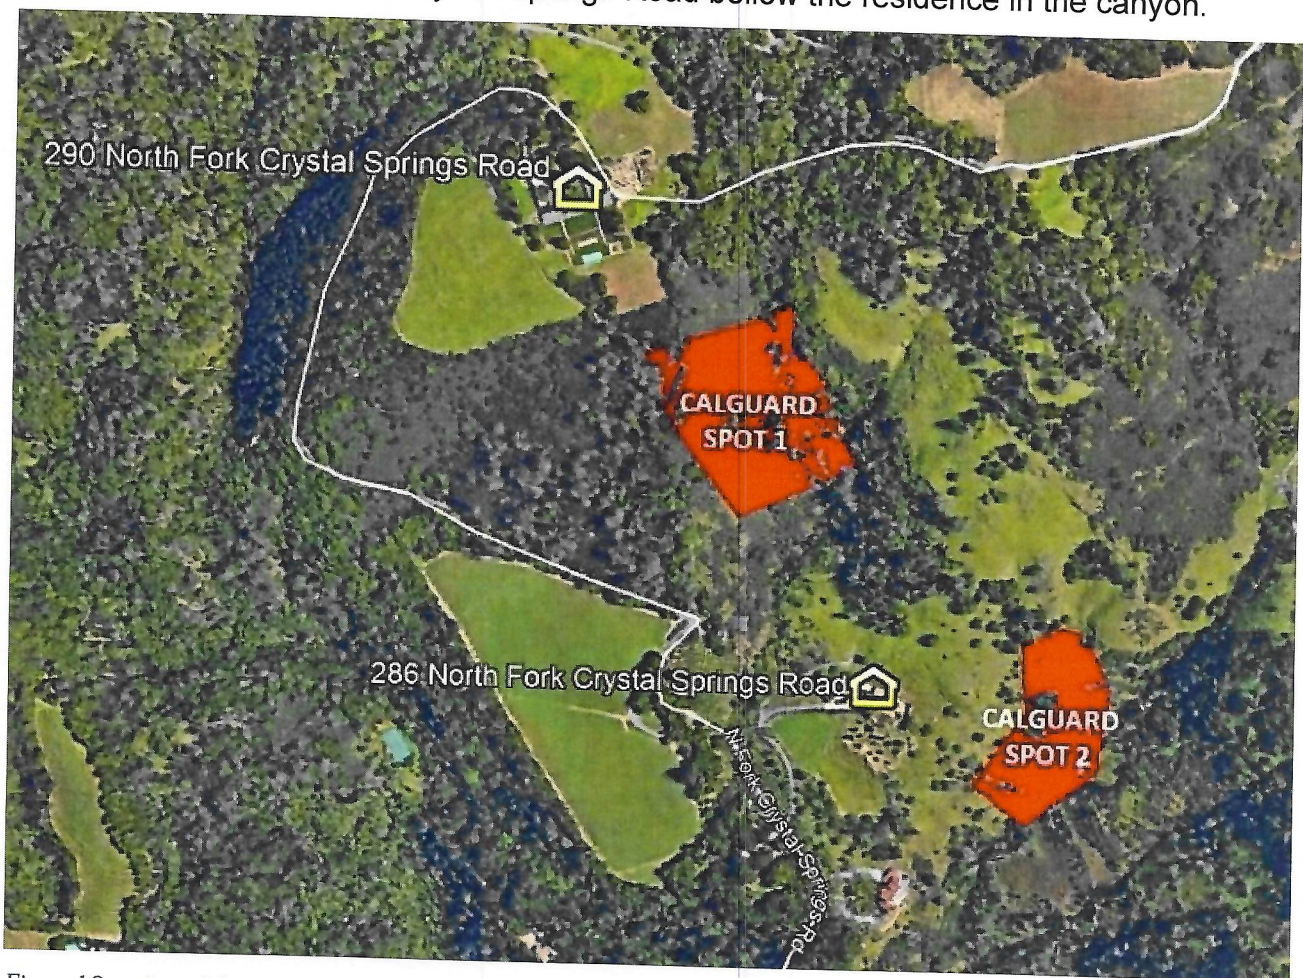
5  
6 I continued driving east to the address of 290 North Fork Crystal Springs Road. While  
7 en route to this location, CAL FIRE Battalion Chief Joe BALDWIN sent me an email.  
8 The email contained an attachment from the California Military Department (CAL  
9 GUARD). The attachment was an electronic document in the form of a heat signature  
10 map from September 27, 2020 at 4:16 AM. The heat signature map showed an  
11 approximate location of a heat source which was detected at 4:16 AM, southwest of the  
12 address of 290 North Fork Crystal Springs Road bellow the residence in the canyon.

13  
14 *Figure 1 Overview of CALGUARD heat signatures. (FC. UBOLDI, G)*

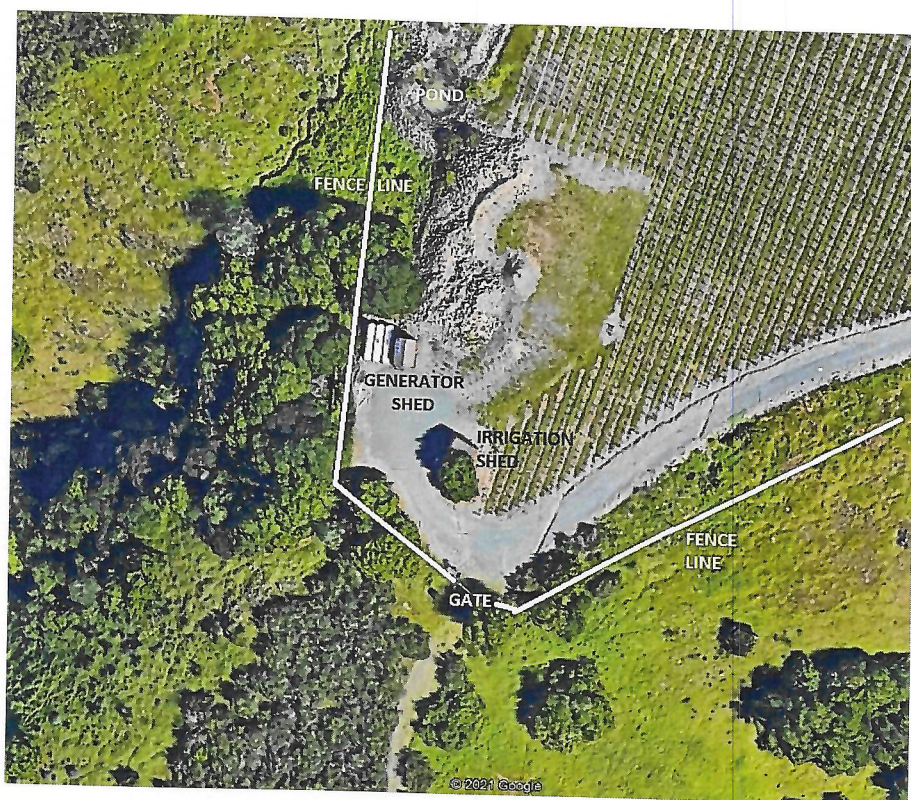
1 The area in question is located below wide gravel parking area and two separate shed  
2 type structures. Below the two sheds was a vehicle gate across a dirt road which was  
3 off the main gravel road. The gate appeared to have been originally designed for an  
4 automated gate opener. On both sides of the fence along the dirt road were keypad  
5 pedestals for the gate. I saw a concrete pad was built for a gate opener on the exterior  
6 side of the perimeter fence north of the dirt road.

8  
9 *Figure 2 Overview diagram image of 300 N. Fork Crystal Springs site. (FC. UBOLDI, G)*

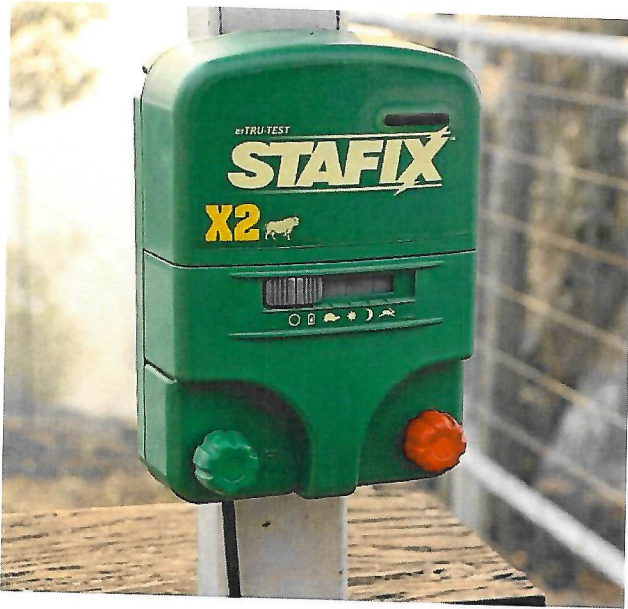
24  
25 I saw the electric fence controller sliding switch was set in the "off" position.

26 The electrical fence controller had two threaded stud type terminals on the front face of  
27 the unit, one green in color, and one red in color. Both threaded stud type terminals had  
28 large plastic type threaded nuts which secured two separate wires, one was red in color,  
29 and one was green in color.

Figure 3 Close up view of electric fence controller. (FC. UBOLDI, G)

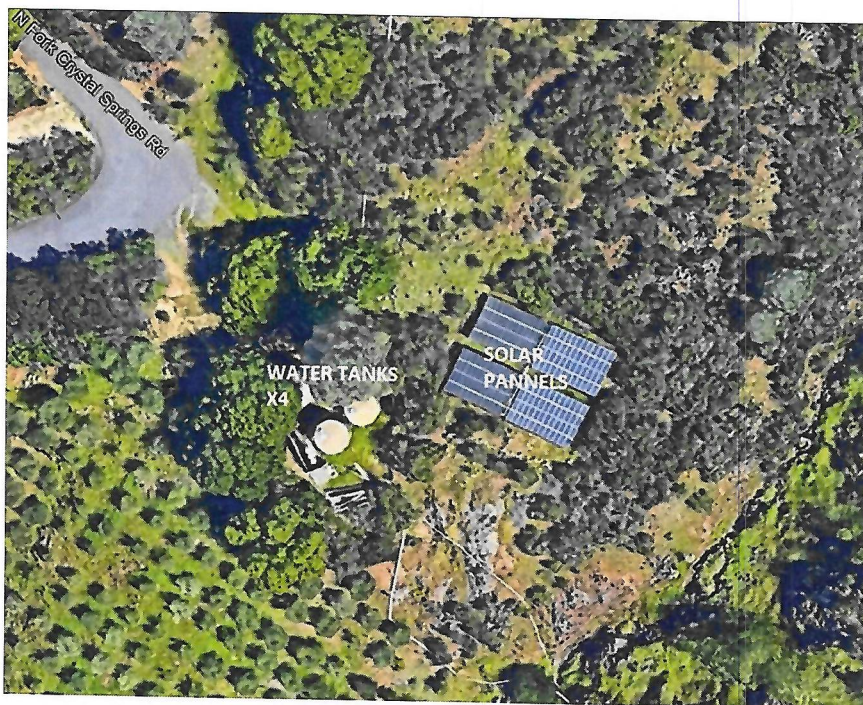
16  
17 *Figure 4 Overview diagram image of 286 N. Fork Crystal Springs Road (FC. UBOLDI, G)*

18 COLE told me based on his experience it appeared a fire had occurred in the interior of  
19 the electrical panels and spread to the outside. I asked COLE if he had seen and  
LE80 (Rev. 7/2011)

9  
10 I saw that the area consisted of three concrete water tanks which were approximately  
11 ten thousand gallons each. Between two of the tanks were the remains of what  
12 appeared to be a plastic water tank against the hillside. The plumbing connecting the  
13 tanks which ran underground had been recently exposed post fire for repair work. On  
14 the western side of the cluster of water tanks were several valves and three electrical  
15 panels which appeared to have been mounted to a wooden frame.

16  
17 The wooden frame securing the electrical panels had been destroyed by fire. Around  
18 the outside of the valves and electrical panels was a wooded fence. The wooden fence  
19 sustained minimal damage compared to the surrounding vegetation. The fire damage  
20 sustained to the fence was limited to a partially burned section located near the ground  
21 orientated directly behind the electrical panels.

22  
23 The second area of fire damage to the fence was on the northeast end of the fence.  
24 This area the fence ran from the bottom of the fence to the top and had fully consumed  
25 several fence boards and a structural fence post. The plumbing connecting the valves to  
26 the tanks consisted of polyvinyl chloride (PVC) and iron pipe of assorted diameters.
