**RE: Visual Structural Inspection – Apparatus Bay Floor Slab**  
Amesbury Fire Station  
Elm Street, Amesbury, MA

McBrie, LLC Project # 17-197

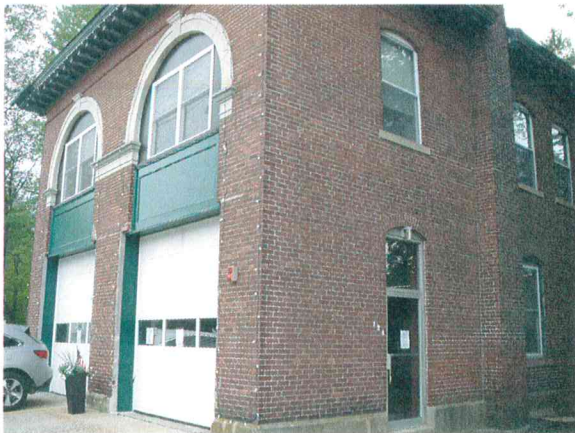
Front/Right Corner Elevation

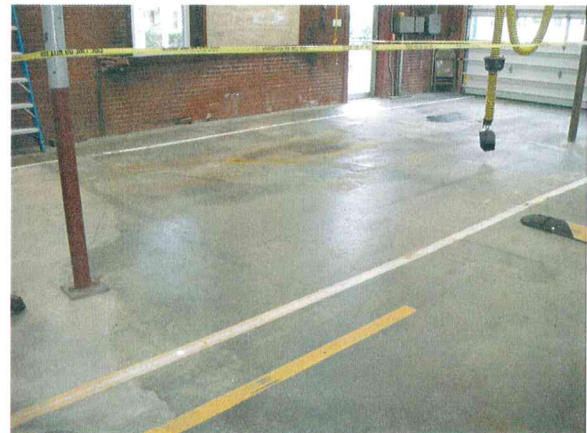
Apparatus bay of concern

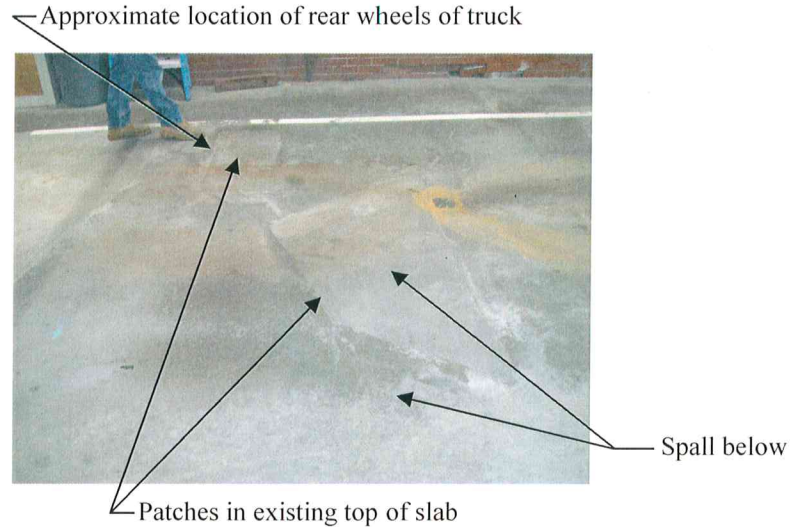
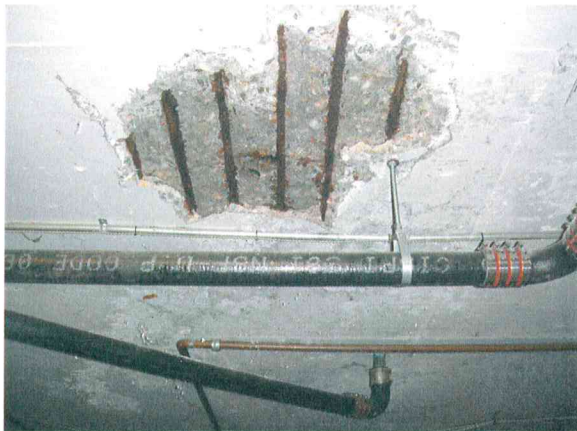
Rusted rebar with large spalled area near patch observed from above

In conclusion, based upon McBrie, LLC's observations, it is McBrie, LLC's opinion that the floor slab has deteriorated /rusting rebar that is resulting in spalling of the concrete cover and loss of bond to the surrounding concrete. McBrie, LLC recommends the following:

1. That the apparatus bays at this location not be used for vehicular storage;
2. Repairs be initiated to either replace the floor slab or to reinforce the floor from below with steel beams;
3. Installation of an epoxy waterproof membrane coated with an anti-skid top coat. This will stop water from penetrating the concrete slab and rusting additional rebar.

Please be aware that waterproofing the slab now/alone will not solve the problem so reinforcing or replacement of the floor slab must occur prior to installation of an epoxy waterproof membrane

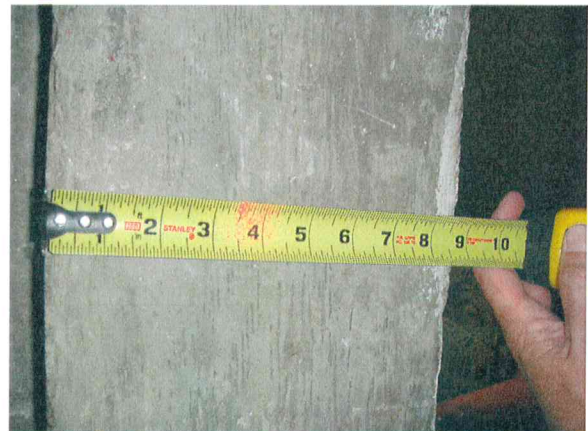
Approximately 8½" thick slab
