Alliant Gas GAS LINE FORM

Town: Payson

Address: 106-108 N Pinecrest Dr

GAS LEAK INSPECTION & REPAIR REPORT

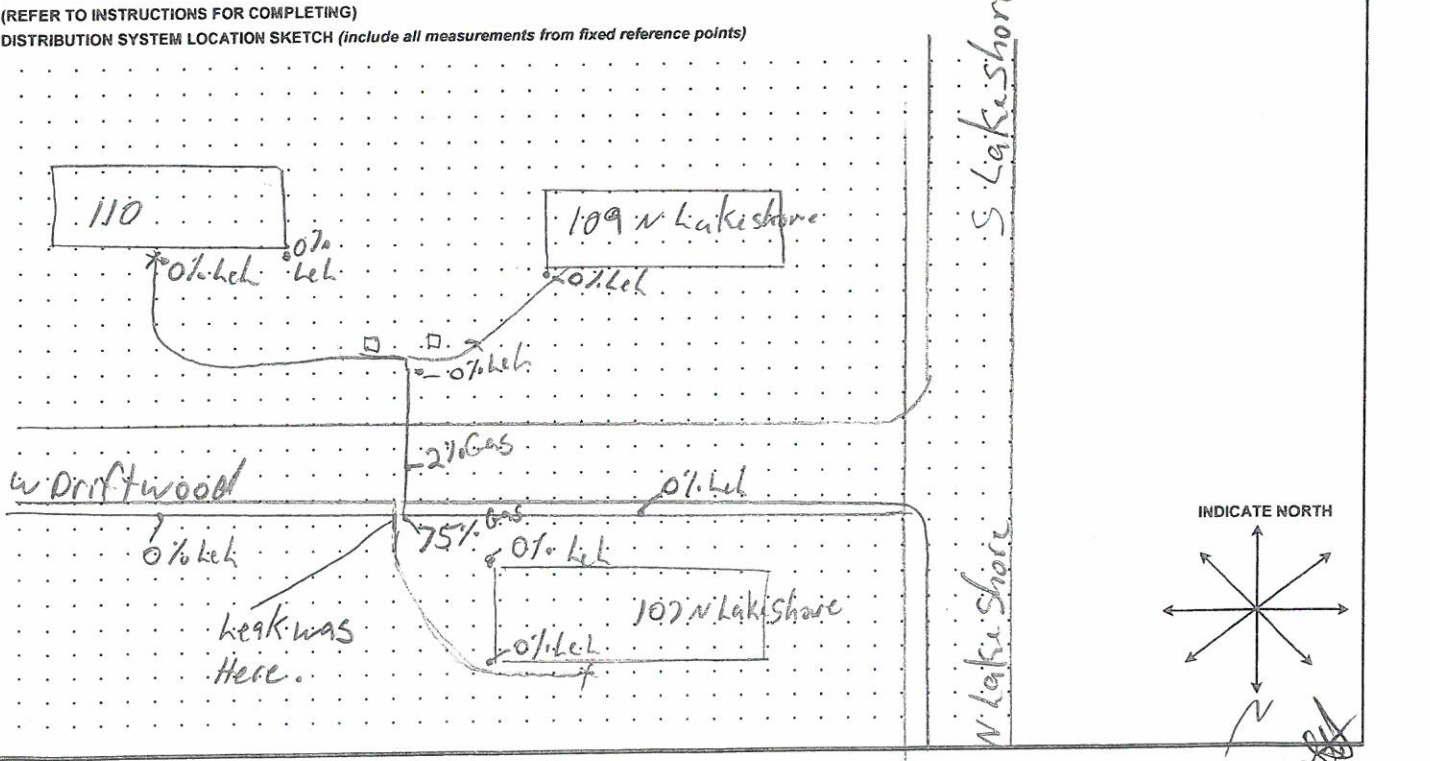
Town: Payson Address: 102 N Lakeshore Date: 7-28-15
 If leak, Date Detected: 7-28-15 By Whom: Chris
 Date Leak Investigator was Dispatched: 7-28-15 Time: 8:50 AM PM LEAK CLASS (circle)
 Date Leak Investigator Responded: 7-28-15 Time: 8:35 AM PM 1 2 3
 Pipeline Type (Check one): Distribution Main Describe specific location: (See instructions) Leak was on 3/4" service
 Service Line line going to 107 next to fusion coupling
 Map Book #: _____ approx 1' off main on Driftwood. See Attached map

Stress Crack next to fusion coupling

Method of Repair: Cut out and replaced
 Date Repaired: 7-28-15 Service Order #: _____
 Date of Follow-up Inspection (if needed): _____
 If DOT Reportable, Date and Time of telephone report: _____
 To Whom was leak reported: _____

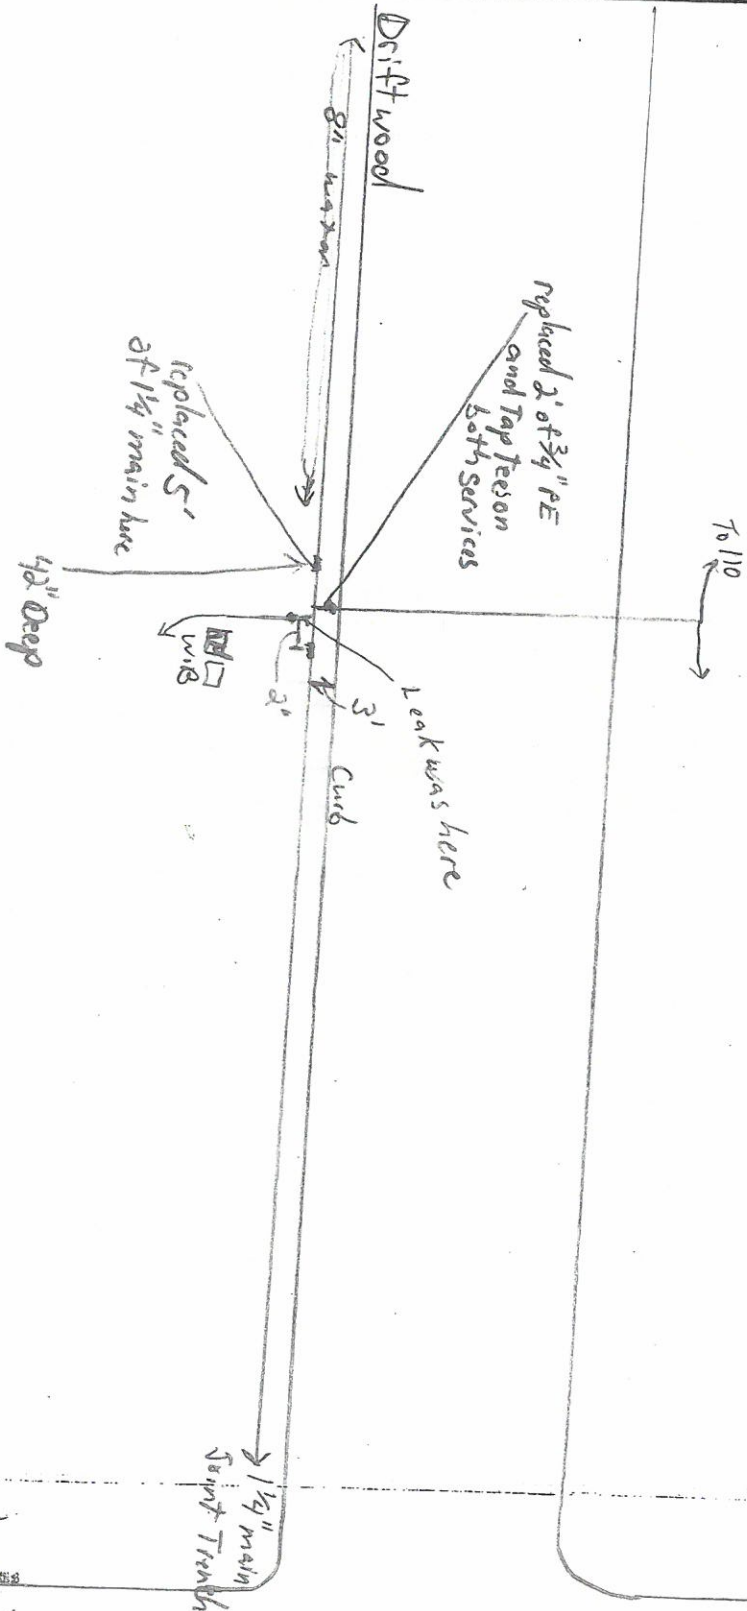
Sketch of Gas Line (include all measurements from fixed reference points and must be as accurate as possible)

Comments: We found leak on 3/4" service going to 107 Lakeshore. Leak was under water where we could not get to repair. So we replaced 5' section of 1 1/4" main and installed new Tap Tees and moved to above water main. We pressure tested 3/4" fittings services at 92 PSI air for 15 min used gauge #190-03 cal 8-6-14. Soap tested purged and reset meters at 109-107 and 110.

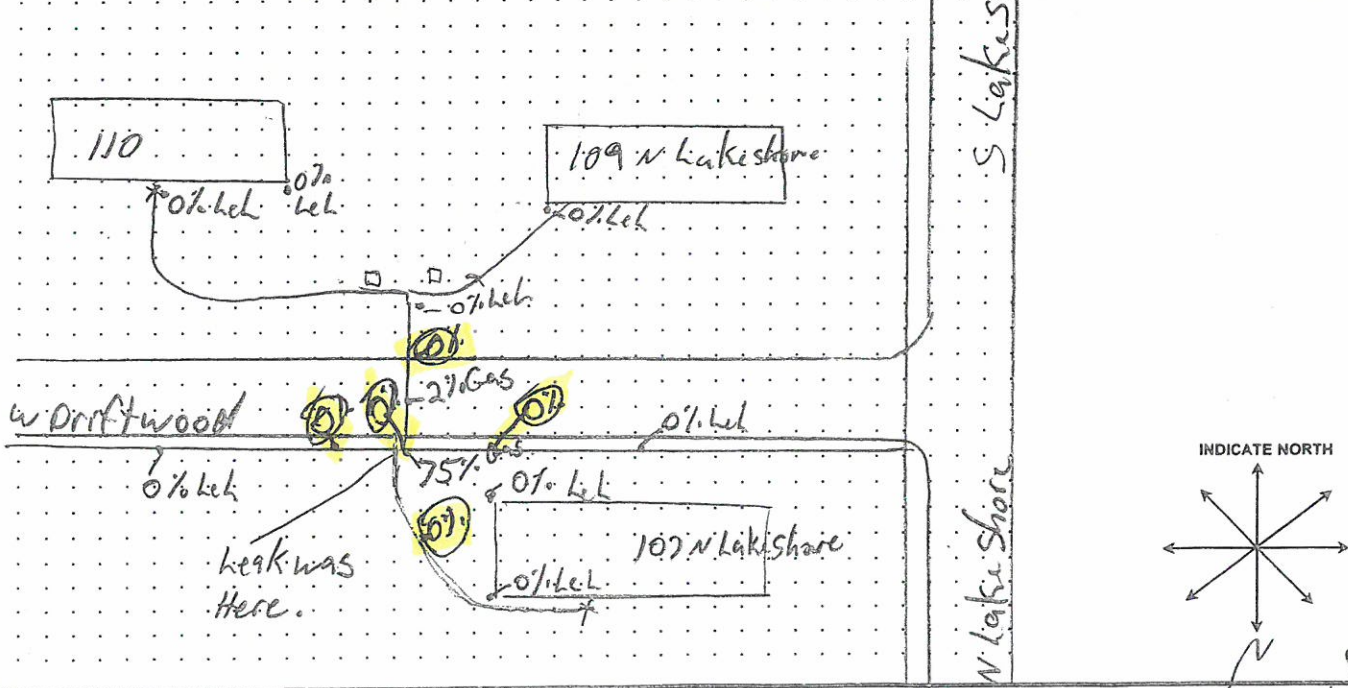
(REFER TO INSTRUCTIONS FOR COMPLETING)
DISTRIBUTION SYSTEM LOCATION SKETCH (include all measurements from fixed reference points)

Describe specific location: (See instructions) Leak was on 3/4" service line going to 107 next to fusion coupling approx 1' off main on Driftwood. See Attached map

INSTRUMENT USED: FI Unit CGI Description of Leak / Investigation Performed: Water Dept called and said they smelled gas while repairing a water leak. So I checked with FI got some leads then I switched to CGI zeroed out leak spaced graded leak then pinpointed.
Highest Reading: 25 % Gas
SIGNATURE OF LEAK INVESTIGATOR: Chris Barber
(first person on site of leak)

SOIL CONDITIONS: Gravel Sand Granite Clay Gumbo Other _____
SOIL MOISTURE: Dry Damp Wet
CAUSE OF LEAK: Corrosion Natural Force Excavation Outside Force Materials/Welds Equipment Operations Other
Internal Condition of Steel: Good Fair Poor Wet Dry
External Condition of Pipe: Good Fair Poor Wet Dry
Tracer Wire Condition: Good Fair Poor Wet Dry
Pipe-to-Soil Potential: _____ Anodes Installed (#): _____
Stress crack next to fusion coupling

Method of Repair: Cut out and replaced
Date Repaired: 7-28-15 Service Order #:
Date of Follow-up Inspection (if needed):
If DOT Reportable, Date and Time of telephone report:
To Whom was leak reported:

REMARKS: We zeroed out leak repair on 8-25-15. We used CGI #6485 on 8-25-15 all holes checked were 0% leak. Chris-Pan 8-25-15
Chris Barber 7-28-15 Hambleton

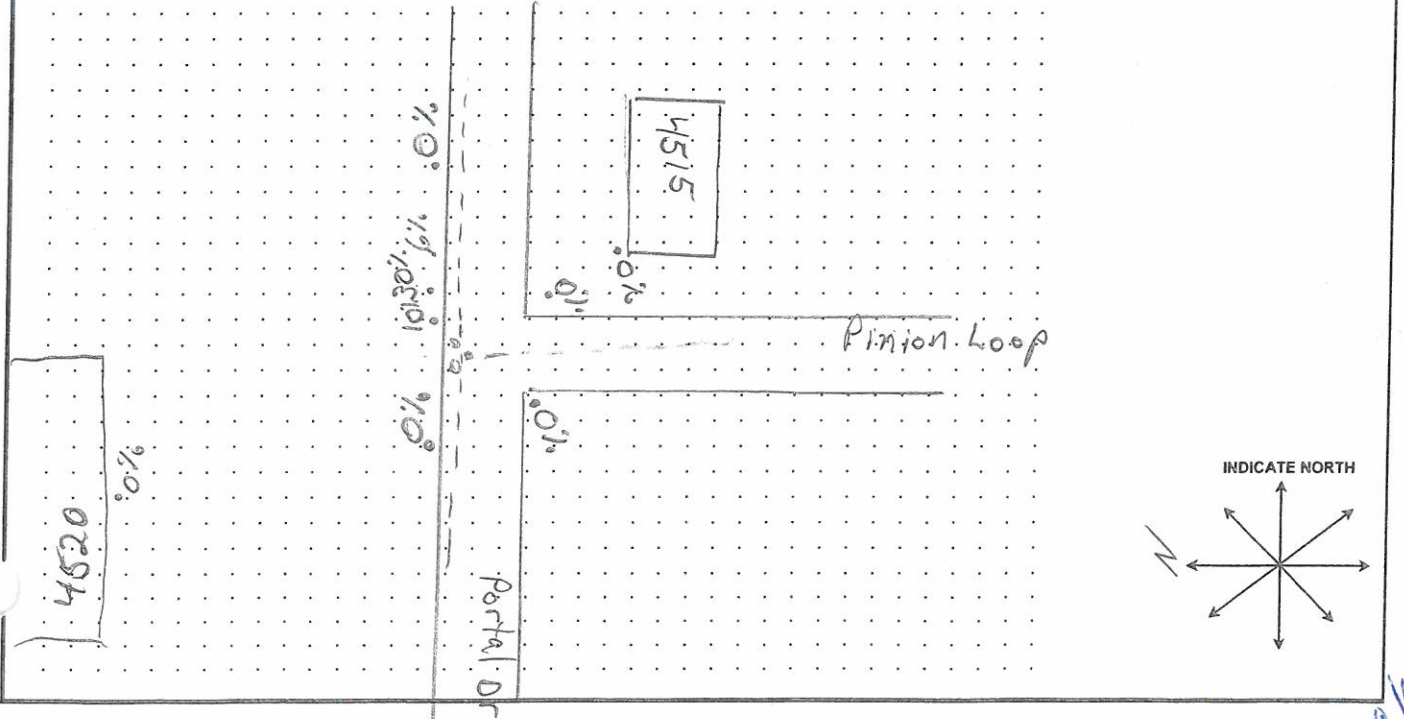
DISTRIBUTION SYSTEM LOCATION SKETCH (include all measurements from fixed reference points)

Pipeline Type (Check one): Distribution Main Service Line Describe specific location: (See instructions) Leak was on 1/4" main 9' East of water valve in Intersection of Portal Dr and Pinion Loop. See Attached map

INSTRUMENT USED: FI Unit CG Description of Leak / Investigation Performed: I was walking area with FI I got some reads. I switched to CG # 4692 zeroed out leak spread graded & pin pointed.

Method of Repair: Cut out and replaced 3' of 1/4" PE.
