Appendix 2: North System Photograph Log

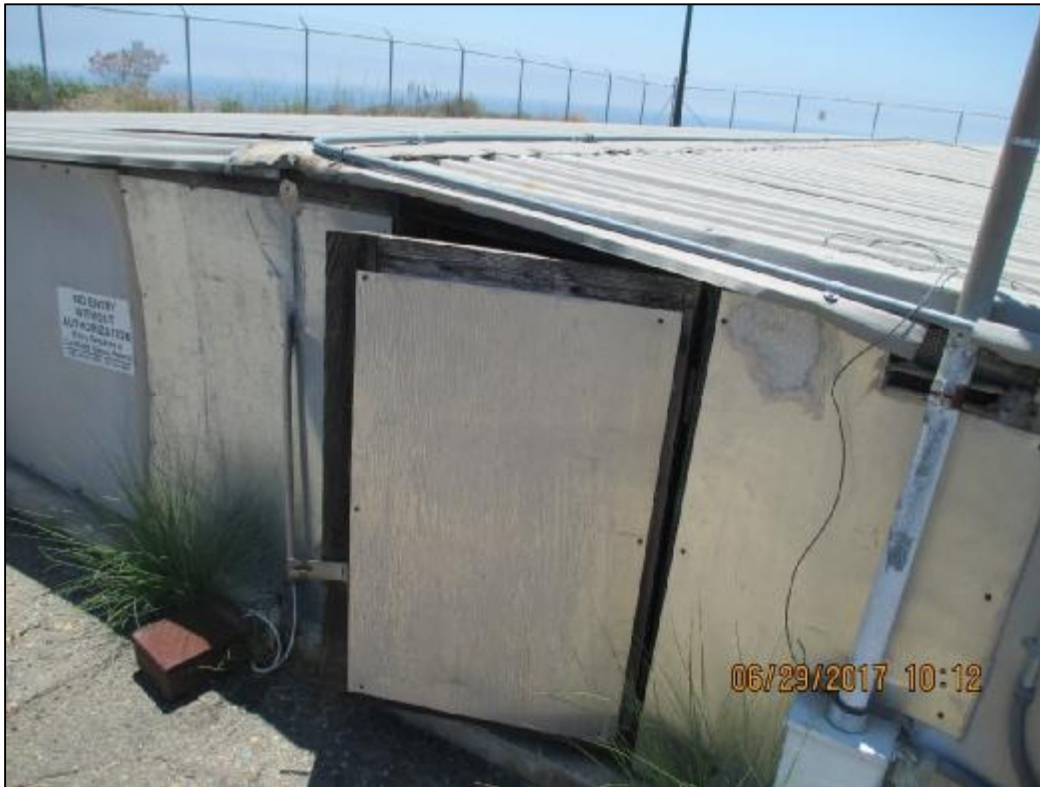
Photograph 1: The hatch door at Reservoir 51770 was not adequate. The hatch door did not have a shoebox lid design, was constructed of wood, and did not form a sanitary seal with the door frame.

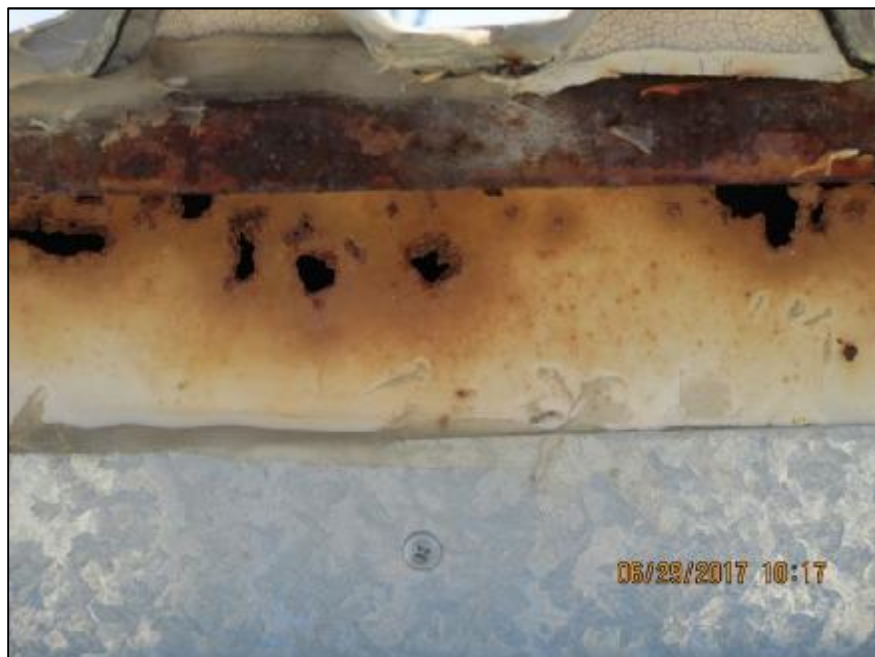
Photograph 2: Rust holes were observed at Reservoir 51770.

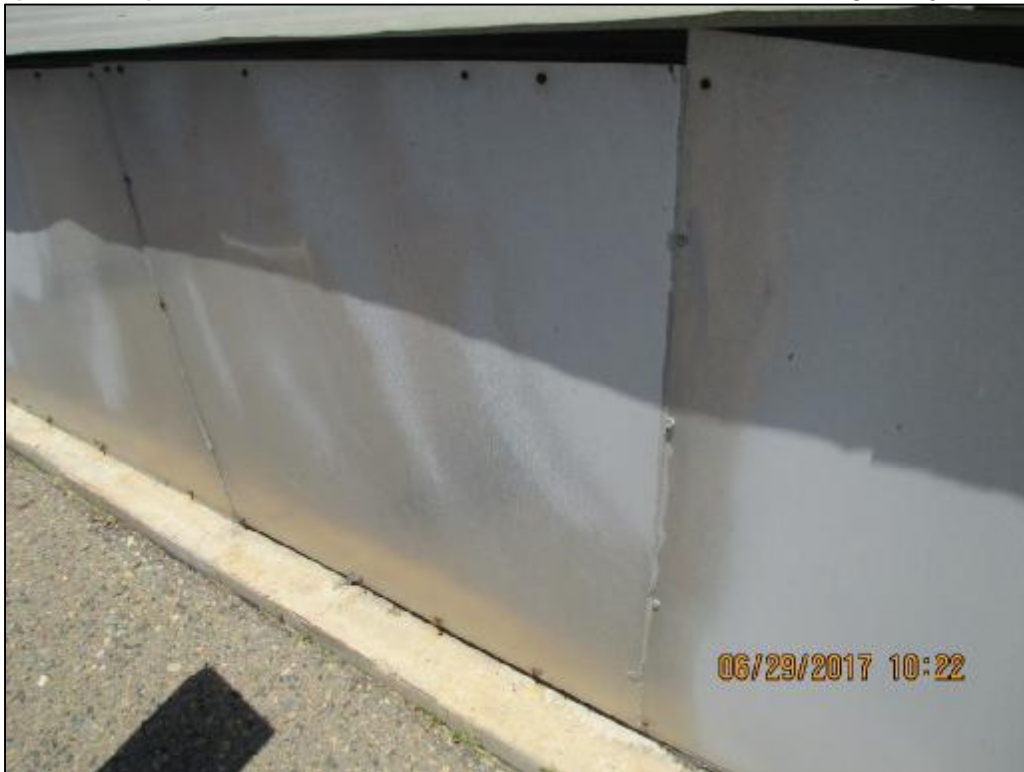
Photograph 3: The panel walls for Reservoir 51770 were loose and missing many bolts.

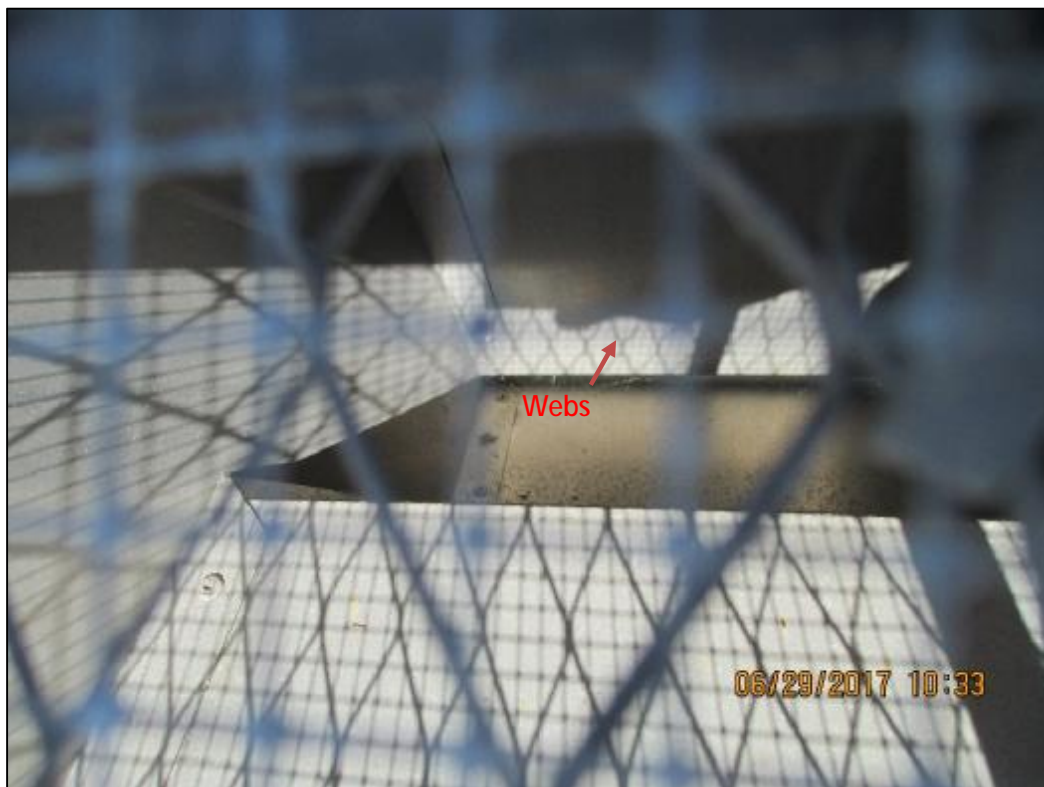
Photograph 4: Reservoir 51771's vent mesh is too wide, as evidenced by a spider and webs living within the vent.

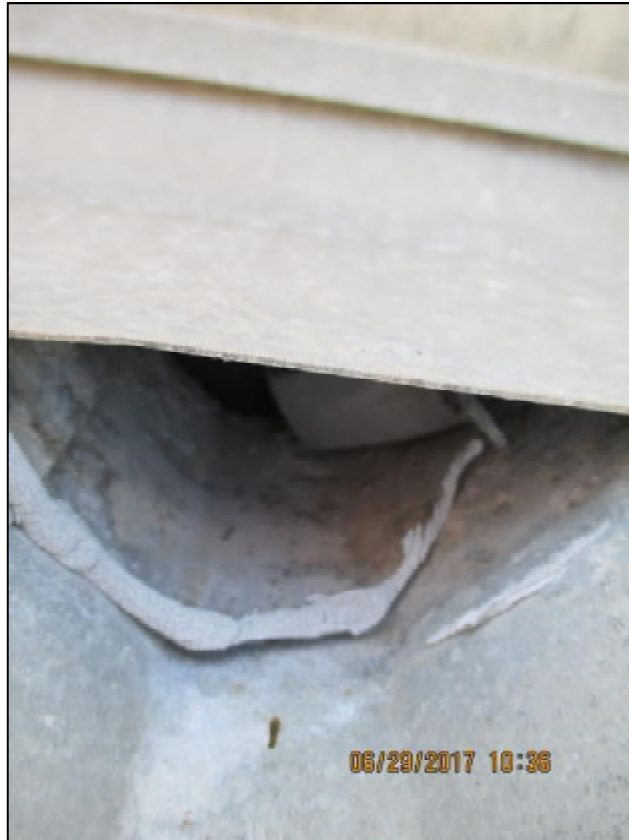
Photograph 5: For Reservoir 51771, some of the divot plugs between the corrugated roof and the vent need repairs.

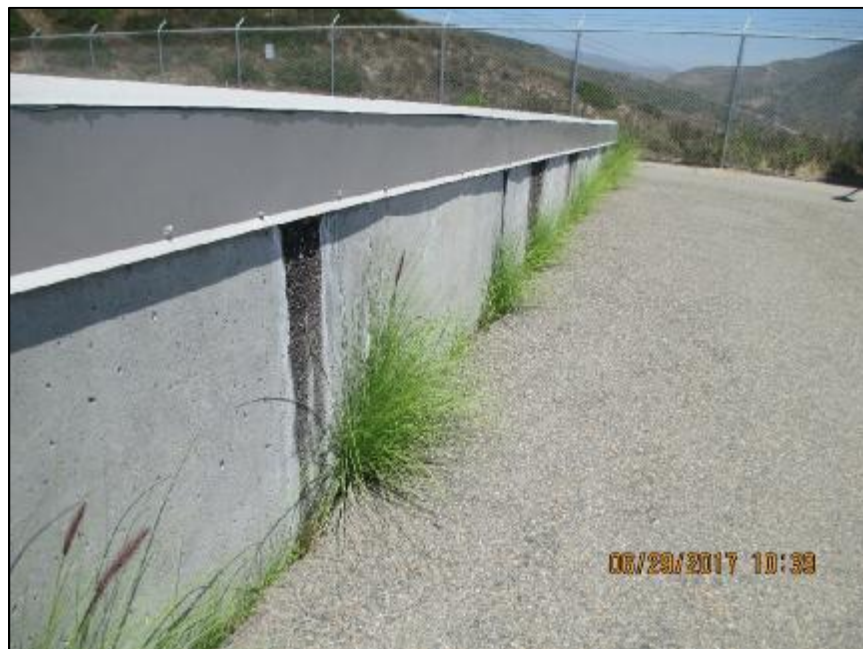
Photograph 6: There was evidence of condensation in Reservoir 51771 leaking along the outside of the concrete walls.

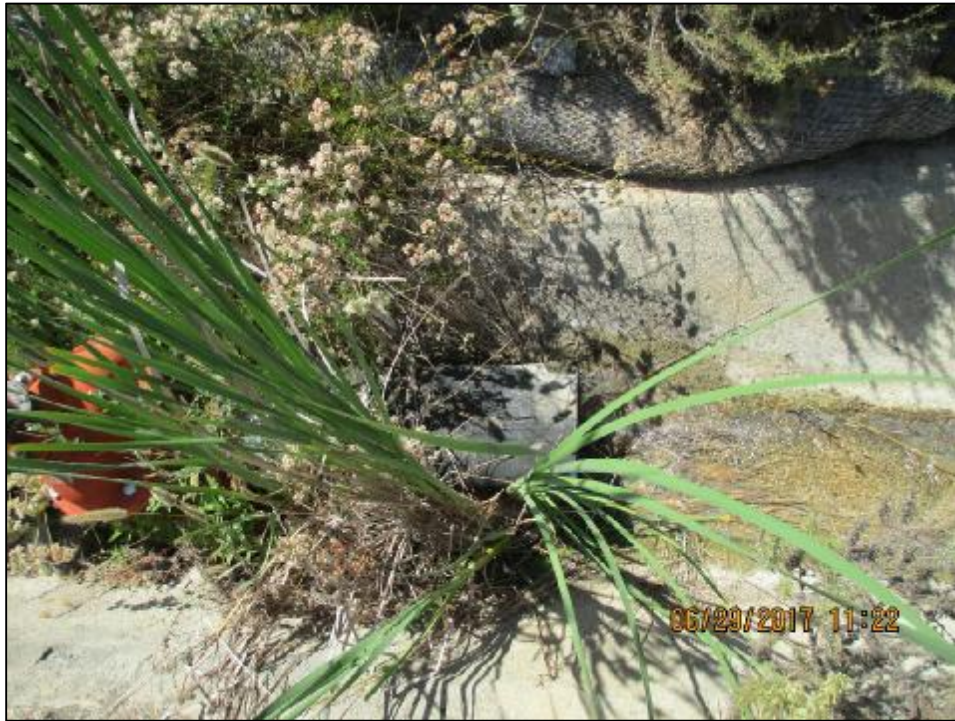
Photograph 7: Reservoir 51771's overflow valve was too close to the ground and surrounded with brush. In addition, the overflow was constantly leaking water.

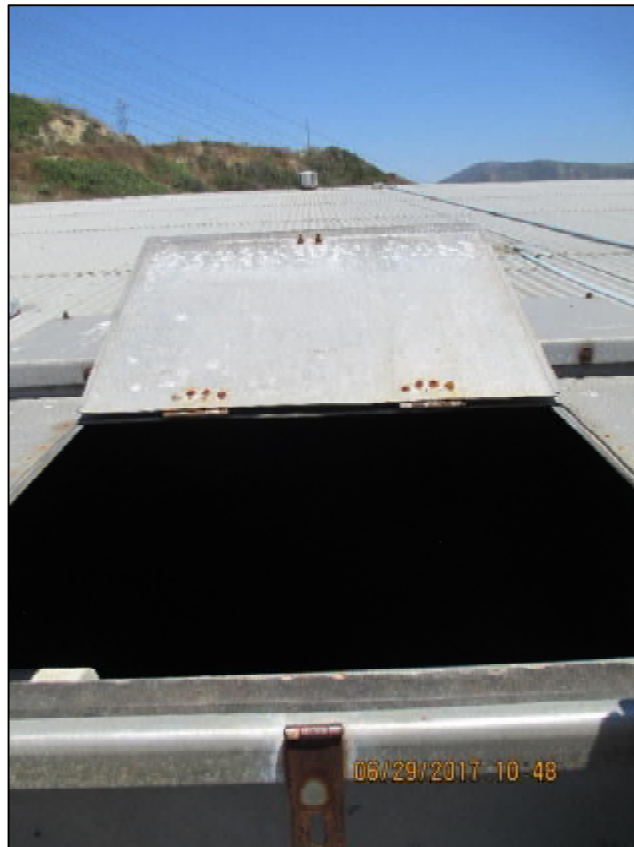
Photograph 8: Reservoir 51772's hatch was flush with the roof.

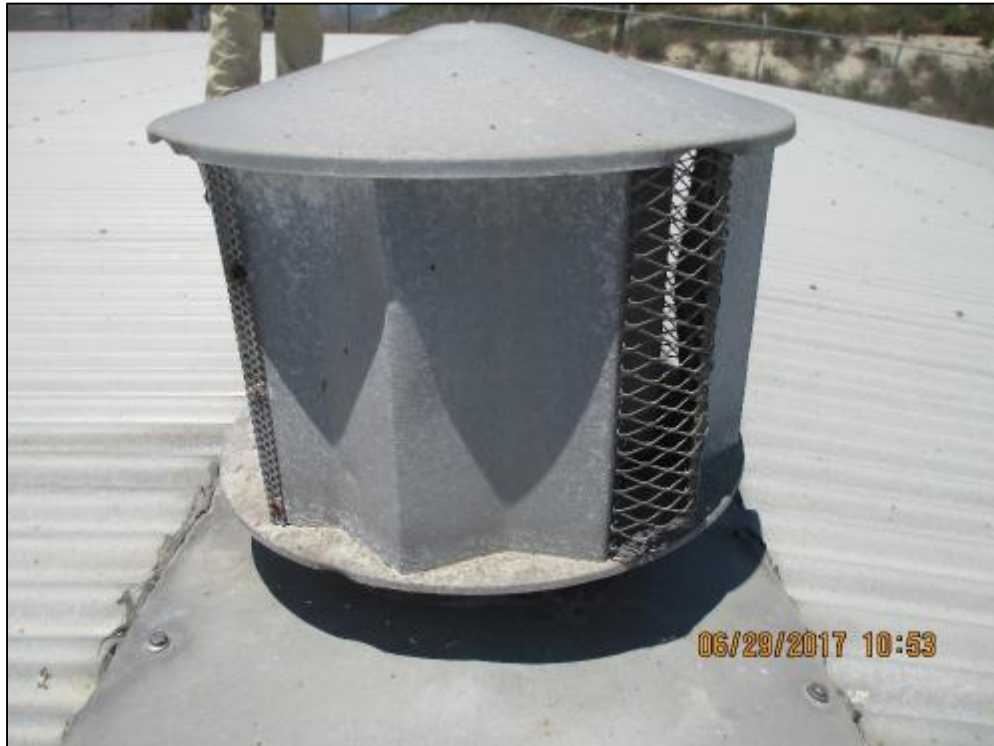
Photograph 9: Reservoir 51772's vent did not have a 24-mesh screen and protection from rain and airborne contaminants.

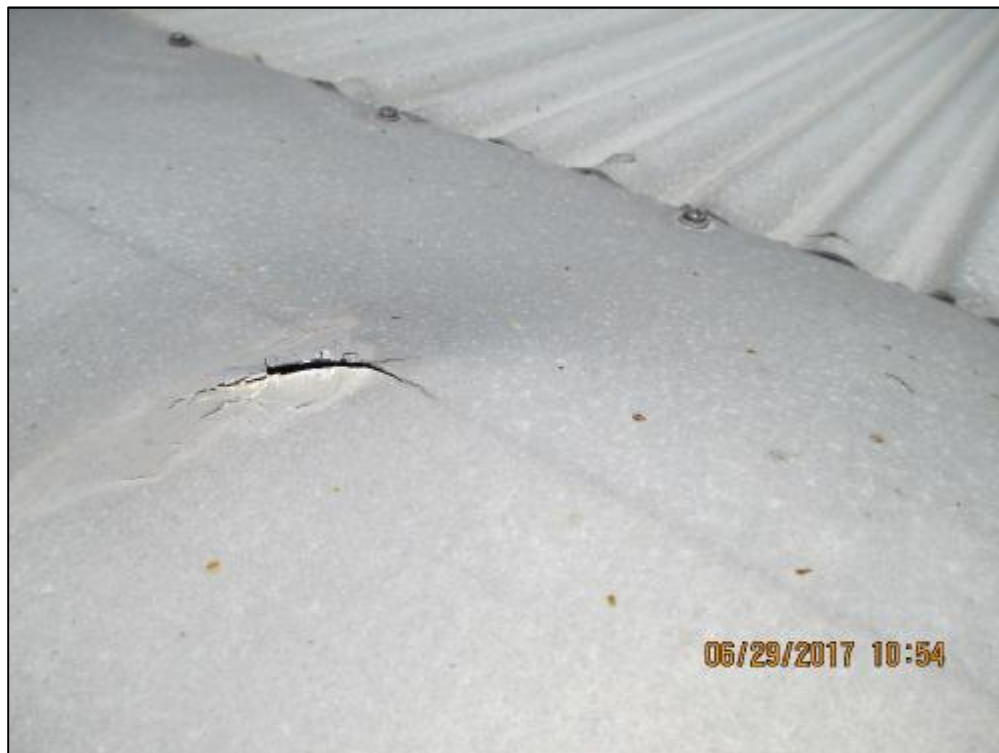
Photograph 10: A crack in the roof of Reservoir 51772.

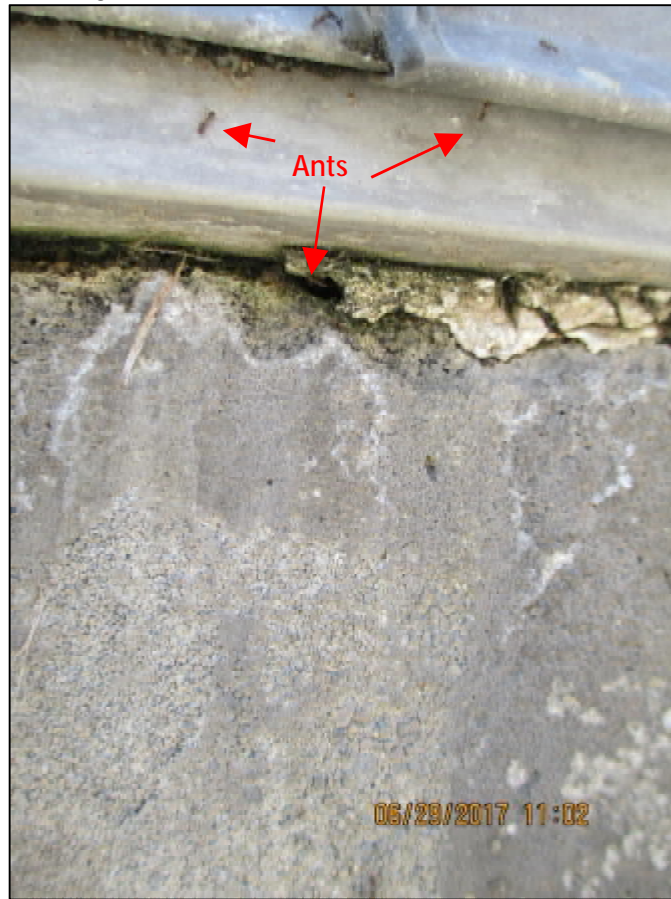
Photograph 11: Ants crawling into cracks in Reservoir 51772.

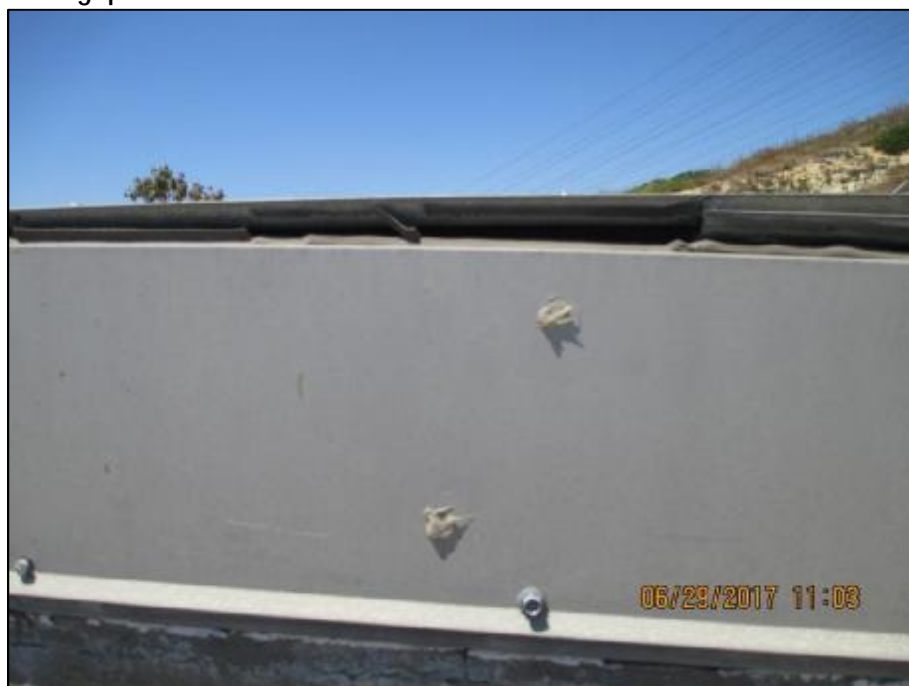
Photograph 12: A gap in between the roof and the wall at Reservoir 51772.

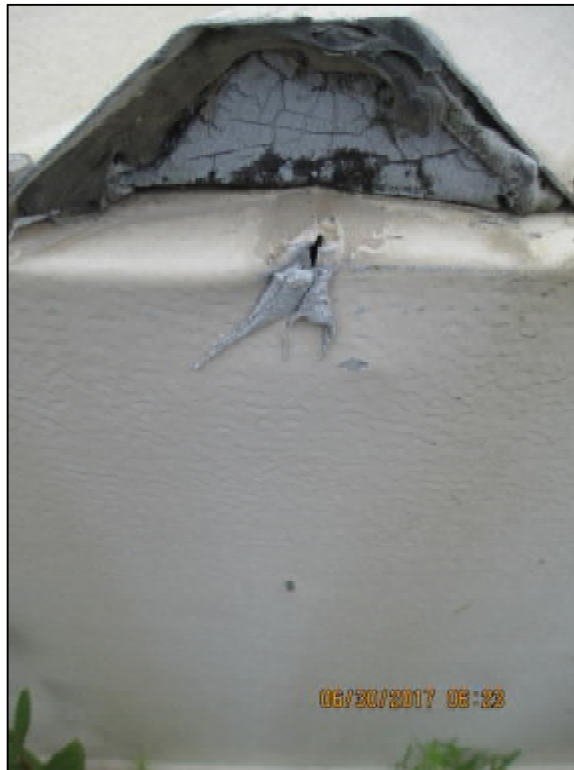
Photograph 13: Repairs are needed at Reservoir 62310.

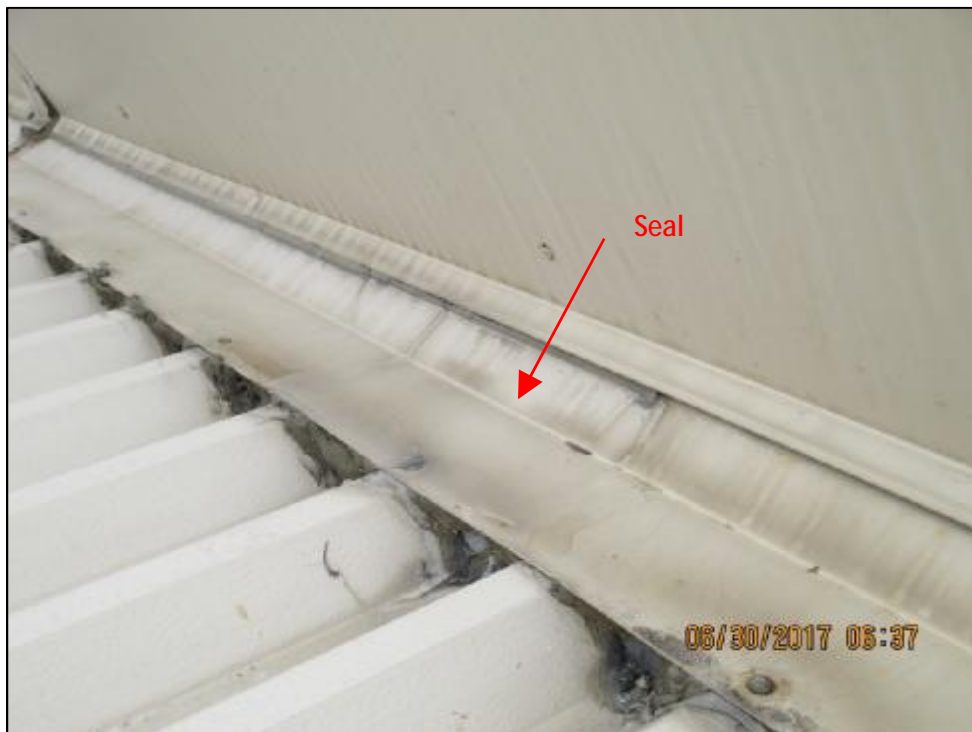
Photograph 14: The upward facing vent had a seal along the base that would prevent rain water from exiting the vent. This may lead to rain accumulation that would enter Reservoir 62310.

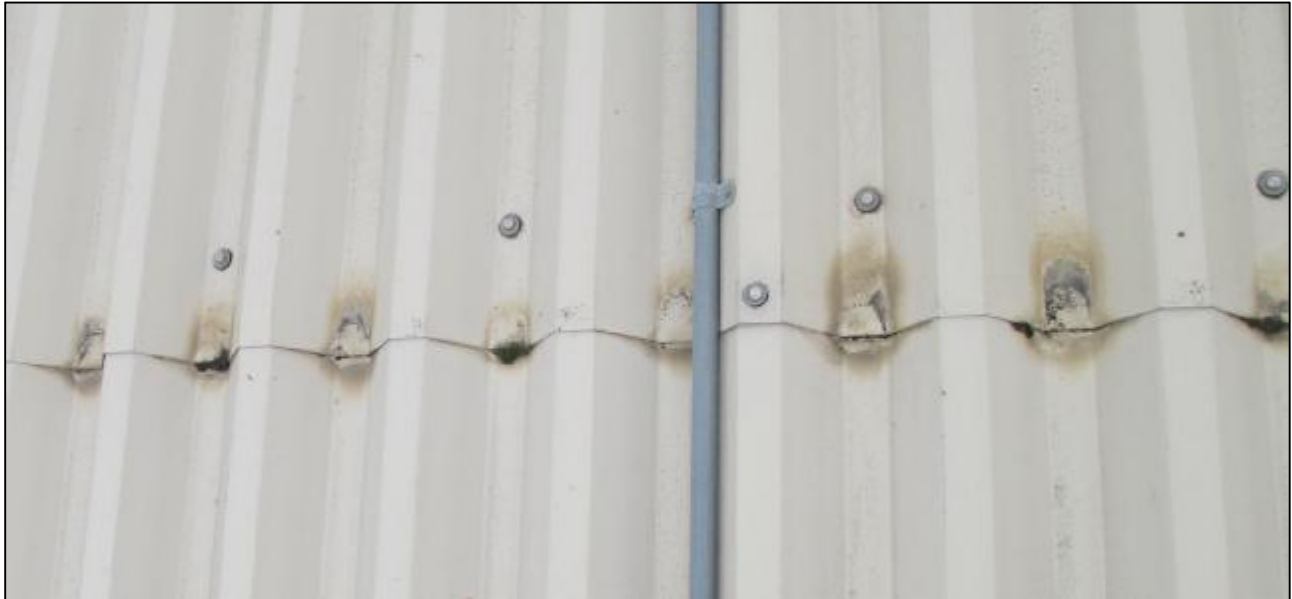
Photograph 15: Reservoir 62310 had moss growing in the seams between the roof panels.

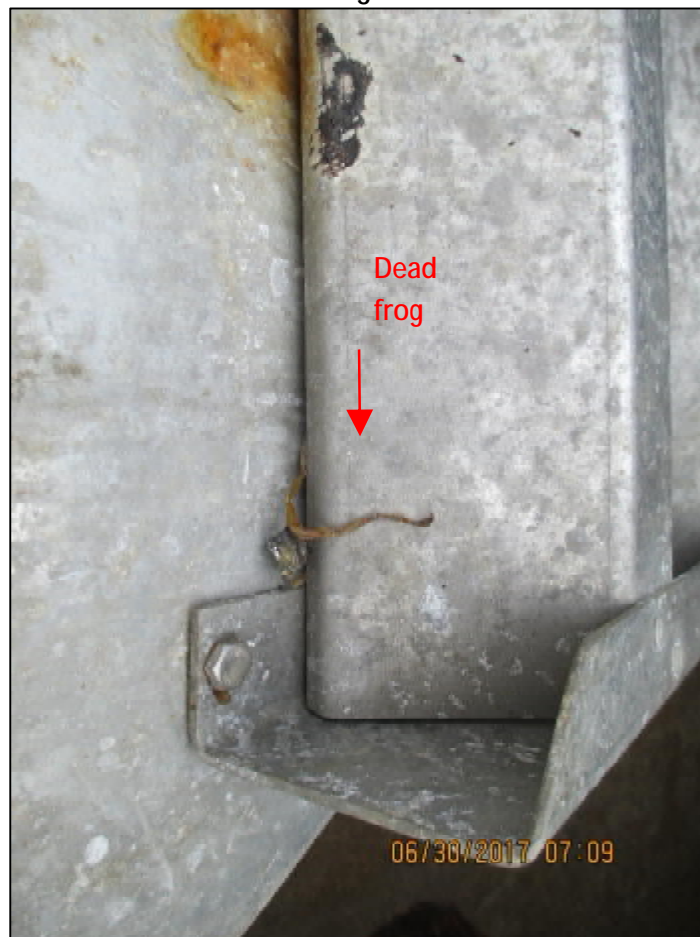
Photograph 16: Reservoir 63210 had a dead frog inside the reservoir.

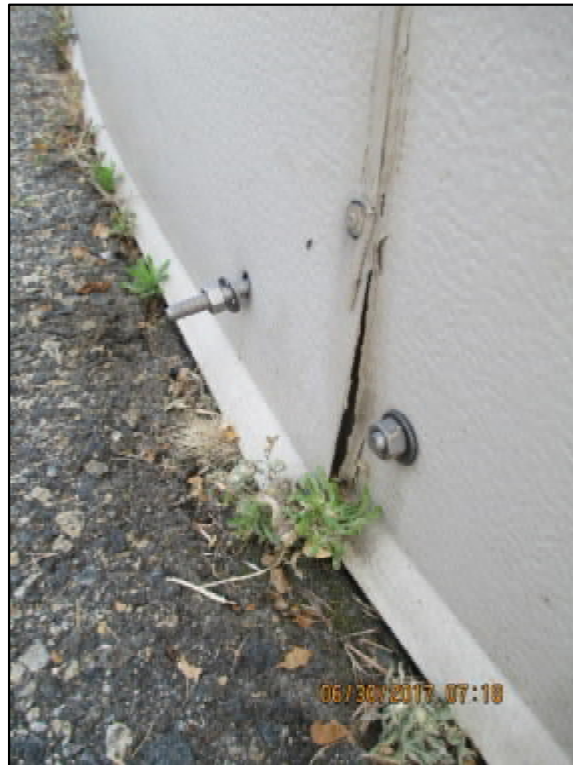
Photograph 17: the paneling at Reservoir 63210 was coming off and needs repairs. Gaps are created by loose siding and holes from loose bolts.

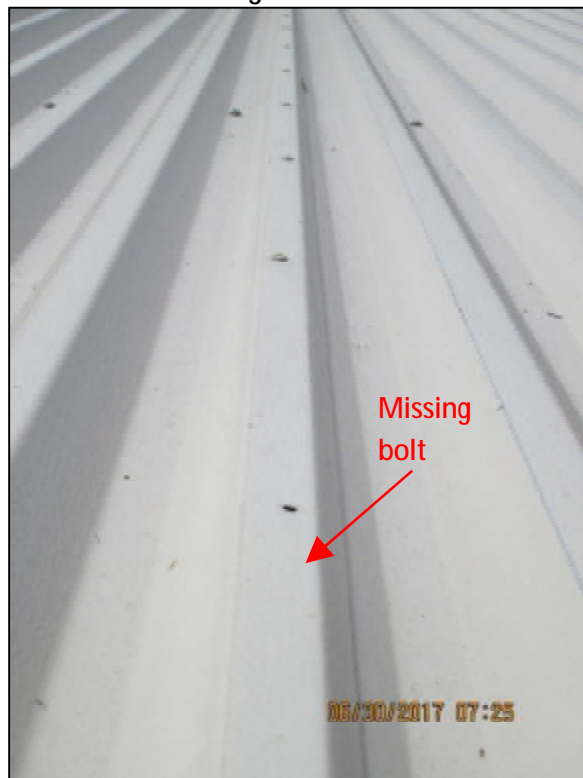
Photograph 18: Reservoir 63210 was missing bolts in the roof.

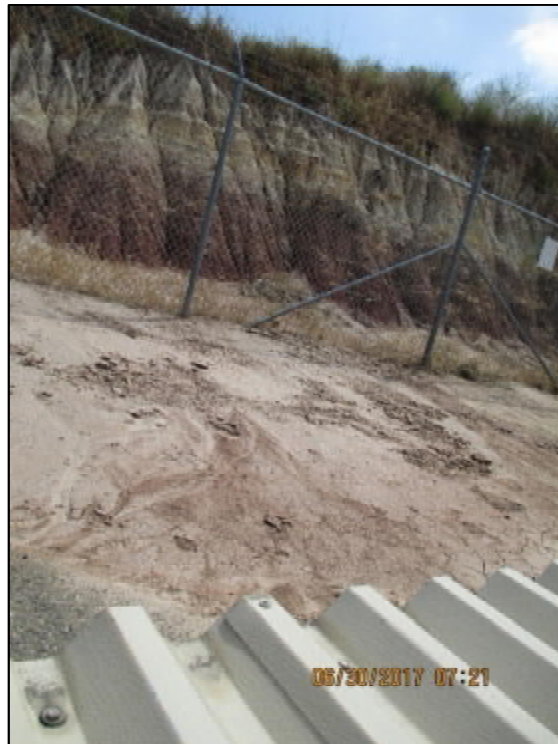
Photograph 19: A hill near Reservoir 63210 was eroding and depositing loads of dirt immediately adjacent to the reservoir.

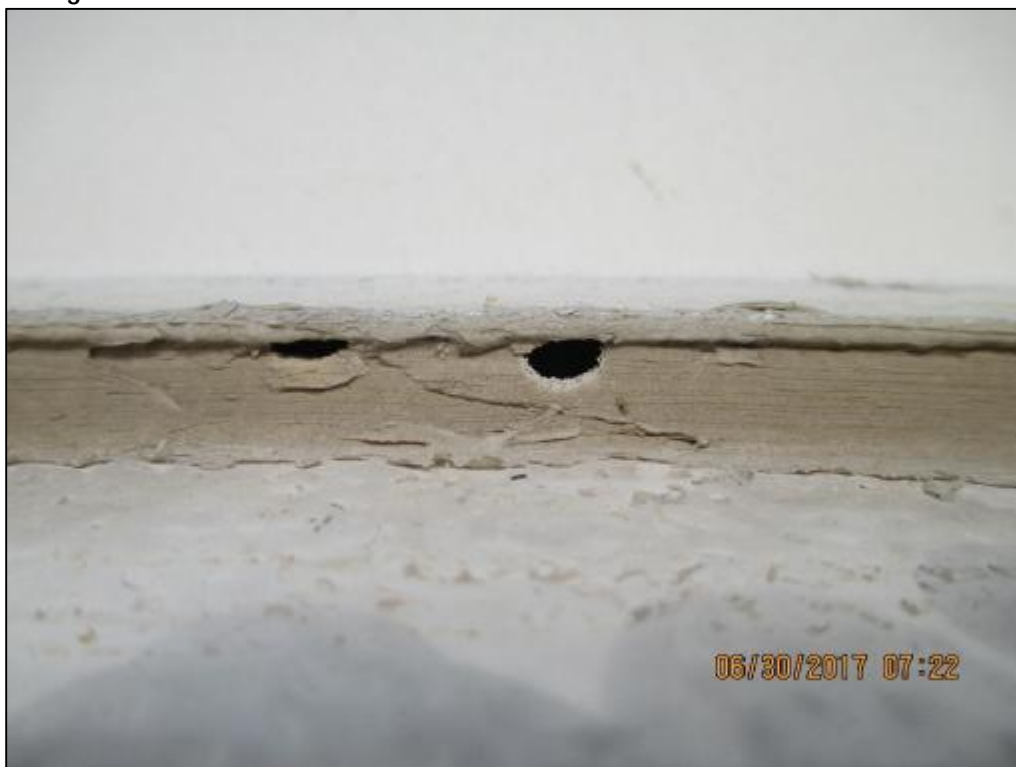
Photograph 20: The sealant between the roof of Reservoir 63210 and the wall had some minor cracks forming.

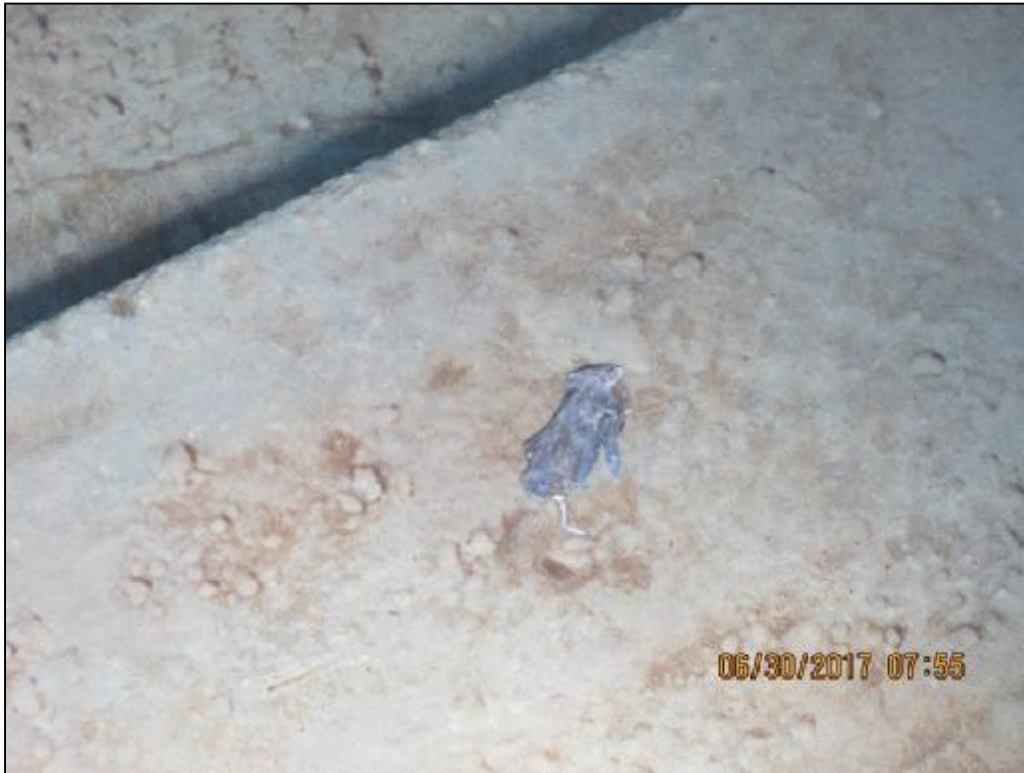
Photograph 21: A dead rodent was found in the finished water of Reservoir 52698.

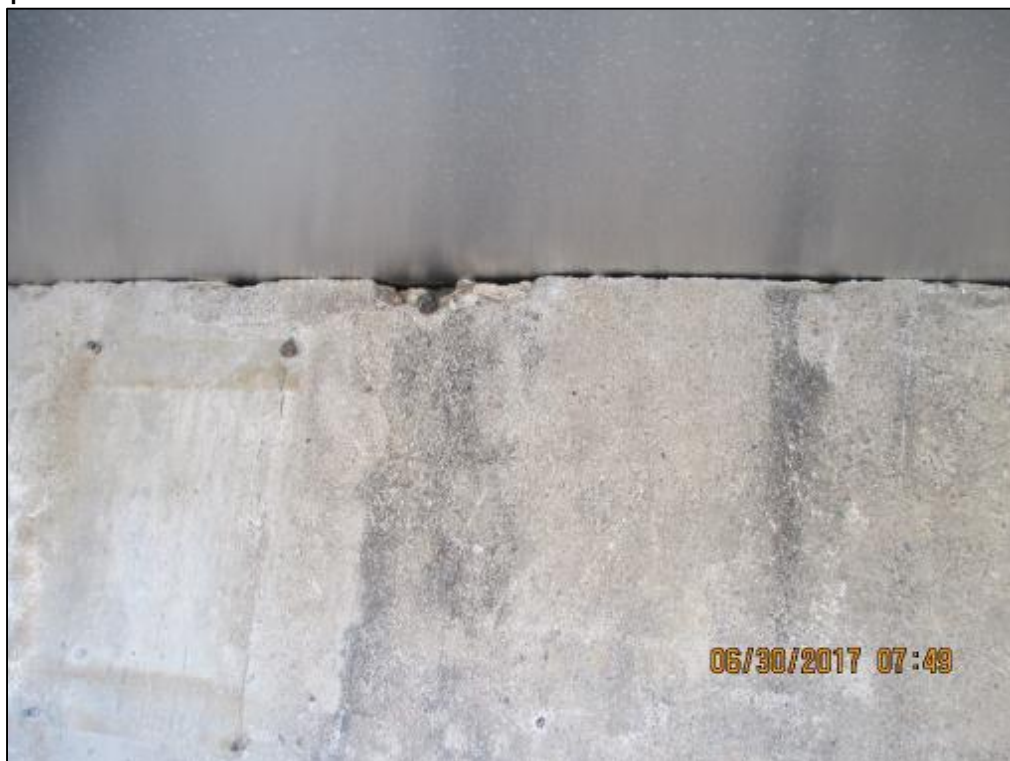
Photograph 22: The concrete roof and the metal roof need a seal at Reservoir 52698.

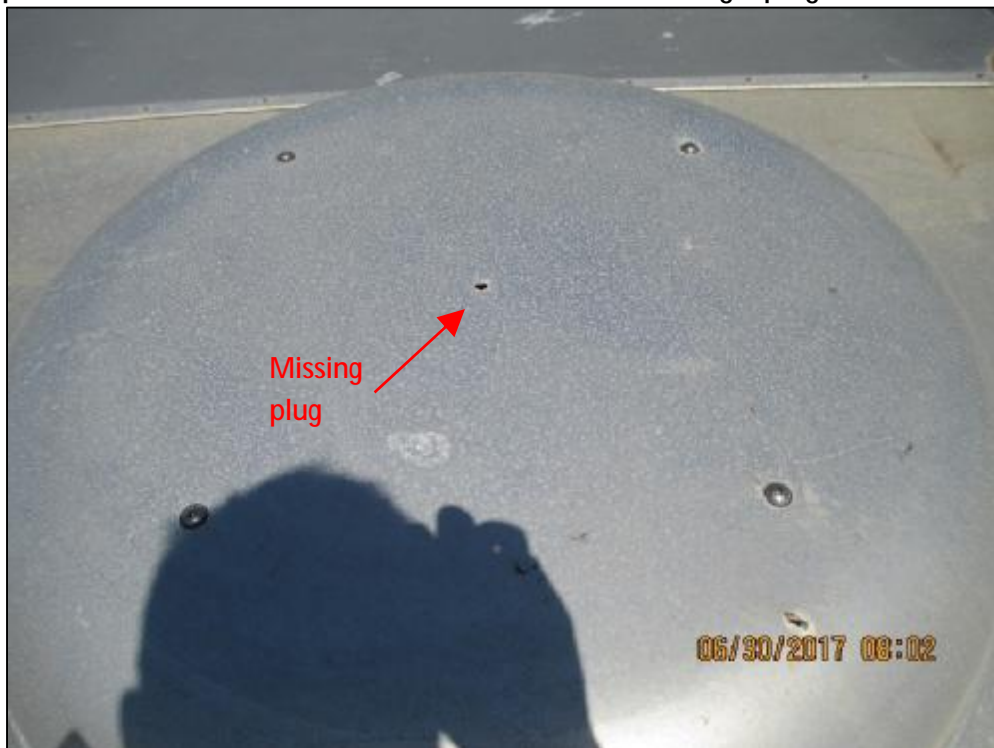
Photograph 23: One of the vents for Reservoir 52698 was missing a plug on the vent roof.

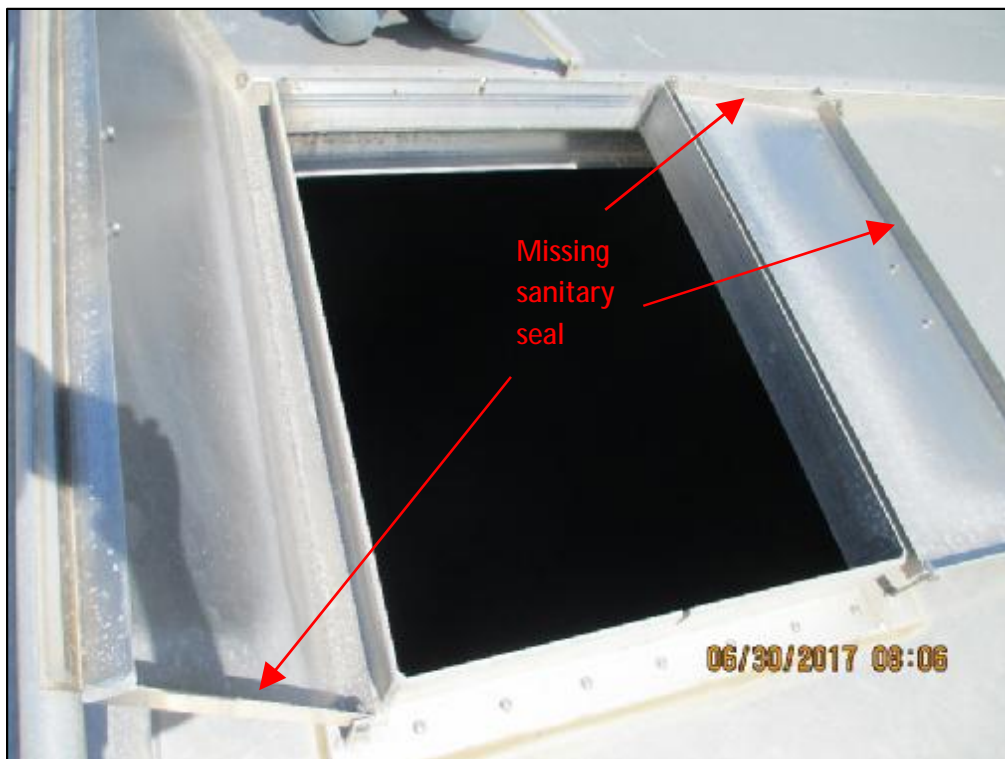
Photograph 24: Reservoir 52698's hatch doors need a sanitary seal along the entirety of the door.

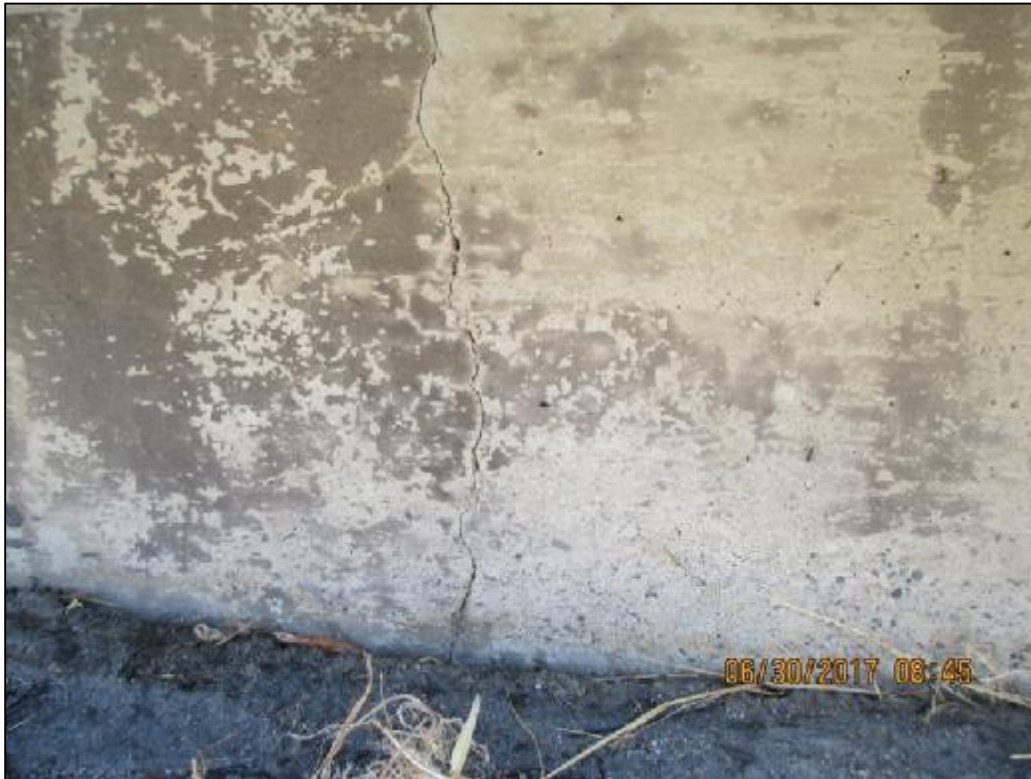
Photograph 25: A crack along the wall of Reservoir 53116

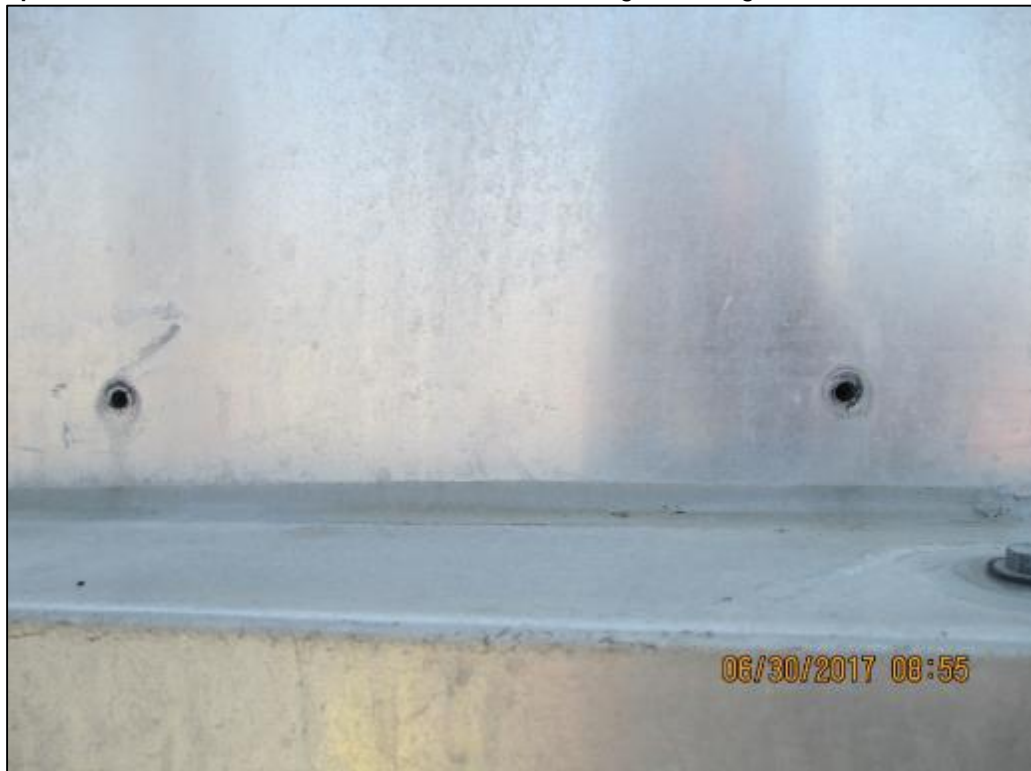
Photograph 26: Reservoir 53116's wall had bolts missing, creating holes in the reservoir.
