Department of  
Environmental  
Conservation

# LAKE GEORGE BEACH

## Pollution Source Investigation Update

June 2018

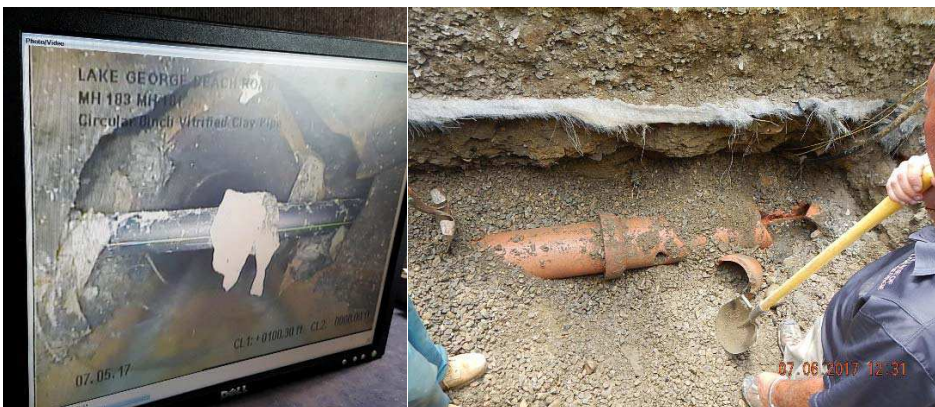
Dye testing was performed on the sanitary sewer lines located on Cedar Lane, Beatty Lane, Latham Road, Rose Point Lane, Front Street, West Brook Road, Route 9, Route 9L and Beach Road. Dye testing was also performed on a number of commercial buildings to verify that they were properly connected to the sanitary sewer system. No evidence of leakage or issues with the sanitary lines were detected through dye testing. Camera inspections were performed in the sanitary lines on Beatty Lane, Cedar Lane, and Beach Road. The camera investigation did reveal a break in the sewer main on Beach Road across from the Garrison Restaurant. A gas line installation had penetrated and broken the sewer pipe. The broken section was repaired the day after it was discovered.

Broken sewer line and actual photo from camera inspection

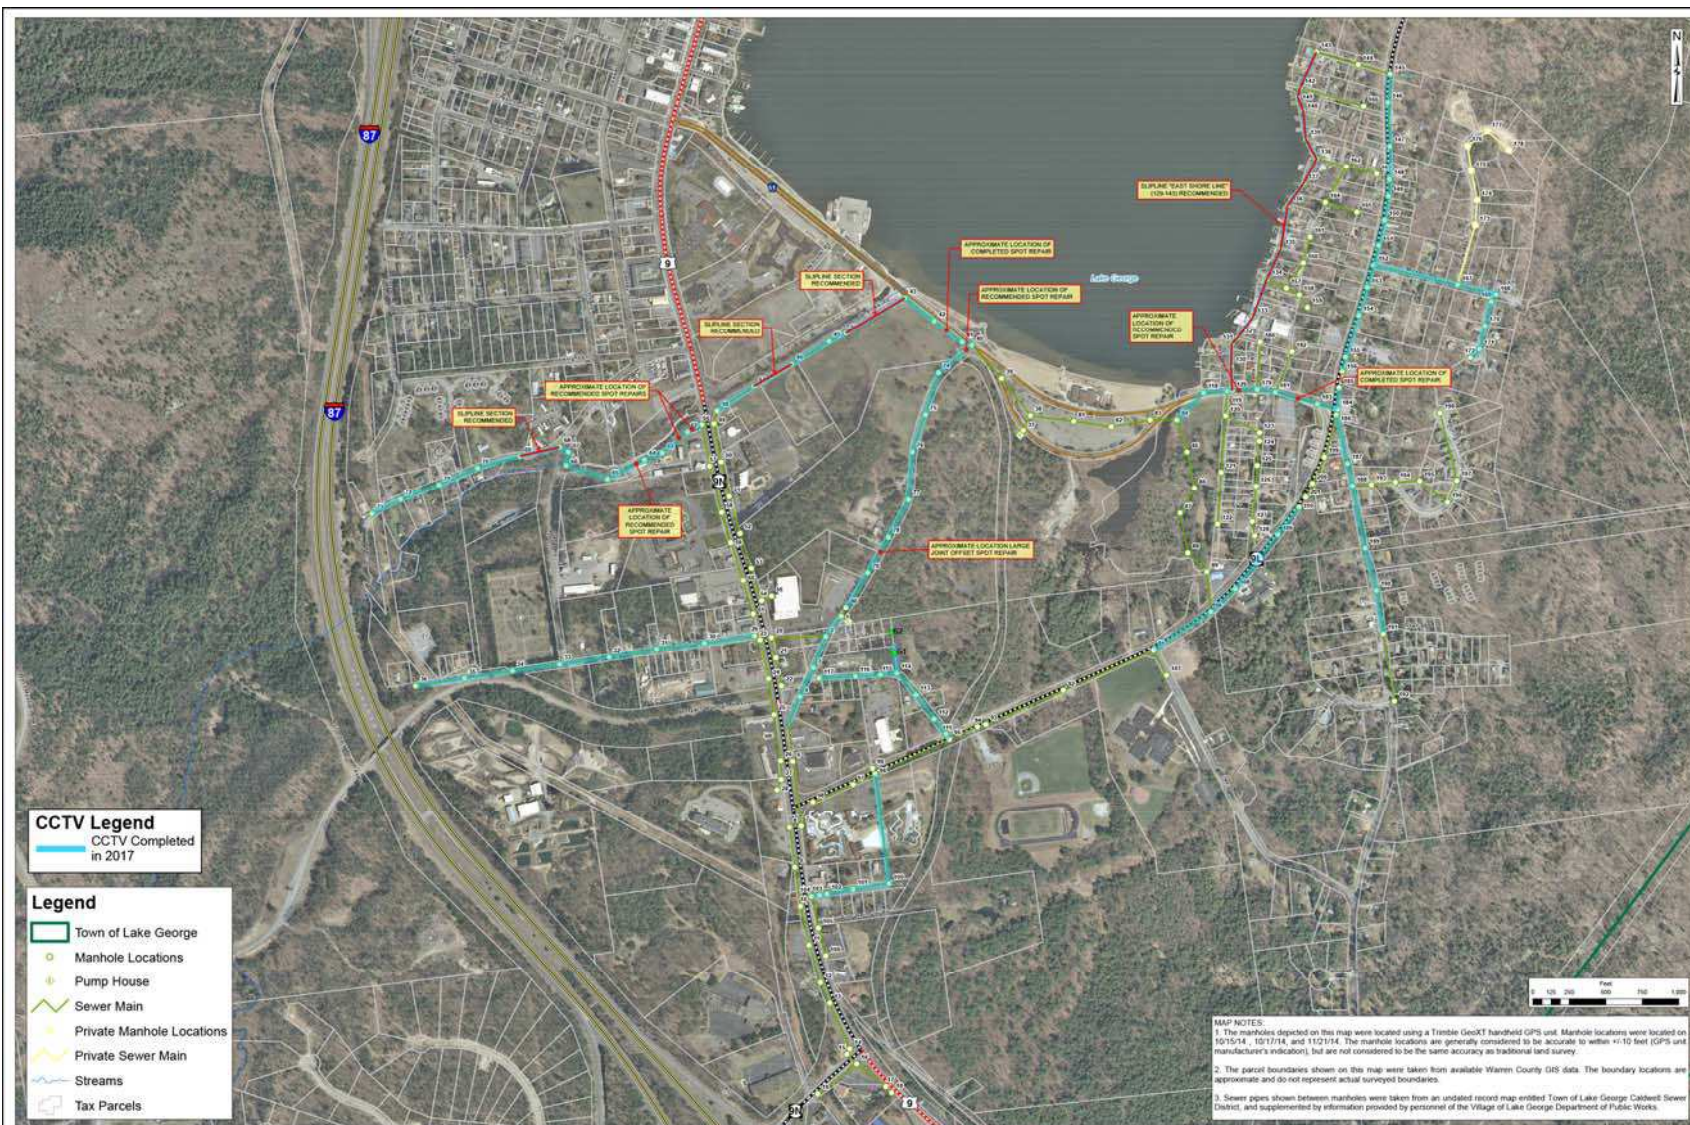
**Caldwell Sewer District CCTV Completed in 2017 & Preliminary Finding Regarding Recommended Repair**

Preliminary findings from an evaluation of the sewage collection system in the Town of Lake George’s Caldwell Sewer District revealed severe defects in numerous pipe segments, manholes, and pump stations. Although no direct connection between these defects and surface waters has yet been established, due to the close proximity of this aging infrastructure to Lake George and Million Dollar Beach, past microbial source testing revealing the presence of human bacteria, and high levels of E.coli in surface water typically found associated with sewage pollution, these defects are likely a contributing source of bacteria to the environment. The estimated cost to repair these issues is \$463,000. The town was recently awarded a \$343,000 Clean Water Infrastructure Act grant, a \$100,000 engineering planning grant, and a \$120,000 Water Quality Improvement Project grant through DEC and the New York State Environmental Facilities Corporation to assist with repairing the collection system.

The Town of Lake George is examining the entire Caldwell Sewer District that serves the town. The town has provided DEC with a report detailing their investigation to date, which identified sewer infrastructure in need of repair or upgrade. Much of this investigation work is close to the lake. They are performing a full camera investigation and cleaning of the entire system and will identify and prioritize any needed repairs that are discovered. This may include future slip lining of aging sewers that might be leaking. The town has been awarded a grant for sewer repairs identified in their 2017 investigation. The town has also submitted a grant application to complete a watershed management/green infrastructure plan for the southern basin area.

The Town of Lake George will repair the defects in the sewage collection system for the Caldwell Sewer District. The estimated cost to repair the severe defects is \$463,000. The town was awarded a \$100,000 engineering planning grant and a \$120,000 Water Quality Improvement Project grant through DEC and the New York State Environmental Facilities Corporation to assist with the repairs.
