# Structural Assessment Report

August 2023

3313 Bay Avenue,  
Ocean City, NJ 08226  
TADCO ID: J-021171  
Block: 3306, Lot: 1

Seaspray Condo Association  
3313 Bay Avenue  
Ocean City, NJ 08226  
c/o I. Dominic Simeone, Esq.  
Harvard Law Building  
1522 Route 38  
Cherry Hill, NJ 08002

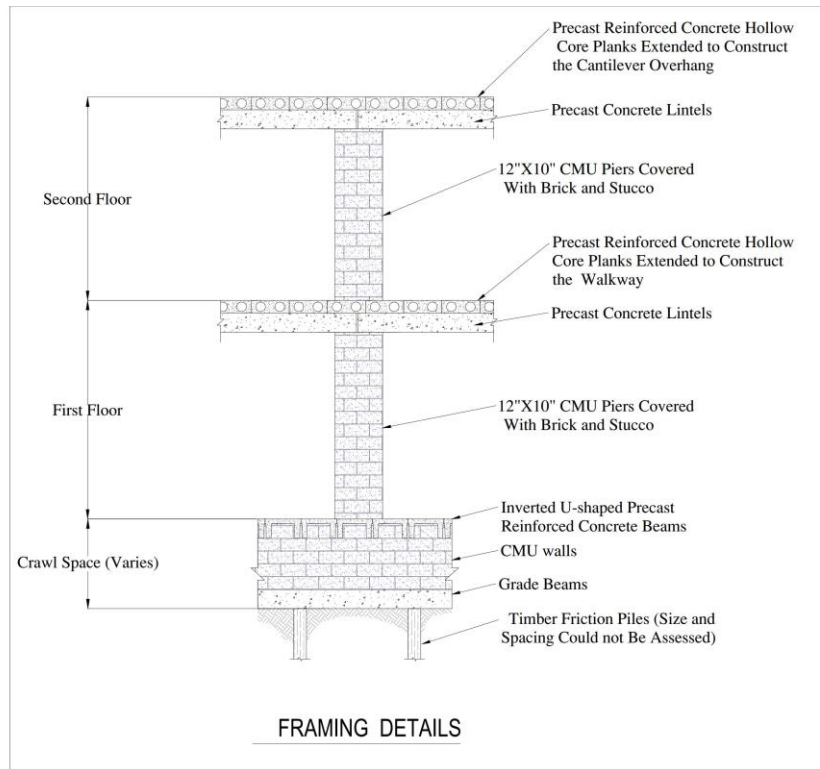
**Figure 1 Framing Details**

The foundation system is constructed of reinforced concrete grade beams (GB) supported by what is believed to be timber friction piles (refer to Figure 1). Some of the girder beams support

The upper structural components, including the roof, are constructed of pre-cast reinforced concrete circular hollow core planks. For more details See Figure 1. The planks extend beyond the lintel supports, creating a cantilevered structure on the second floor that serves as a walkway for the second-floor units towards the courtyard (pool) area. The terrace(s) facing 34<sup>th</sup> Street are supported by concrete lintels resting on CMU on one side and round shaft steel columns. The lintels are pitched to the south and north to allow for roof drainage. The hollow core planks are resting on the lintels and show no signs of distress.

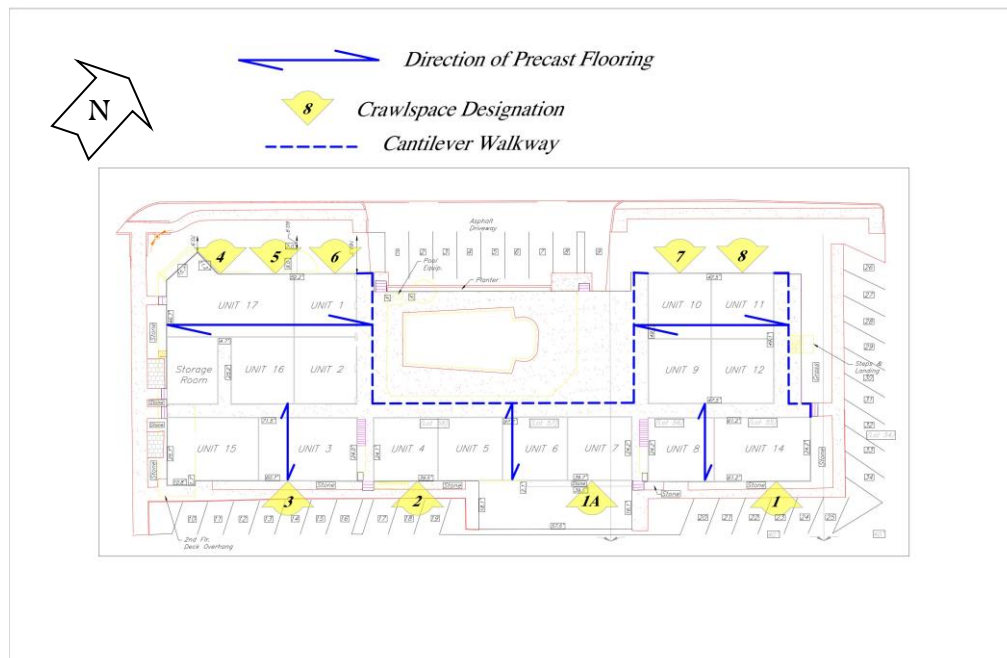
**Figure 2 Directions of Precast Flooring for First Floor**

The distribution directions of both the precast reinforced concrete channels and planks for the first and the second floors are shown in the Figure 2 and Figure 3.

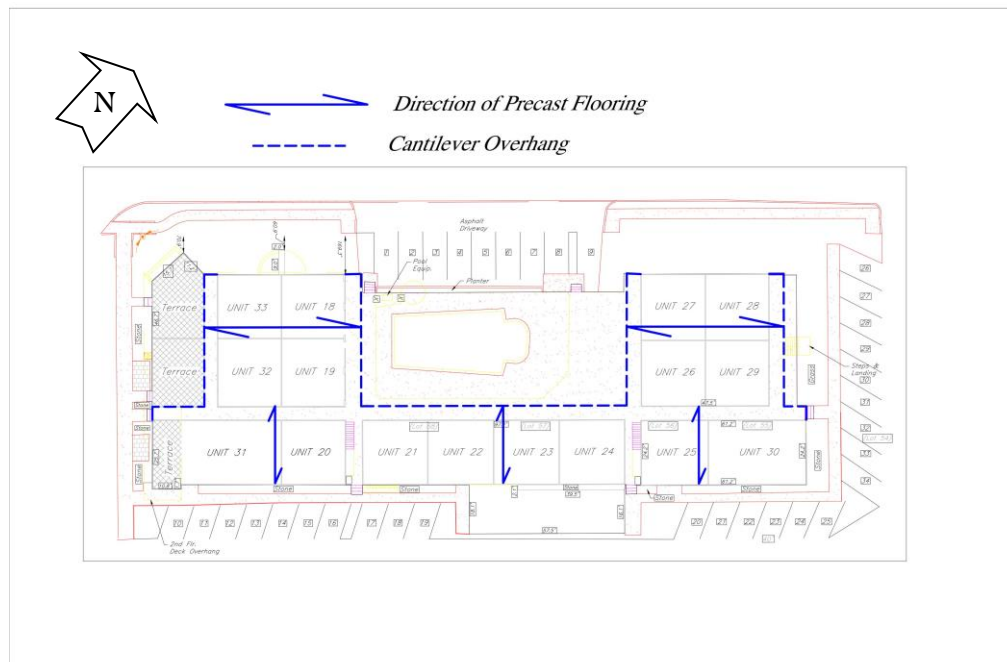
Figure 3 Directions of Precast Flooring for second Floor

9. The terrace areas located at the southwest of the property facing 34<sup>th</sup> Street as shown in Figure 3 were inspected through the storage room. The underside of the hollow core planks is intact. The planks were designed and constructed on a pitch to allow for the roof drainage. Visible cracks on the drywall board are due to improper installation and finishing of the drywall boards. As to the walls under the concrete lintels or those that run parallel to the direction of the planks are not for structural purposes as can be clearly identified by the composition and discontinuity. As to the loads imposed on the concrete planks including the roofing membrane, the composite wood patio, patio furniture, etc. it can be clearly understood that the load-bearing capacity of concrete planks is far more

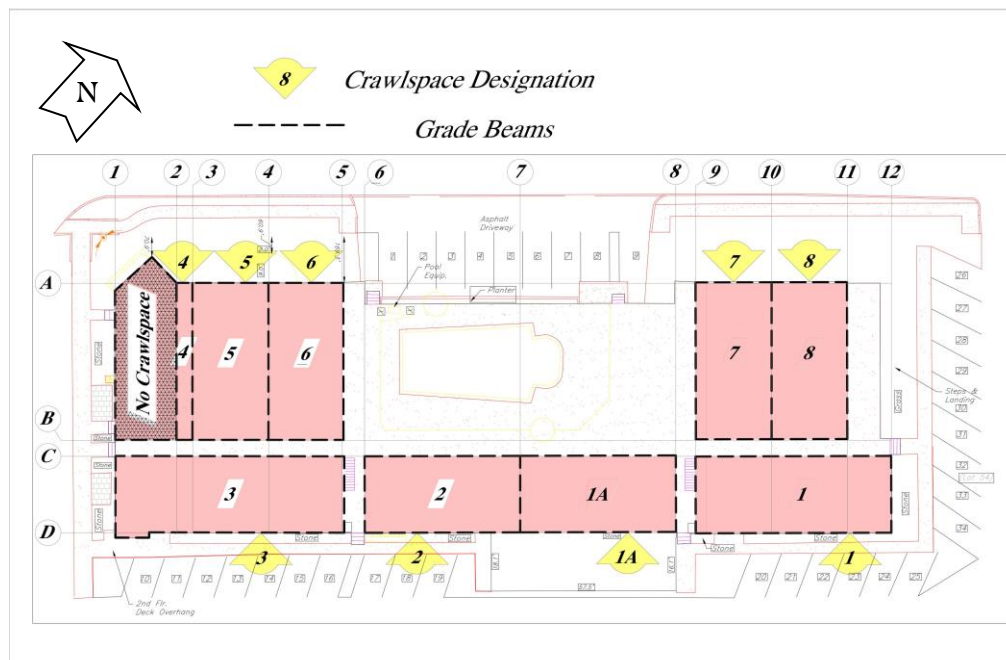
Figure 5 The locations of crawlspace hatches, crawlspaces, and grade beams

Figure 5 shows the locations of access ports (hatches) into the crawl spaces as well as the locations and directions of the GBs. Based on the precast flooring directions, the GBs and the CMU walls that align along with sections A and B (crawlspaces 4, 5, 6, 7, and 8) are considered as nonbearing walls (only carrying the self-weight of the walls above). However, the GBs and CMU walls in between sections A and B are considered as bearing walls.

On the other hand, the GBs and the CMU walls aligning with sections C and D are considered as bearing walls, while the other in between GBs and CMU walls are considered nonbearing walls. The nonbearing walls are holding the self-weight only of the walls and any cracks on nonbearing walls are not considered as high risk and would require minimal repairs. The space under the storage space has a slab-on-grade (No Crawlspace).

1. The grade beams, CMU walls, and pre-cast concrete planks were, when visually accessible, inspected via crawlspace hatches located around the structures as shown and designated in Figure 5. Advanced robotic crawling with HD video camera was used to inspect the areas that have not accessed in the first inspection. However, some places were not accessible due to the obstructions of utility pipes disposed articles, and plumbing debris, which hindered adequate visual access or crawler routes. The detailed conditions and observations for all the crawlspaces were listed in Table 1. See Photographs section below for more details.

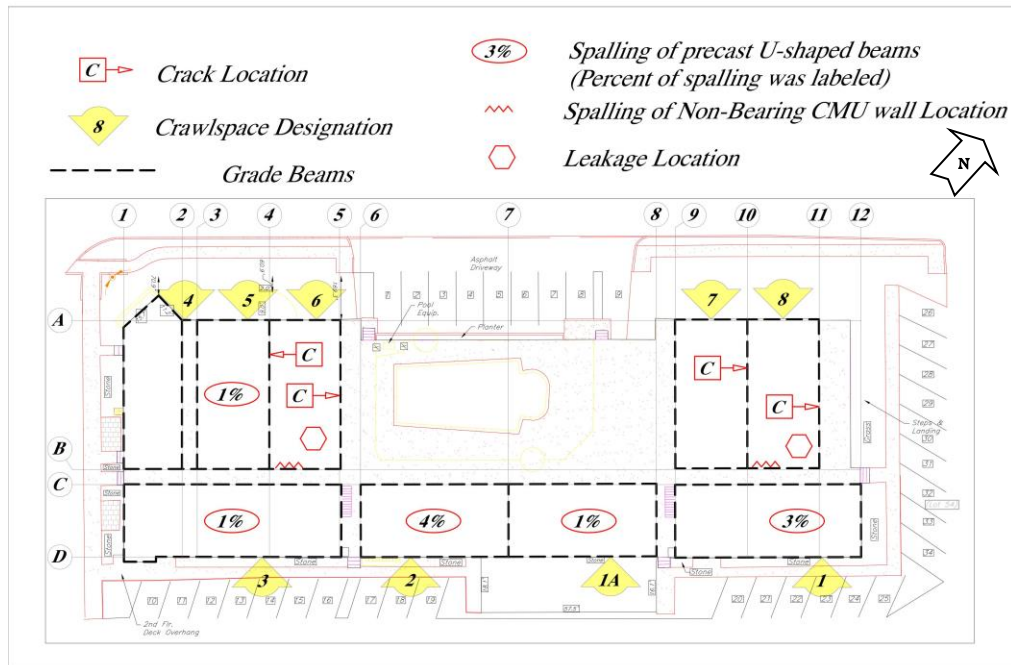
4. Two areas of concrete spalling of nonbearing CMU walls were observed as shown in Figure 6. It is worth repeating that these nonbearing walls are holding the self-weight only and the failure in these areas are not considered a structural risk. Fixing and repairing of these areas are recommended.

10. In certain sections of crawlspace 6, as shown in Figure 6, signs of active plumbing leakage were noted.
11. Due to the combining of approximately six (6) building into one complex, some transitioning took place. The transitions are most observed, as expected at the walkways. The walkways, being constructed of hollow core planks were covered at the end with timber fascia boards and coil-type capping. In some areas, the capping and fascia boards dislodged, causing exposure of the hollow core and reinforcement, thus promoting oxidation. In those areas observed where cracking and spalling is evident on the underside or sections, repairs would be recommended. See Figure 7 below.

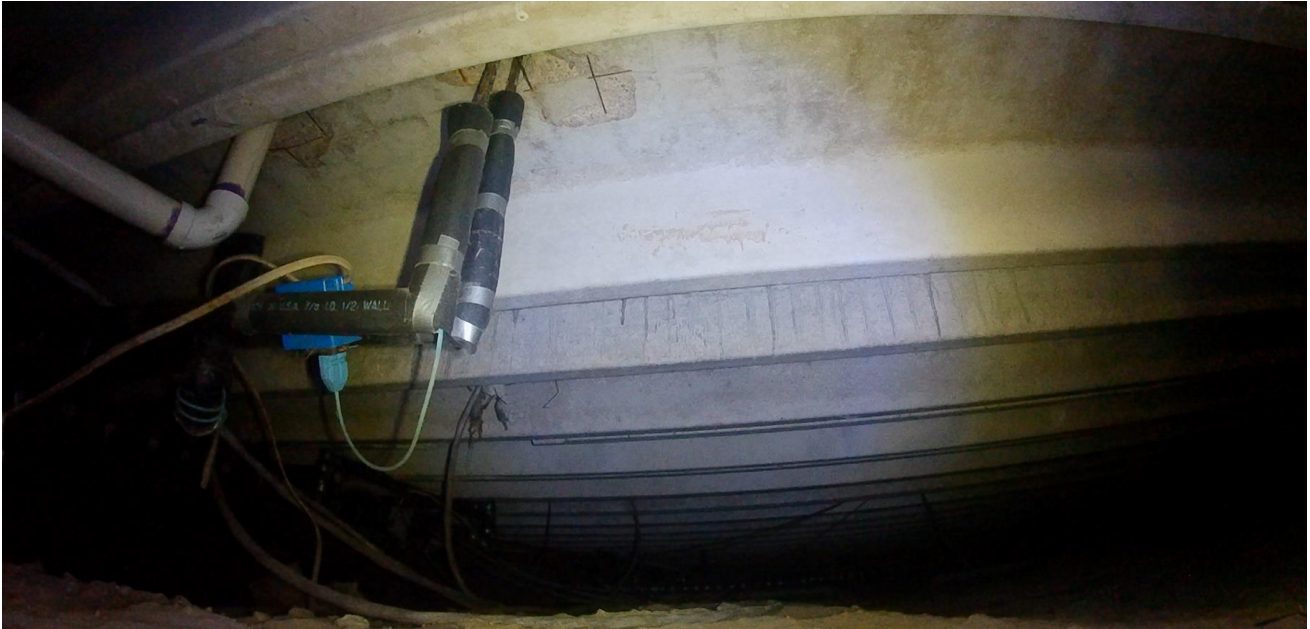
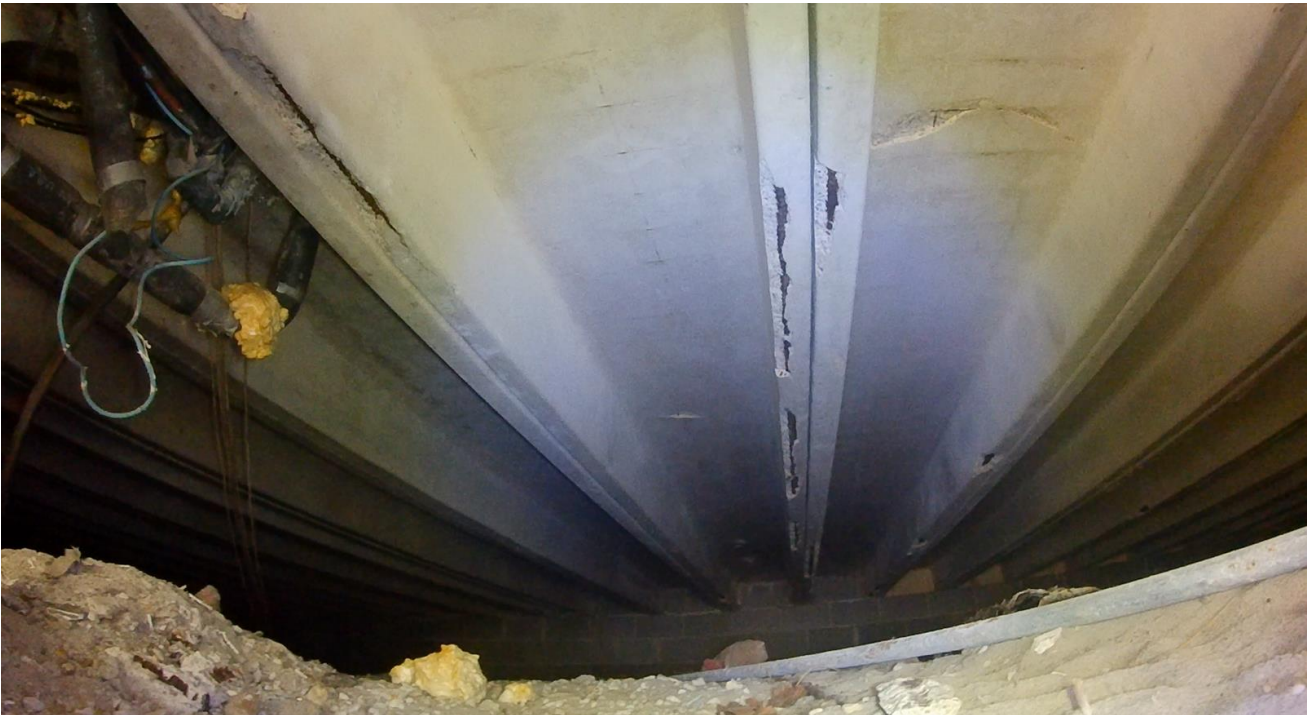
2. It was observed that some of the concrete channels (Inverted U-shaped beams) exhibited spalling and corrosion of reinforcement in sporadic locations under the first-floor, especially at crawlspaces (1, 1A, 2, and 3). However, at the remaining crawlspace (4, 5, 6, 7, and 8) concrete spalling and reinforcement corrosion were observed to be limited to a much lesser extent; thus, the condition of the concrete channels is deemed acceptable with local repairs needed. The locations and estimated percentage by size, of the areas to be repaired are shown in Figure 6. The recommended repairs for the concrete spalling and the corroded reinforcements were listed in Table 1.

| Inspected Components | Observations | | | Notes | Recommended Repairs |
|---|---|---|---|---|---|
| Crawlspace 1 | No Visible Cracks Observed | No Visible Cracks Observed | Local and sporadic concrete Spalling and surface reinforcement corrosion (lower part of the web) | Moisture intrusion have been noticed on the GB and CMU walls. | 1- Remove corroded layer and cracked portions of concrete then inject the epoxy materials to restore cover to the reinforcement. Follow by applying carbon fiber reinforced polymer fabric (CFRP) to increase the tensile capacity of the beams.<br><br>2- Improving ventilation in crawlspaces is required to reduce humidity levels and prevent issues like corrosion. |

Corrosion of reinforcement and concrete spalling in some of first floor beams (crawlspace 1)

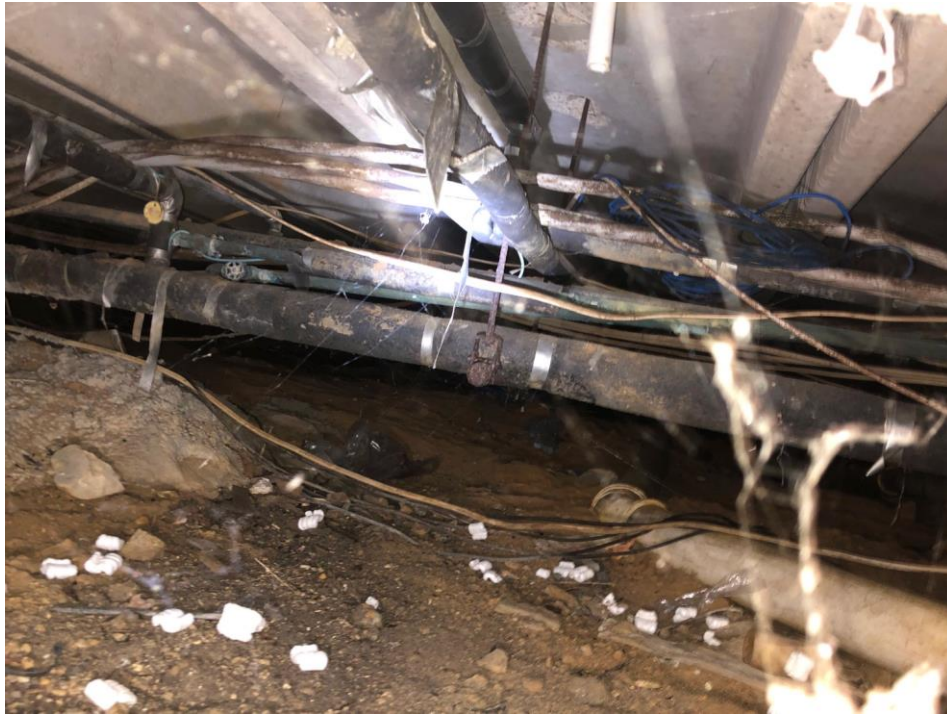
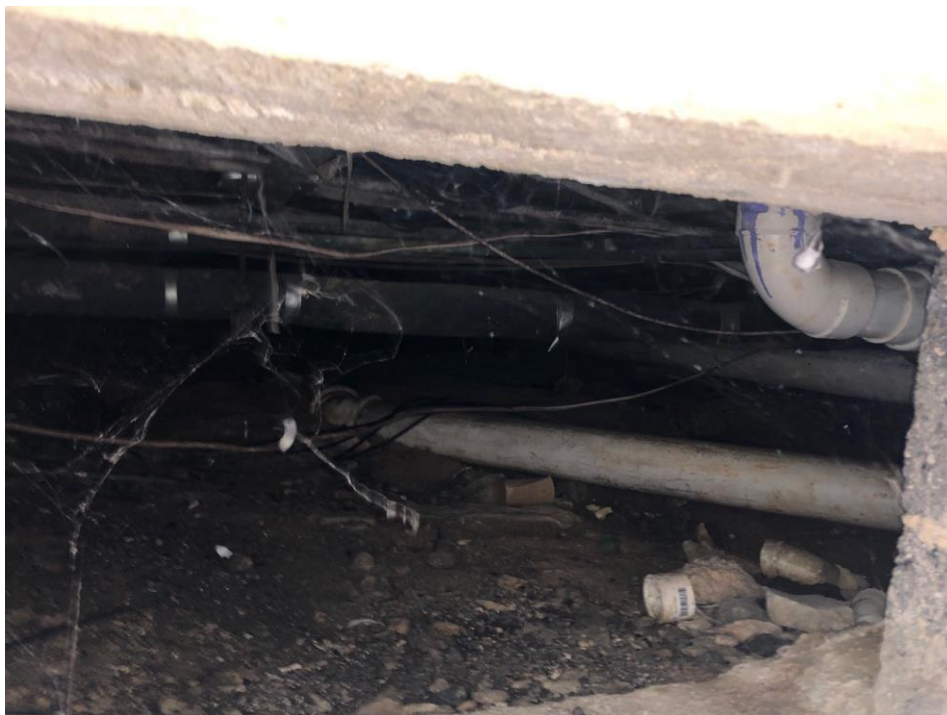
| Inspected Components | Observations | | | Notes | Recommended Repairs |
|---|---|---|---|---|---|
| Crawlspace 1A | No Visible Cracks Observed In accessible areas | Inaccessible | Local and sporadic concrete Spalling and surface reinforcement corrosion (lower part of the web) | --- | |

(Crawlspace 1A) Inaccessible Due to Utilities Pipes.  
Note that concrete and reinforcement corrosion are not in advanced stage

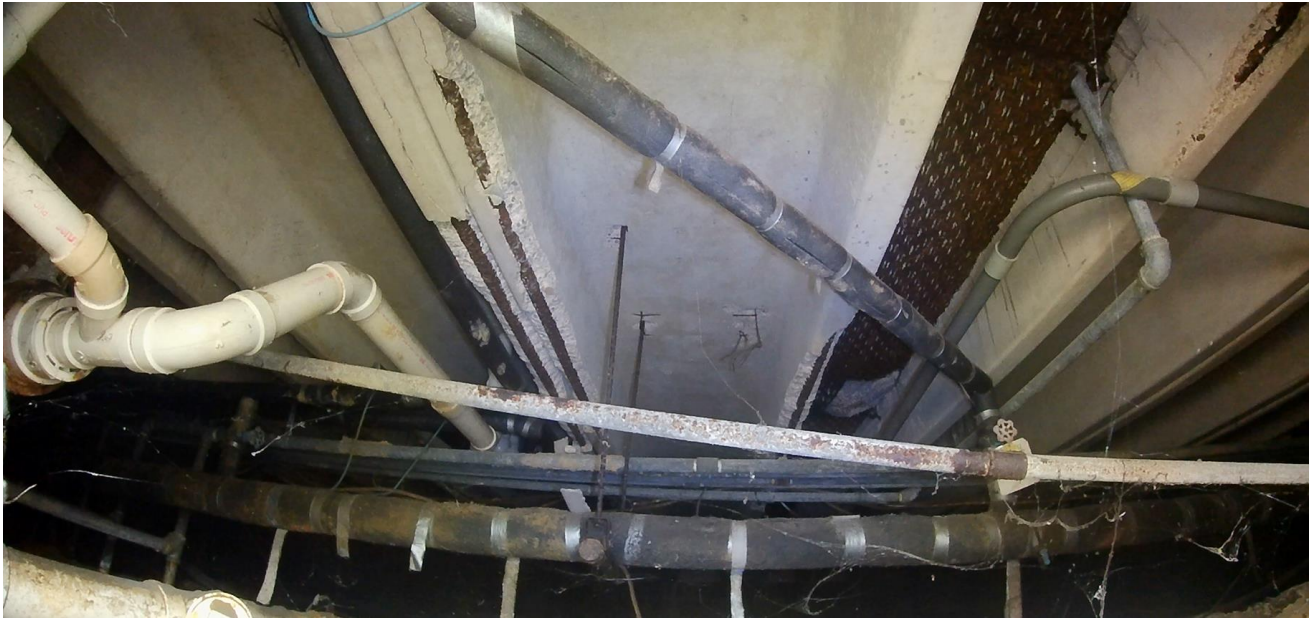
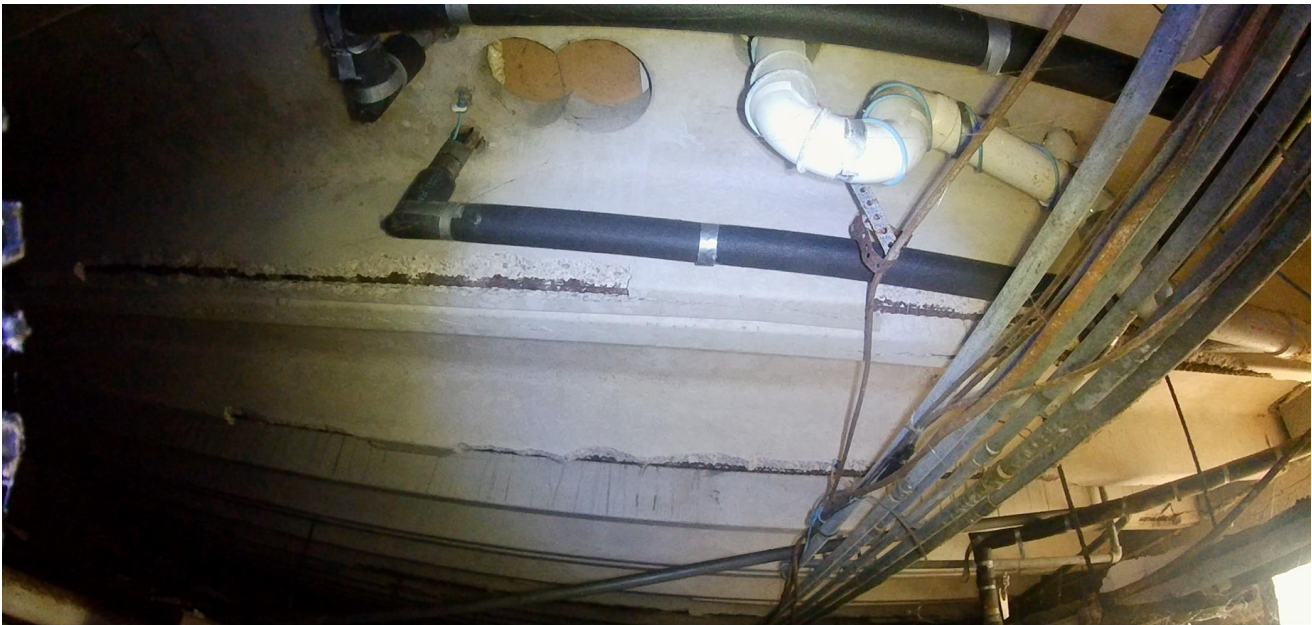
| Inspected Components | Observations | | | Notes | Recommended Repairs |
|---|---|---|---|---|---|
| Crawlspace 2 | No Visible Cracks Observed In accessible areas | No Visible Cracks Observed In accessible areas | Local and sporadic concrete Spalling and surface reinforcement corrosion (lower part of the web) | --- | |

Corrosion of reinforcement and concrete spalling in a few of first floor beams. Most are likely caused by chipping activities (crawlspace 2)

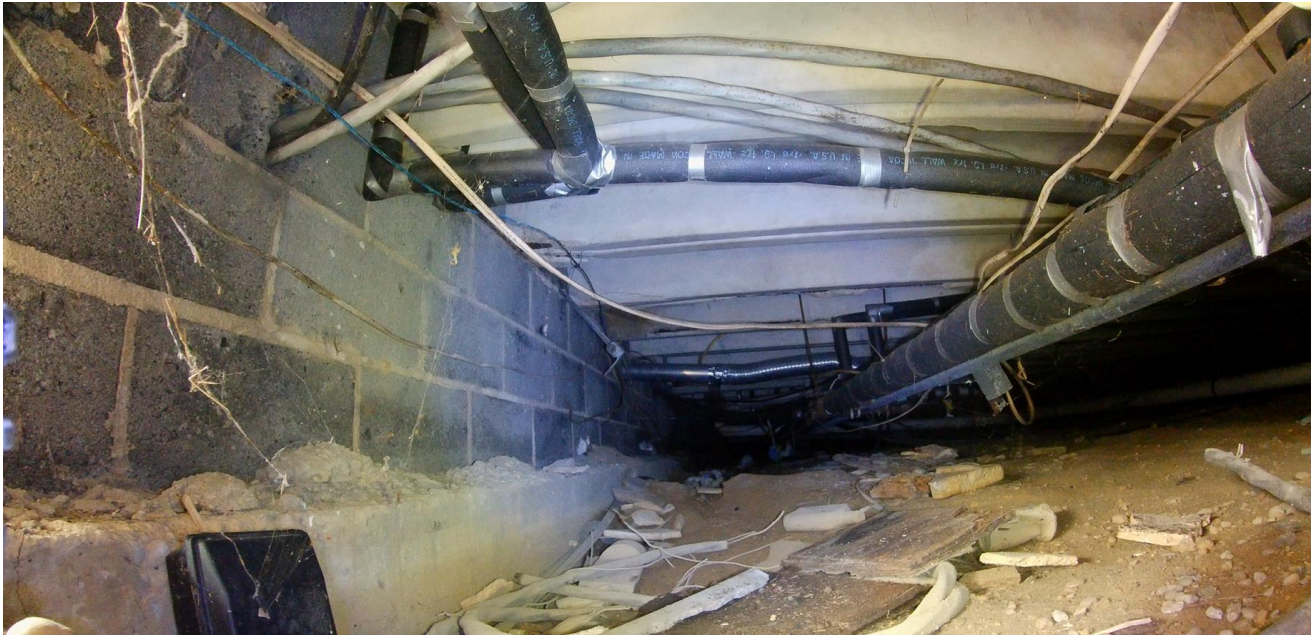
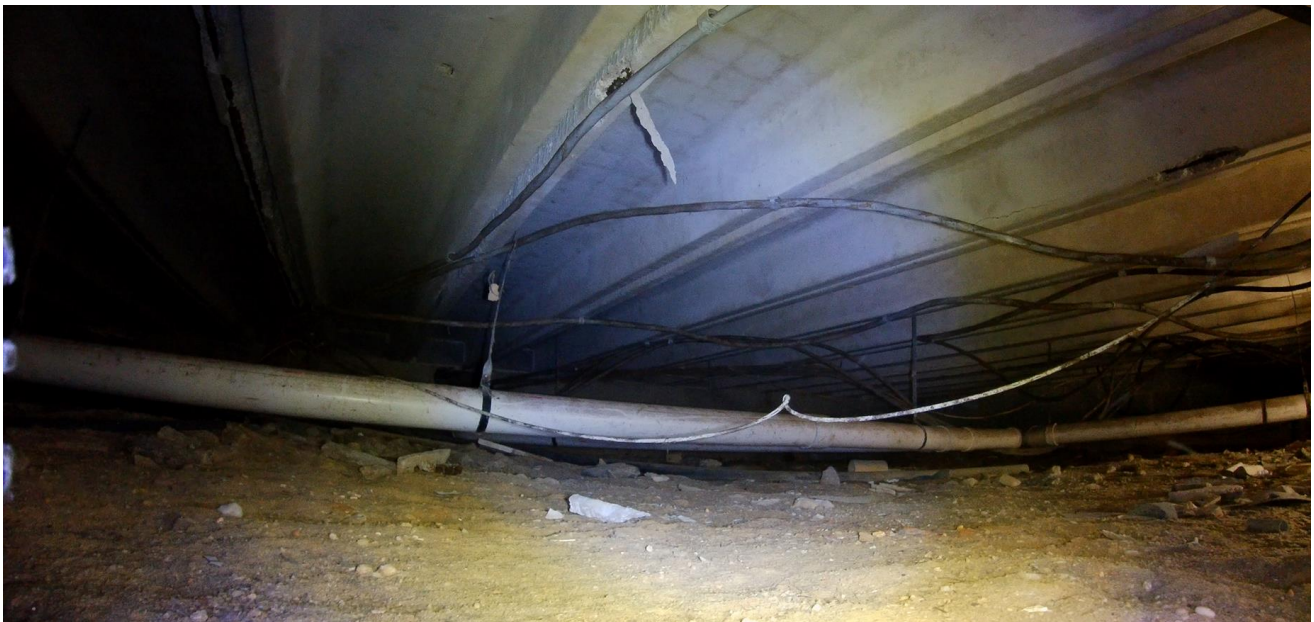
(Crawlspace 3)

| Inspected Components | Observations | | | Notes | Recommended Repairs |
|---|---|---|---|---|---|
| Crawlspace 3 | No Visible Cracks Observed | No Visible Cracks Observed | Local and sporadic concrete Spalling and surface reinforcement corrosion (lower part of the web) | --- | |

Approximate 1% of Corrosion of reinforcement and concrete spalling in one or more first floor beams

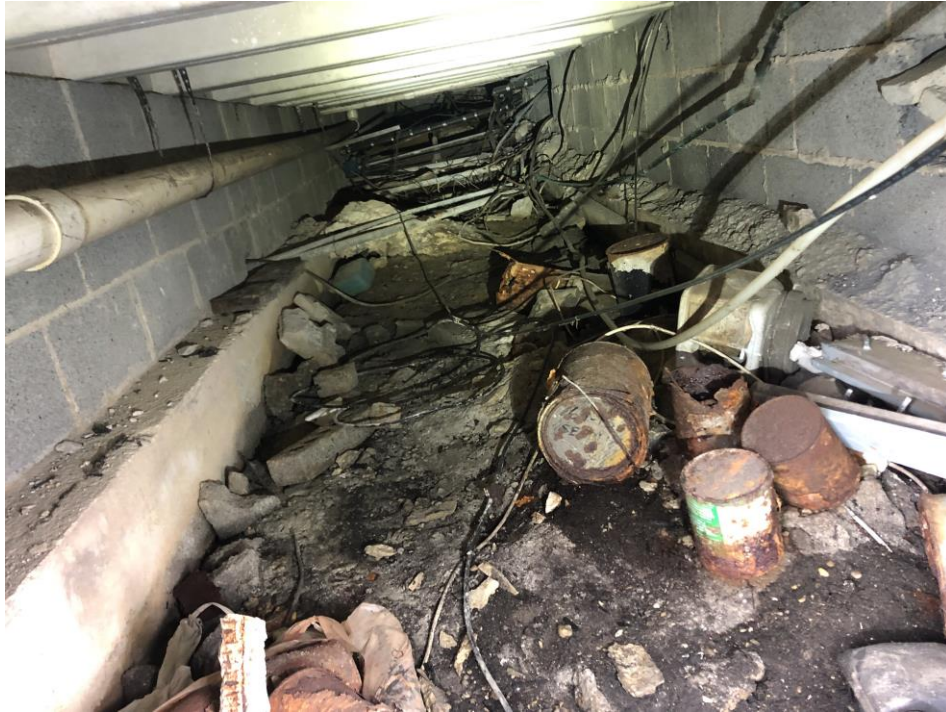
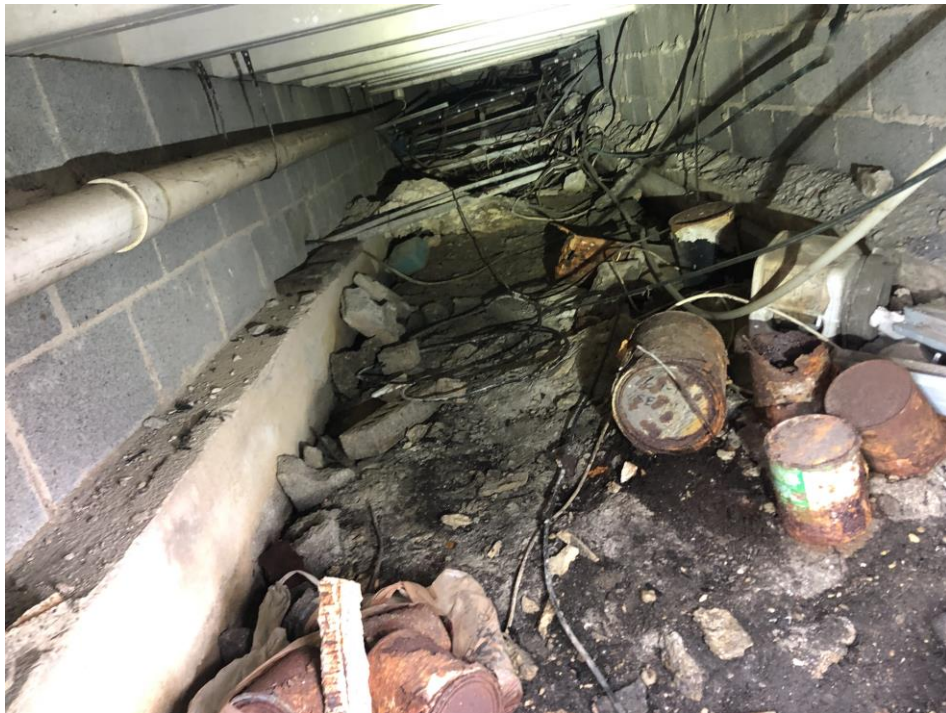
(Crawlspace 4)

| Inspected Components | Observations | | | Notes | Recommended Repairs |
|---|---|---|---|---|---|
| Crawlspace 4 | No Visible Cracks Observed | No Visible Cracks Observed | Looks in good conditions | --- | Improving ventilation in crawlspaces is required to reduce humidity levels and prevent issues like corrosion. |

Note No observed reinforcement corrosion or concrete spalling

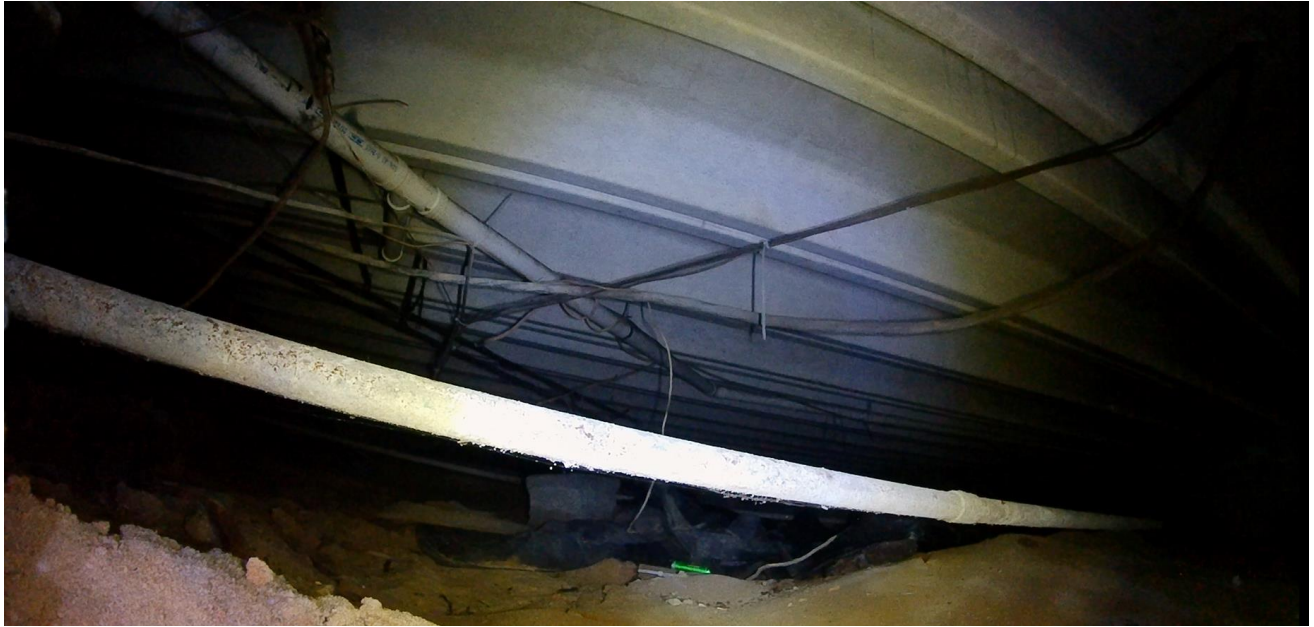
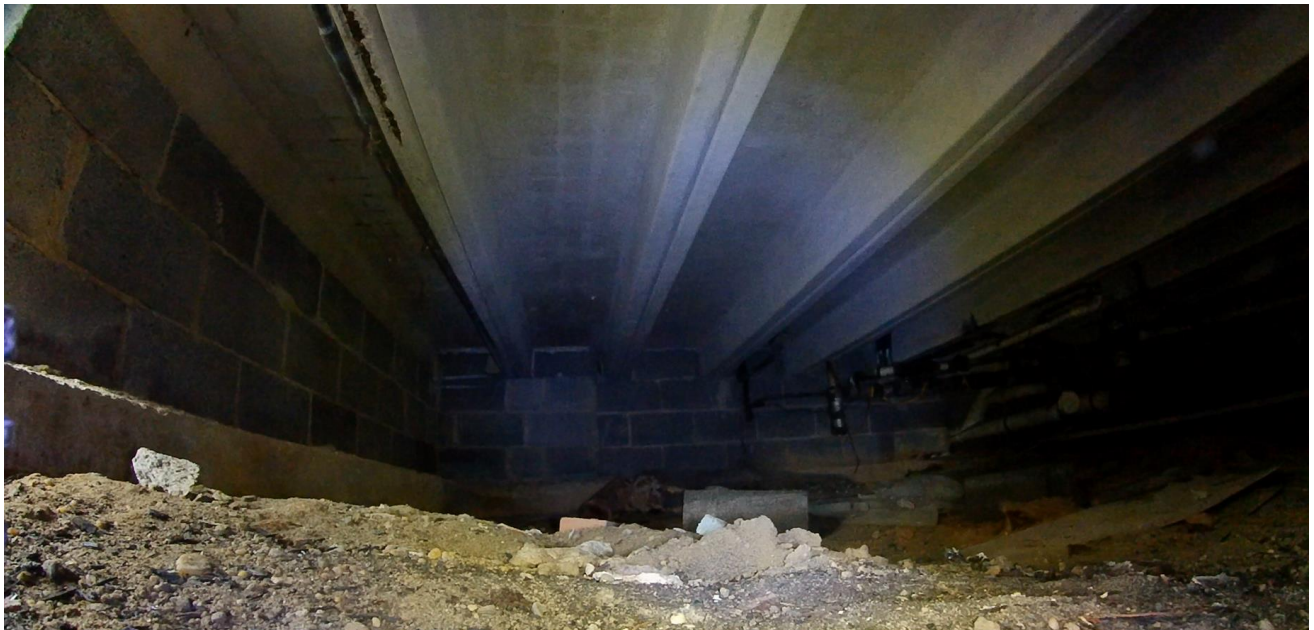
| Inspected Components | Observations | | | Notes | Recommended Repairs |
|---|---|---|---|---|---|
| Crawlspace 5 | No Visible Cracks Observed | No Visible Cracks Observed | Limited concrete spalling and reinforcement corrosion (lower part of the web) | --- | |

Crawlspace 5  
Approximate 1% of Corrosion of reinforcement and concrete spalling in first floor beam

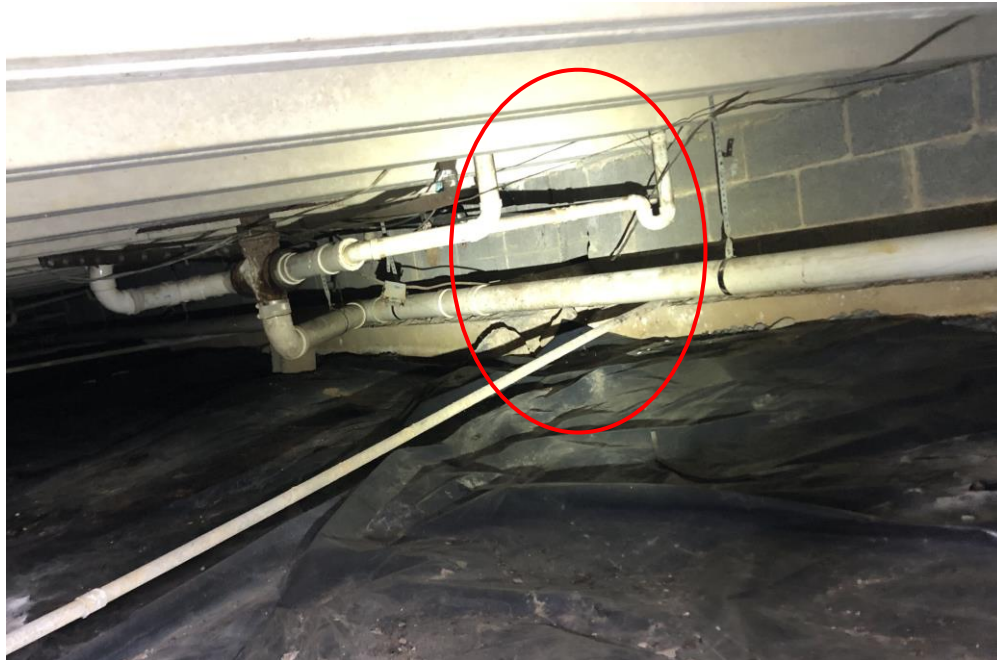
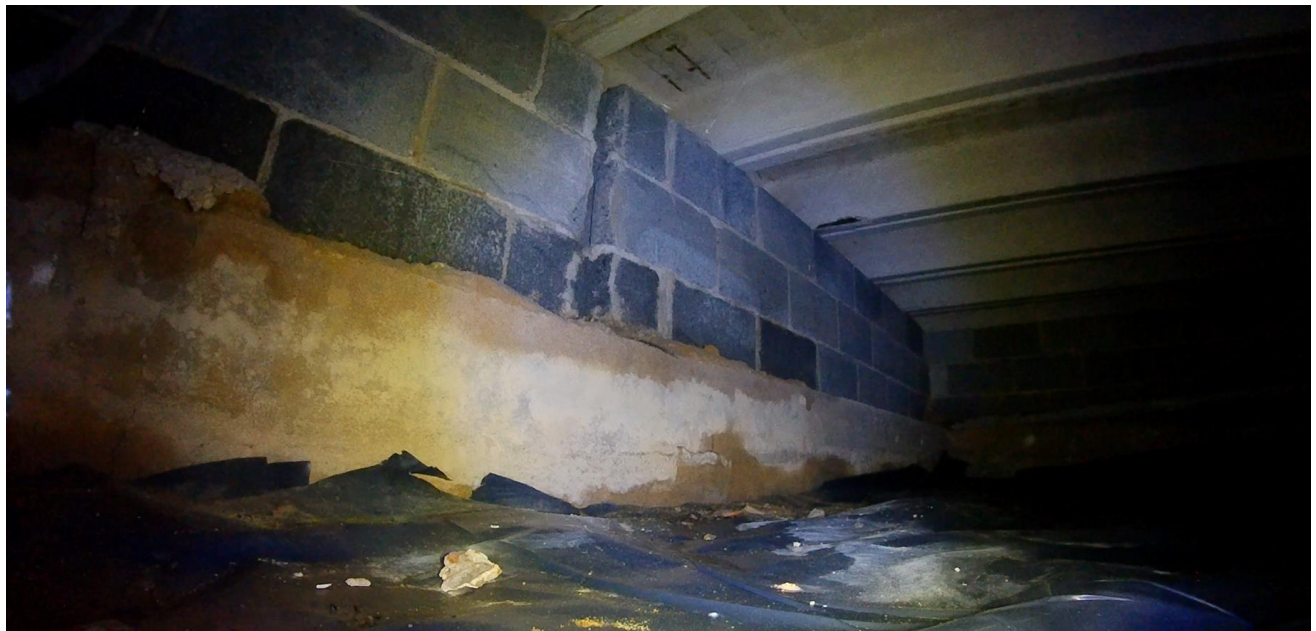
#### Crawlspace 6

3. In crawlspaces 5 & 6, locally damaged and cracked grade beams and CMU walls were observed mostly at crawlspace 6. CMU damage was observed in crawlspace 5, some appearing to be due to intrusive forces applied during plumbing and electric pipe installation between crawlspaces 5 & 6. None appeared to be due to widespread failure of the timber piles. One small crack at crawlspace 7 and another at crawlspace 8 have been observed. Prior reports prepared by engineering consultants, also focused on the damage to the grade beams **only** within crawlspaces 5 and 6. On the other hand, no significant cracks were detected by this firm on CMU walls or grade beams in crawlspace (1, 2, 3, and 4). Crawlspace 1A was inaccessible due to the installed utility pipes. Refer to the Photographs section below. The observed concrete grade beams appear to have been subjected to compounded blunt horizontal forces as well as loss of under support due to decay of exposed top of timber friction pile(s). The latter is estimated, not confirmed.

| Inspected Components | Observations | | | Notes | Recommended Repairs |
|---|---|---|---|---|---|
| Crawlspace 6 | Cracks observed in some locations | Cracks observed in some locations | Limited concrete spalling and reinforcement corrosion (lower part of the web) | Water leakage and water intrusion have been noticed on the GB and CMU walls. Spalling areas in nonbearing CMU walls | 1- Remove corroded layer and cracked portions of concrete then inject the epoxy materials to restore cover to the reinforcement. Follow by applying carbon fiber reinforced polymer fabric (CFRP) to increase the tensile capacity of the beams.<br><br>2- Attach two steel plates with epoxy adhesion materials to the sides of the GB to restore the bearing capacity of the GB.<br>3- Improving ventilation in crawlspaces is required to reduce humidity levels and prevent issues like corrosion. |

Note that there are cracks in the grade beam and the CMU wall. Also note that the condition of the U-Shaped beams is acceptable with no evidence of deterioration (minor sporadic spalling)

The recommendations for repairs entail installing steel plates on the lower sides of the grade beam and injecting grout into the cracks. Restoration of the spalling beams can be conducted upon the restoration of the grade beam. Restoration of the hollow core slabs can be conducted in a manner similar to what was successfully completed.

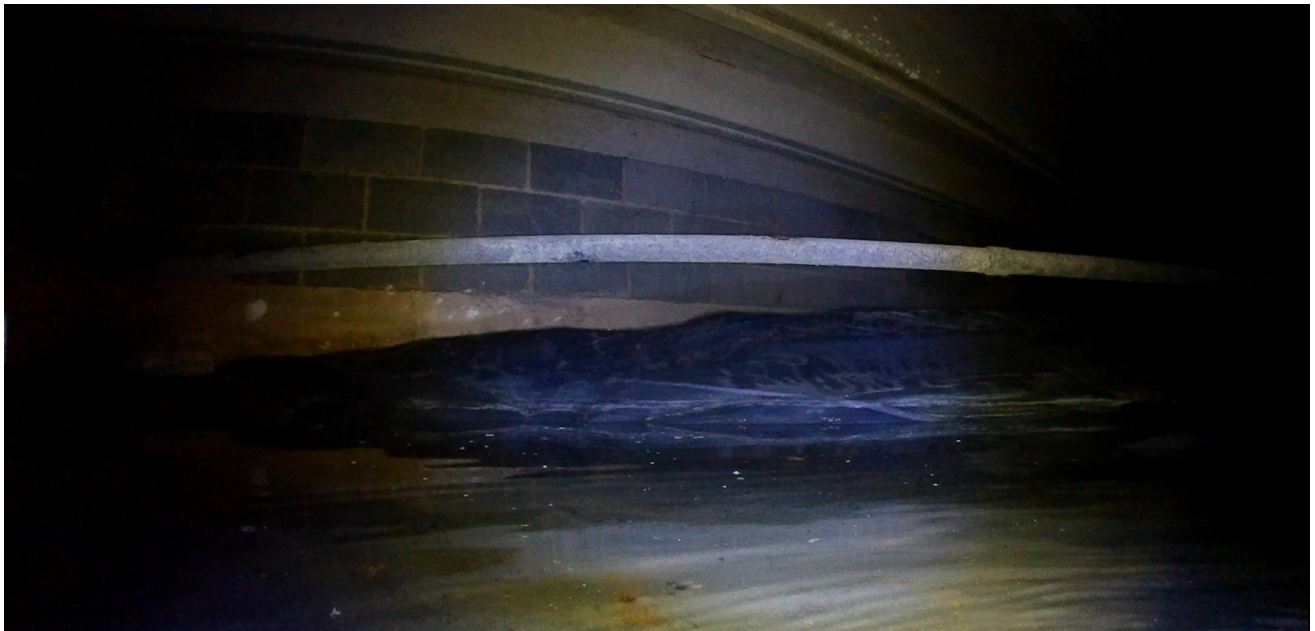
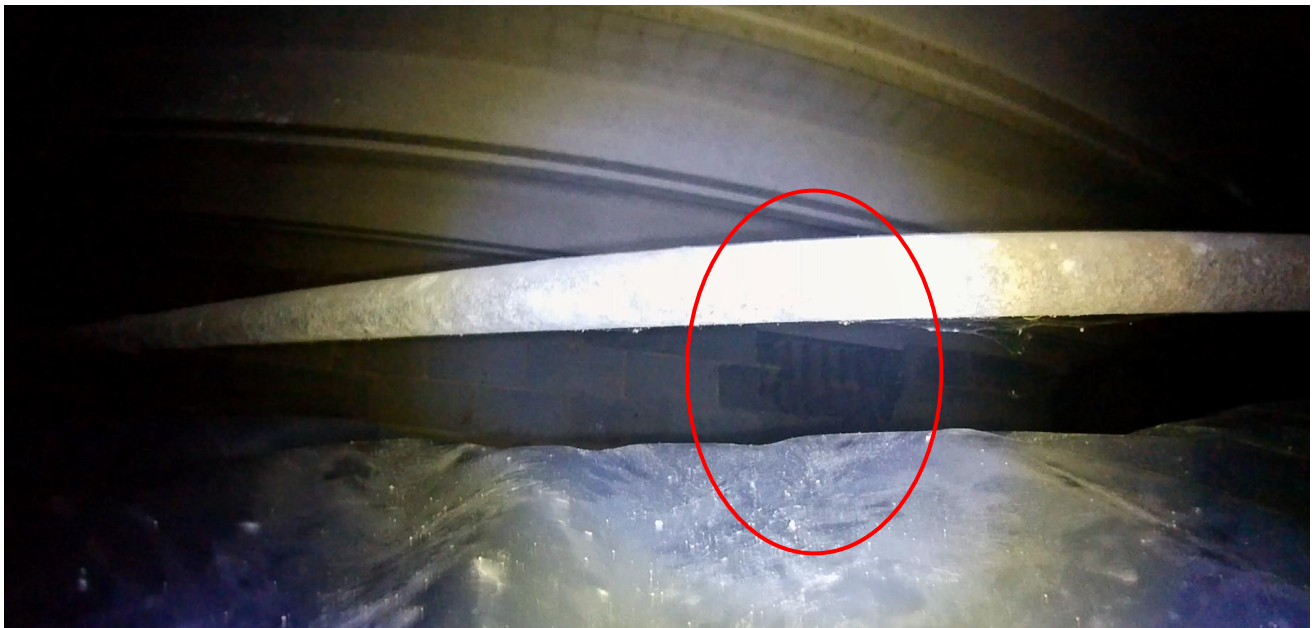
Crawlspace 6

Note that there is water leakage (top) and spalling at the non-bearing CMU wall (bottom). CMU appears to be due to hammering and chipping

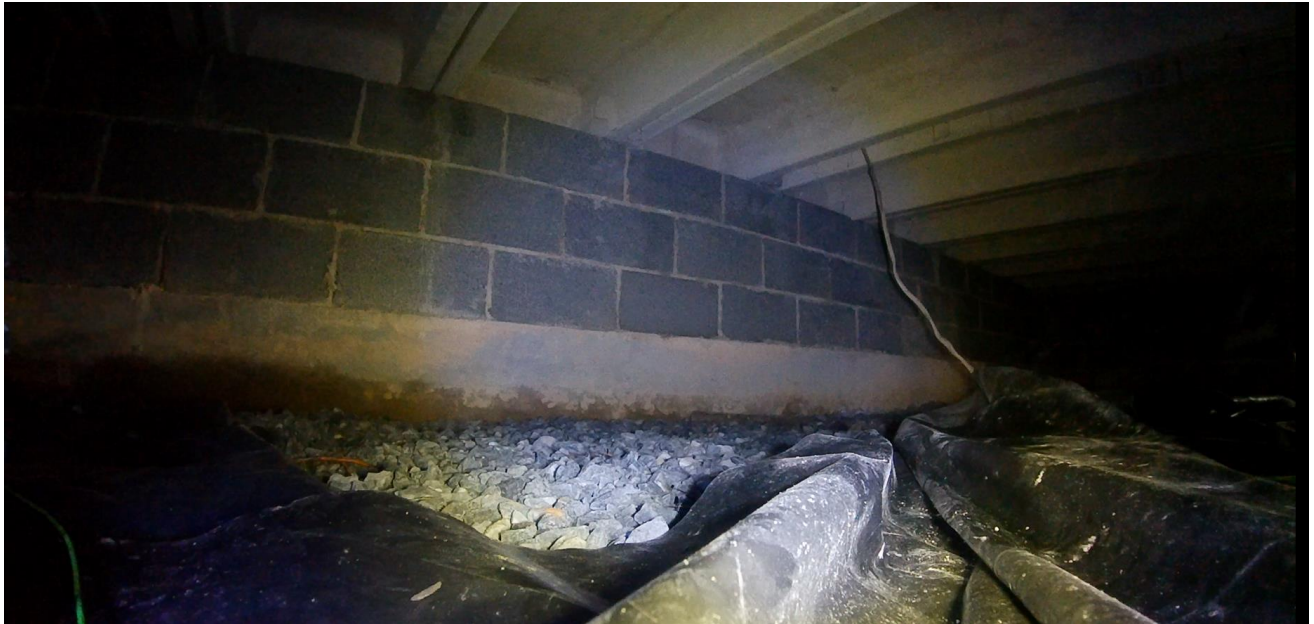
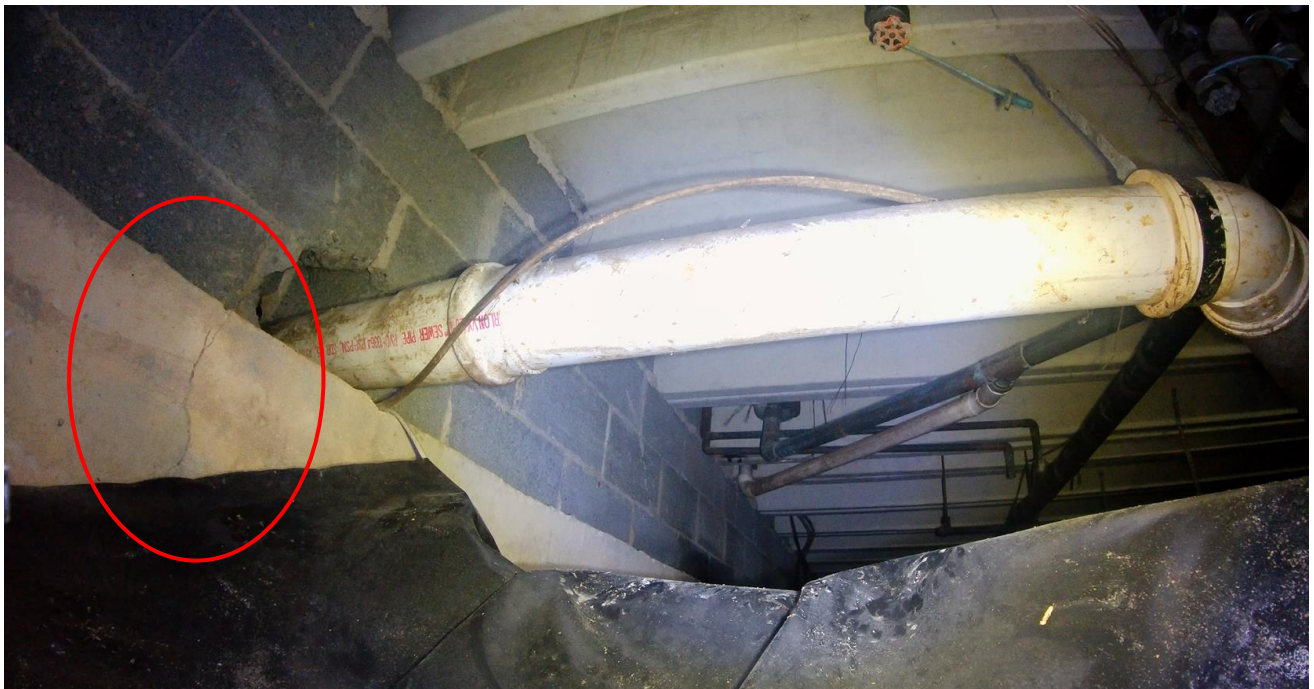
#### Crawlspace 7

| Inspected Components | Observations | | | Notes | Recommended Repairs |
|---|---|---|---|---|---|
| Crawlspace 7 | Cracks observed in One location | Cracks observed in One location | Limited concrete spalling and reinforcement corrosion (lower part of the web) | The floor supports above damaged GB or CMU walls do not exhibit any sign of distress | |

Note that there is a small crack in the grade beam near intrusive plumbing activities. This is local and is not due to subgrade failure.

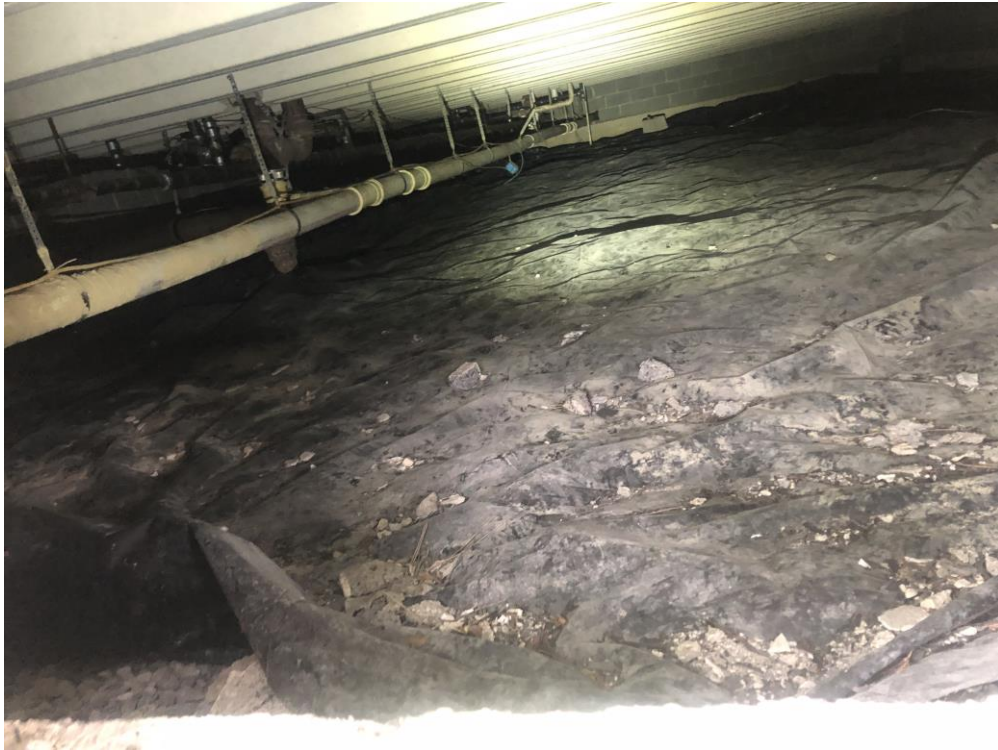
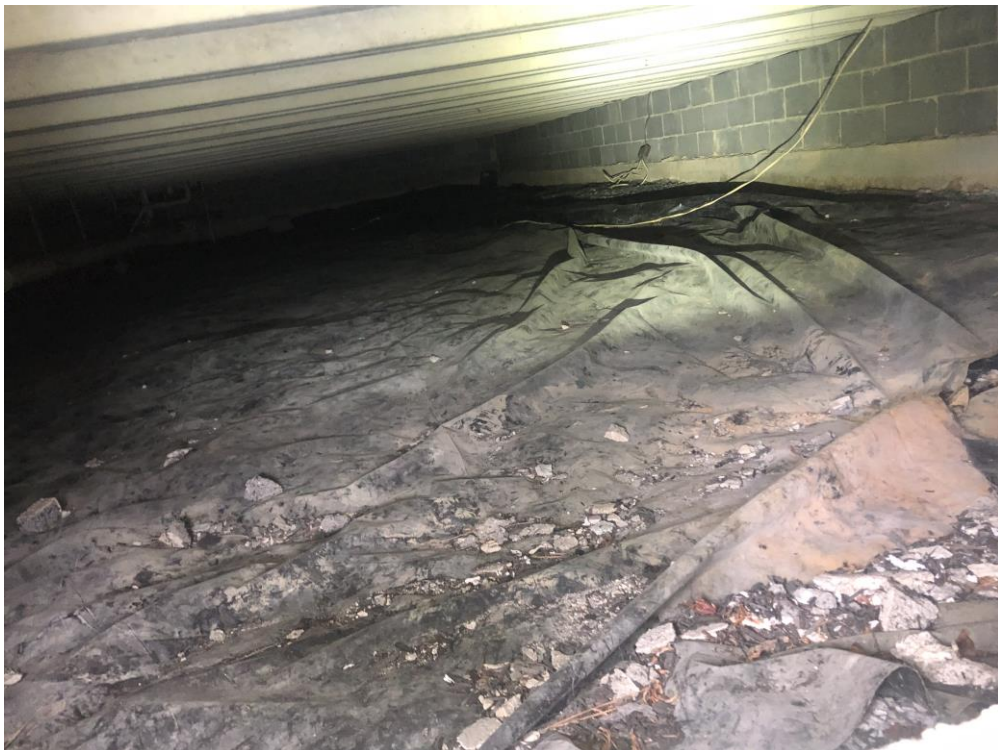
Crawlspace 7

Note that the CMU wall and the planks are in an acceptable condition
