# Structural Assessment Report

August 2023

3313 Bay Avenue,  
Ocean City, NJ 08226  
TADCO ID: J-021171  
Block: 3306, Lot: 1

Seaspray Condo Association  
3313 Bay Avenue  
Ocean City, NJ 08226  
c/o I. Dominic Simeone, Esq.  
Harvard Law Building  
1522 Route 38  
Cherry Hill, NJ 08002

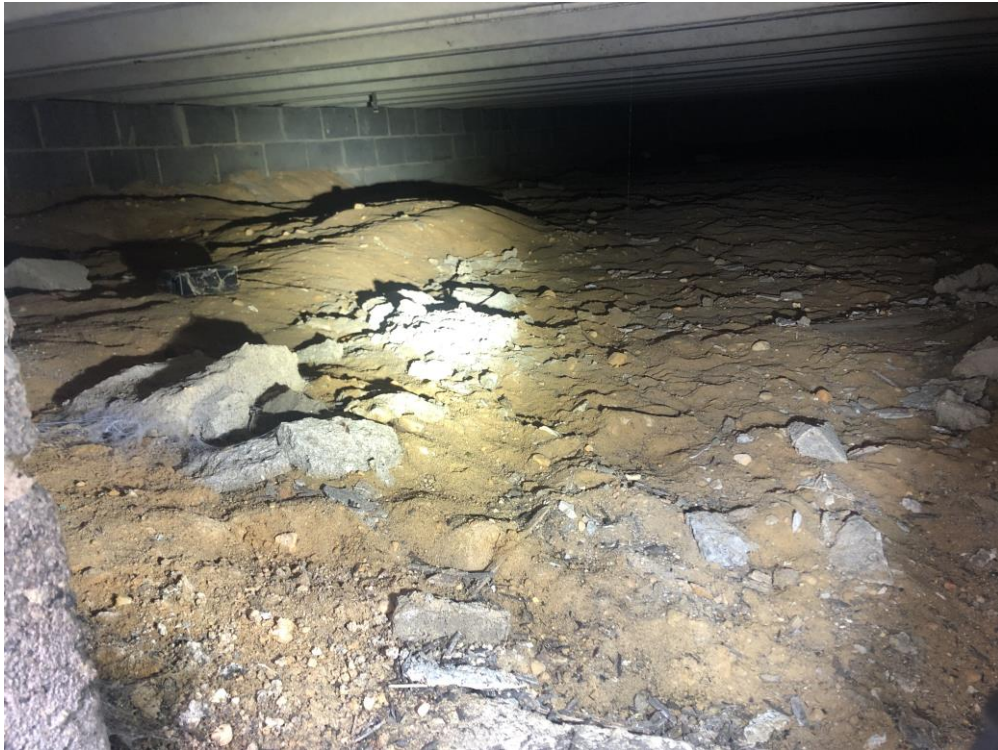
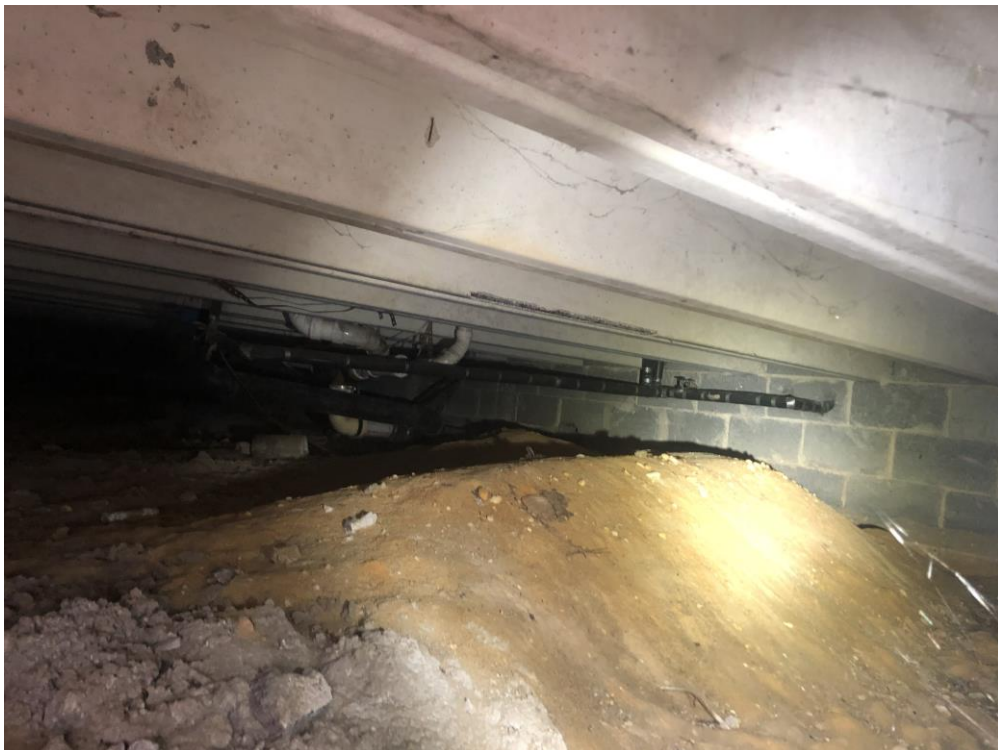
| Inspected Components | Observations | | | Notes | Recommended Repairs |
|---|---|---|---|---|---|
| Crawlspace 8 | Cracks observed in One location | Cracks observed in One location | Limited concrete spalling and reinforcement corrosion (lower part of the web) | The floor supports above damaged GB or CMU walls do not exhibit any sign of distress. Spalling observed in nonbearing CMU walls | |

Note that the planks and CMU are in an acceptable condition with localized spalling

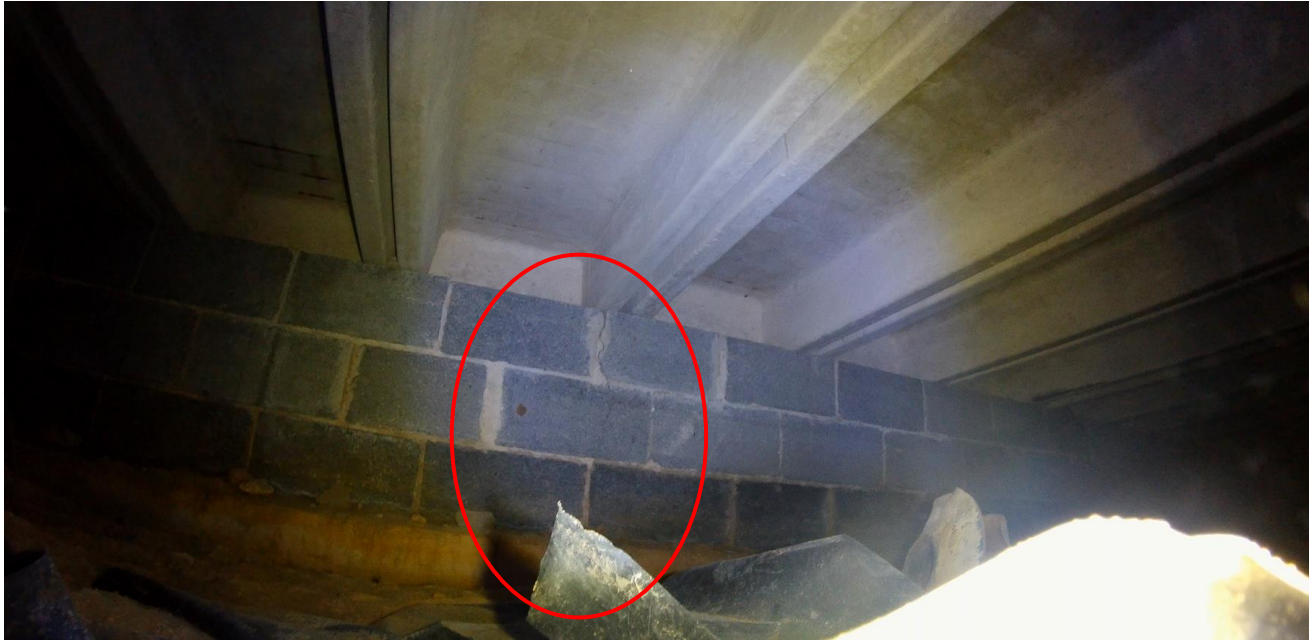
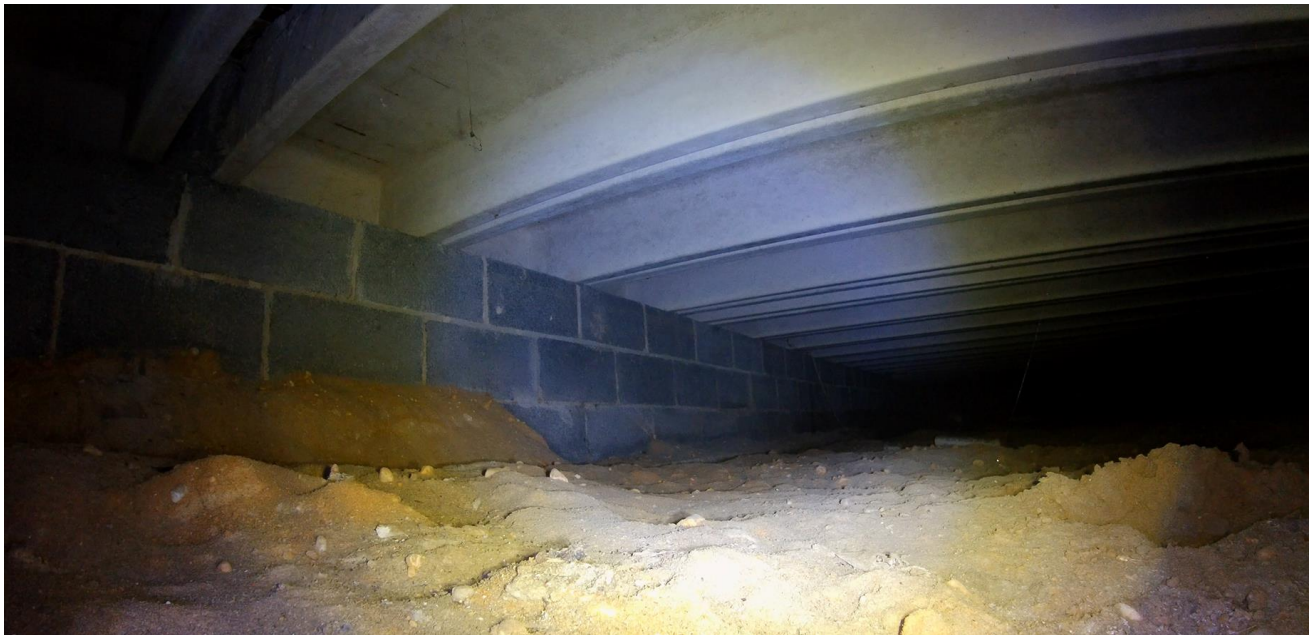
Crawlspace 9  
Note that there is a crack in the CMU wall need to be repaired.

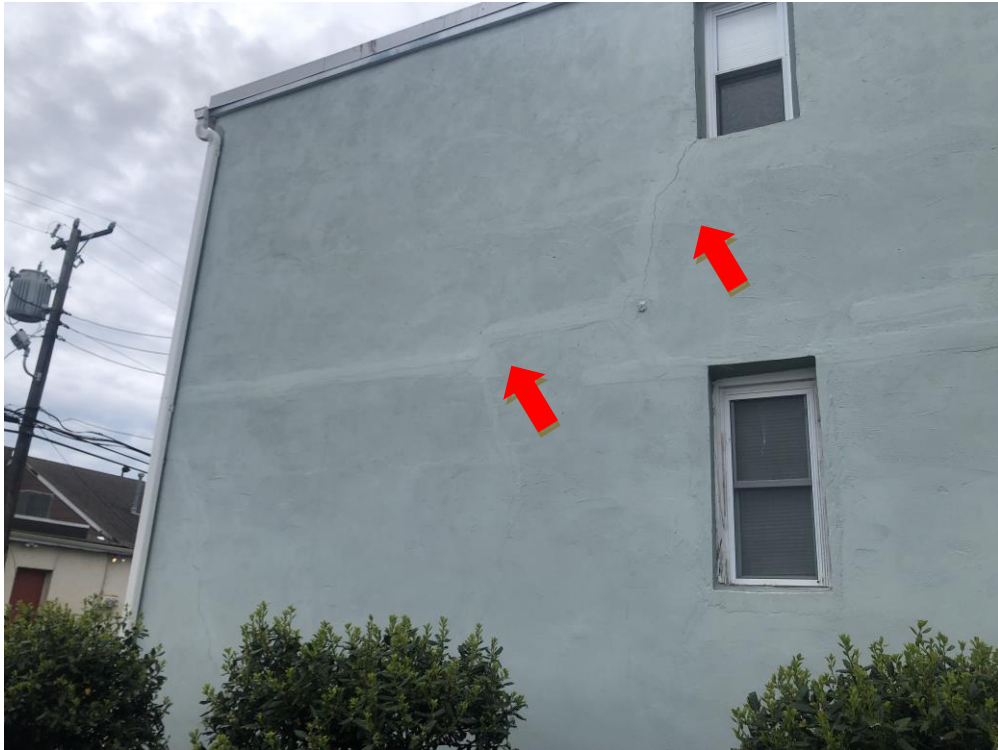
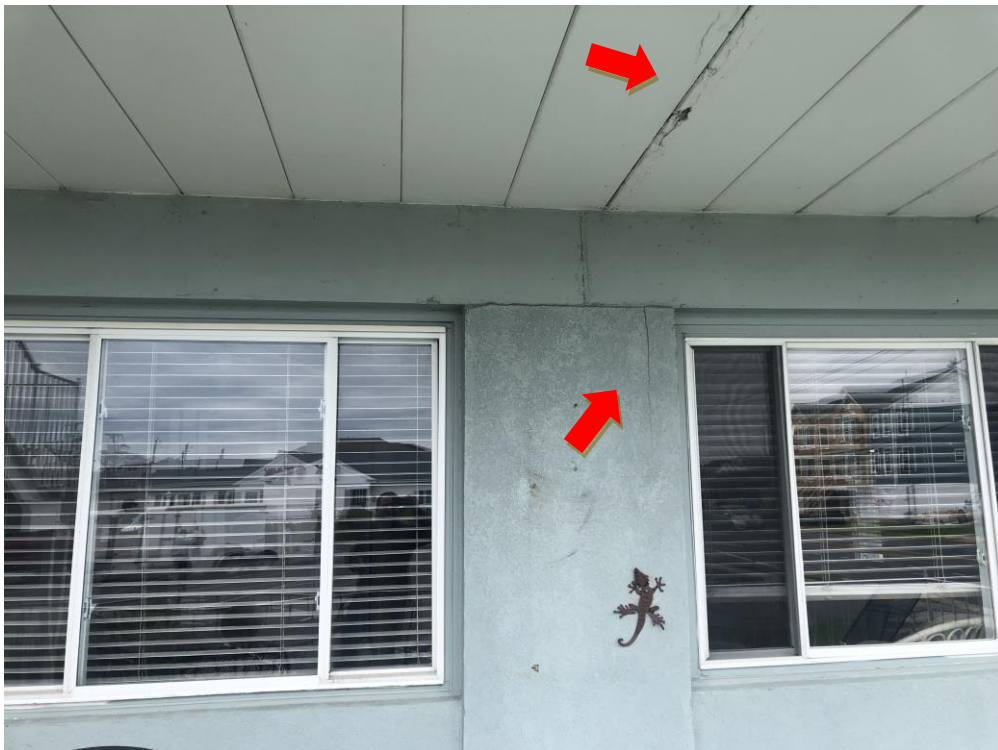
| Inspected Components | Observations | | | Notes | Recommended Repairs |
|---|---|---|---|---|---|
| Unit 14 | --- | --- | --- | Cracks have been observed on exterior walls. | widen crack and utilize approved crack fillers |
| Unit 30 | --- | --- | --- | Cracks were observed on exterior walls. | Widen crack and utilize approved crack fillers |

Northeastern side (Units 14 and 30)  
Note limited wall cracks

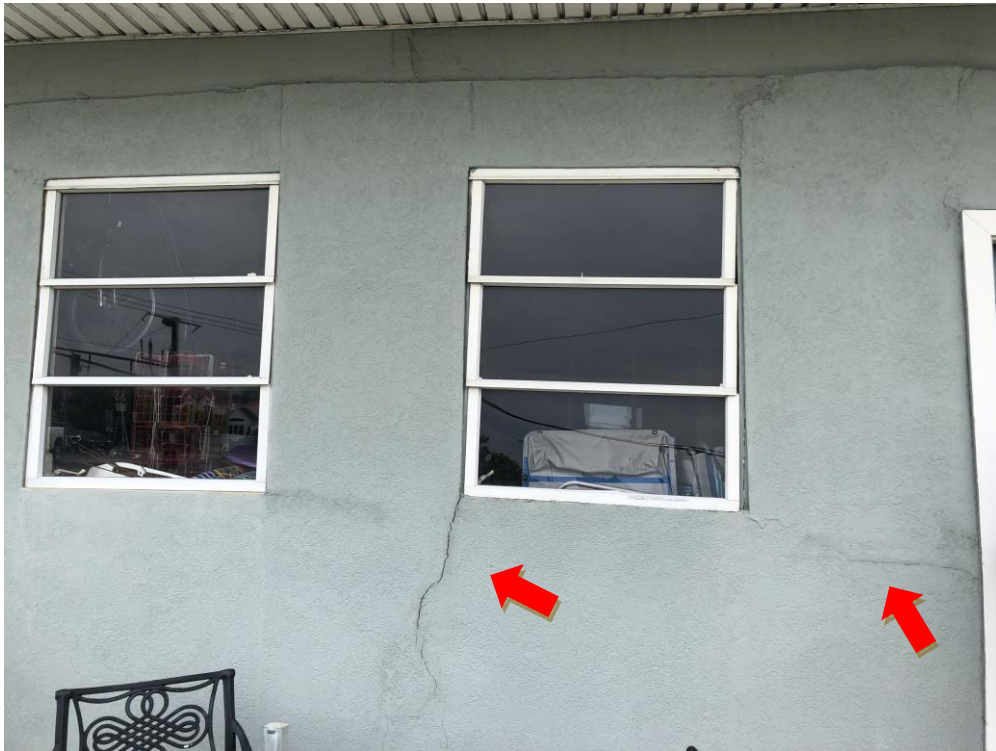
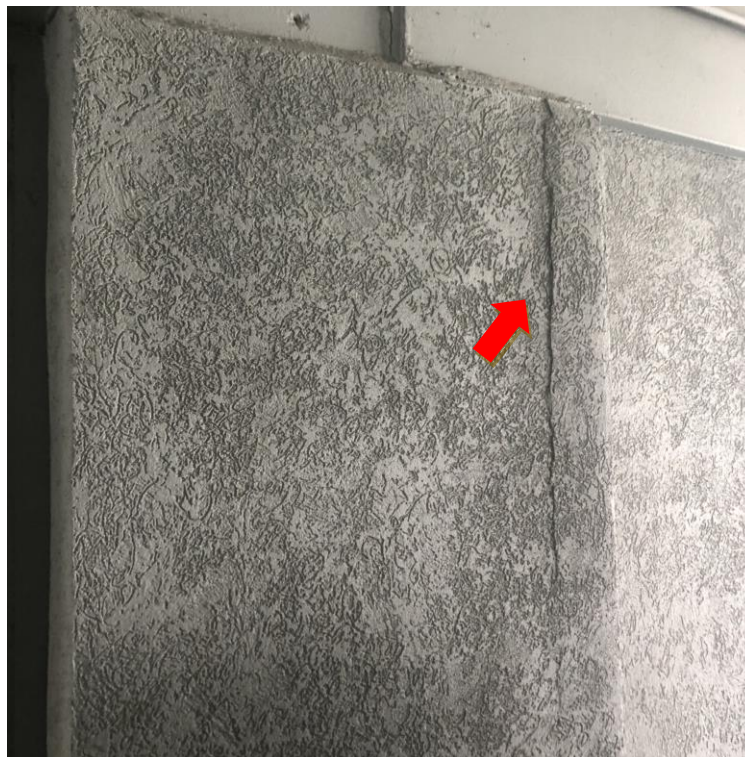
6. Unit 17 was accessed for inspection. It is above crawlspaces 4 & 5. While the ceiling did not exhibit signs of distress, the walls and columns appeared to have minor to moderate cracking associated with uneven settlement. Other observed cracks are not associated with overloading, but rather due to alterations and displacement of point loads. None of the cracks are considered detrimental or can cause sudden catastrophic failure. Unit 1 was not accessible, but the exterior exhibited local cracking without shifting across the face of the cracks. Unit 11 and Unit 12 which are above the crawlspaces 7 & 8 were inaccessible. However, no cracks have been observed at the exterior walls of these units.

| Inspected Components | Observations | | | Notes | Recommended Repairs |
|---|---|---|---|---|---|
| Unit 17 | --- | --- | --- | Cracks were observed on exterior walls. | widen crack and utilize approved crack fillers |

Southwestern side (Units 17 ~ exterior)  
Note cracks through the walls

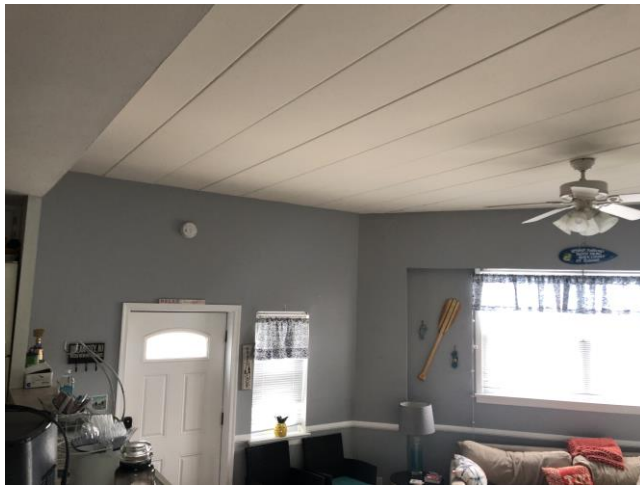
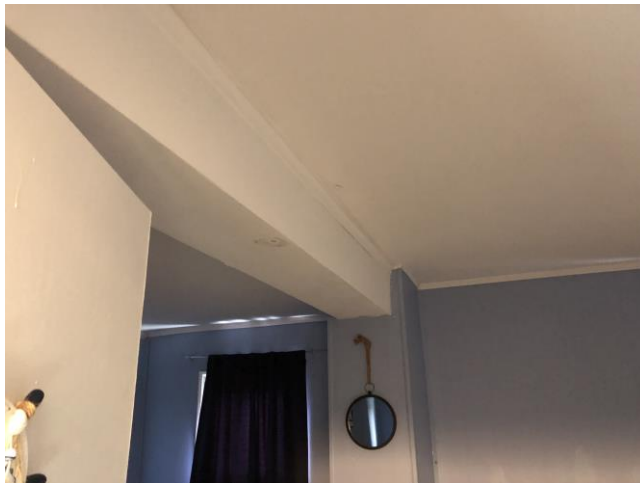
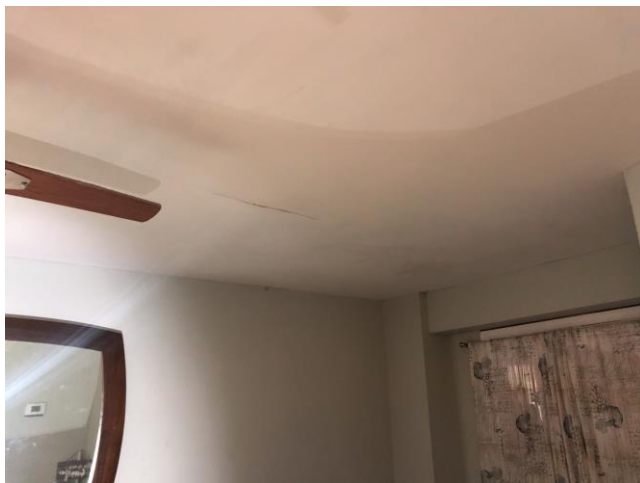
(Units 18 – interior)

Note moisture cracking of the surface cover on the ceiling

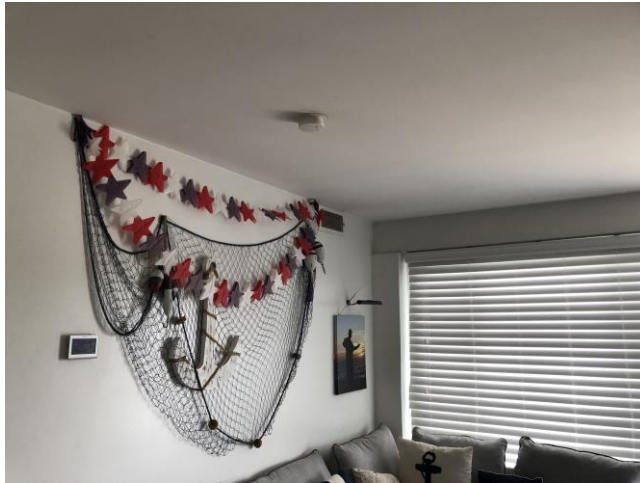
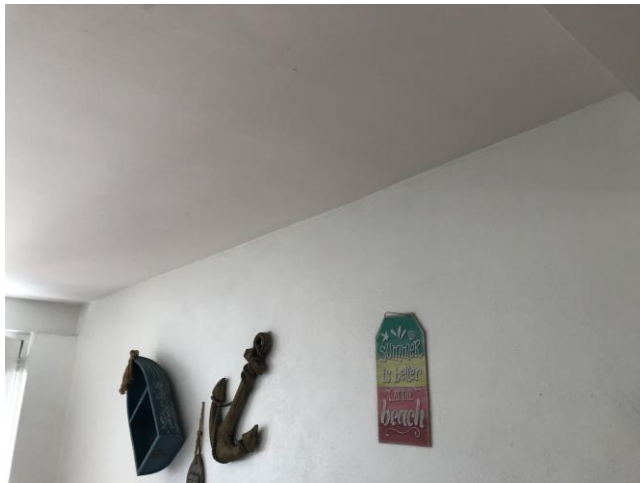
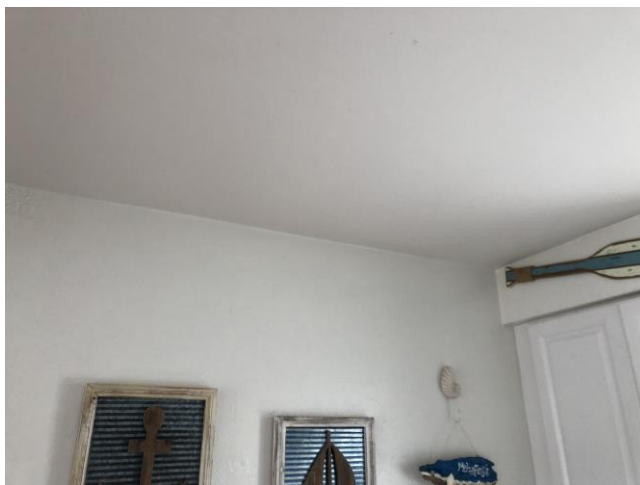
(Units 22 - interior)  
No visible cracks

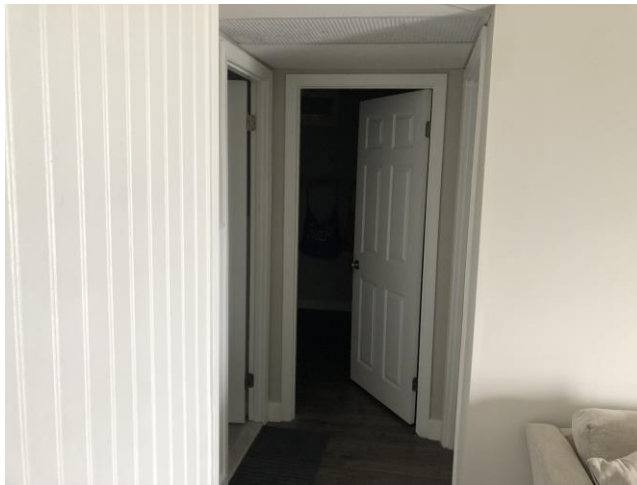
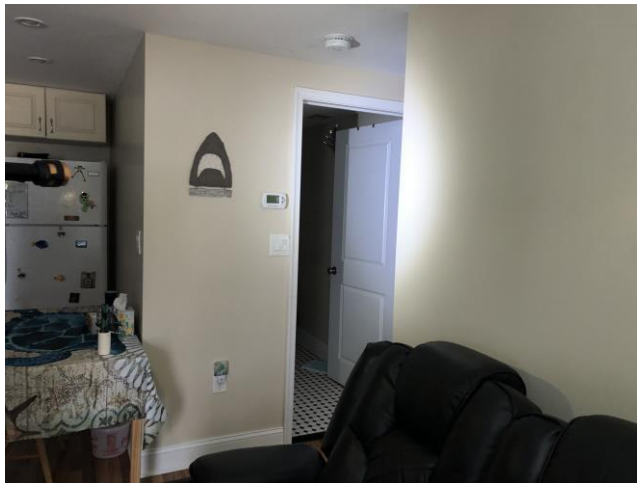
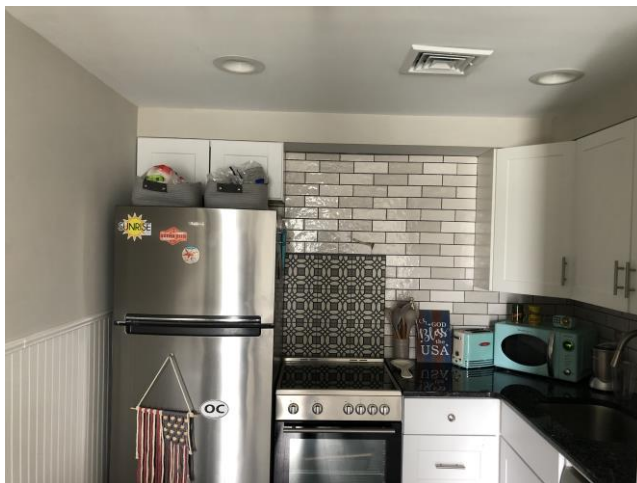
(Units 26 – interior)  
No visible cracks

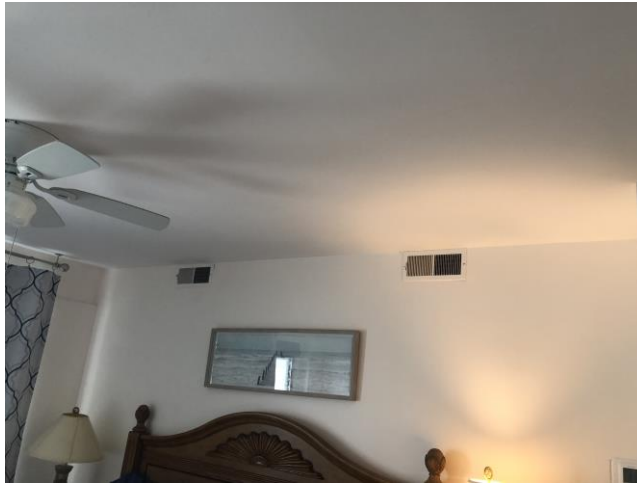
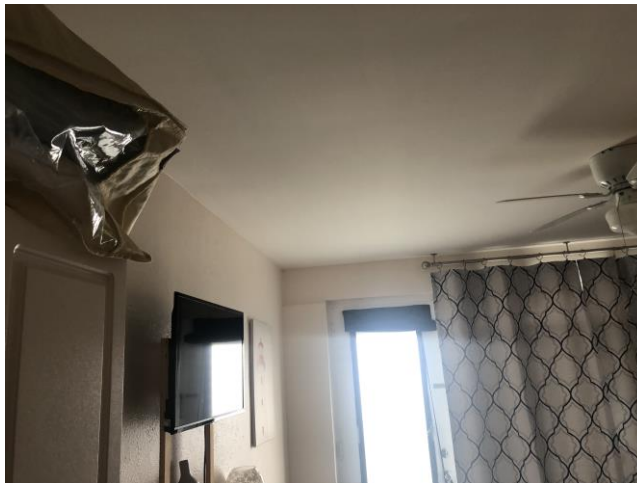
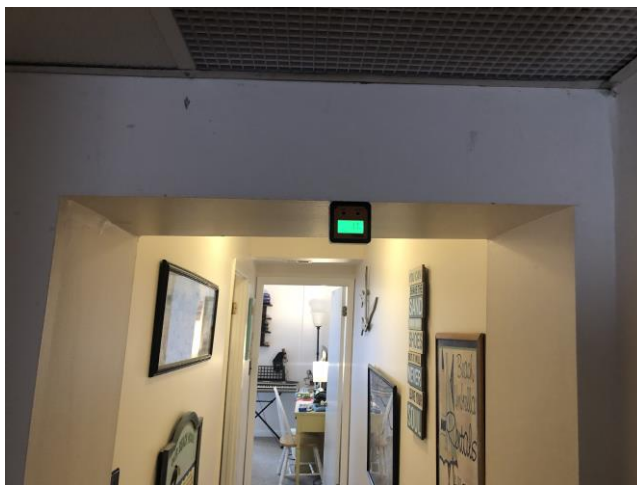
(Units 19+32 – interior)  
No visible cracks

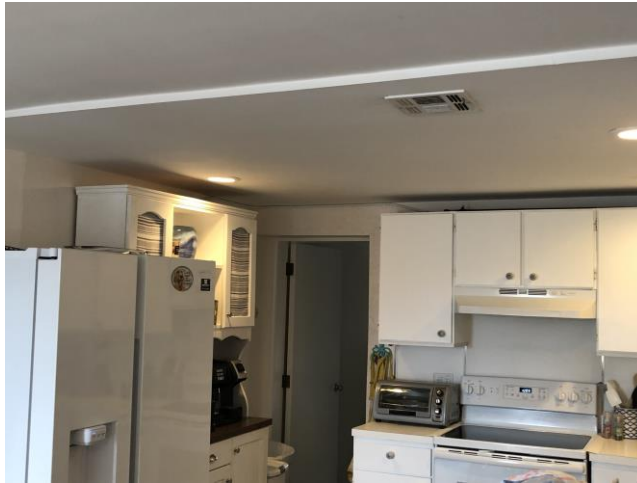
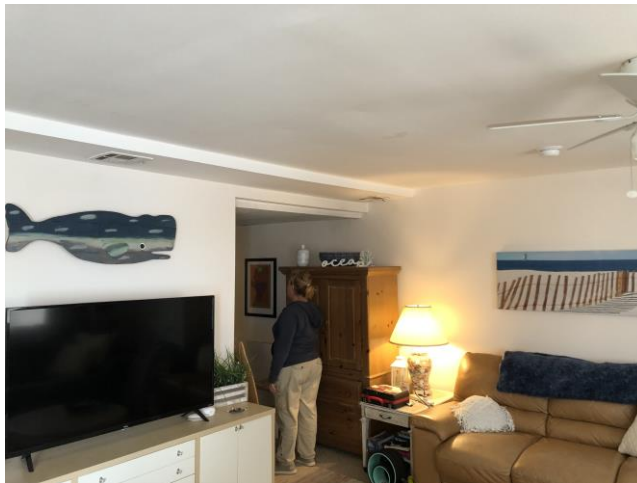
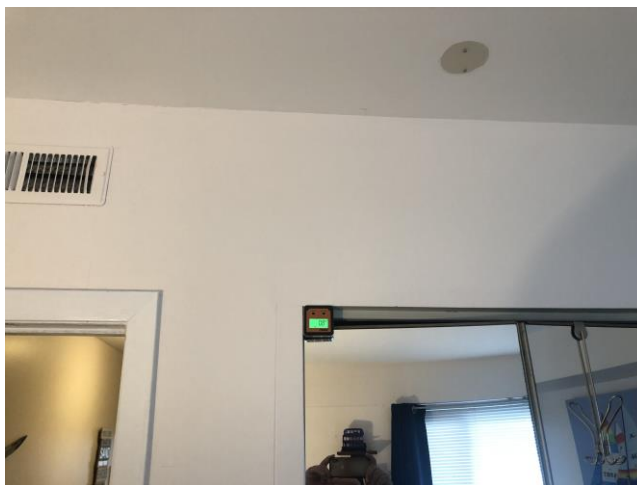
(Units 19+32 ~ interior)  
No visible cracks

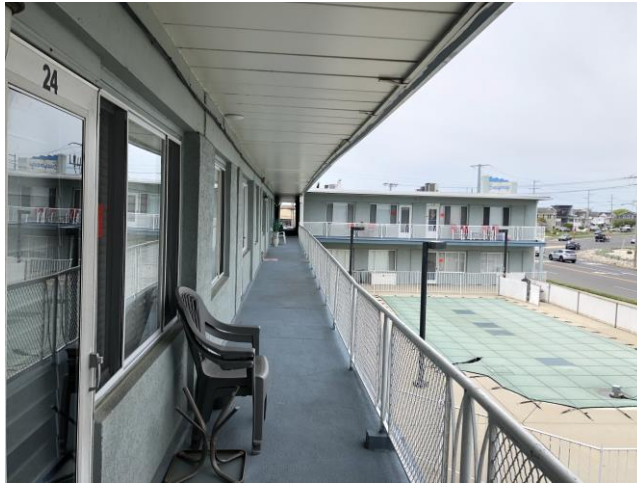
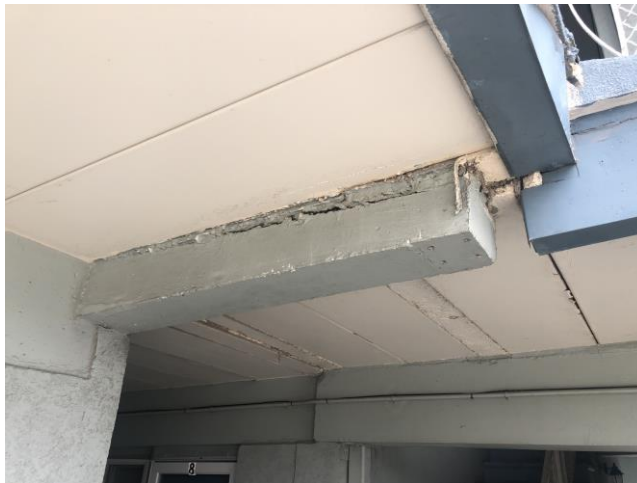
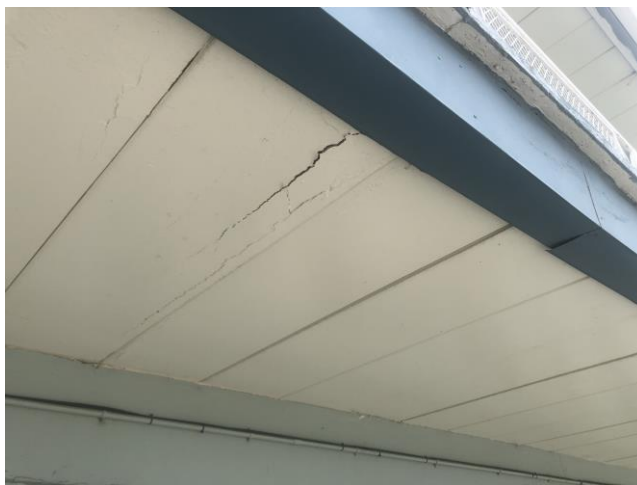
8. For the second-floor walkways cantilevered hollow core concrete slabs, previously rebounding hammer compressive strength tests were conducted on various spots on the underside face of the slabs. Readings of averaged compressive capacity of approximately 9300 pounds per square inch (psi) were recorded for the intact planks (between units 2 and 3). That was within the intact planks. When the test was conducted on the partially cracked planks (west of unit 7), an averaged compressive strength of approximately 4800 psi was recorded. Such readings are still considered higher than acceptable for concrete structural members. That means that the compressive capacity of concrete slabs (U-shaped beams) to be twice the acceptable strength for the intact slab sections and higher or at the acceptable strength for partially damaged slabs/beams. In one or two severely damaged slabs (between units 12 and 14), the strength was recorded to be approximately 2900 psi. The 2900 psi reading is still within acceptable limits, although our recommendation is to consider repair of these sections as previously conducted for similar areas. No immediate hazard is noted. The suggested repair plan for the walkway can be seen in Figure 7. These repairs were designed by a licensed engineer, permitted, constructed and approved with evidence of high efficacy. This repair would be recommended for all hollow core planks with visible cracking at the cantilevered section. As to the concern of the concrete being carbonated, while this might cause and accelerate steel corrosion, it may also increase the compressive strength of concrete. Our observation indicates that the steel corrosion is minimal and the exposed concrete within stem walls and hollow core planks is in average condition. The condition will improve upon implementing the proposed repairs.

4. The preliminary compressive strength assessment of the hollow core planks was recorded as double as the acceptable compressive strength for intact sections and meet or exceed the acceptable strength for partially cracked slabs/beams. Cracked hollow core slabs may be repaired in similar methods to successfully repaired slabs.

2<sup>nd</sup> Floor walkways  
Note cracks with need of repairs or restoration

| Inspected Components | Observations | | | Notes | Recommended Repairs |
|---|---|---|---|---|---|
| 2nd Floor Walkways | --- | --- | --- | cracks are observed on several areas of cantilevered walkways especially between units 12 and 14. | Repair the damaged beams by installing a steel pipe inside the hollow core and fill the gaps with epoxy materials to restore and repair the damaged parts. |

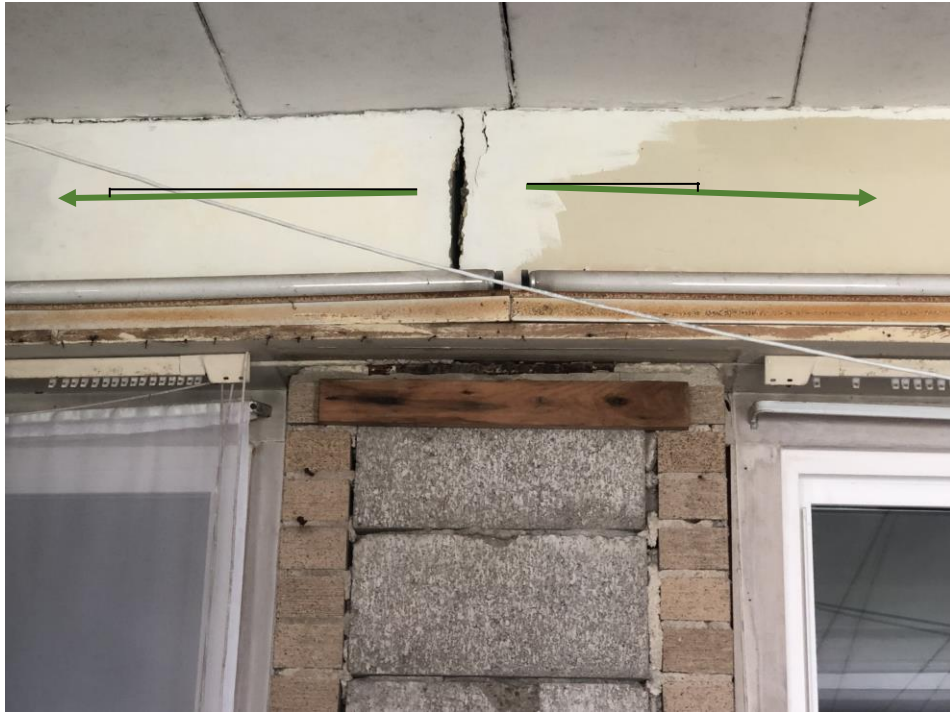
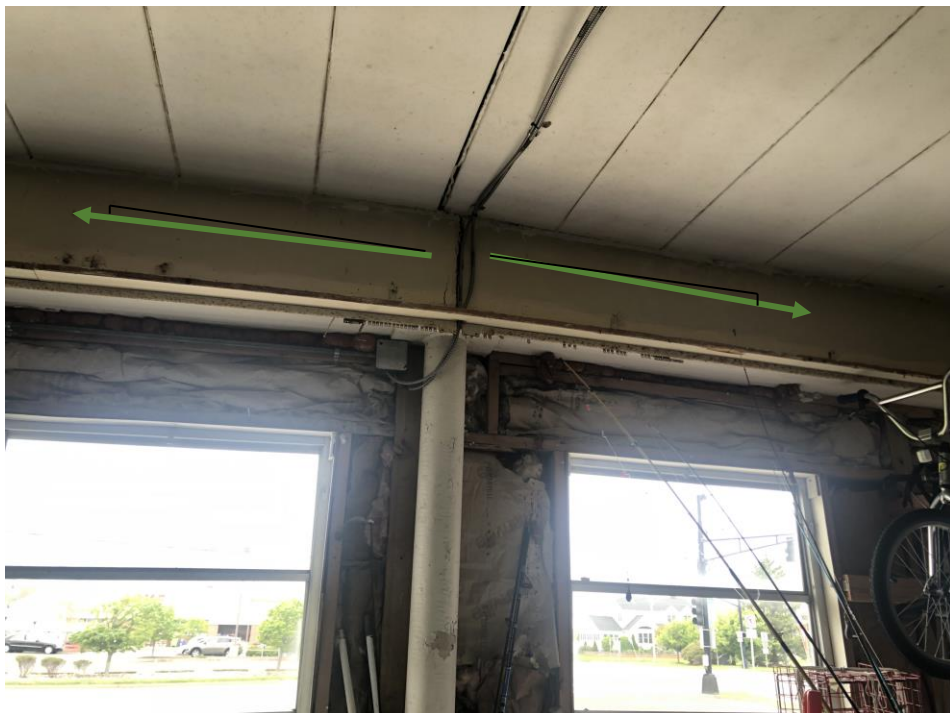
(Storage Room)  
Note the lintels pitched (by design) to facilitate roof drainage
