# PHASE II ENVIRONMENTAL SITE ASSESSMENT

## BUILDING MATERIALS INSPECTION

# Phase II Environmental Site Assessment Report for Building Materials Inspection

El Centro Motel  
112 South Kendrick Avenue  
Glendive, Montana

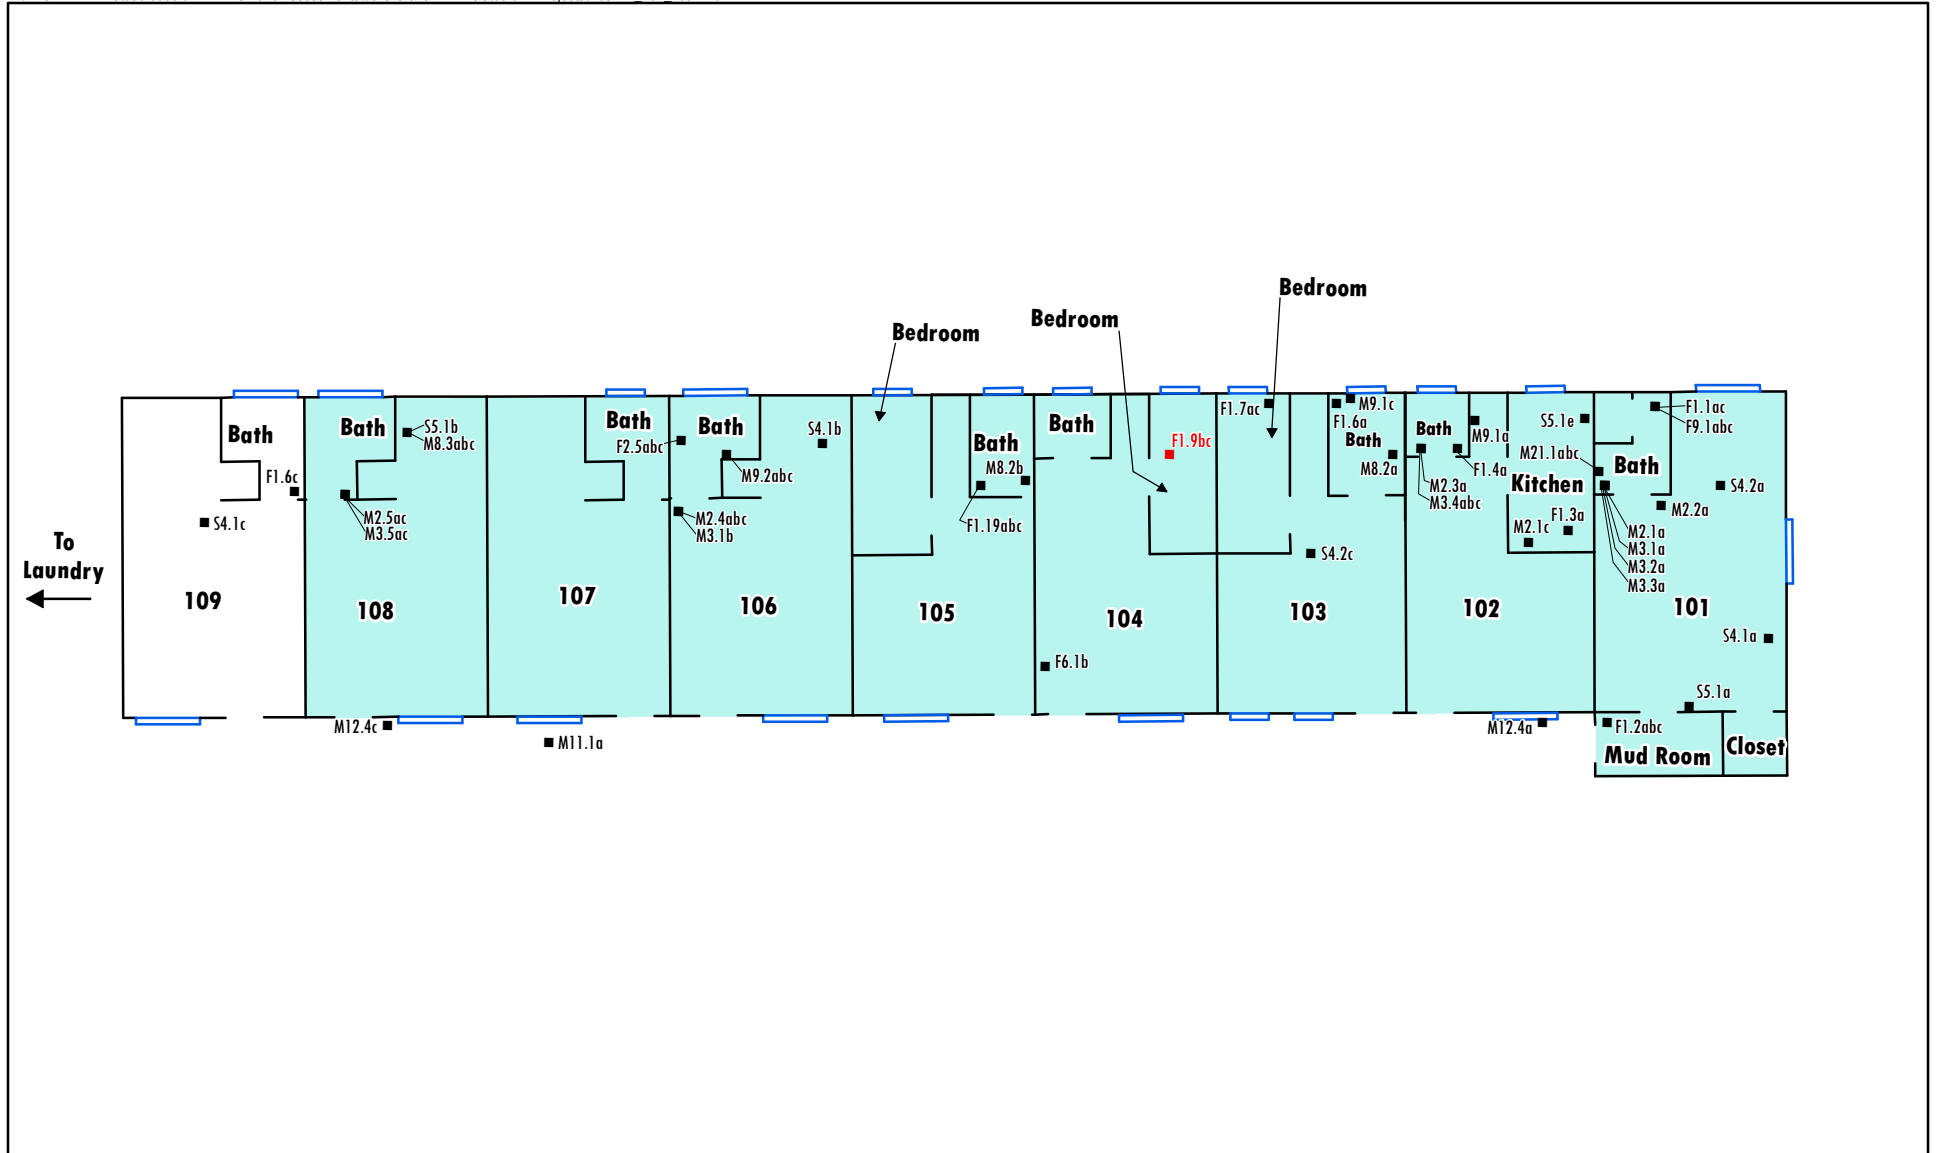
**Asbestos and Methamphetamine Results - Rooms 101 - 109**  
El Centro Motel  
112 S Kendrick Ave  
Glendive, Montana  
**FIGURE 3**

Samples collected from rooms 101/102, 103, 104, 105, 106, 107, 108, 121, 123, 124, and the Laundry room contained methamphetamine at a concentration above the MDEQ threshold of 1.5 µg/100cm<sup>2</sup> (see **Table 4**). To address the methamphetamine contamination, we recommend hiring a methamphetamine remediation contractor to remediate these areas. The waste materials should be disposed of at a Class II landfill. A contractor trained to complete methamphetamine clearance sampling, who is separate from the methamphetamine cleanup contractor, should collect methamphetamine clearance samples after all cleaning has been completed.

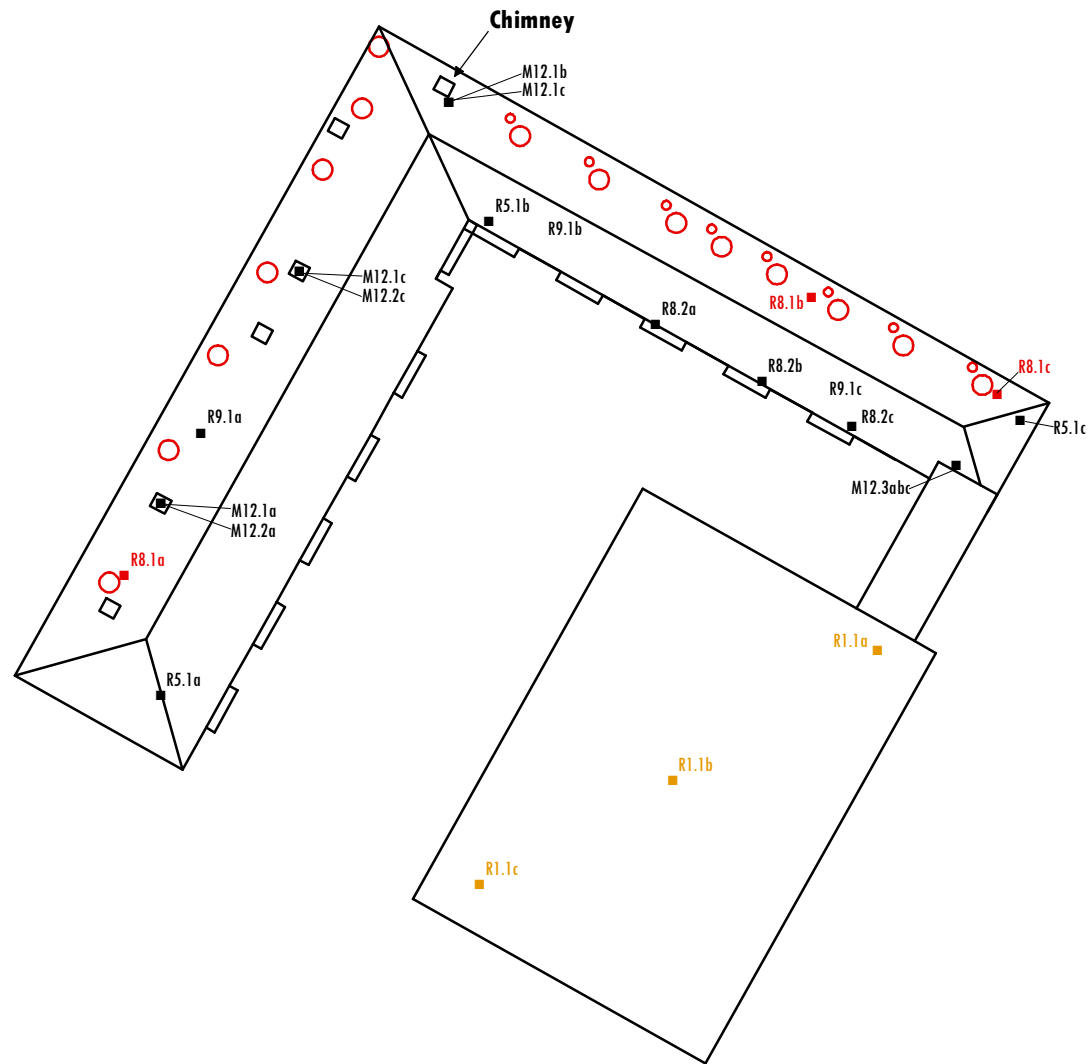
Asbestos Results - Roof  
El Centro Motel  
112 S Kendrick Ave  
Glendive, Montana  
FIGURE 8

This inspection confirmed VSF in multiple rooms and black roof tar as Category I ACBMs and spray on ceiling surfacing and stucco as RACM. Built-up roofing over the offices and drywall w/joint compound also contained asbestos below the U.S. EPA regulatory threshold of 1 percent and is considered non-asbestos-containing material per U.S. EPA and Montana DEQ regulations. However, NewFields recommends abating these materials because they still are hazardous to workers and require specific handling per Occupational Safety and Health Administration (OSHA) requirements.

NewFields recommends that GNDC hires a licensed abatement contractor to abate all asbestos according to U.S. EPA and Montana DEQ regulations before renovating the building. The licensed abatement contractor will be required to file a demolition and renovation notification with the U.S. EPA at least 10 business days prior to abatement. In addition, the abatement contractor must maintain a copy of this report on-Site throughout the abatement period. A copy of this report may also be required for disposal of the asbestos waste at a licensed Class II landfill.
