USAF ACCIDENT/INCIDENT REPORT							
(b) (6)							
1. DATE OF OCCURRENCE (Year, month and day)		2. VEHICLE/MATERIAL INVOLVED (THIS & Serial No., if applicable)		3. FOR GROUND ACCIDENTS ONLY (Base Code and Report Serial No.)			
1964 December 5, Saturday		LGM-30B 64-006		64-12-5-401 N/A (b) (6)

NARRATIVE SEQUENCE OF EVENTS

FINDINGS AND RECOMMENDATIONS

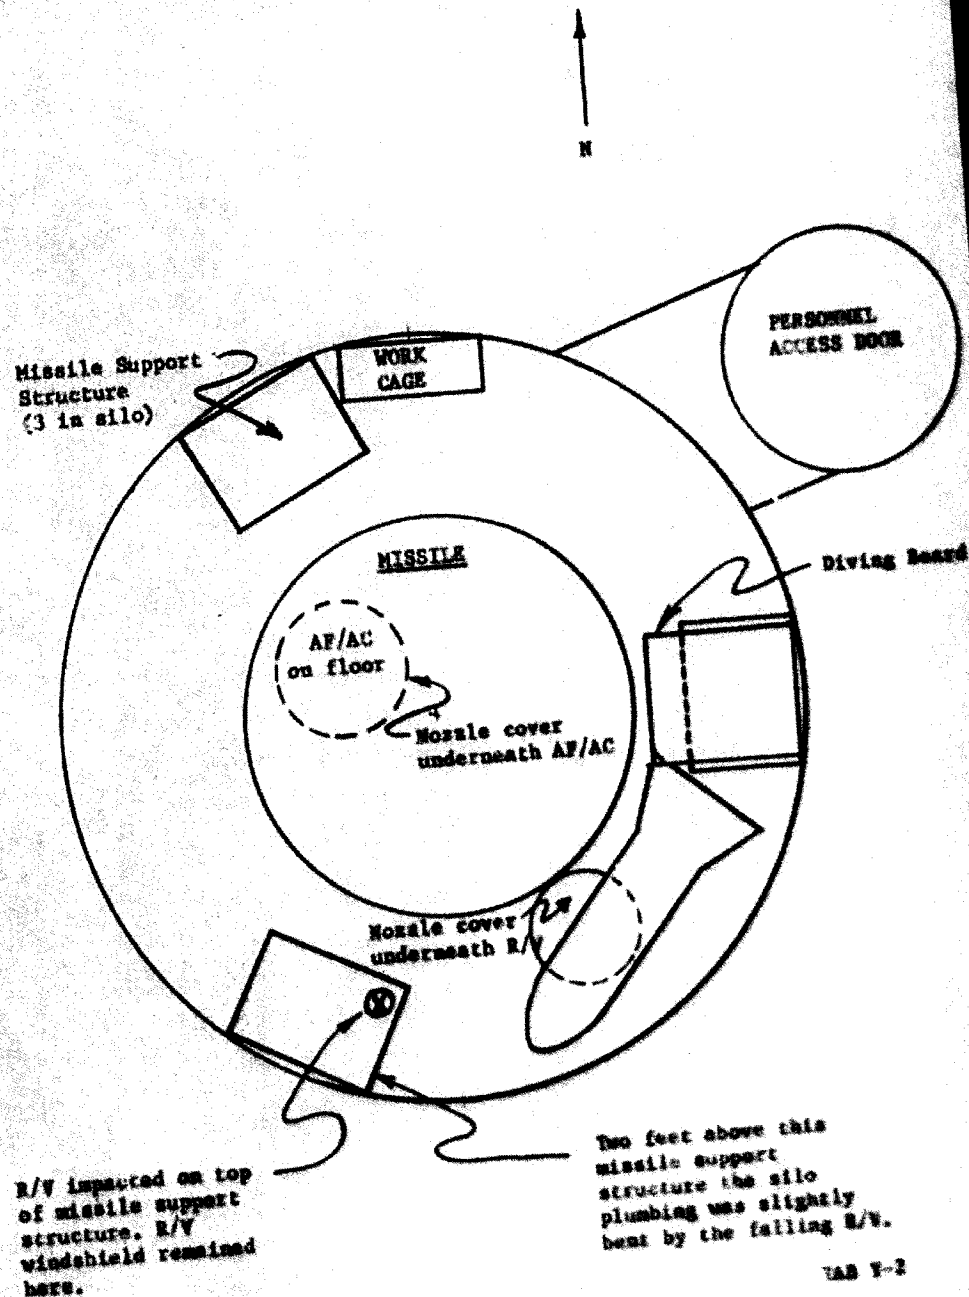
TAB Y-2

It was subsequently discovered that the explosion, a re-entry vehicle retro rocket firing, had caused the re-entry vehicle to separate at the ball lock interface of the spacer assembly and topple approximately seventy-five feet to the floor of the launch tube.

0347 CBR team entering below ground with T-290 and 27C test equipment. Negative reading with 27C. Negative reading level 1 and 2 (All possible radioactive checked). Smell of burnt rocket motors - possible retd. R/V not visible - R/V found at bottom of silo on its side.

SILO FLOOR LOCATION OF R/V DEBRIS

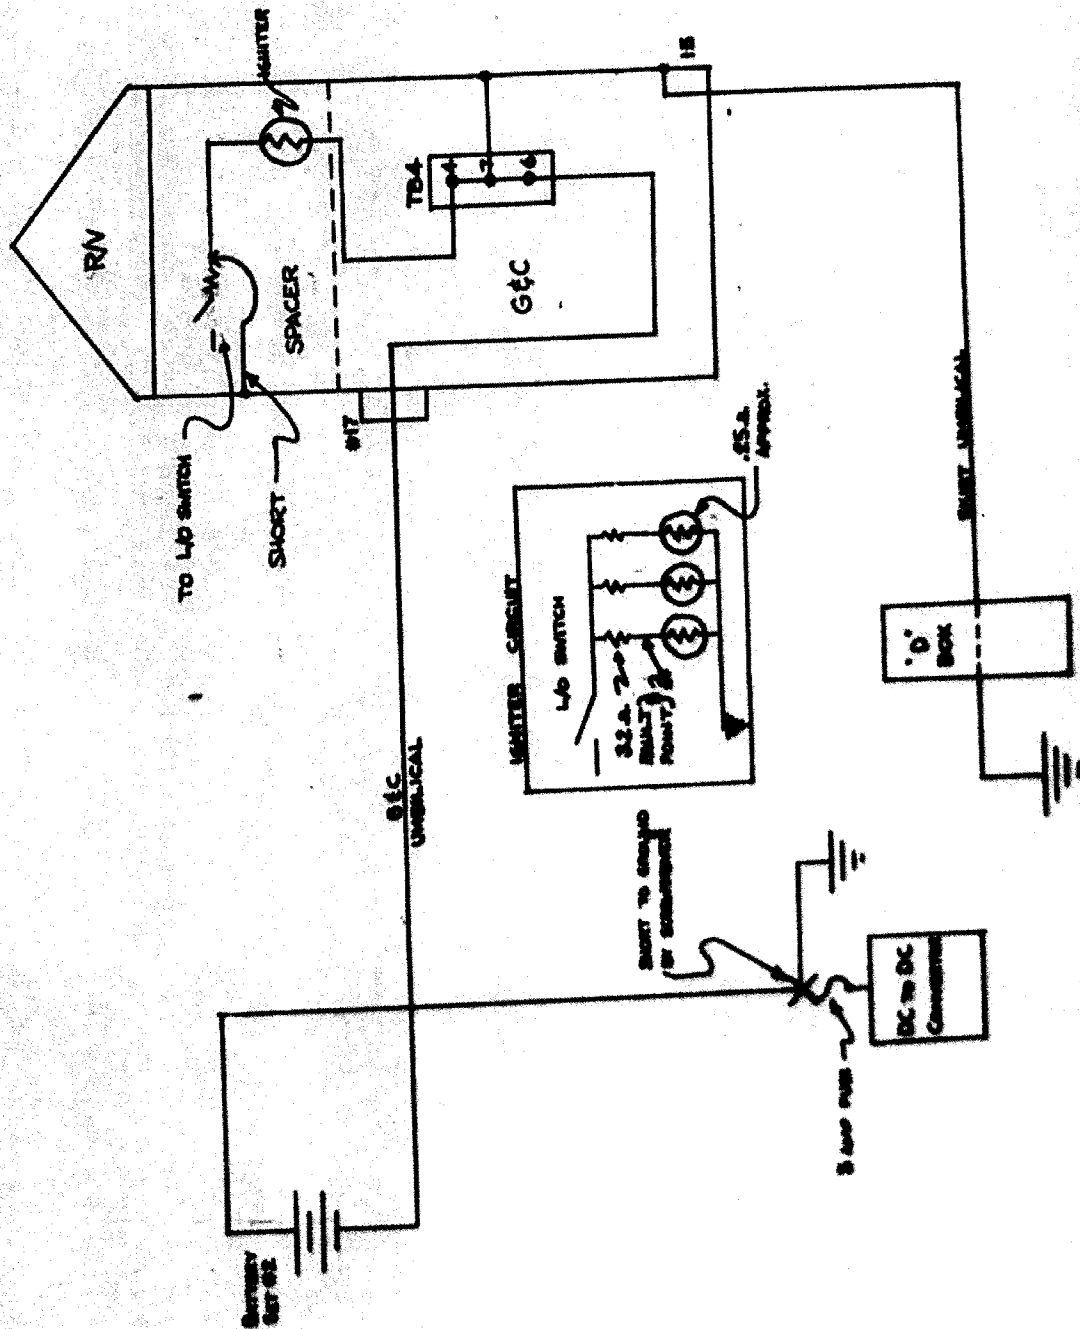
D/S 1-4

PRIMARY CAUSE: Personnel Error, in that a maintenance technician inadvertently shorted a plus battery potential to ground. This application of plus battery voltage coupled with the fault in the retro cable connector provided a path for sufficient current to flow and ignite the retro rocket. The technician did not use the authorized, available tool to remove the fuse.

A/F Nr. 4: The existing retro rocket circuitry does not provide enough protection against short circuits.

DIAGRAM OF FAULT CIRCUIT

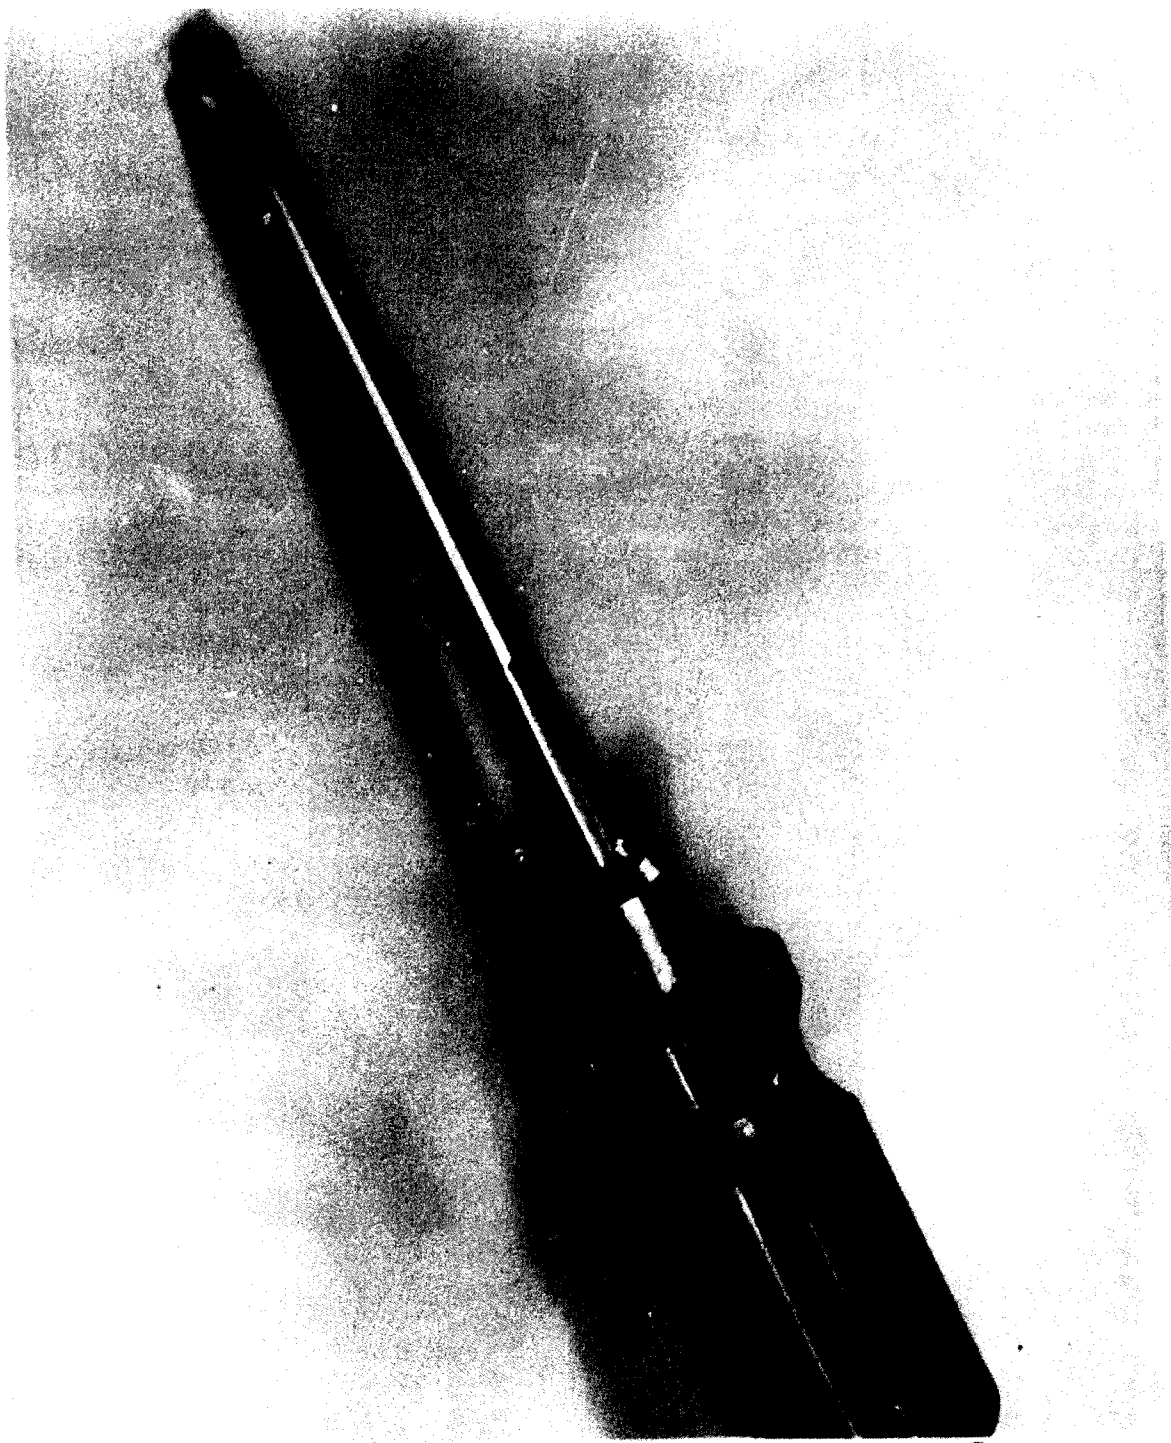
NO RED RETRO CABLE CONNECTOR
