| <b>SUBJECT:</b> | Union Street Dam 2021 Inspection Report |

SUBJECT: Union Street Dam, Dam ID No. 511, Grand Traverse County

**DAM SAFETY INSPECTION REPORT  
UNION STREET DAM – DAM ID NO. 511  
BOARDMAN RIVER  
GRAND TRAVERSE COUNTY – SECTION 3, T27N, R11W**

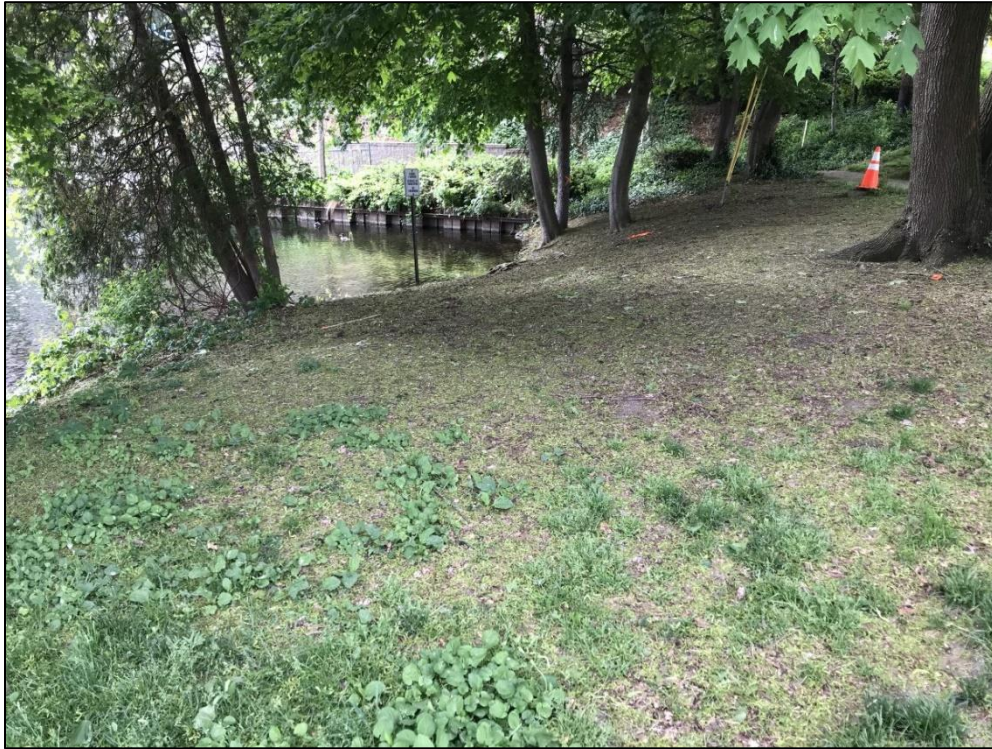
The dam embankment is in fair to poor condition. Most of the embankment is well vegetated with a healthy growth of grass that is well maintained. However, there are numerous trees of considerable size along the embankment. These trees present several risks to the dam, such as piping routes along the root systems and loss of embankment section in the event of a tree fall. All trees should be removed from the embankments to the abutments.

**Photograph 1 – Upstream slope at left abutment viewed from auxiliary spillway.  
Note trees on embankment.**

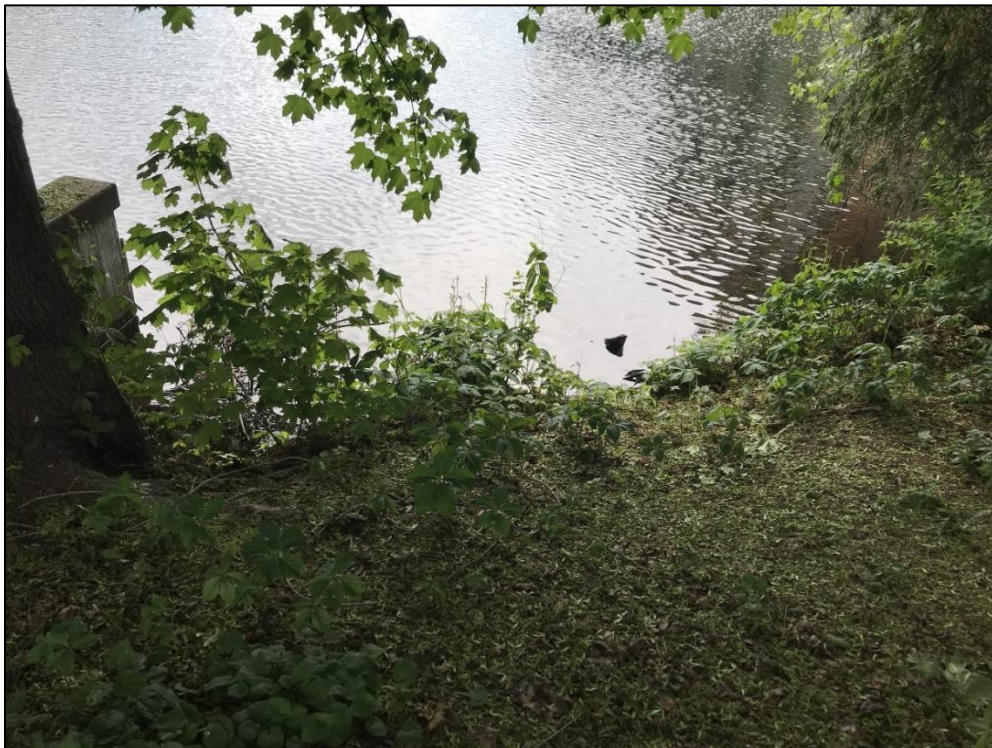
There are also numerous locations along the upstream and downstream slopes that are experiencing surface erosion due to foot traffic and to a lesser degree shoreline scour. These areas should be restored as necessary and protected with appropriate erosion control measures such as riprap or mulch.

**Photograph 2 – Upstream slope left of auxiliary spillway. Note erosion, trees and vegetation.**

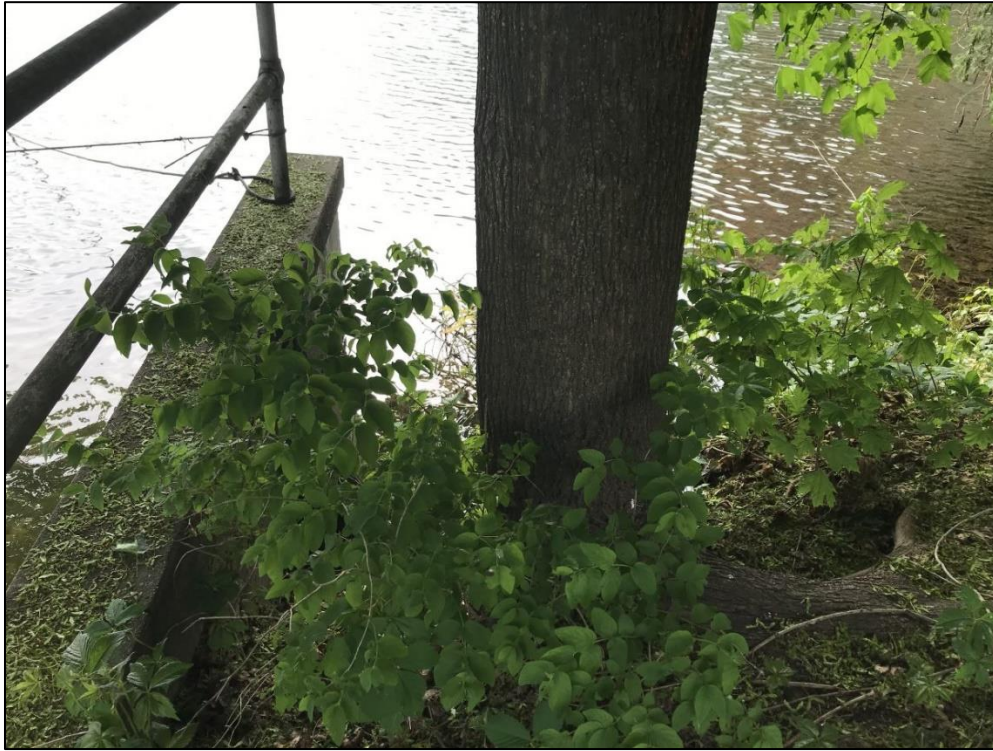
**Photograph 3 – Erosion and tree growth adjacent to left upstream auxiliary spillway wing wall.**

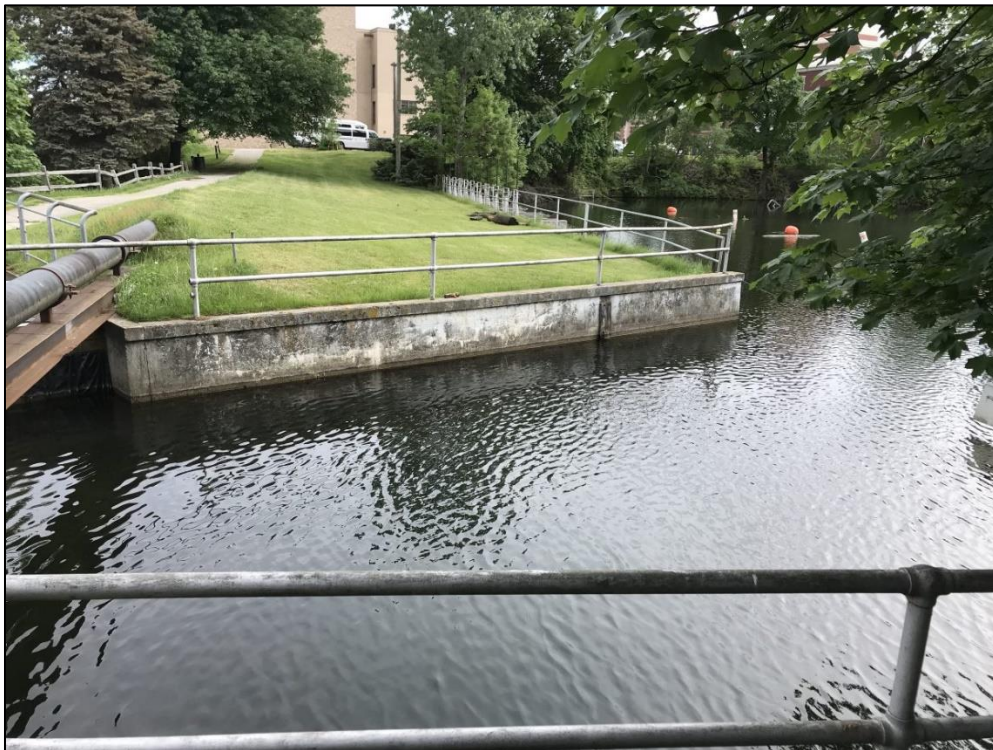
**Photograph 4 – Right auxiliary spillway wing wall. Note minor cracking and efflorescence.**

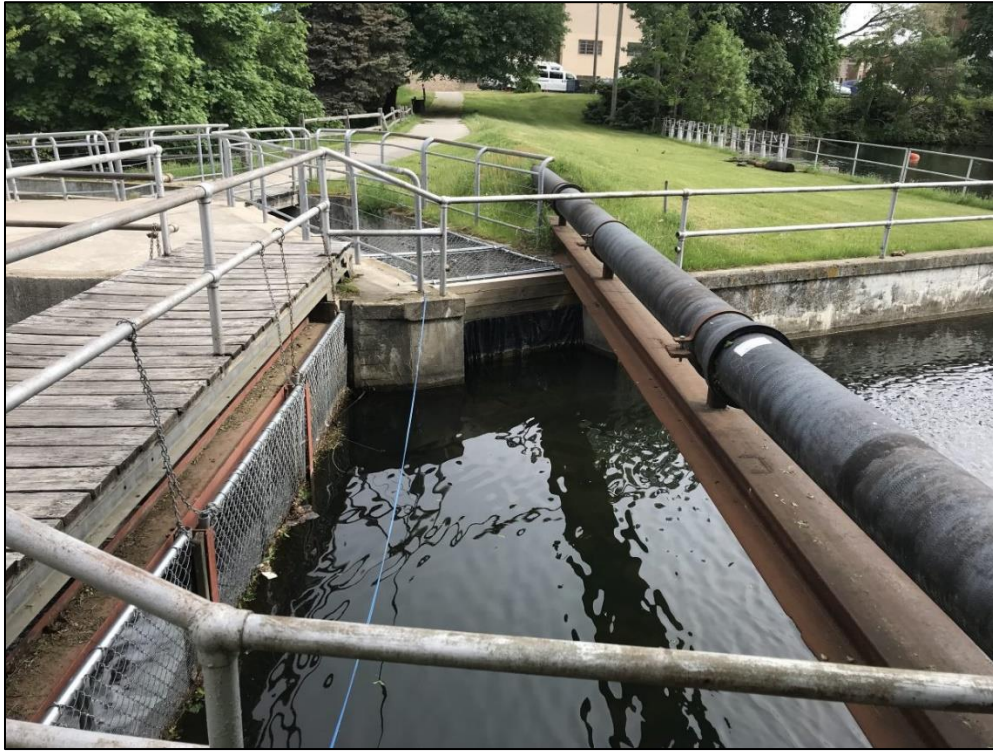
The auxiliary spillway is in fair to poor condition. In order to prevent fish passage at the dam, fencing has been applied to the upstream weir. It is reported that debris buildup on this fencing is frequent and requires increased maintenance effort. During high flow conditions, debris removal could be challenging and limit the efficacy of the spillway. Frequent inspection of the auxiliary spillway is required to keep it free of debris.

**Photograph 5 – Upstream face of auxiliary spillway and fish ladder. Note fencing on spillway and fish ladder to prevent fish passage.**

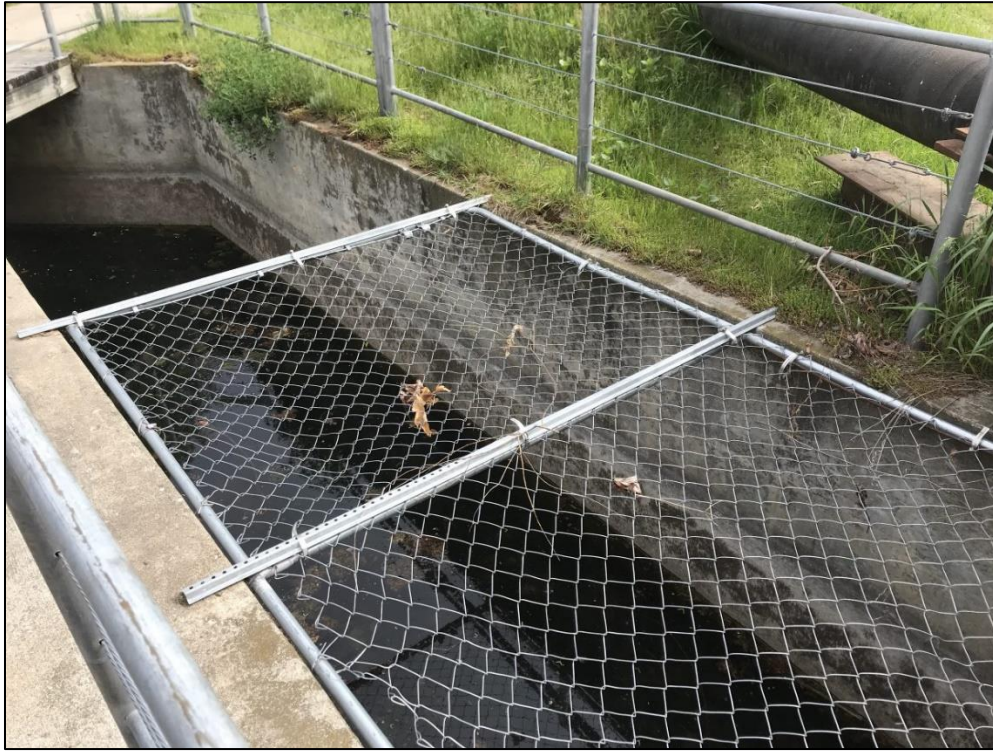
**Photograph 11 – Looking downstream at fish ladder from upstream entrance.  
Note fencing to block fish passage.**

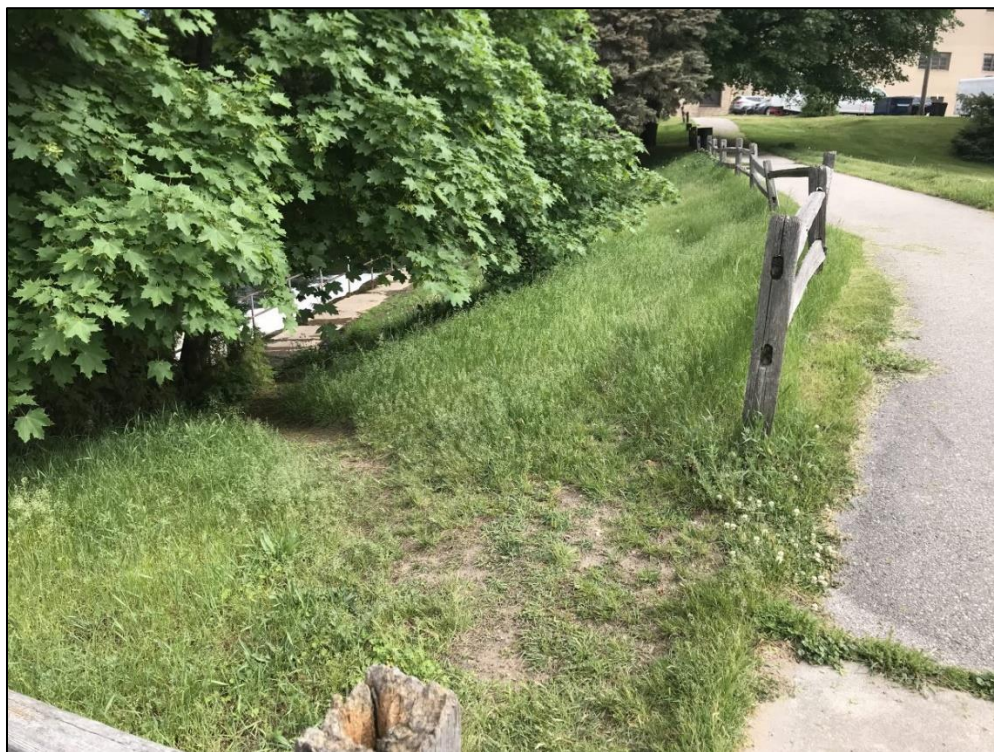
**Photograph 15 – Downstream slope of embankment viewed from fish ladder.  
Note trees and foot traffic erosion.**

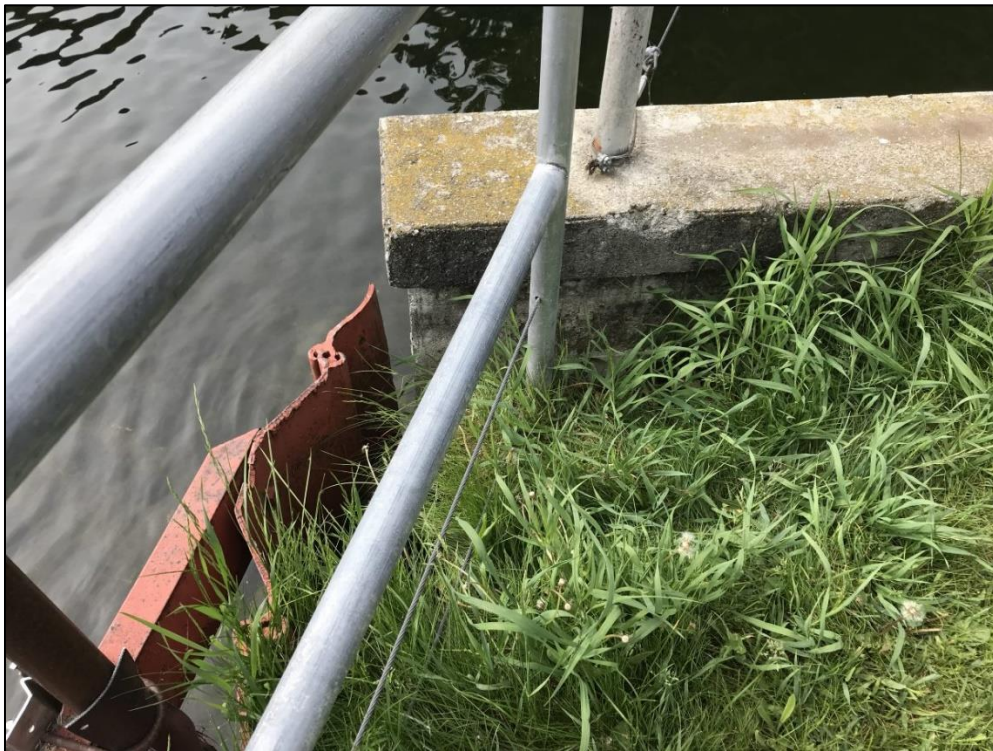
A gap was observed between the upstream sheet pile wall and the right wingwall for the auxiliary spillway, as can be seen in Photograph 20. There appears to be material loss in the area of the gap with settlement observed on the embankment. If the dam isn't replaced, this gap should be closed, and the embankment restored.

**Photograph 20 – Separation between upstream sheet pile and right auxiliary wingwall.**

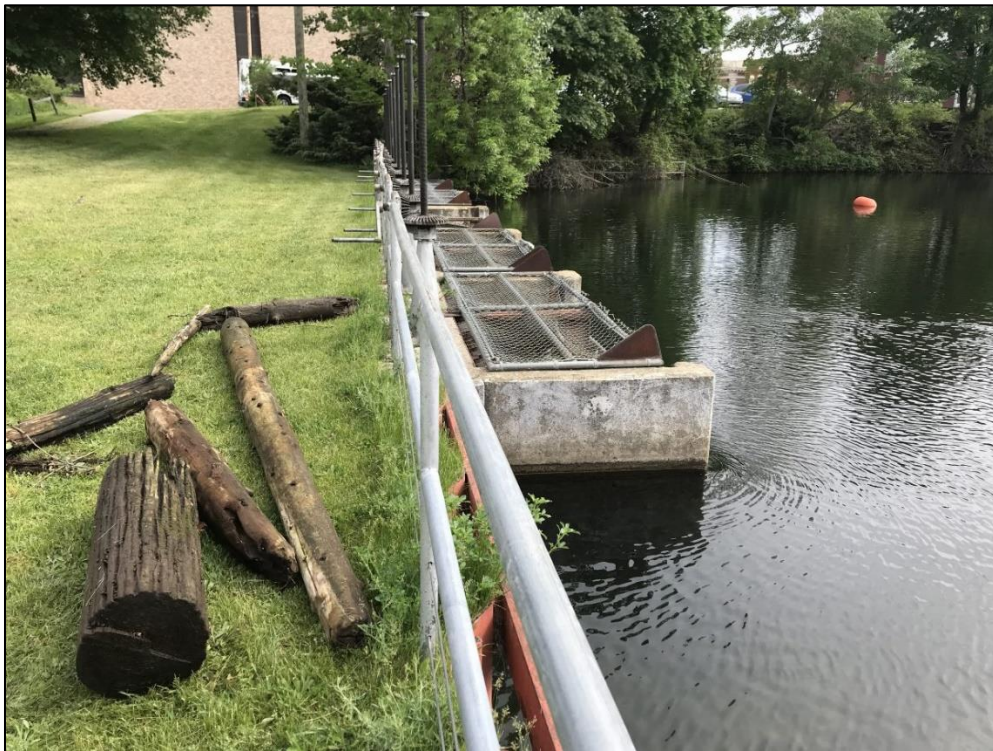
**Photograph 22 – Upstream face of embankment and primary spillway. Note recently removed debris.**

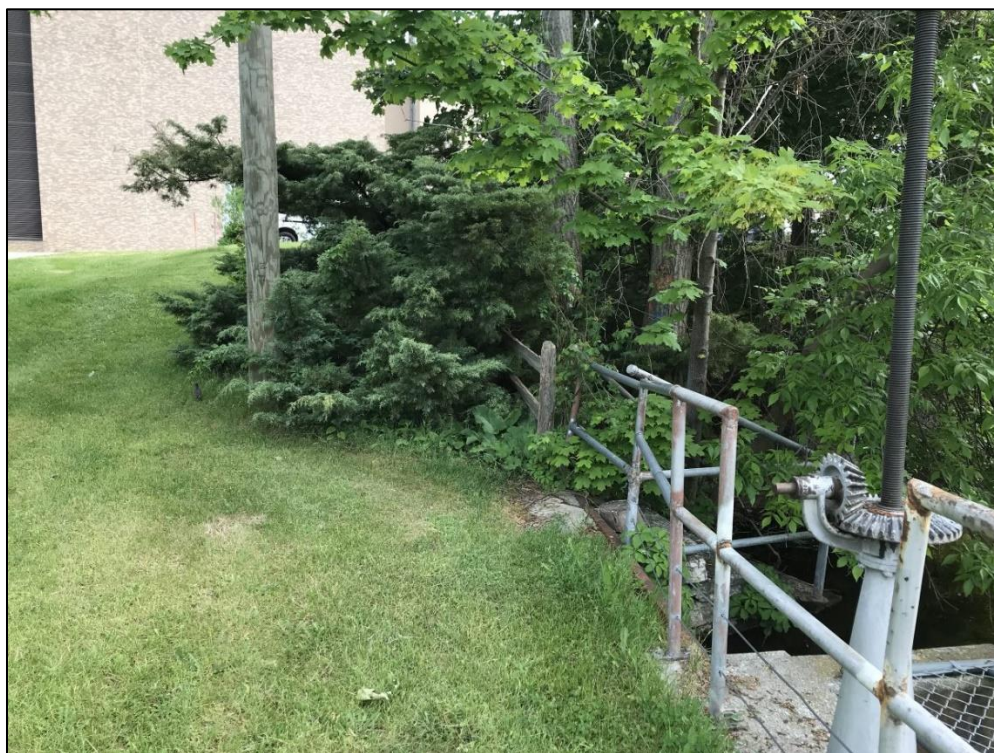
**Photograph 29 – Upstream right abutment. Note trees and vegetation.**

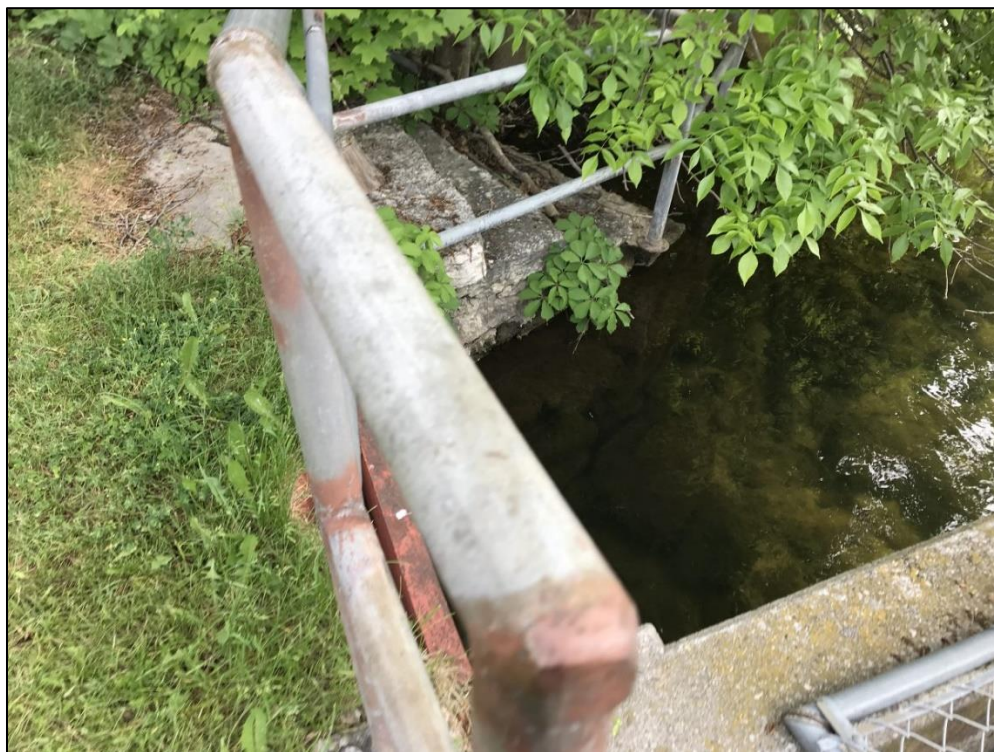
**Photograph 30 – Upstream right abutment. Note submerged steps and walkway.**

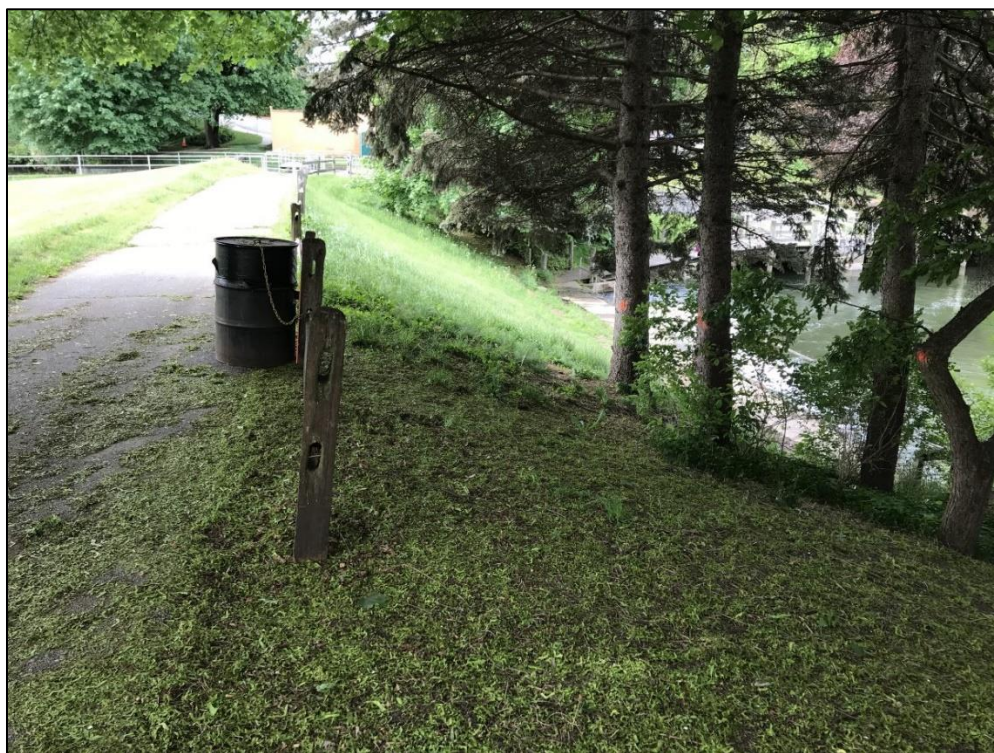
**Photograph 35 – Downstream slope from right abutment. Note trees.**

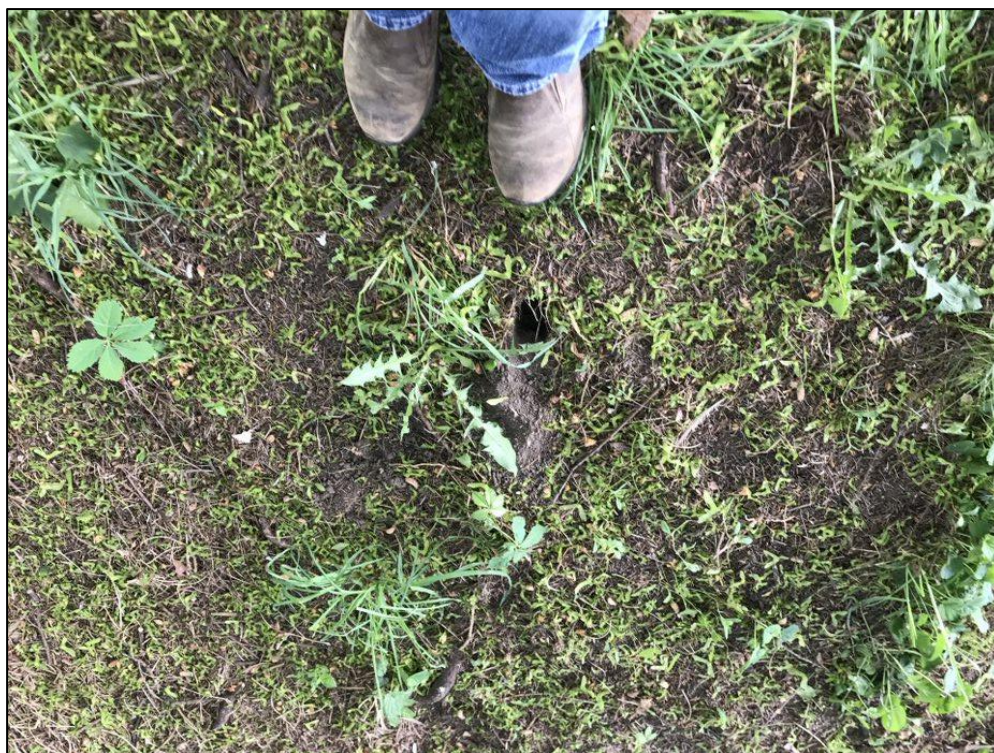
**Photograph 37 – Animal burrow on downstream slope near right abutment.**

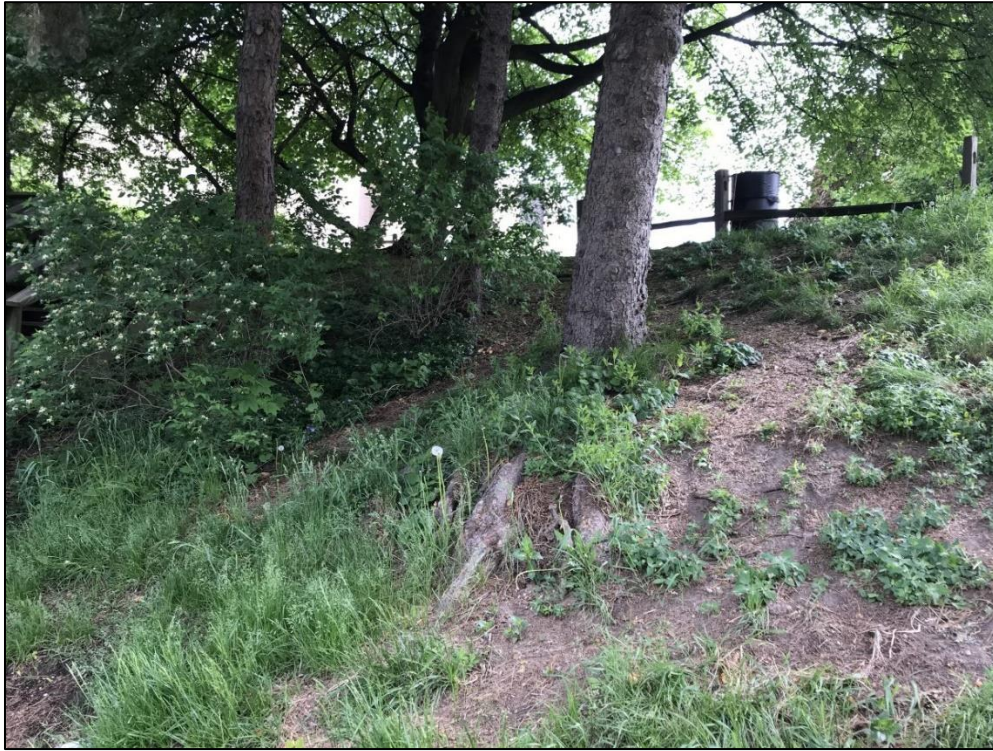
**Photograph 38 – Trees and foot traffic erosion on downstream slope near right abutment.**

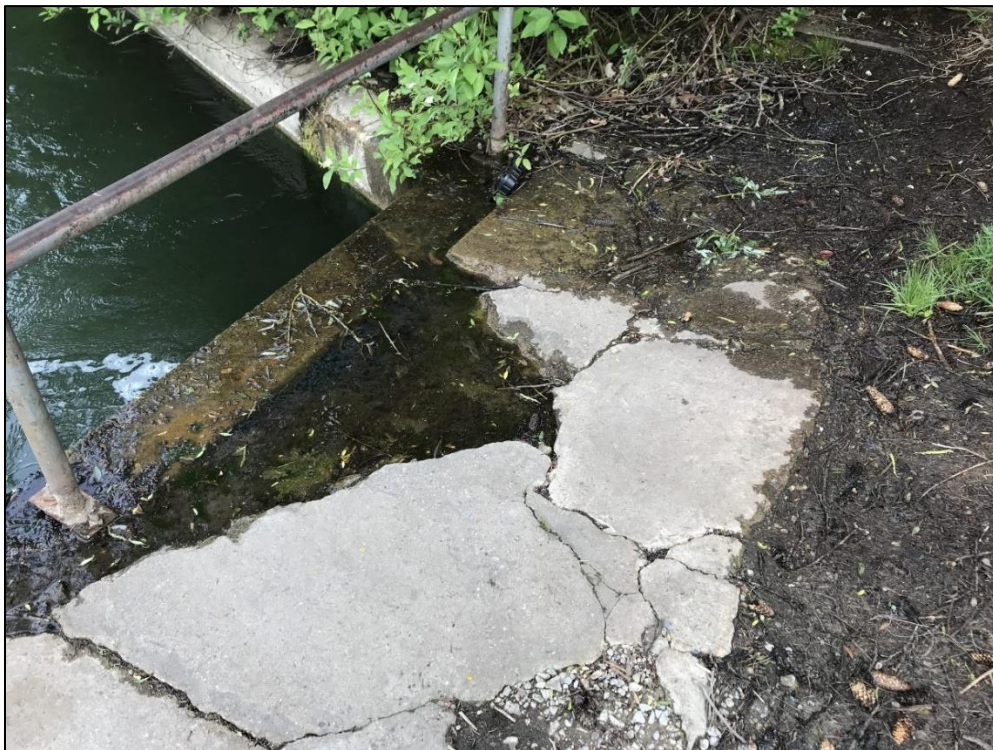
**Photograph 39 – Concrete walkway over primary spillway outlet. Note broken concrete and seepage.**

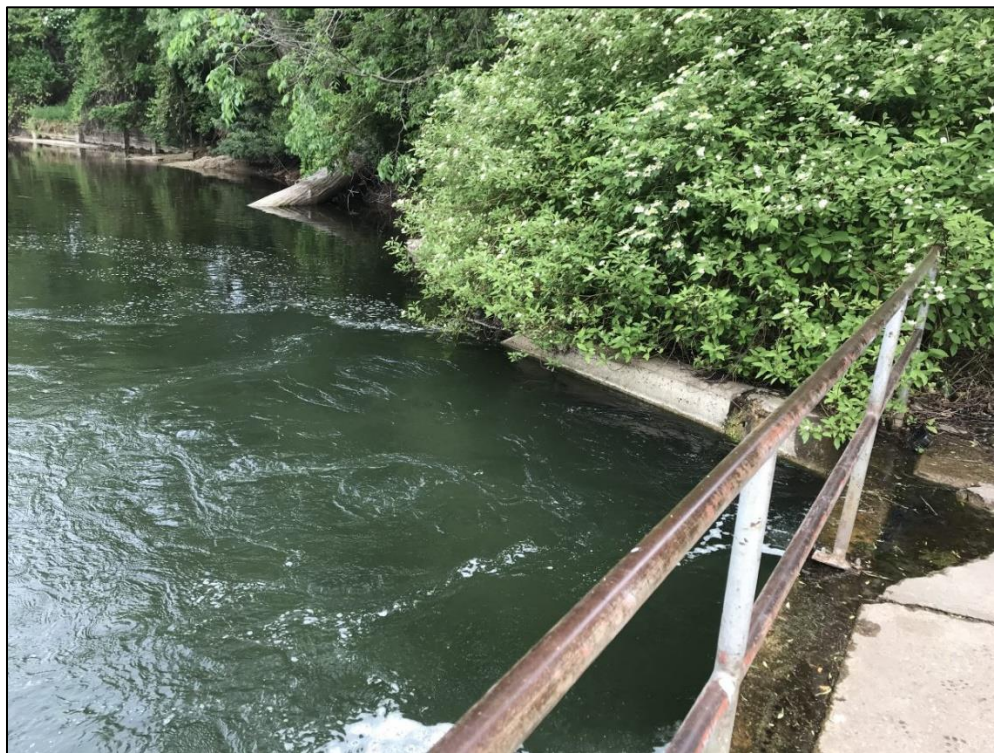
**Photograph 41 – Downstream right bank. Note extensive vegetation.**

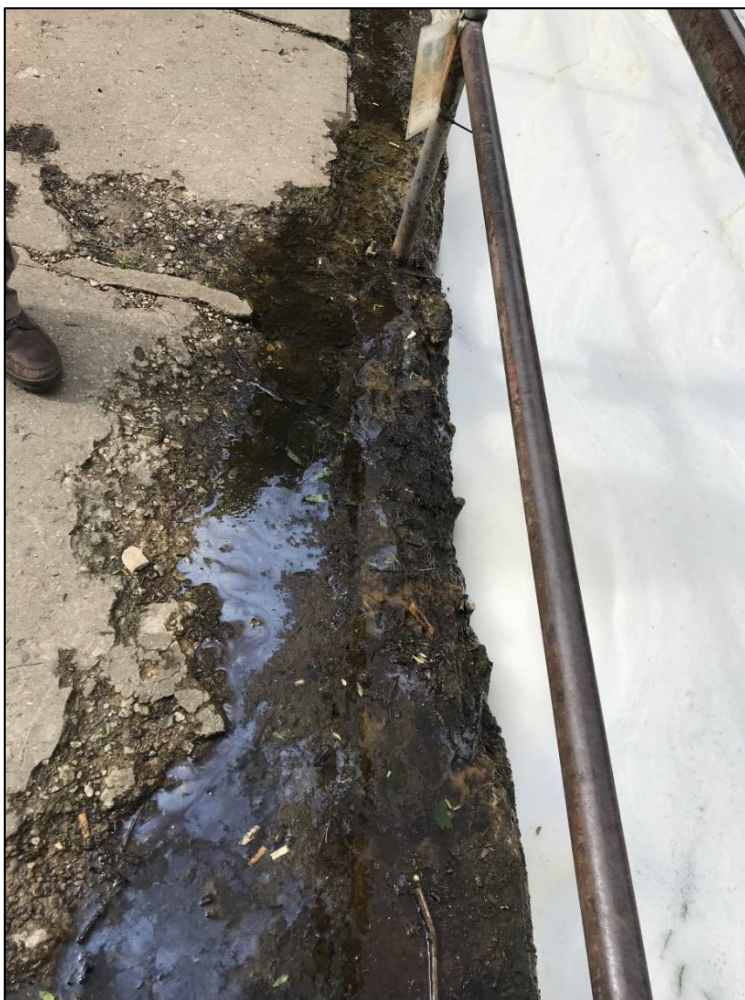
The primary spillway appears to be in fair condition based on visual observation. The observable concrete components appear to be in fair condition with minor cracking and efflorescence. Spalling and deterioration at the top of the outlet headwall can be seen in Photograph 42 and 45. This should be repaired to prevent further deterioration.

**Photograph 42 – Concrete walkway over primary spillway. Note broken concrete and seepage.**

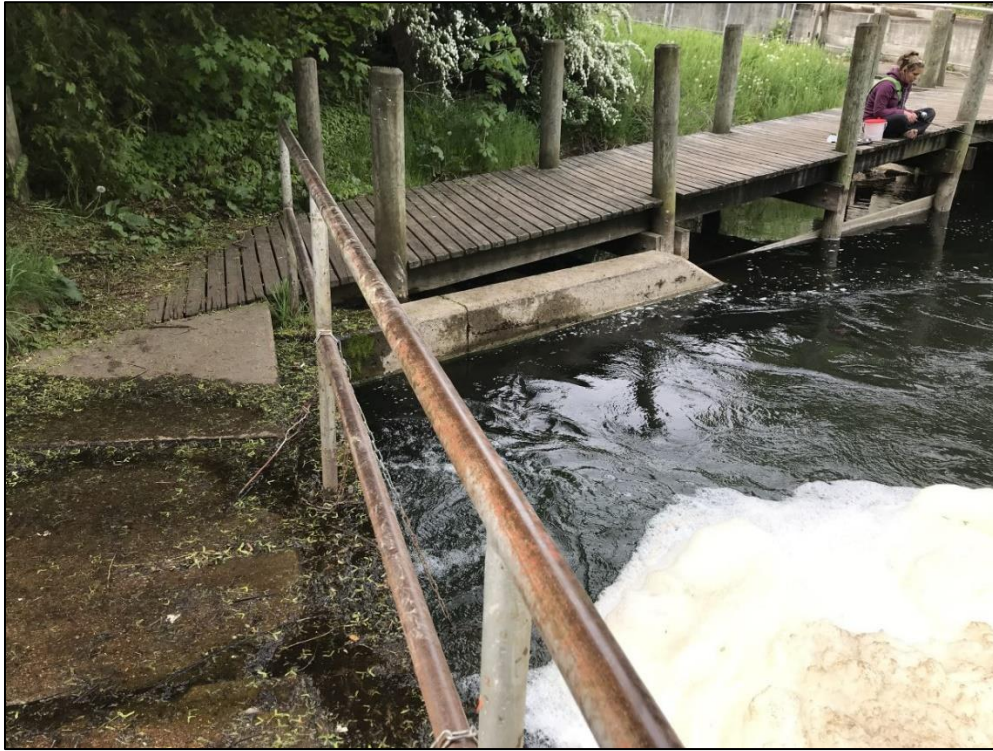
**Photograph 43 – Concrete walkway and boardwalk along downstream toe of embankment. Note seepage and broken concrete.**

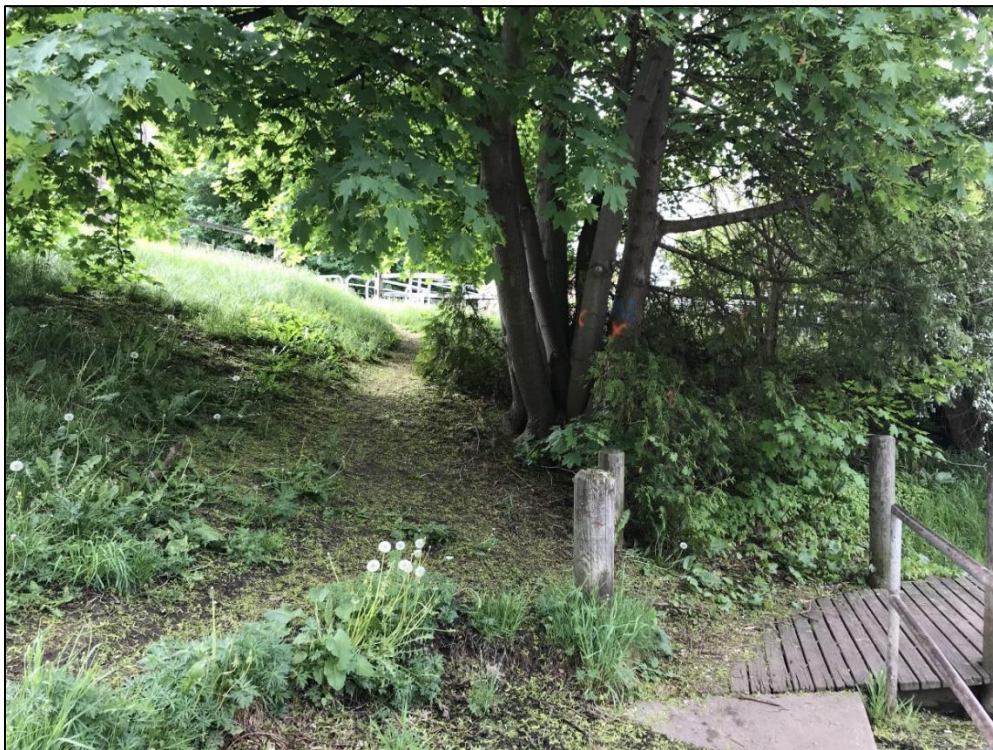
**Photograph 44 – Downstream slope of embankment to right of primary spillway. Note foot traffic erosion, trees and vegetation.**

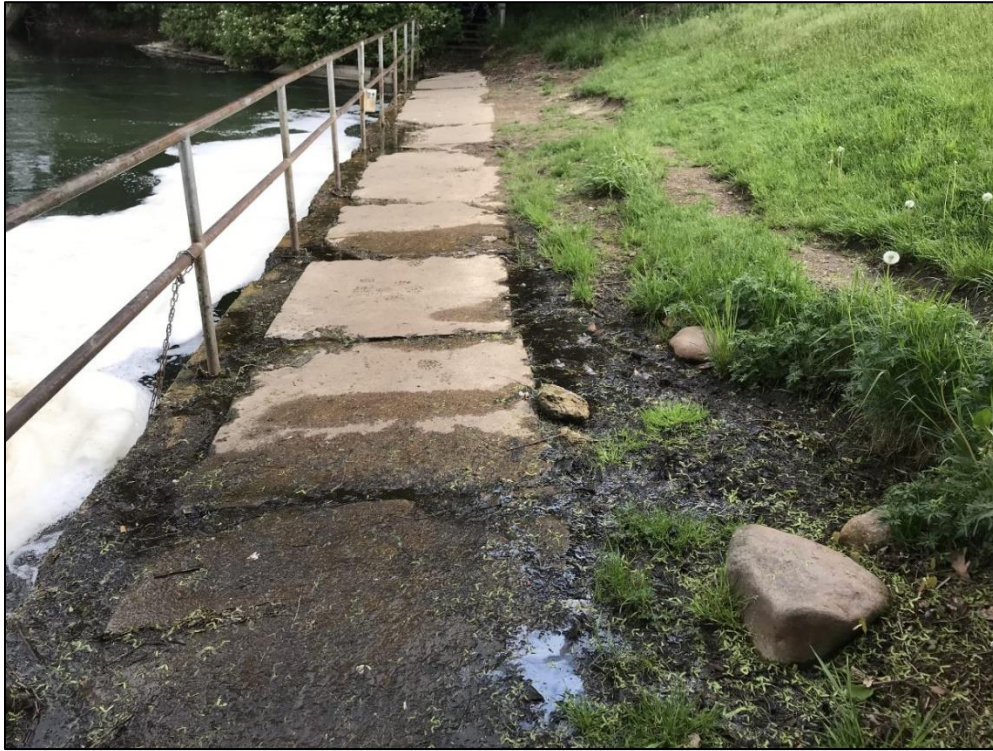
**Photograph 45 – Concrete walkway over primary spillway outlet. Note seepage and erosion along toe of embankment.**

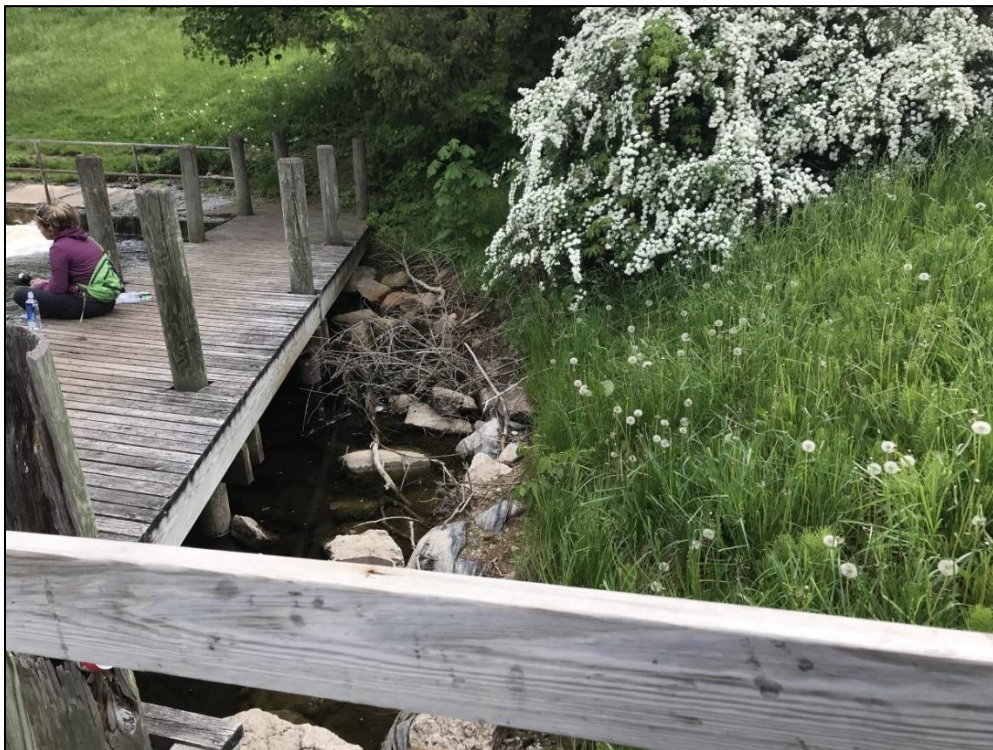
There is extensive seepage along the downstream toe of embankment in the vicinity of the primary outlet. This seepage, coupled with recent high water, appears to have induced some erosion and sloughing at the toe as can be seen in Photographs 46 through 48. The concrete walkway along the headwall of the primary spillway outlet is uneven and broken (Photographs 39 through 45) which is indicative of settlement typically associated with seepage and freeze/thaw effects. Given the extent of seepage on the dam and the age of the structure, geotechnical investigations and analyses should be performed on the embankment to ensure acceptable stability and seepage factors of safety under normal and extreme loading conditions, if the dam isn't replaced.

**Photograph 46 – Toe of embankment between primary spillway and fish ladder.**

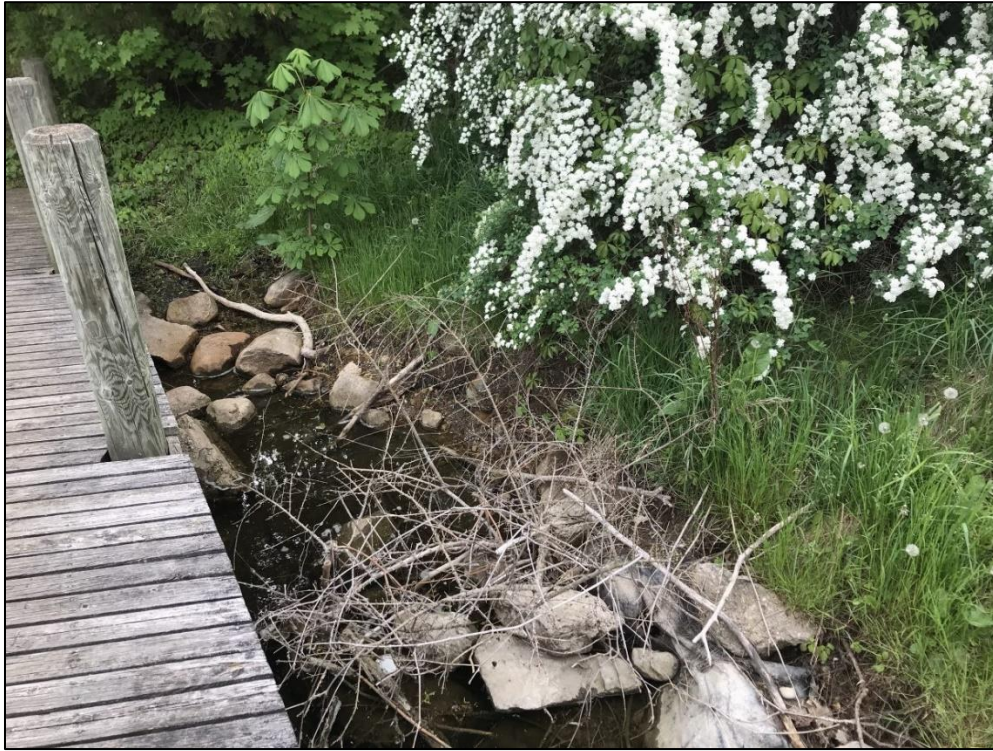
**Photograph 47 – Erosion along toe of embankment between primary spillway and fish ladder.**

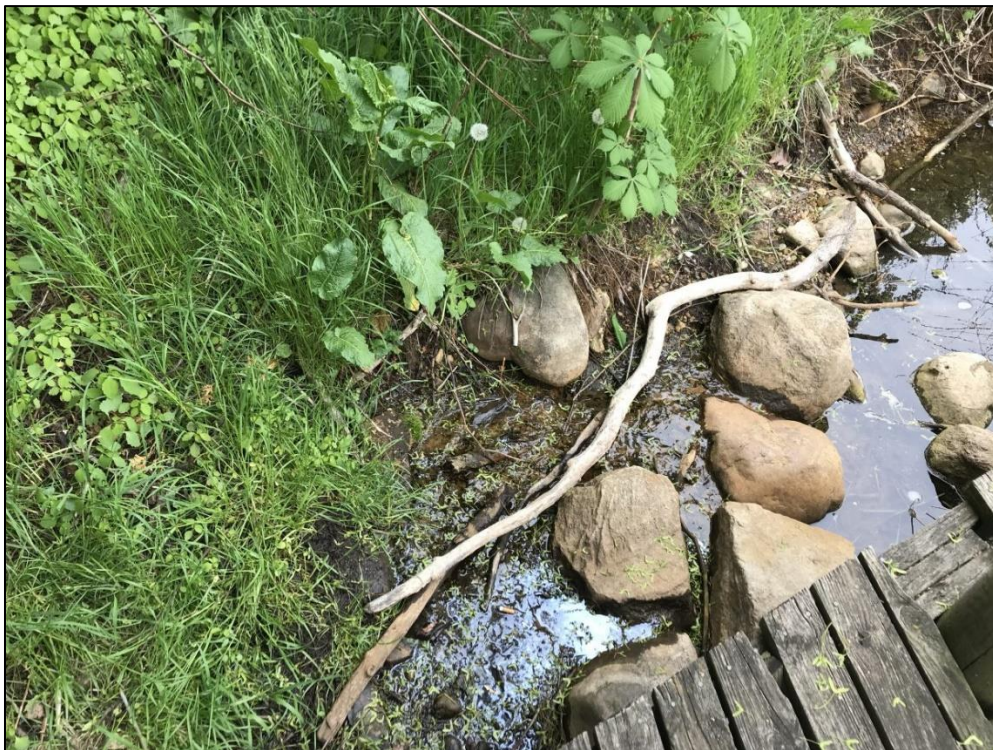
**Photograph 48 – Seepage and erosion along toe of embankment between primary spillway and fish ladder.**

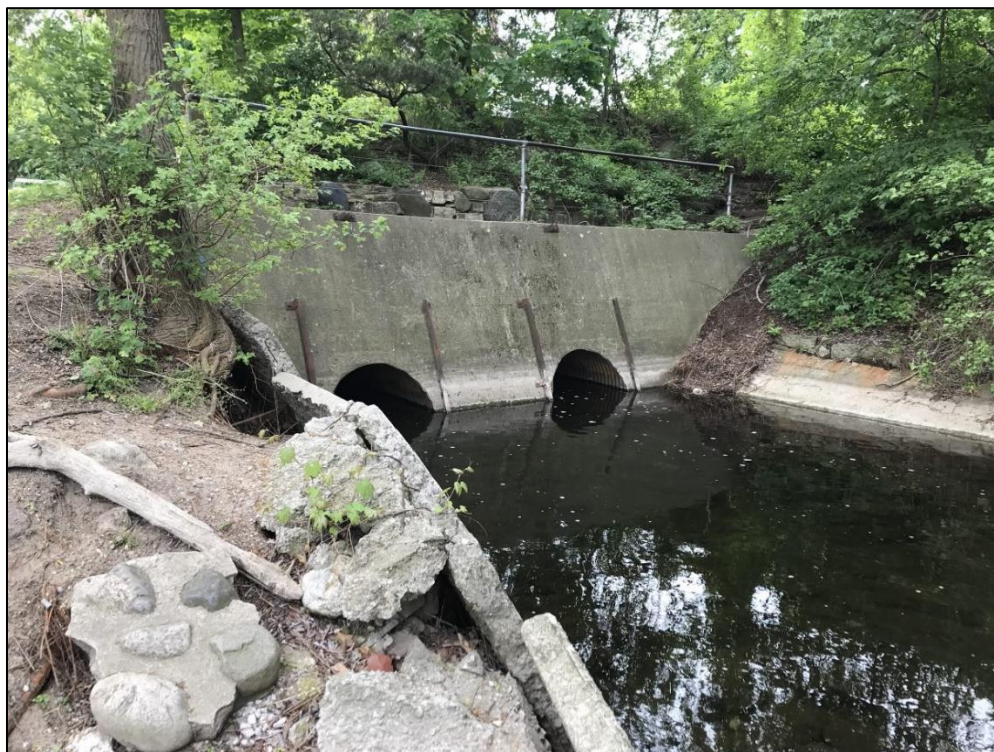
The bank protection at the outlet of the auxiliary spillway appear to be compromised with the concrete slabs being undermined and displaced. These banks should be restored and protected with riprap or other erosion protection measures.

**Photograph 55 – Erosion behind auxiliary spillway right wingwall.**
