# Winter Island Barracks Building Re-Use Feasibility Study

SALEM, MASSACHUSETTS

### 3.0 CONDITIONS ASSESSMENT AND CHARACTER-DEFINING ELEMENTS

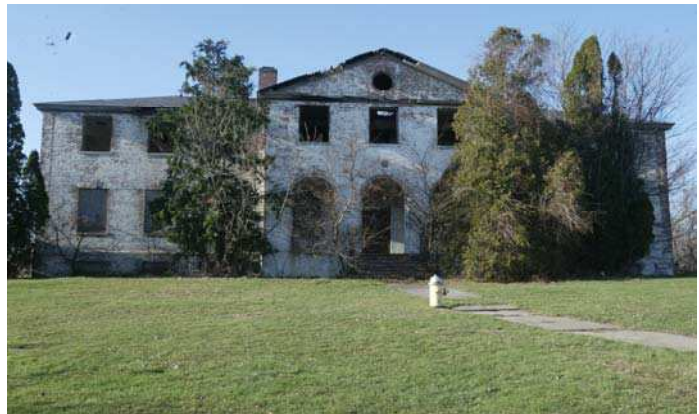
East Elevation

The primary east façade contains nine bays. It is centered on a 10-foot wide, three bay, projecting frontispiece that serves as a vestibule for the main entrance. The first story contains three open arches on the front and one on each side, all with header brick surrounds and cast stone keystones. Three standard window openings that originally contained 8 over 8

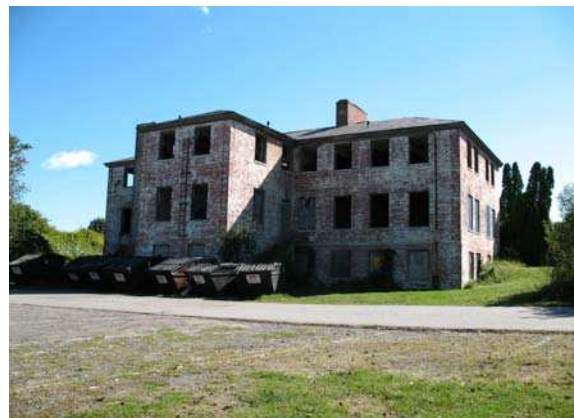
West Elevation

The west elevation has little architectural merit: the wing is disproportionate, the chimney off balance, and the fire escape utilitarian looking. If alterations to this side of the building are necessary, such alterations would have minor ramifications on historical or architectural character.

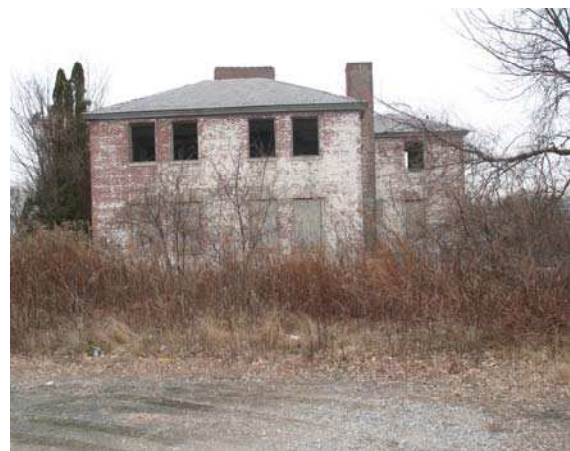
North Elevation

*North Elevation and South Elevation:* These facades fare a little better than the west facade. From the north, the fenestration of the wing is more composed than the south fenestration where the stairs can be seen and the doors seem disproportionate. Fortunately, the view from the south is not prominent. However, the North elevation can be seen from the entrance to the site, and hence should be treated with sensitivity. On this side of the building, historical and architectural character should be maintained.

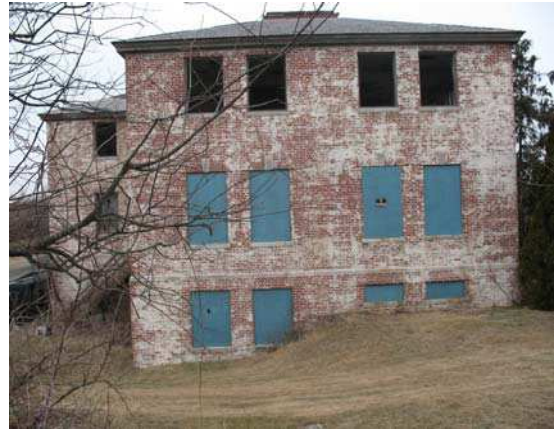
South Elevation

The South elevation contains four windows arranged in groups of two at all three stories. The eastern pair of basement windows are narrow due to the higher grade. The north end is similar.

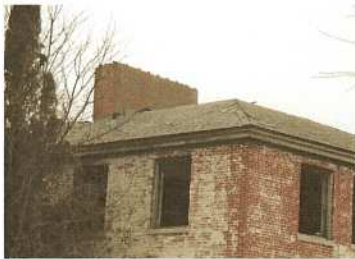
Roof East and Northeast

The entire roof needs to be replaced. Currently water enters through the roof and freezes in the joints between the concrete floors and the walls causing damage to the structure.

*Structure:* Although exposed to the elements for many years, the steel trusses looked pretty good, in spite of the rust and scaling. A more detailed inspection is necessary to determine if they are sound, although they appear adequate at this time. If they are retained, they will need fire proofing to meet the code. The board sheathing and the wood rafters are in poor condition. Much of the sheathing is missing. The roof should be replaced.

*Slates:* The slates were in very good shape, but there appeared to be many missing. There is no reason not to expect that they can be salvaged and re-used. An as yet undetermined number are missing and have to be replaced.

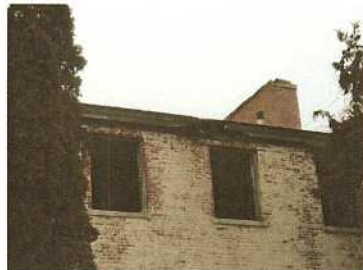
Roof Trim and Chimney Northeast

The visual inspection revealed minimal structural problems except for the roof which needs to be replaced. There are some problem areas including the timber framing supporting the ornamental chimneys which has deteriorated to the point that it presents hazard for chimney collapse. Both chimneys seem to be out of plumb, need coping stones, and could have water damage. Whether these will have to be removed and rebuilt or only repaired depends on the condition of the roof structure. Recommended approach is to remove and replace with lighter materials of the same size and appearance.

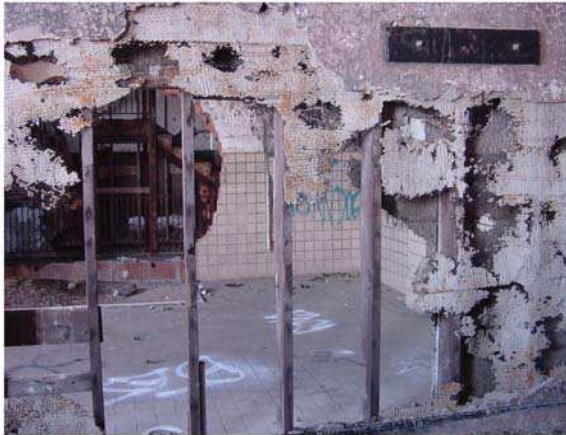
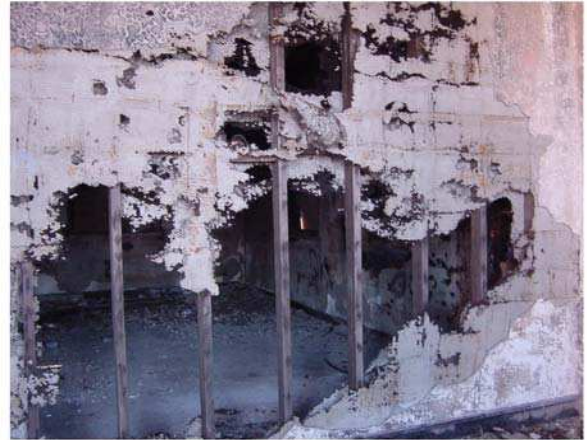
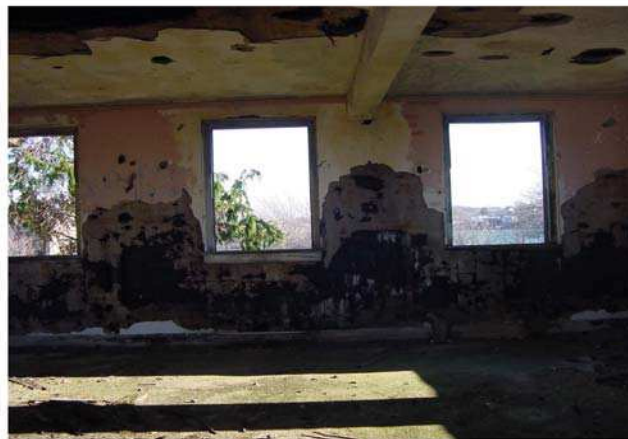
### Barracks Building 2007 Interior Walls and Ceiling

*Interior walls:* There are not any reusable wall surfaces. All existing wood stud/plaster partitions should be taken down to the studs. Where they are retained, the brick and the clay tile/plaster walls should be individually evaluated as to whether all plaster is removed or plaster is repaired. Strapping and plaster should be removed from the interior of the exterior walls.

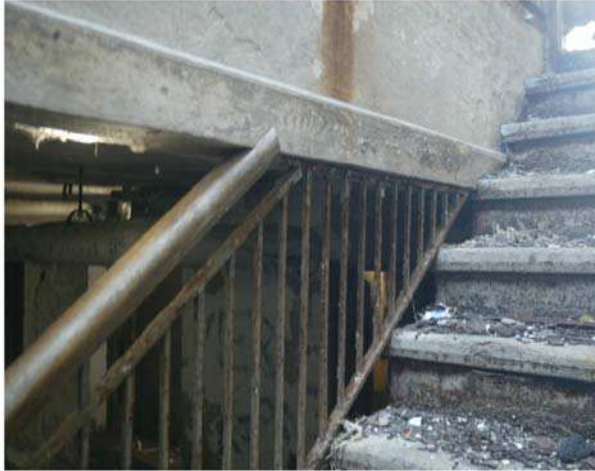
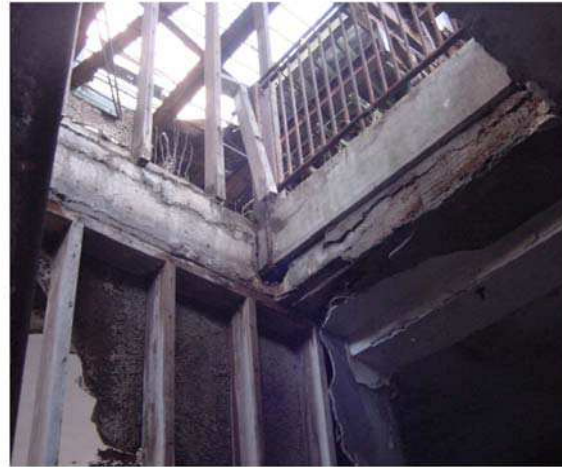
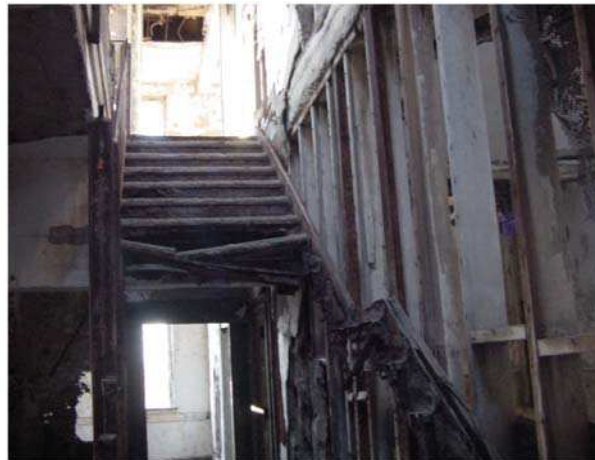
**Barracks Building 2007 Interior Stair**

The building has been vacant since the City took ownership in 1972 and has experienced significant vandalism over the years. As noted earlier in this report, there are no windows, no interior doors, the interior stairways are dilapidated, the interior trim and molding has been removed and there is nothing in the interior of any historic significance. Currently the upper floor windows on all sides and the first floor windows on the rear side are open to the elements and there are holes in the roof allowing water to penetrate the structure. The basement contains at least one foot of water.
