MASSACHUSETTS DEPARTMENT OF ENVIRONMENTAL PROTECTION
FIELD ASSESSMENT AND SUPPORT TEAM (FAST)

**Evaluation of Investigations, Remedial Activities, and
the Potential for Vapor Intrusion at the
Varian Site, Beverly MA**

MassDEP RTN 3-00485

January 2021

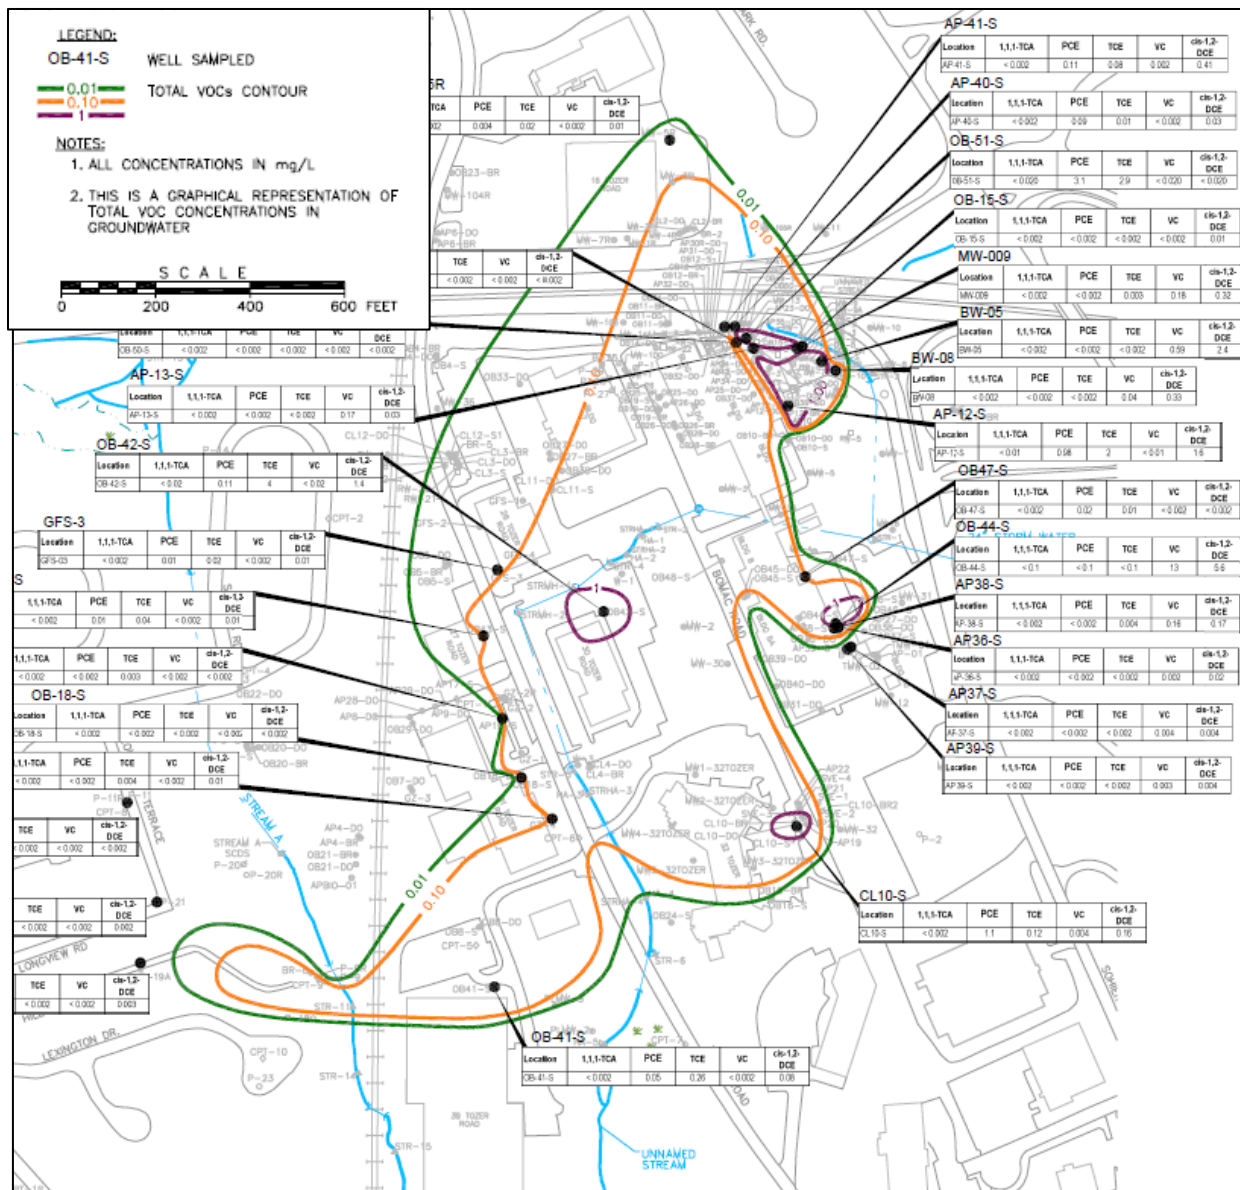
Figure 7. VOC plume in shallow overburden aquifer, based on data from May 2020.

It is noted that in December 2020, as part of an effort to evaluate the vapor intrusion pathway in residential neighborhoods, APTIM collected additional water samples from five wells near the western lobe. No VOCs were detected in P-09R (Hill St.), P-11R (Longview Terrace), or P-23 (Lexington Dr.). In two wells, cis-1,2-DCE was detected below the GW-2 standard (P-19A [Hill St.] and P-21 [Longview Ter./Longview Dr.]). TCE was also detected in P-21 below the GW-2 standard. Based on these recent results, VOC contamination in groundwater extends west of the plume shown in Figure 7, particularly along Hill Street and to at least the intersection of Longview Terrace and Longview Drive. These data affirm the need for additional sampling in the areas north of the lobe.

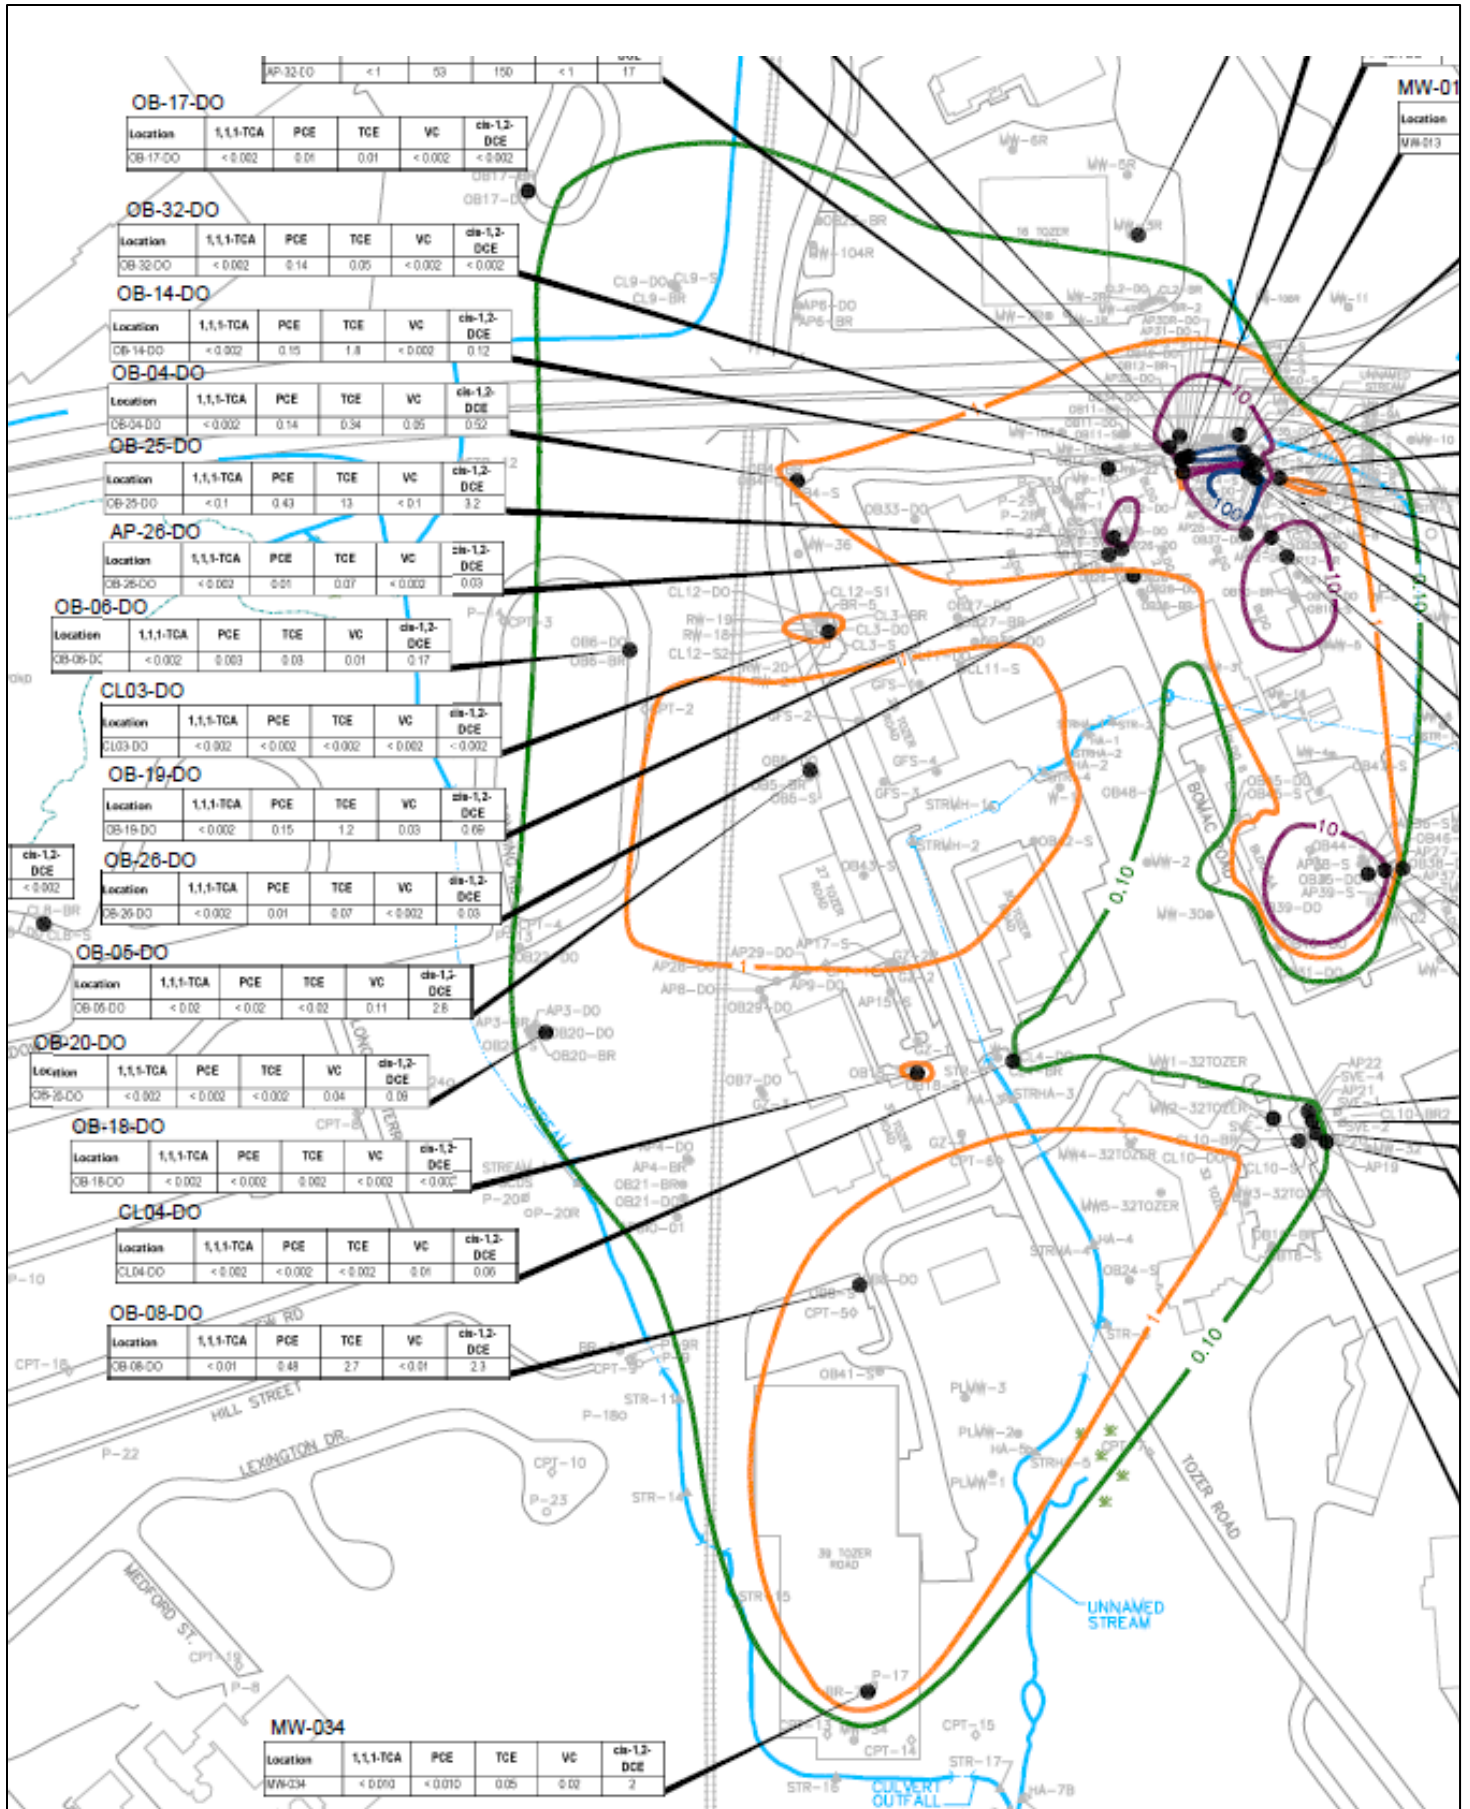
More recent plume depictions (Figure 9) correctly infer the continuous nature of the source area plumes east of 32 Tozer Road, but fail to adequately follow up on the southerly detections of cis-1,2-DCE, inferring the dissipation of site contaminants in this area. In the depiction of 2020 conditions in Figure 9, well MW-034, located beneath the building at 39 Tozer Rd., was the southernmost well sampled. This well contained cis-1,2-DCE at 2000 µg/L; TCE and vinyl chloride were detected at lower concentrations.¹¹ Since 2002, no samples have been collected from the deep overburden wells south of 39 Tozer Rd. Therefore, we have no recent information about the purported detached plume area shown in the Phase II report (IT 2000). Additional sampling of the deep overburden in this area is needed to fully delineate the VOC plume.

Figure 9. VOC plume in the deep overburden aquifer, based on data from May 2020.

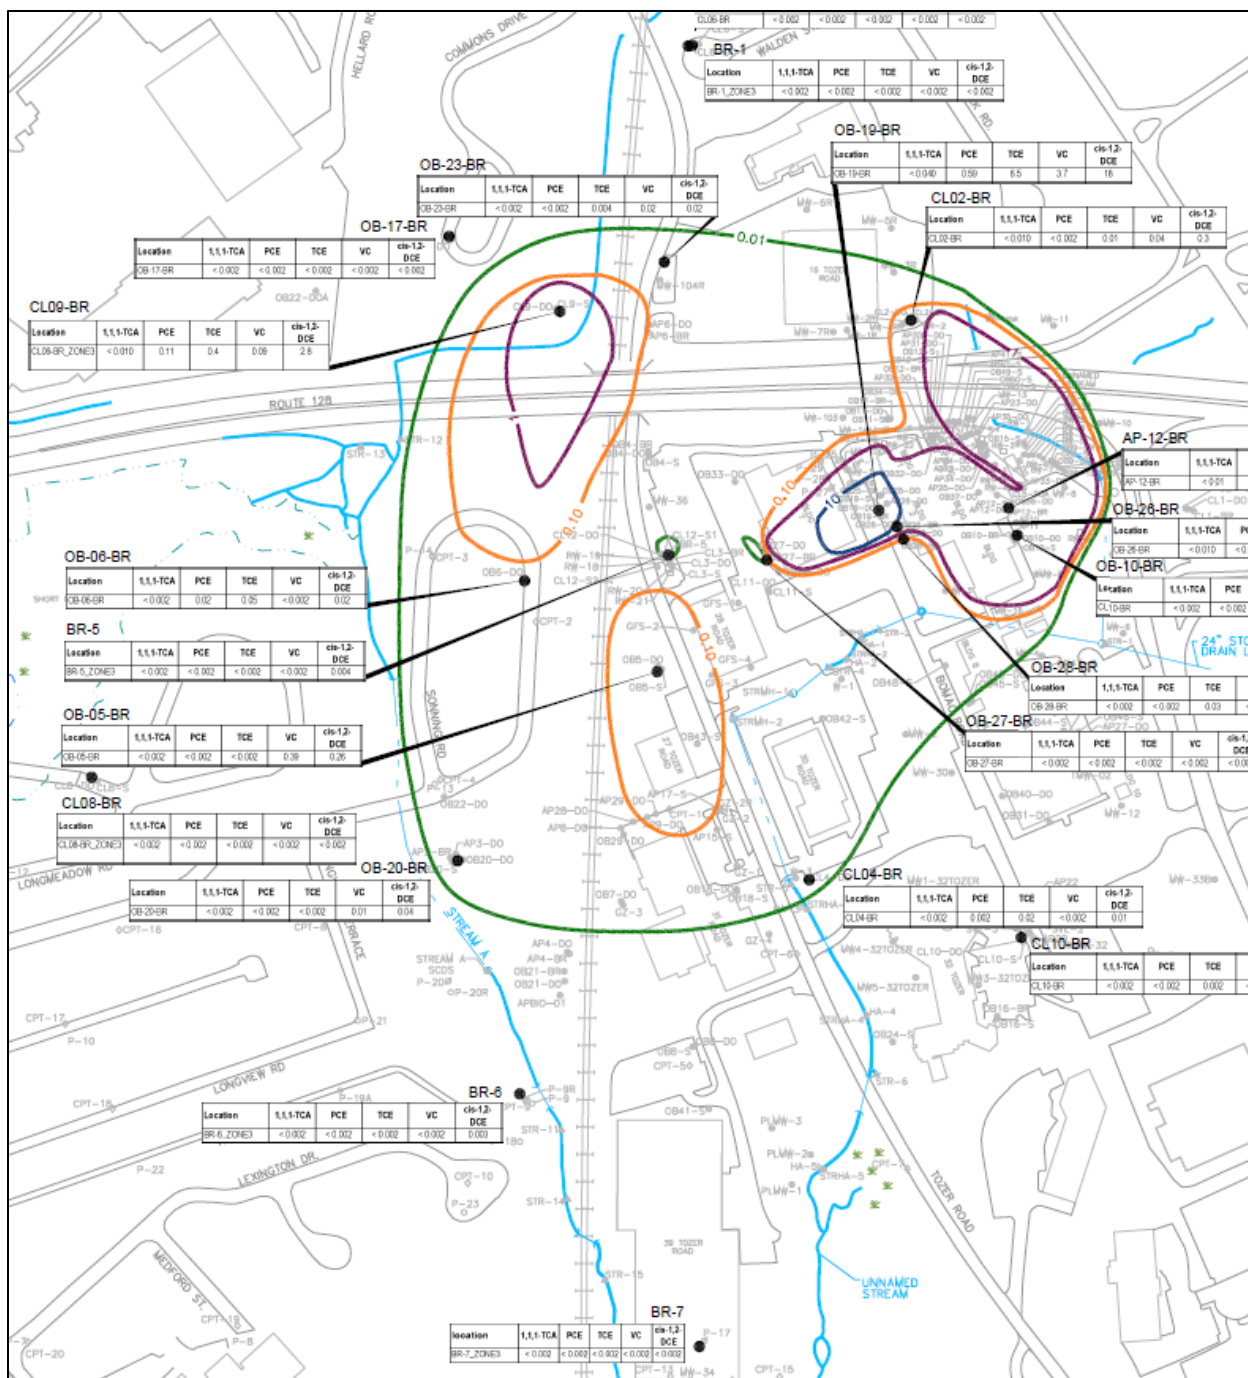
In 2020, the bedrock plume had a smaller extent than the deep overburden plume. Given the likelihood of ongoing migration from the overburden to the bedrock, it is important to continue monitoring bedrock wells where VOCs are present in the deep overburden.

Figure 11. VOC plume in the bedrock aquifer, based on data from May 2020.

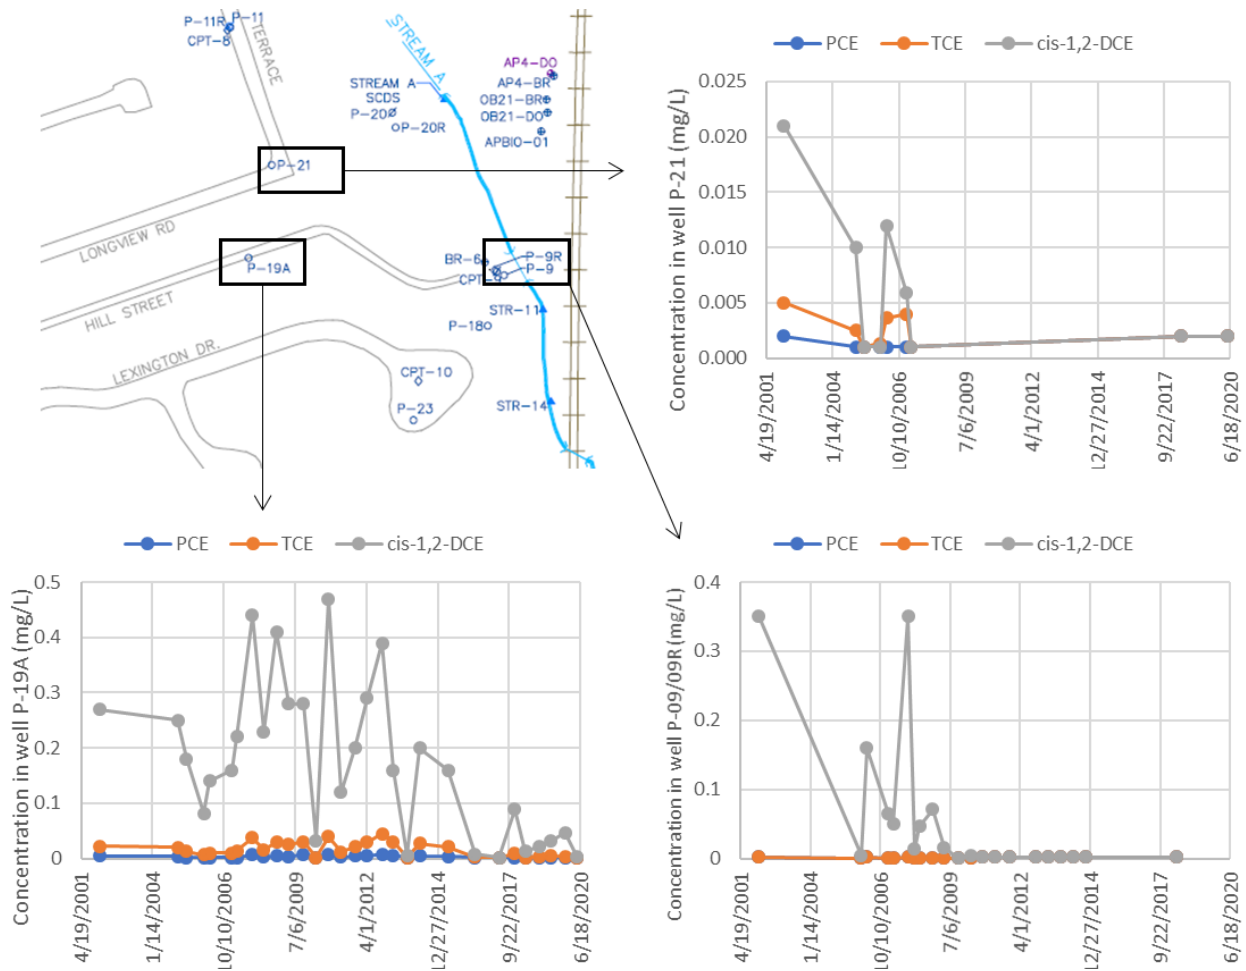
There is, however, evidence that water-table VOC concentrations in this area have significantly decreased over time, due in part to the remedial measures that have been ongoing in source areas and previous remedial measures in this area. Declining concentrations are demonstrated in Figure 12.¹² Ongoing monitoring of these and other wells in this area will be needed to ensure that these contaminant reductions continue over time.

Figure 12. VOCs in water table wells located in the residential neighborhood near Hill Street have declined since 2002.

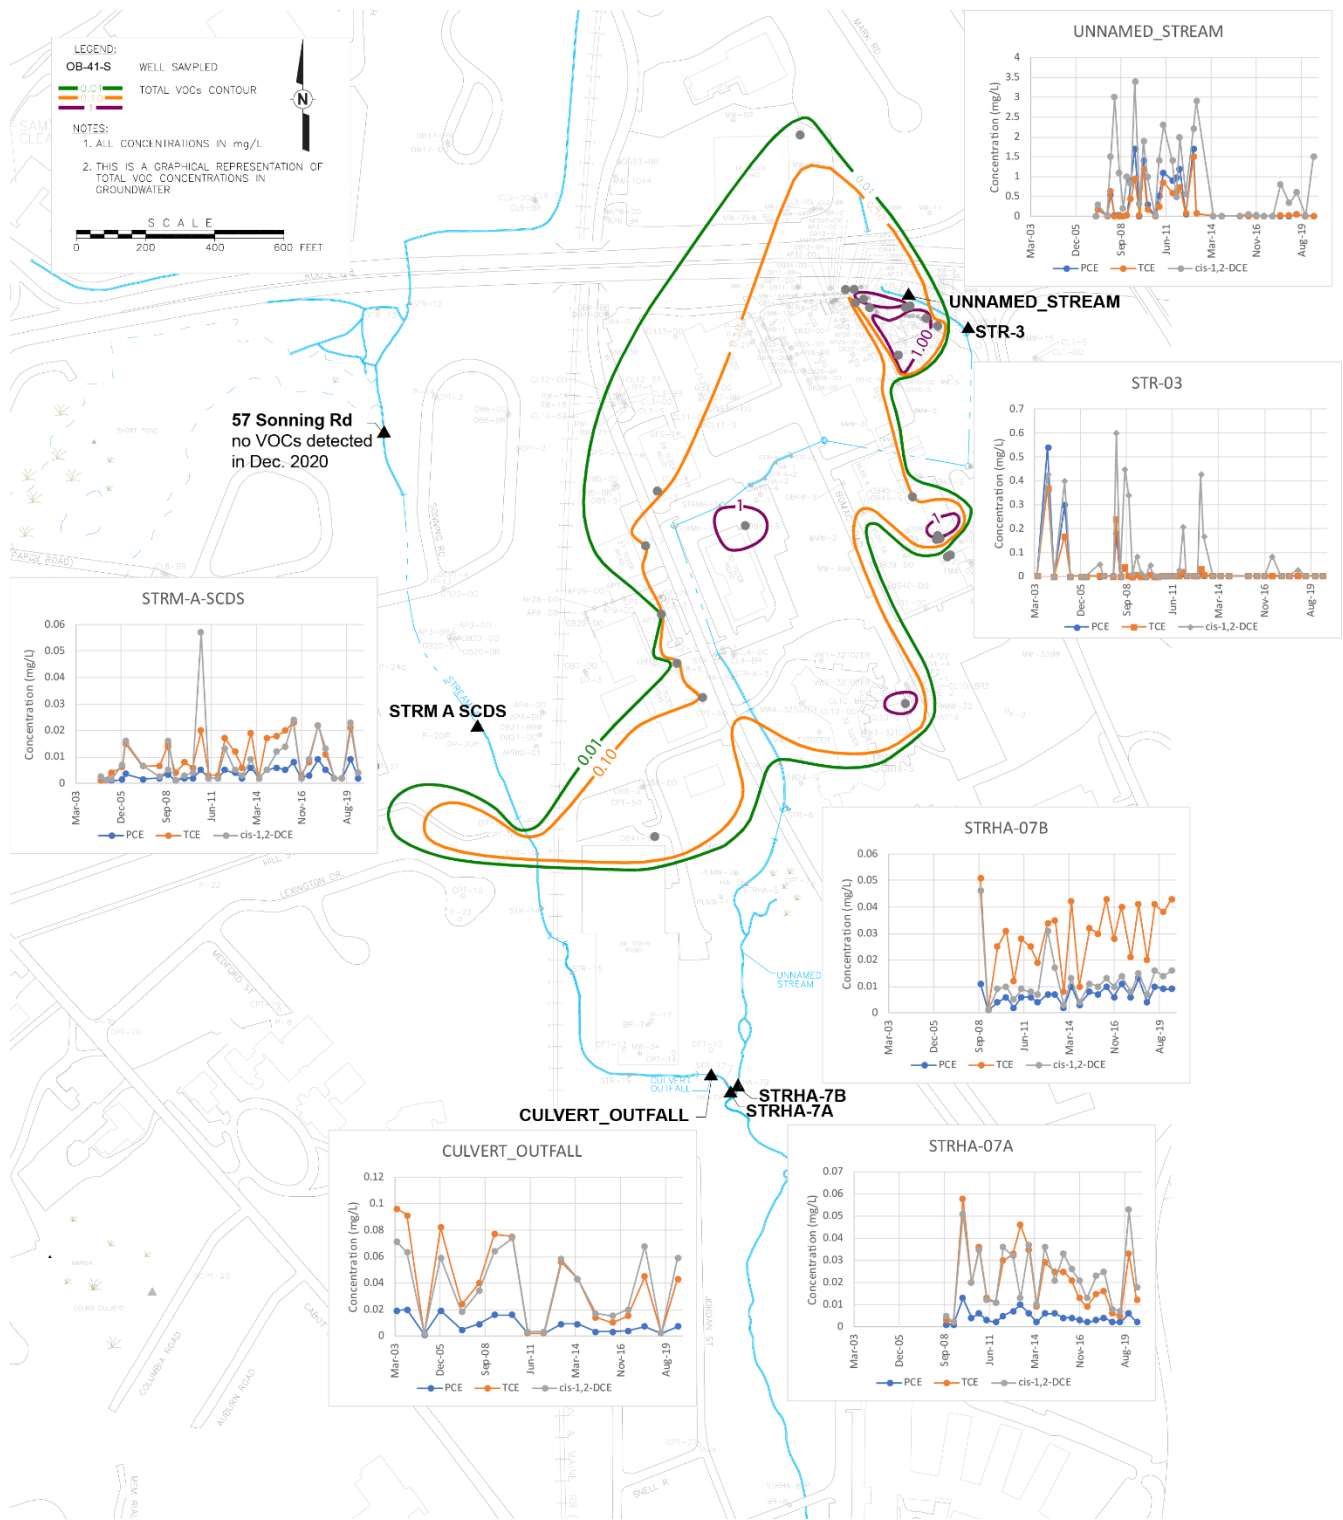
Conversely, VOC concentrations in Stream A do not decrease with distance in the direction of flow. Samples collected upstream, in Patton Park, contain a similar concentration to downstream samples (collected near the confluence with the Unnamed Stream). In December 2020, APTIM collected a stream sample at 57 Sonning Road, which is farther upstream than Patton Park, and no VOCs were detected. The increasing VOC concentration with distance in Stream A indicates that groundwater infiltration is the source of VOCs in this waterbody, and that the shallow groundwater plume is likely larger than depicted on the map.¹³

Figure 13. VOCs, including PCE, TCE, and cis-1,2-DCE, have been detected in the Unnamed Stream and Stream A for over 2 decades. VOCs are present outside the shallow groundwater plume as depicted by APTIM.

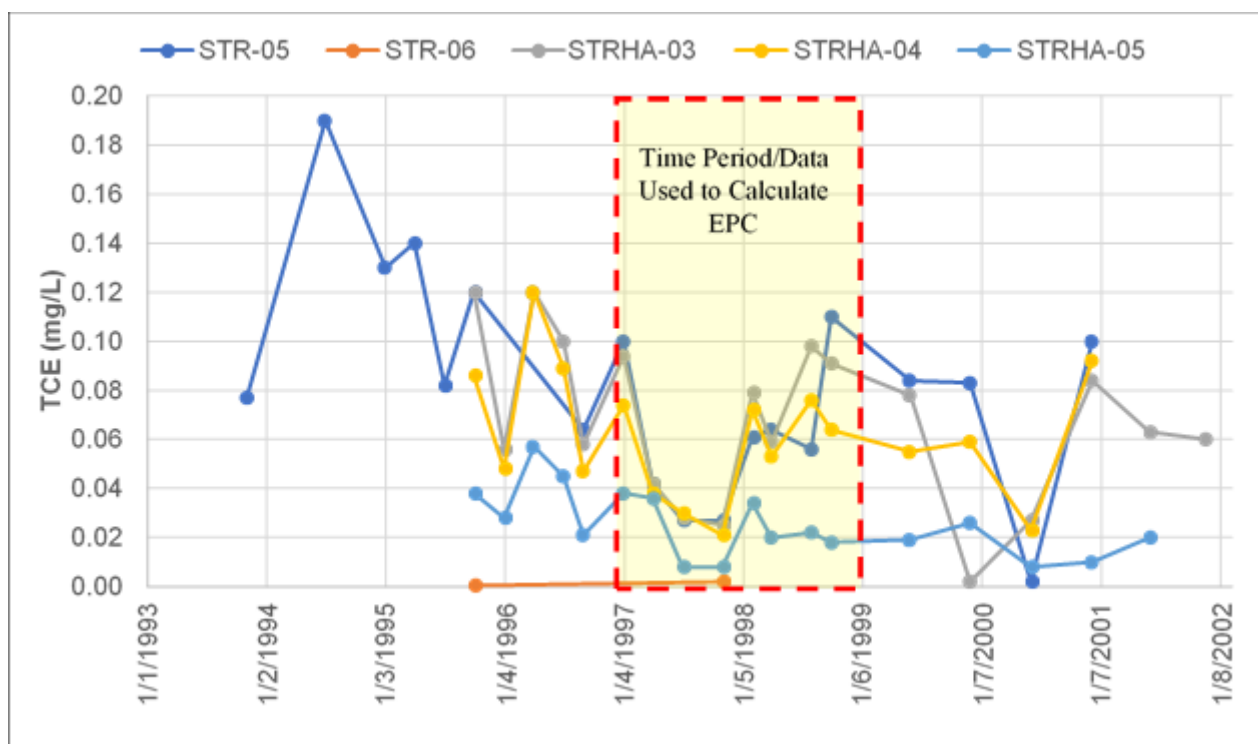
As the mechanism of stream contamination is via the discharge of contaminated groundwater, the EPCs should reflect “base flow” conditions, which are presumably more representative of day-to-day conditions. As such, a suitably conservative EPC value for TCE would be 60 µg/L, with PCE at 11 µg/L. Using these values, and correcting a mathematical mistake in the original risk assessment, the revised Hazard Index would be 0.71 and the revised ELCR would be 2.6×10^{-6} , which are still below the allowable limits.

Figure 14. TCE concentrations at specified sampling points in Unnamed Stream used to calculate Exposure Point Concentrations for Phase II risk assessment.

Many stream sample locations, however, including some of those with the highest historical VOC concentrations, have not been sampled since 2001. Additional sampling of the Unnamed Stream in areas that historically had the largest VOC concentrations should be done in order to confirm the continued condition of no significant risk.

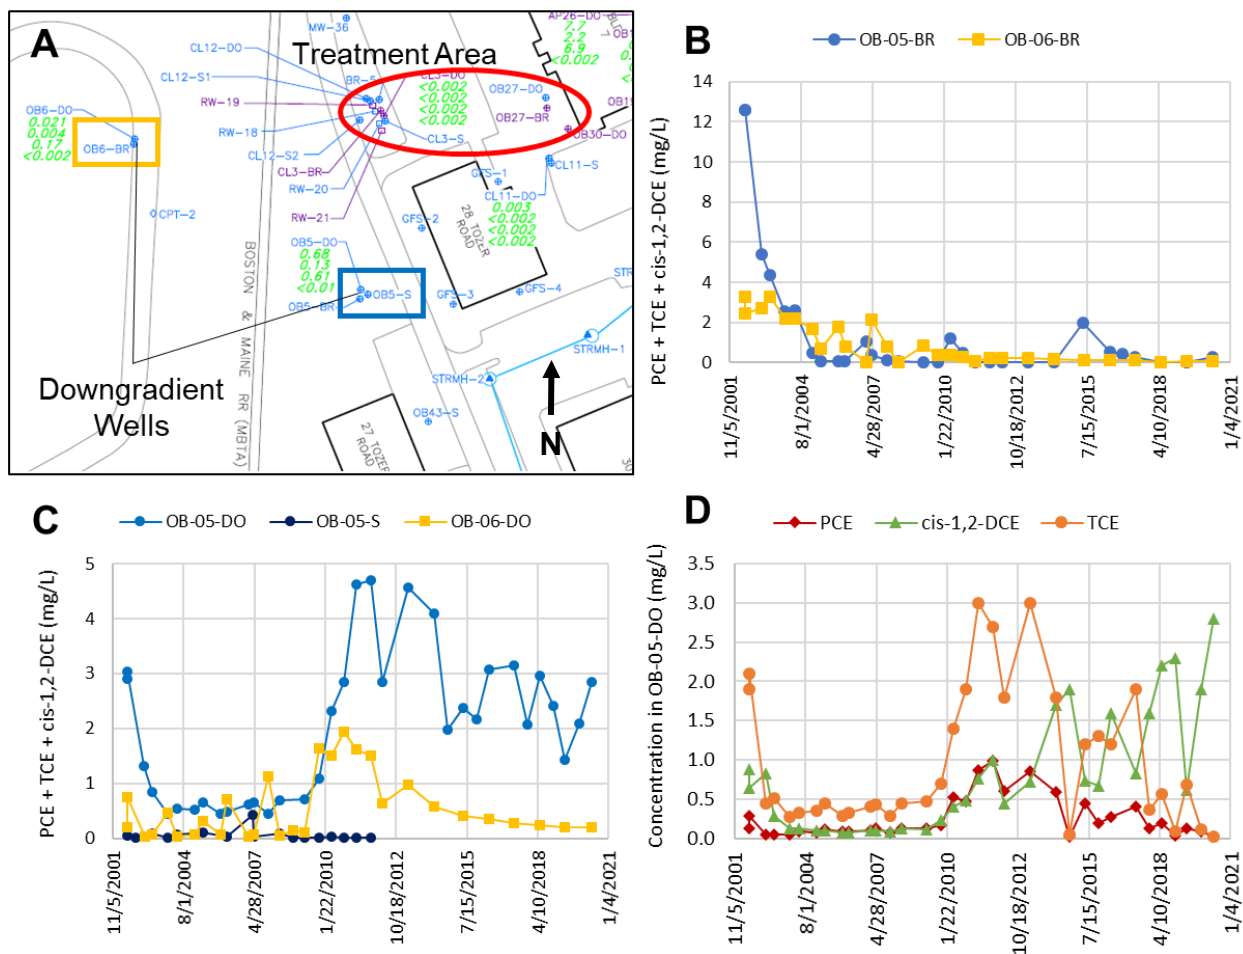
Figure 16. Two clusters of monitoring wells are located downgradient from the treatment area at 28 Tozer Rd (A, base map from APTIM 2019). VOCs in downgradient bedrock wells decreased in response to treatment (B). In deep overburden wells, VOC concentrations initially decreased with a strong rebound in 2009–2010 (C). Starting around 2014, evidence of biodegradation (increasing cis-1,2-DCE) is present in the deep overburden aquifer, possibly the result of treatments applied to the source area (D).

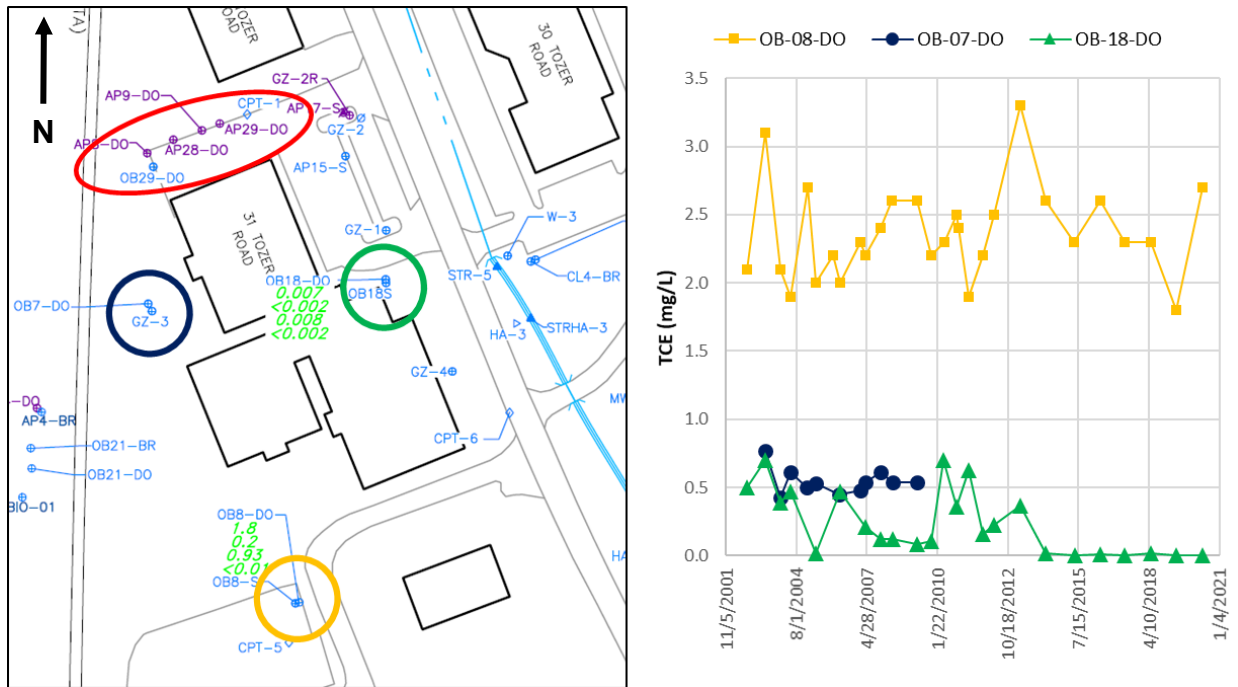
Based on the wells evaluated above, the groundwater plume treatment at 31 Tozer Rd has been effective only in a relatively small area of deep overburden groundwater.

Figure 17. Groundwater at 31 Tozer Rd was treated by permanganate injections in 2002-2004. Downgradient deep overburden monitoring wells show that the impacts of treatment were spatially limited. (Map shows deep overburden groundwater results and is from APTIM 2019.)

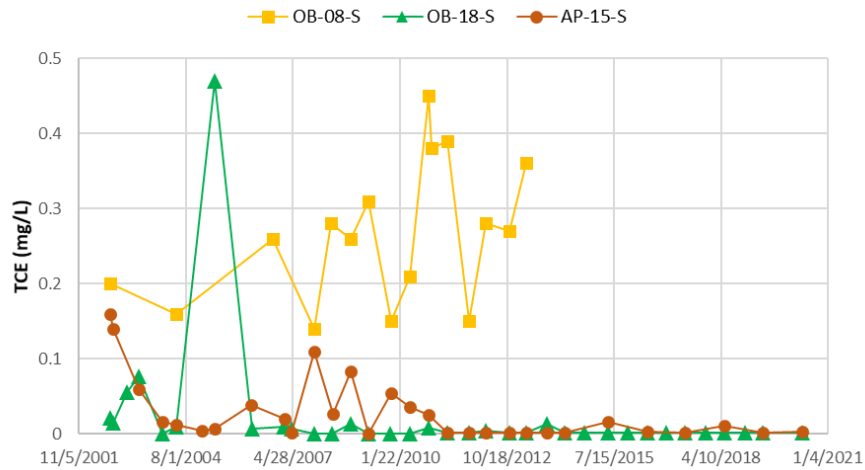
The results in shallow monitoring wells show a similar pattern: in the monitoring well closest to the treatment area (AP15-S), TCE concentrations decreased during the period 2002–2004 (Figure 18). There was an apparent rebound in 2007, followed by a second period of decline. The two wells farther downgradient (OB-08-S and OB-18-S) did not show decreases in TCE in response to the treatments applied in 2002–2004; TCE in OB-08-S (500 ft downgradient) increased during the monitoring period (2002–2013) and TCE in OB-18-S has been consistently low with a few exceptions (temporary spikes of TCE that are roughly correlated in time with the treatments). PCE and cis-1,2-DCE show similar trends in all three wells. Thus, downgradient/plume treatment appears to effectively reduce the VOC concentrations in a spatially limited way, and nearly 20 years after treatment was applied, there is no evidence of VOC reductions 500 ft downgradient.

Figure 18. TCE in the shallow well closest to the treatment area (AP-15-S) decreased after ISCO treatments were applied. Two other shallow wells in the vicinity either show no evidence of treatment (OB-08-S) or showed brief increases in TCE possibly associated with permanganate injections (OB-18-S).

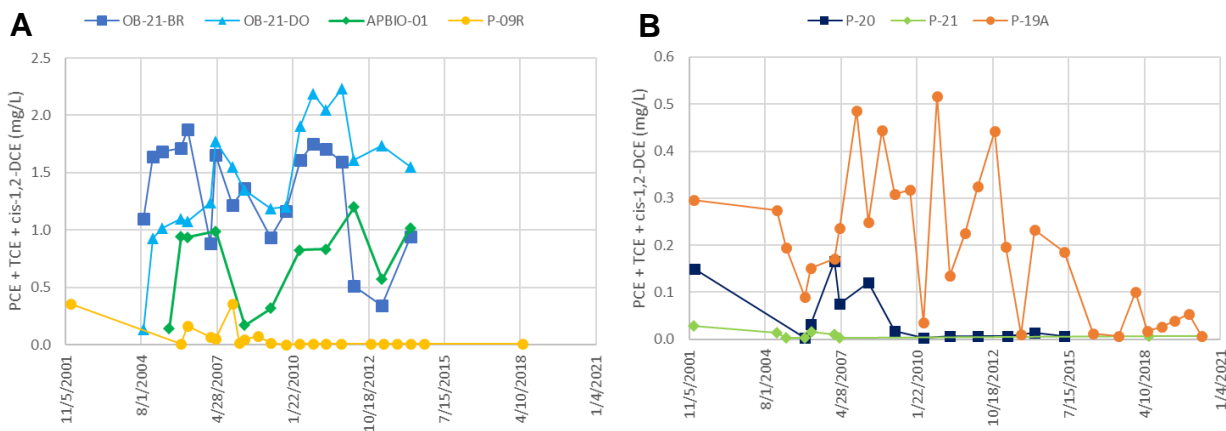
Additionally, there does not appear to be a correlation between groundwater quality and distance from the treatment area. For example, the wells OB-21-DO/BR are located closest to the treatment area, about 70 ft south of AP-04. In both wells, VOCs did not decline after 2004 (or a possible decline was masked by a rebound in early 2005). Well APBIO-01 is located slightly farther south (100 ft from AP-04), and shows a similar pattern to the OB-21 wells with time delay of 6–12 months. In all three wells, there are no samples available from before the ISCO injections, so it's not possible to determine if the injections resulted in a drop in VOC concentration. However, if concentrations did drop following ISCO injections, they rebounded within one year. The data appear to show VOC reductions in 2009, followed by a rebound, and again in 2012–2013, also followed by a rebound.¹⁶ The well farthest to the south (P-9/9R) is located about 350 ft from AP-04. There was a decrease in VOC concentrations between 2002 and 2006, but a lack of data points between 2001 and 2006 makes it impossible to determine precisely when that drop occurred. VOC concentrations have been < 0.1 mg/L since 2009.

Figure 20. Groundwater downgradient (south [A] and west [B]) of the Longview treatment area was minimally impacted by ISCO injections in 2003–2004. However, concentrations in shallow groundwater have since declined.

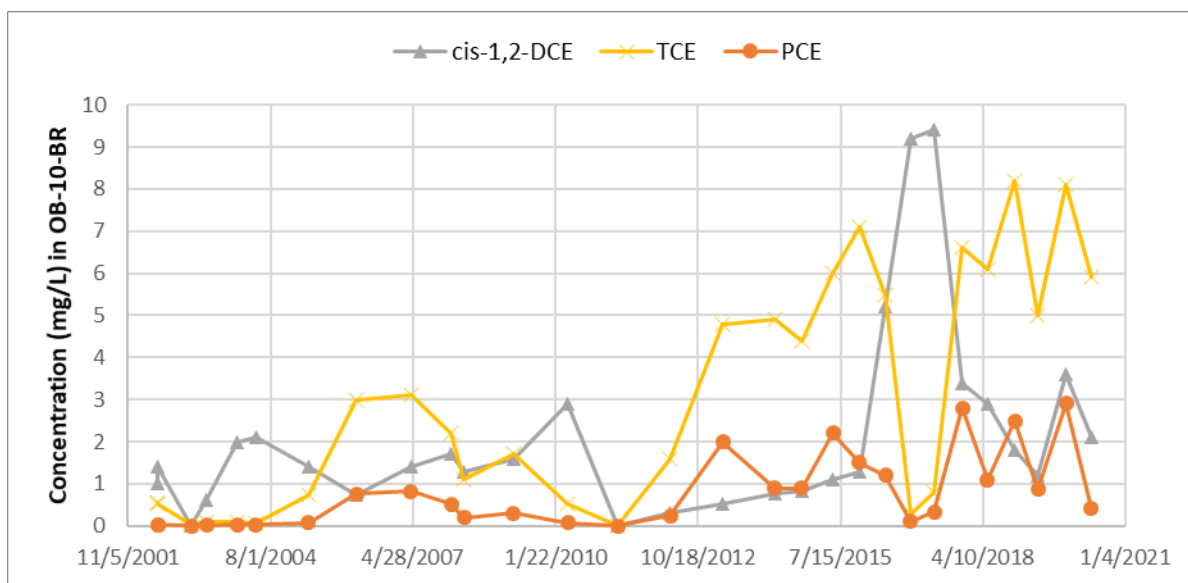
high concentration groundwater into this area. There are several, short-lived periods where the TCE/DCE ratio indicated (bio)degraded material (e.g., April 2010, 2016–2017), but most often, there has been more TCE than DCE present. Thus, this well is further evidence for temporally limited effects from remedial efforts. As of July 2020, relatively undegraded material was present in the bedrock well.

Figure 22. VOC concentrations in well OB-10-BR, south of the Building 3 Treatment Area, have increased since 2002.

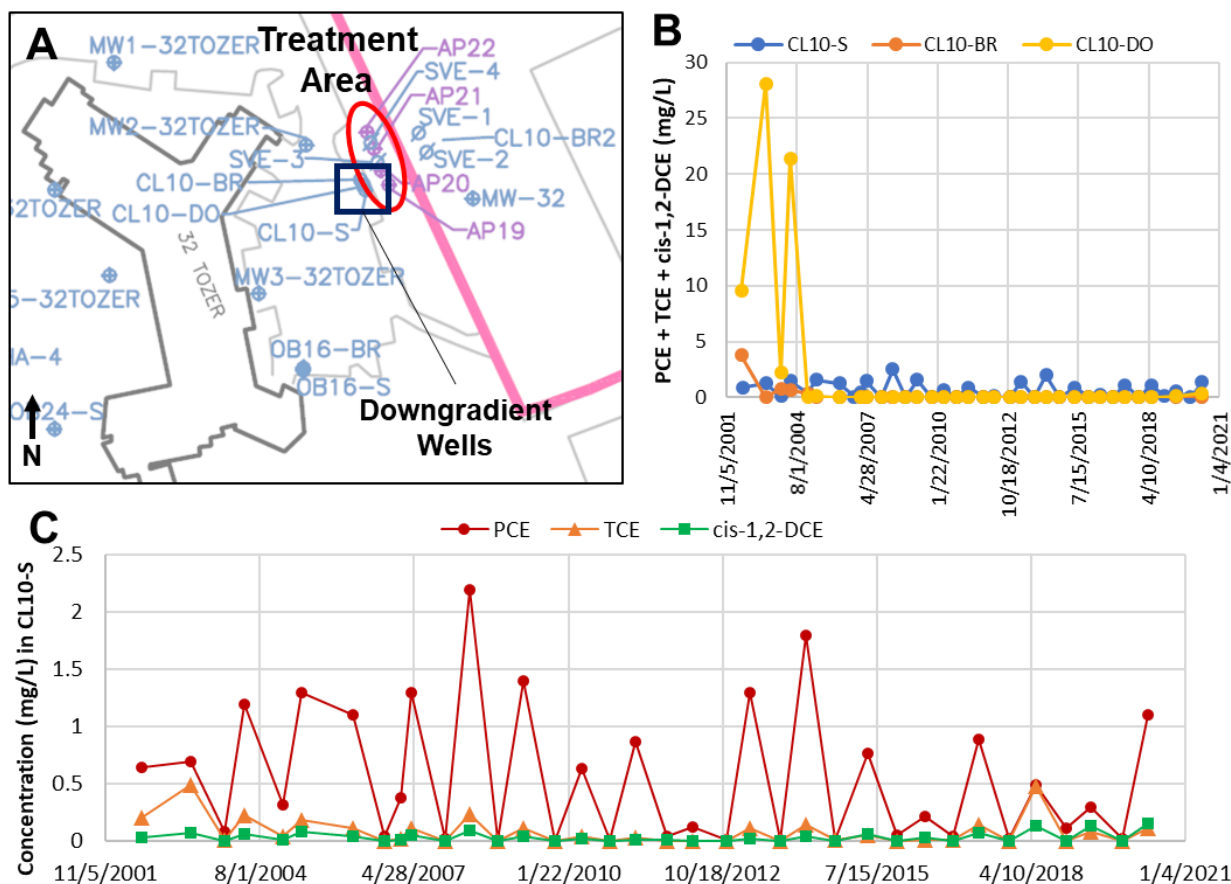
Figure 24. The treatment area on the southern portion of the former Varian property (near 32 Tozer Rd.) consists of four injection wells and one downgradient monitoring well cluster (A). VOC concentrations in the deep overburden rose after initiation of treatment in 2002, but have remained at or near detection limits since 2005 (B). In the shallow overburden, concentrations have fluctuated with no long-term reduction; PCE is the dominant compound (C).

The data from CL10-S are difficult to interpret because of what appears to be very large seasonal variations (Figure 24c). For example, in April 2008, the PCE concentration was 2.2 mg/L; in November 2007 and October 2008, the PCE concentration was 2 orders of magnitude lower. In general, concentrations in the spring/summer sampling events are 1–2 orders of magnitude higher than in the fall sampling events. The cause of the concentration fluctuations is unclear, but it is clear that the VOCs present in spring/summer are relatively fresh/undegraded, with PCE concentrations exceeding those of TCE and cis-1,2-DCE. Given that the shallow groundwater concentrations show no long-term reduction, and the presence of an occupied commercial building downgradient, additional treatment and monitoring in this area is needed.

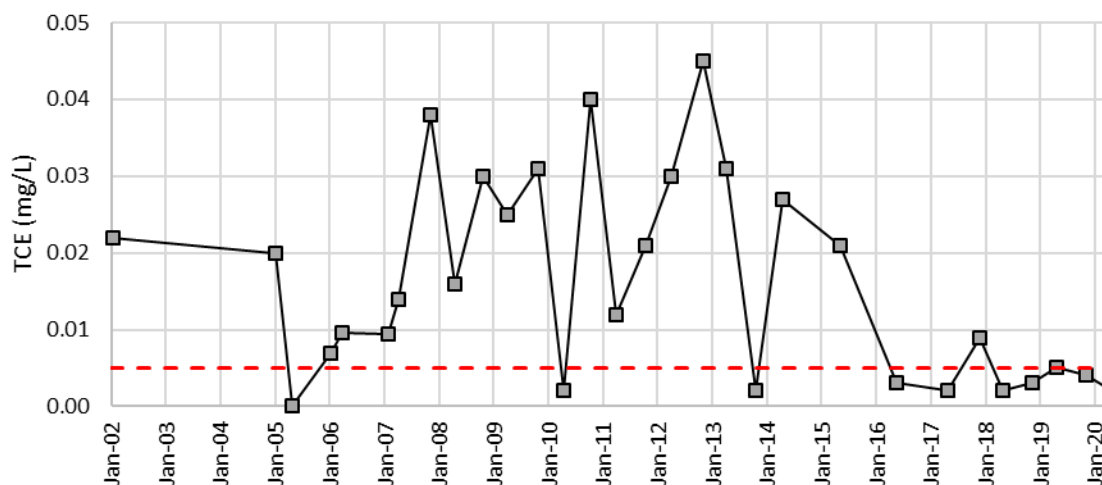
Since the indoor air study was conducted in 2002, concentrations of TCE have declined in shallow groundwater beneath the residential neighborhood (Figure 25). Concentrations declined after 2005, likely due to ISCO injections applied in 2004–2005. TCE rebounded after conclusion of treatment in the Longview neighborhood, but has been steadily declining since 2015. The more recent decline may be due to successful biotreatment upgradient (e.g., at Building 3). Given that concentrations have been largely below the GW-2 threshold over the past 4 years, it's unlikely that vapor intrusion is a concern today.

Figure 25. Since 2015, TCE concentrations have decreased in shallow groundwater beneath Hill Street (generally below the GW-2 threshold, red dashed line) (well P-19A, data from APTIM 2020b and Shaw 2009).

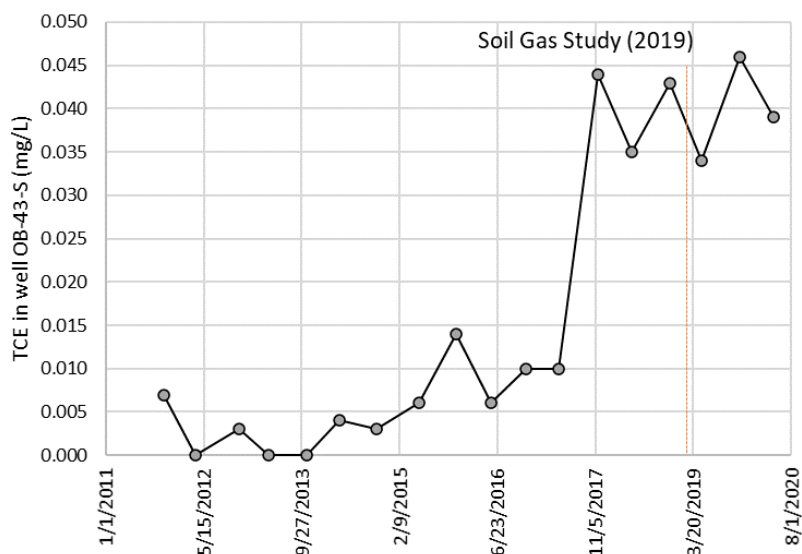
The increase in groundwater TCE concentrations motivated a soil gas study, which was conducted in February 2019 (APTIM 2019). Soil vapor was collected from two sub-slab sampling points. PCE was detected in both samples below screening values; TCE was not detected. Indoor air samples were not collected. Given the lack of indoor air sampling and spike in groundwater concentrations, additional sampling and evaluation is necessary for this building.

Figure 26. TCE concentrations in shallow groundwater at 27 Tozer Rd. have increased over time.

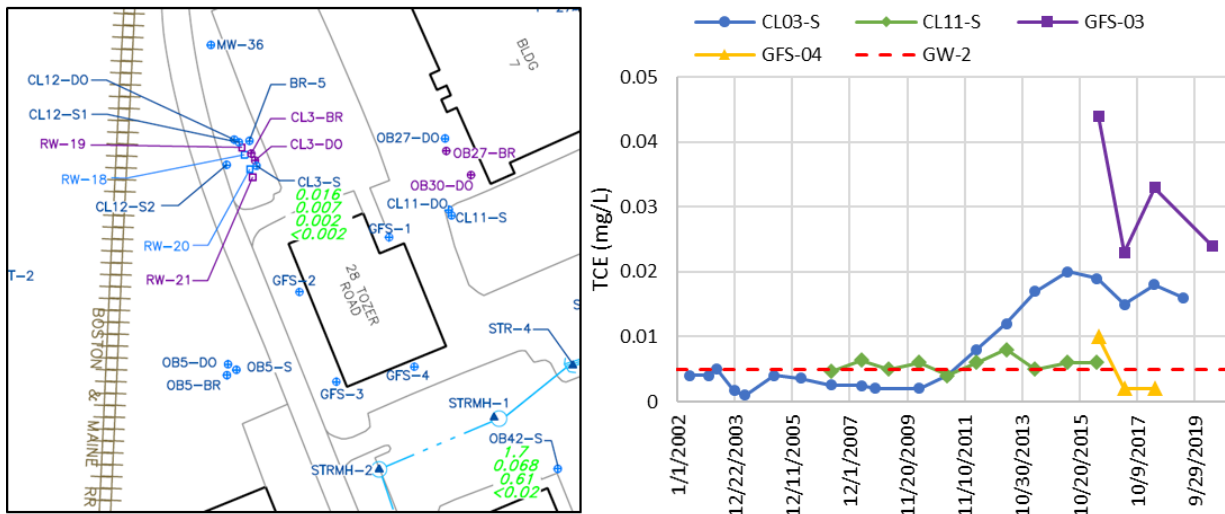
Figure 27. TCE concentrations in shallow wells at 28 Tozer Rd. have risen since 2011 and are currently above the residential/educational GW-2 threshold in two wells.

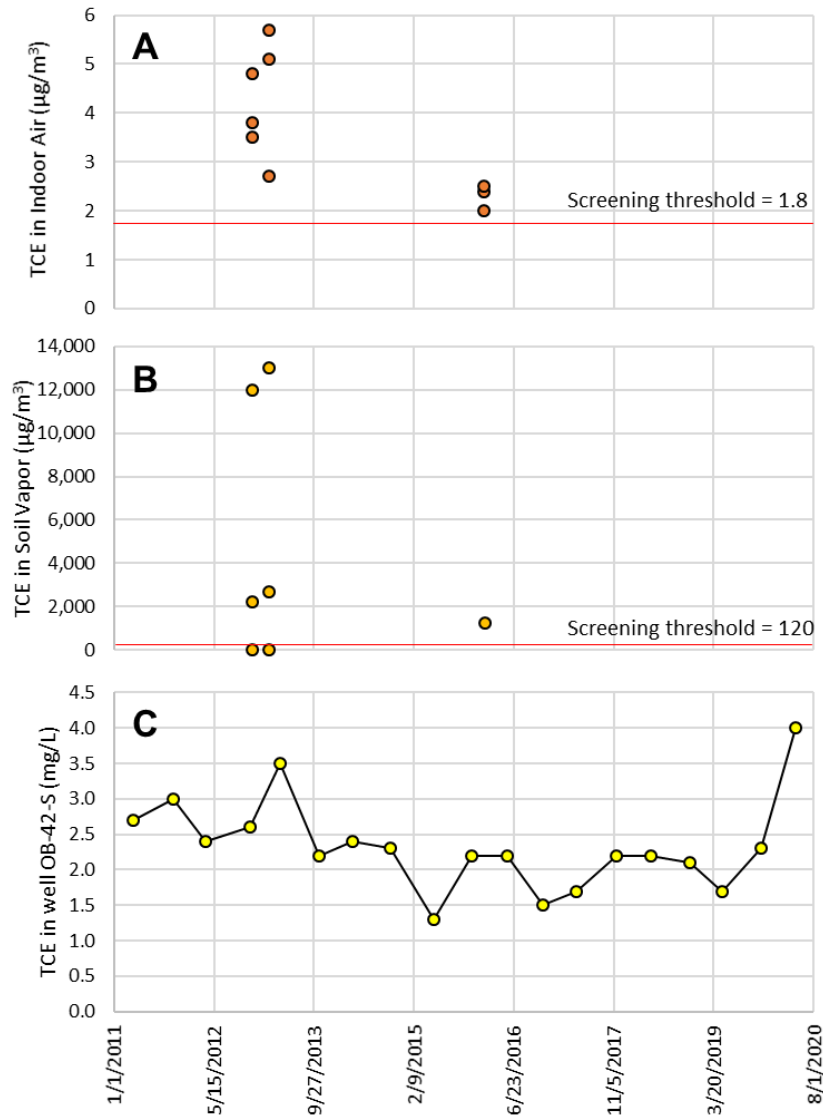
the SSDS is needed to ensure that conditions in all occupied areas of the building are at a condition of No Significant Risk.

Figure 28. TCE in indoor air (A), sub slab soil vapor (B), and groundwater (C) at 30 Tozer Rd.

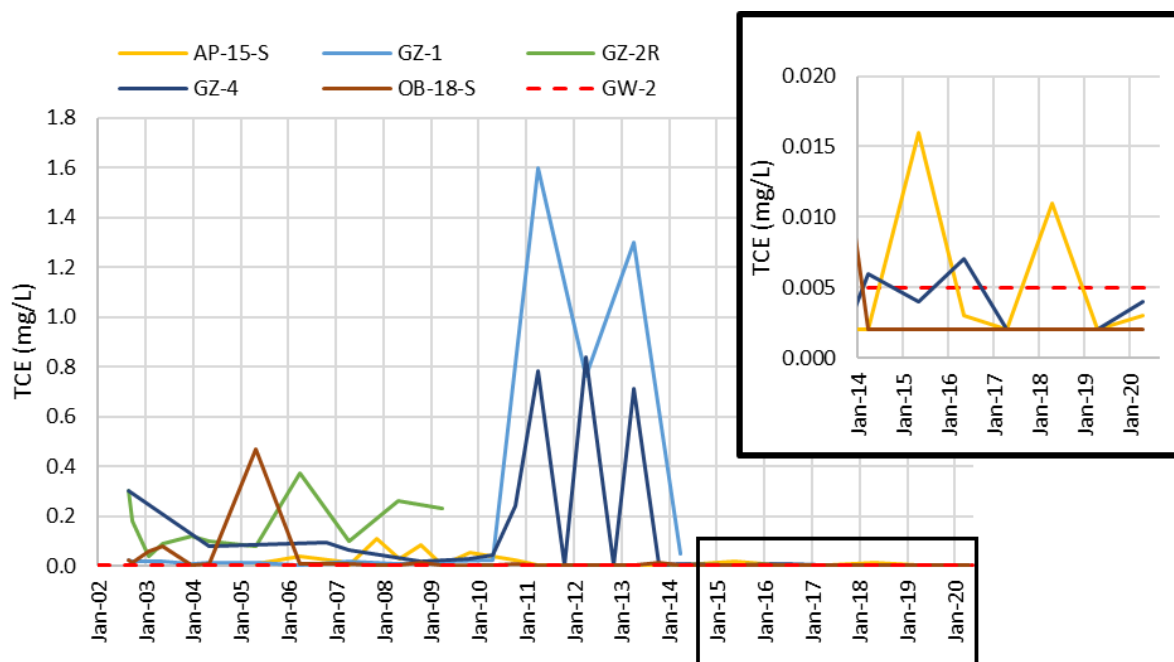
In August 1995, two indoor air and one ambient air samples were collected at 31 Tozer Road. Although VOCs were identified in all 3 samples, it was concluded that none were related to the contaminants emanating from the Varian site. Given the fluctuating levels of TCE, lack of recent indoor air samples, and proximity to source areas, additional investigation is necessary.

Figure 29: Since January 2015, TCE concentrations in shallow groundwater have been near or below the GW-2 threshold. Before 2015, TCE concentrations exceeded the (current) GW-2 standard in multiple wells at 31 Tozer Rd.

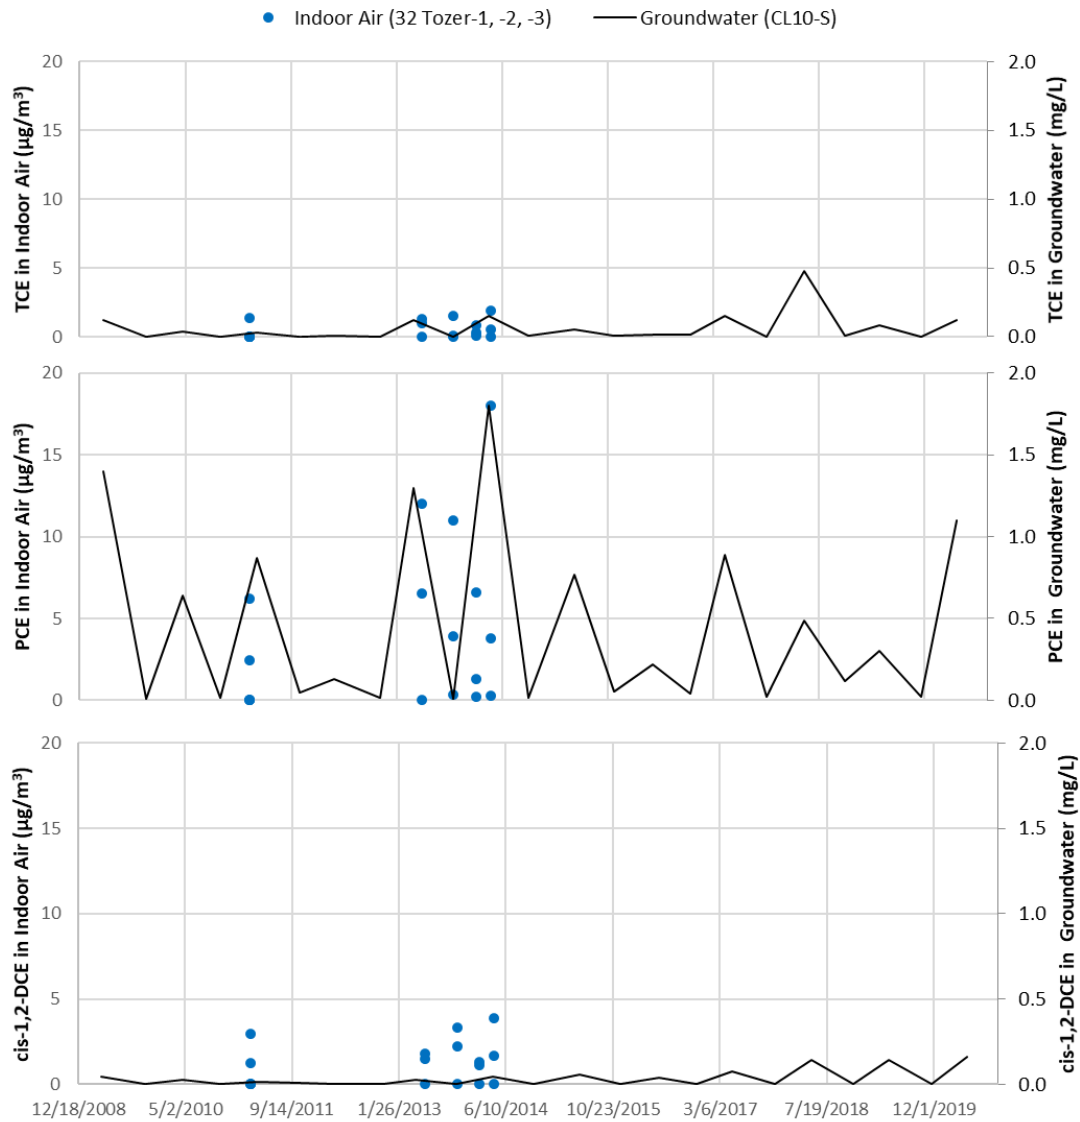
APTIM (2020b) concluded that a condition of No Significant Risk related to indoor air continues to exist at 32 Tozer Rd, based on a decline in CVOC concentrations in well MW-2-32. Concentrations in well CL-10-S have not declined, but are consistent with conditions present when indoor air and sub-slab vapor investigations were last conducted. Thus, we agree that additional indoor air investigations are not warranted at this time.

Figure 30. PCE and TCE concentrations show strong seasonal influences, and the prevalence of PCE relative to TCE and cis-1,2-DCE indicates that the material is relatively undegraded. Indoor air samples were collected in 2013 and 2014; groundwater conditions have not changed since that time.
