MASSACHUSETTS DEPARTMENT OF ENVIRONMENTAL PROTECTION
FIELD ASSESSMENT AND SUPPORT TEAM (FAST)

**Evaluation of Investigations, Remedial Activities, and
the Potential for Vapor Intrusion at the
Varian Site, Beverly MA**

MassDEP RTN 3-00485

January 2021

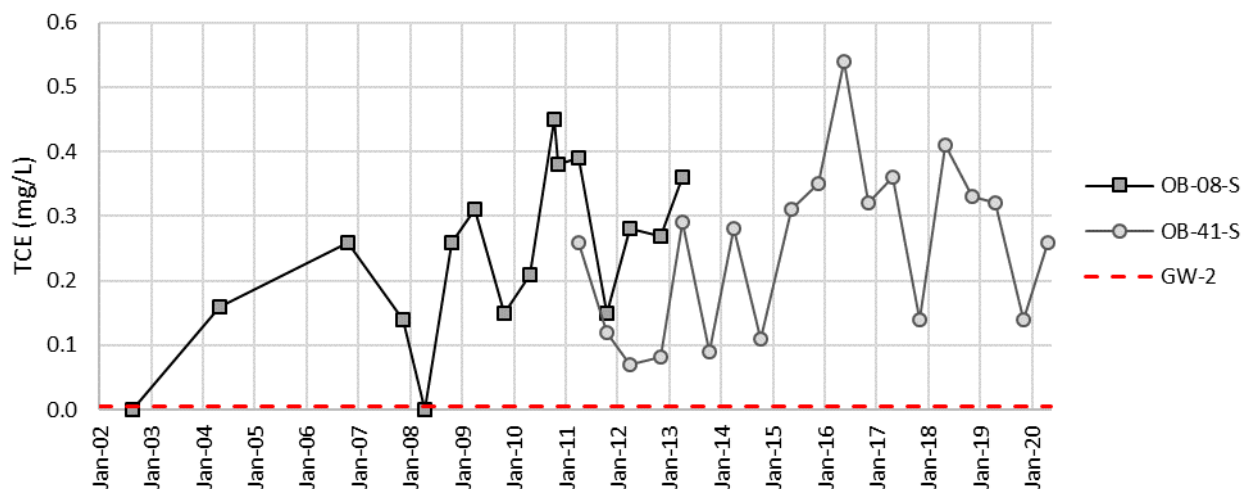
Figure 31. With one exception, shallow groundwater at 39 Tozer Rd. has been consistently above the 2016 GW-2 standard (Data from APTIM 2020b).

At this time, MassDEP recommends additional indoor air sampling at this facility. The 2013 indoor air evaluation was based on a single indoor air sample collected over a 4-hour period, and represents a snapshot in time that may or may not represent typical conditions. Though variable, groundwater concentrations have not trended down since the study was conducted in 2013.
