# Plan Of Action

## SCOUR CRITICAL BRIDGE WITH UNKNOWN FOUNDATIONS

| Structure #: 64-016-130 | Waterway: Brule Creek | Owner: |

# Bridge Inspection Report

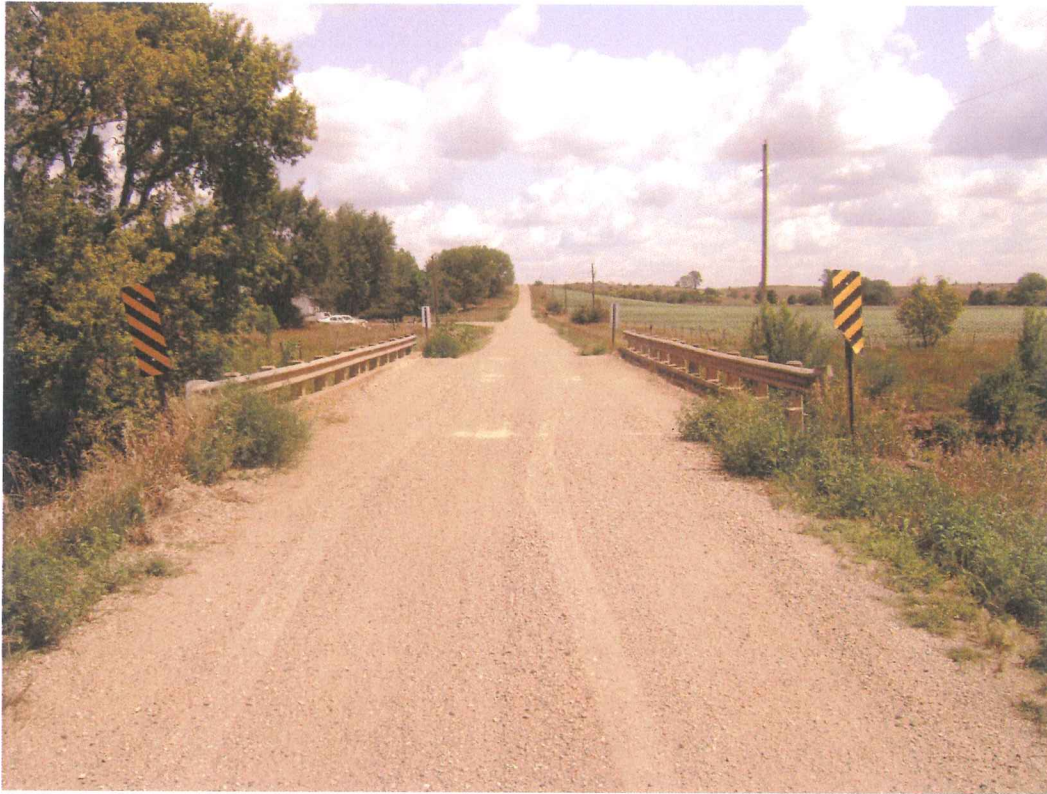
Roadway Facing East

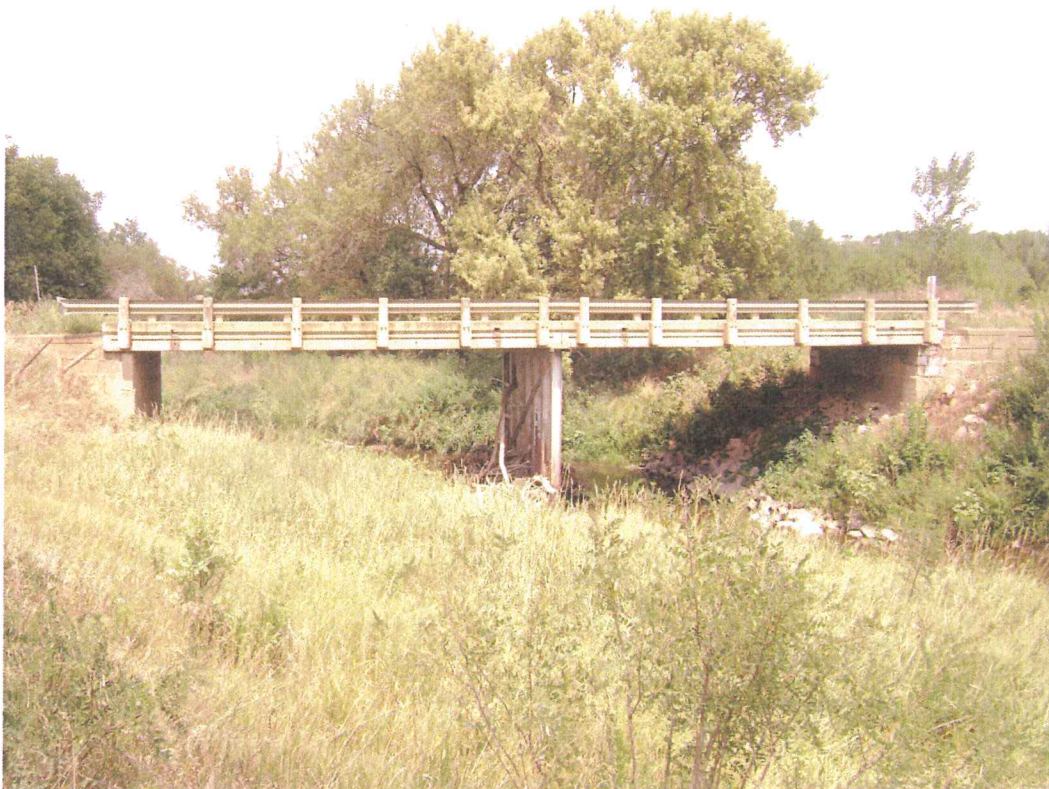
Profile Facing North

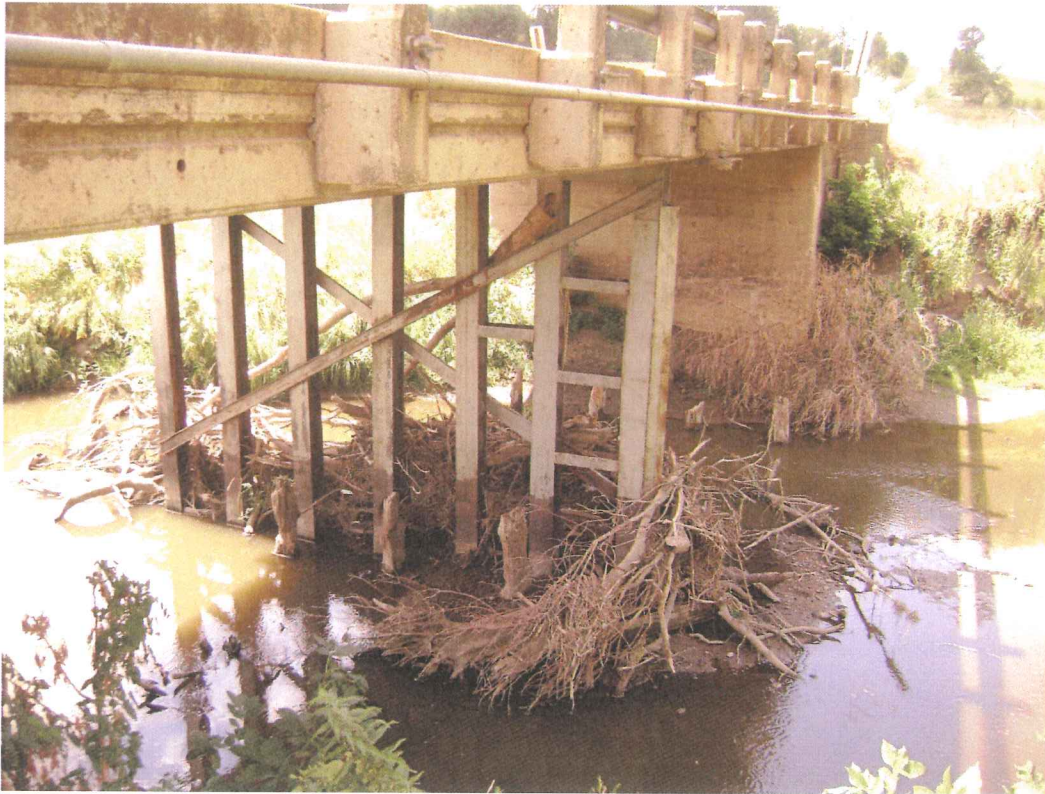
Channel has degraded 6.6' since 1998. Flow is from NW to S-SE and is adverse to 0° skew bridge. No scour problems. Huge amount of debris hung up @ Bent 2.

8-9-12 1 Massive amount of tree debris on Bent 2 (photo)  
2 Embankment erosion is not significantly worse - still 10'-15' high vertical banks @ outside bends of channel  
3-8 No change

Heavy Debris at Bent 2 – Facing West

1. Install FHWA approved approach guard rail.  
2. Install delineators for four at each corner.  
3. Open deck drains and remove gravel from curb lines.  
4. Tighten / replace deck unit stem tie bolts as necessary.  
5. Patch and seal concrete as necessary.  
6. Power tool clean and paint steel bent.  
7. Remove debris from channel under bridge.  
8. Repair abutment berm and riprap.  
9. Remove trees near bridge.
