# Aviation Investigation Preliminary Report

<b>Location:</b>	North Bend, OR	<b>Accident Number:</b>	WPR25LA124
<b>Date &amp; Time:</b>	April 7, 2025, 06:06 Local	<b>Registration:</b>	N826E
<b>Aircraft:</b>	HONDA AIRCRAFT CO LLC HA-420	<b>Injuries:</b>	1 Serious, 4 Minor
<b>Flight Conducted Under:</b>	Part 91: General aviation - Executive/Corporate

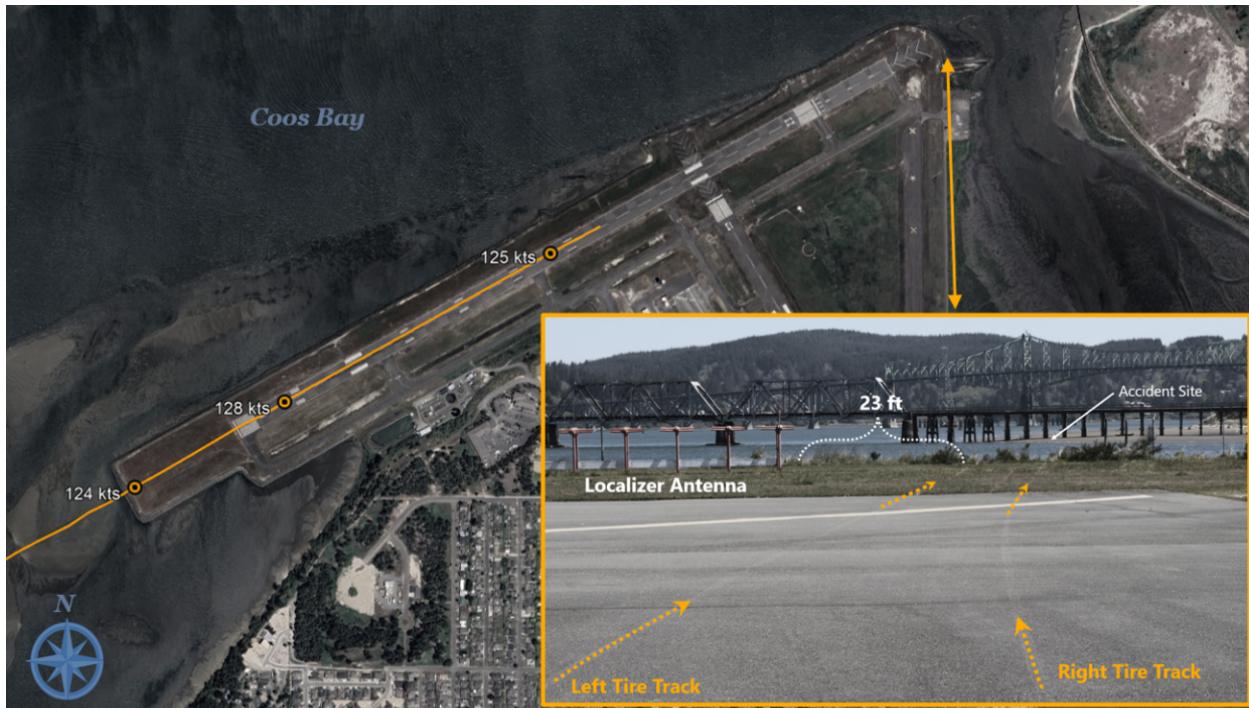
A review of the ADS-B data showed that at 0606:14, the airplane touched down on the runway near the aiming point markings. The airplane continued down the centerline, decelerating from a ground speed of about 128 knots to 125 knots, which was the last recorded hit (near taxiway Bravo). A visual examination of the runway surface revealed no evidence of skid marks or indications of the anti-skid braking system operating. Light tire tracks were observed on the overrun area and through the grass with no indication of braking. The left tire track was about 23ft from the end of the localizer antenna structure; the distance from the left winglet to the left tire is about 15ft (see figure 1).

Figure 1: ADS-B track and landing roll in reference to the localizer antenna.

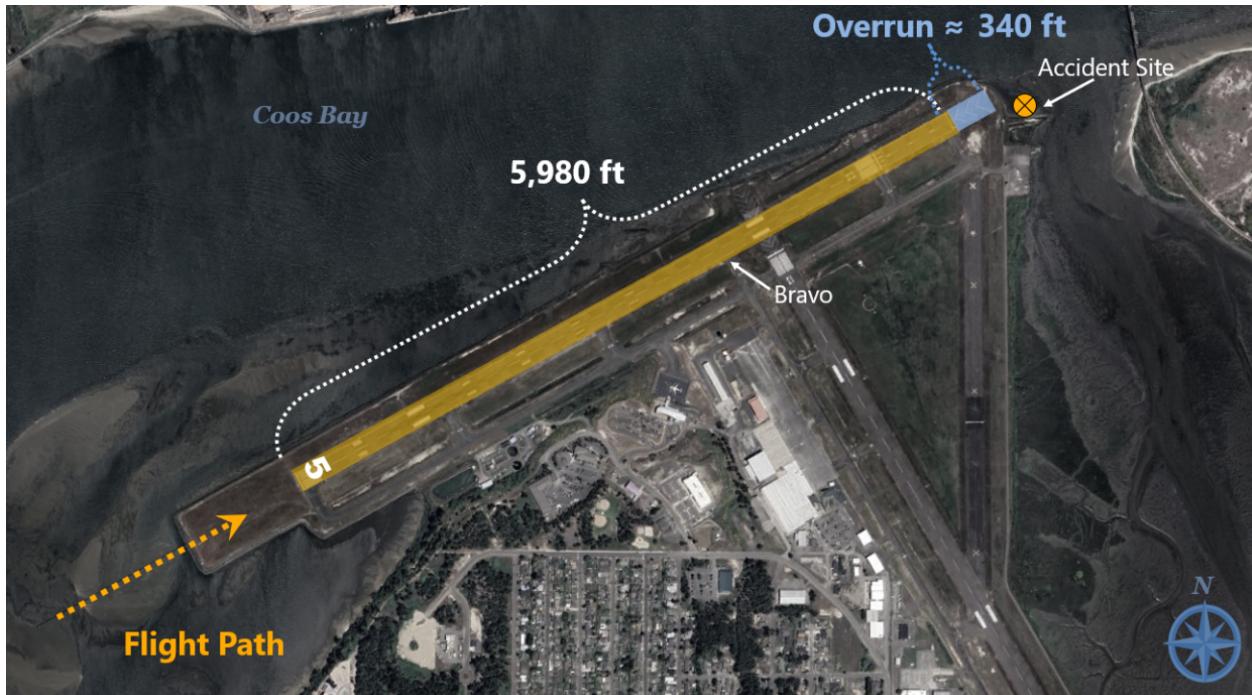
Located on the north side of the airport, runway 5 is oriented northeast-southwest and is 5,980 ft long by 150 ft wide (see figure 2). The runway is constructed of grooved asphalt/concrete and has a listed Landing Distance Available (LDA) of 5,320ft, which excludes the 660 ft length of the displaced threshold for runway 23. The overrun area is about 340 ft, followed by about 100 ft of grass and rocks between the end of the pavement and the water.

Figure 2: Runway 5 in reference to the accident site.

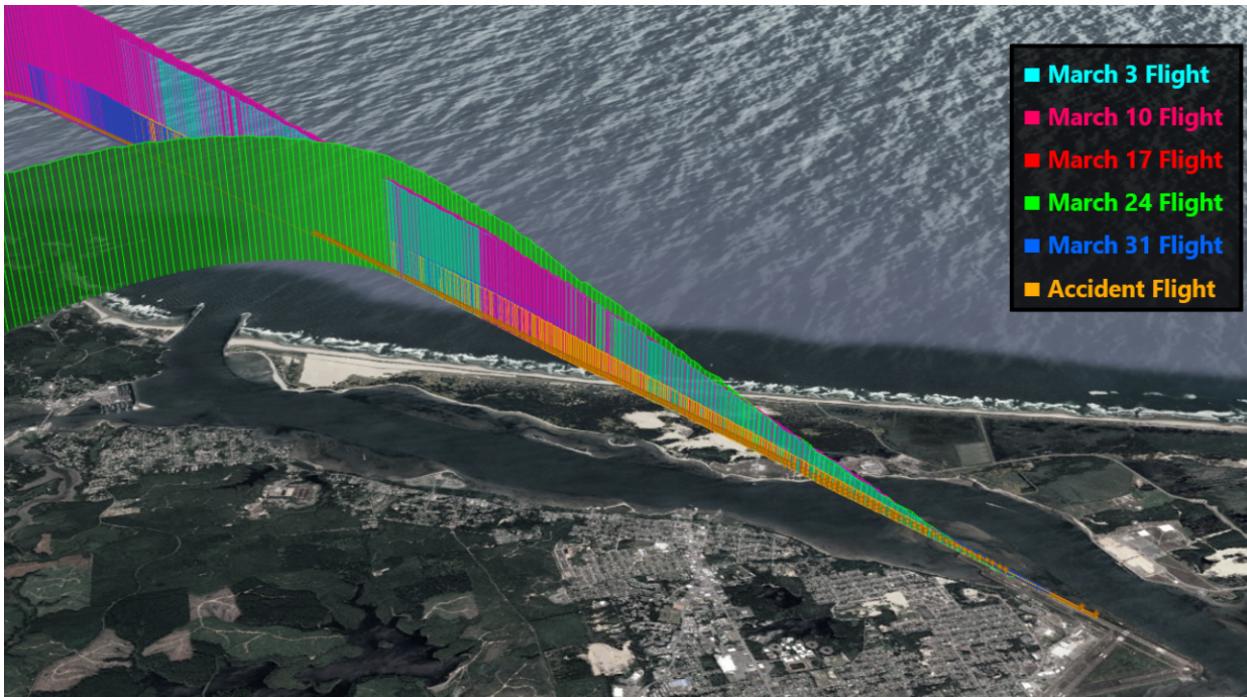
A preliminary comparison of prior flights and the accident flight was performed (see figure 3). The accident flight was similar to the previous flights, aside from a slightly higher ground speed at touchdown.

Figure 3: Comparison of the accident approach to the airplane's five prior approaches to that runway.
