**SUBJECT: Stabilization Loan**

**PURPOSE:** Approve Stabilization Loan for 1200 Gloucester Street.

**Historic Stabilization Loan Application for  
— 1200 Gloucester, Brunswick, Georgia 31520 —  
Rehabilitation/Restoration Plan & Timeline**

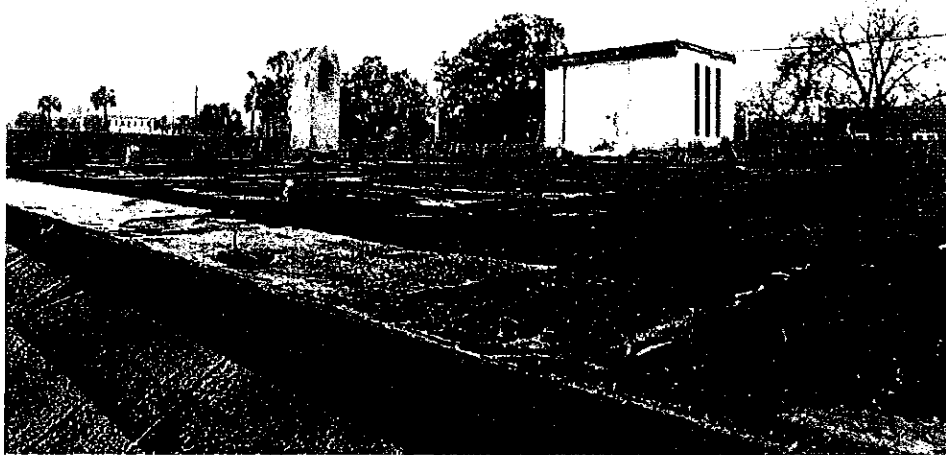
**Photograph 6 - Exterior Condition - Roof**

The ceiling in the service bay area obscures the structural elements of the roof, but the sagging of the ceiling itself, as well as evidence of roof leaks, indicate failures in the roofing system that warrant replacement of at least some of - if not the entire structure.

In our opinion, the roof of the building must be addressed. It is in serious disrepair and represents a hazard that must be remediated. If the roof continues to deteriorate and is allowed to collapse, this failure could result in a loss of structural integrity of the remaining building elements.
