Assessment of Public Housing

Alexander County Housing Authority
AMP IL007000001 – McBride Place

November 5, 2015

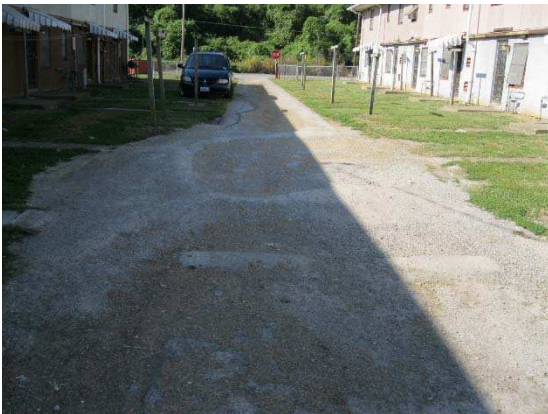
Image 1

Parking and drives; existing parking is located in small, centralized lots and on-street. Vehicle drives are located between buildings, connecting the parking areas to the streets or completely bisecting the sites from street to street. (Images 1 and 2)

Remove drives and interior parking areas that are not fully visible from adjacent streets. Restore these areas to lawn areas. Construct multiple, smaller lots located along all streets to minimize the number of vehicles per parking lot, provide close access to the tenant apartment, and provide a line-of-sight to parking areas for security. Fire lane access will be required between buildings. This can be accommodated by use of narrow concrete strips or wide sidewalks, reinforced for the weight of emergency vehicles.

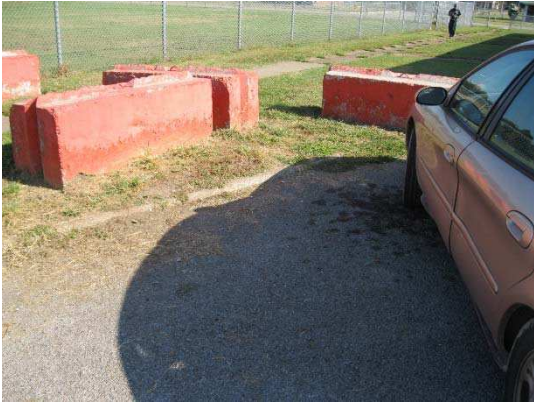
Image 3

The existing paving is significantly deteriorated and has undefined edges (no curbs) which allows vehicles to leave the paving and park in the lawn areas. This leads to bare lawns and ruts that retain storm water. The McBride development is located near the river, which has caused problems with sand boils to form in numerous locations. The HA has placed large, concrete barriers in numerous locations as an effort to prevent vehicles from driving into lawns. (Image 3) The parking lots at McBride are located near the center of the site and have become a security issue for crime activities. The numerous drives bisecting the sites would appear to be an element of danger, allowing vehicles to drive through areas in which tenants gather. The HA has constructed heavy steel gates at each entrance to close the drives during evening hours. (Image 4)

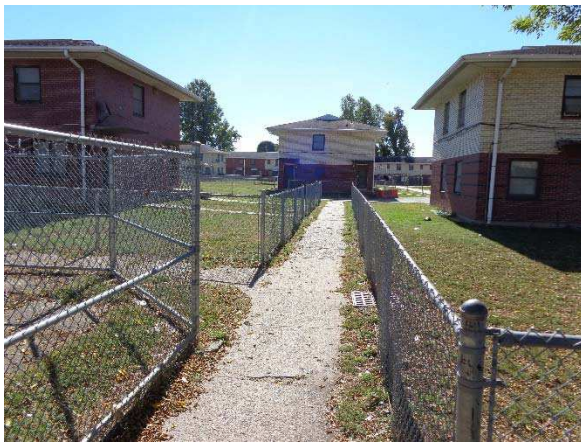
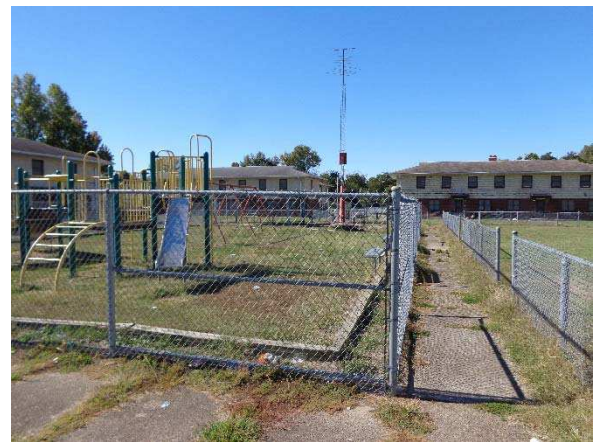
Fencing; the perimeter of the properties are enclosed with chain-link fencing. The fence is also located throughout the sites, enclosing playgrounds, play courts, and around the buildings. (Images 5 and 6)

Chain-link fence should be removed to provide a more open and inviting site for the tenants. Utilize structural steel ornamental fence panels in specific areas of the site to help deter unwanted pedestrian circulation.

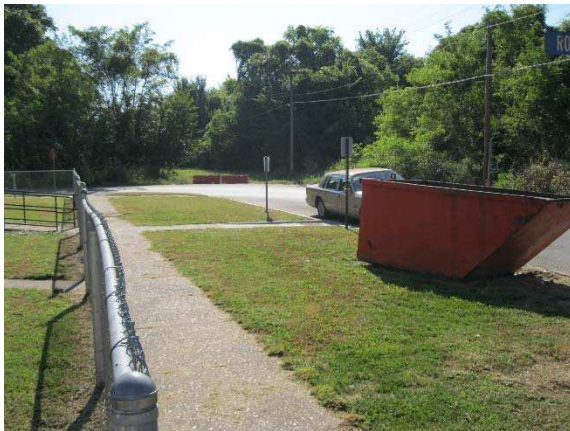
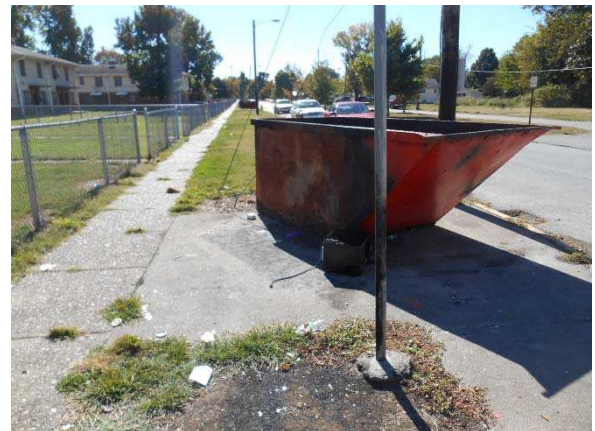
Trash containers; there are currently 13 dumpsters located at the two developments. The dumpsters are located along the street or in parking areas and are not located in defined enclosures. (Images 7 and 8)

The biggest impact to improve the negative appearance of the dumpsters would be to replace the dumpsters with individual trash containers (trash cans) for each tenant. As this can be difficult to negotiate with local refuse companies, it appears to be most feasible to construct defined dumpster pads with decorative enclosures. Other PHA's have had success with decorative steel fencing and painting the containers to match the fence.

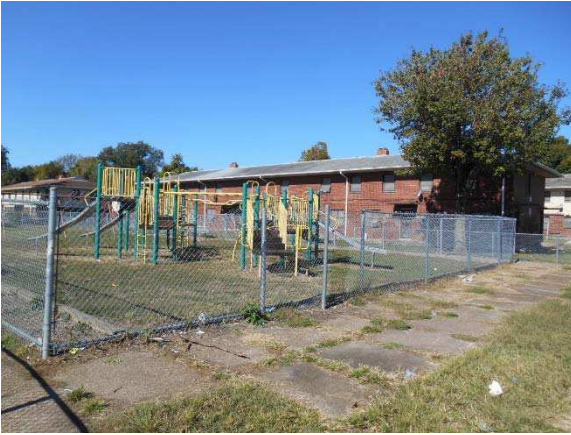
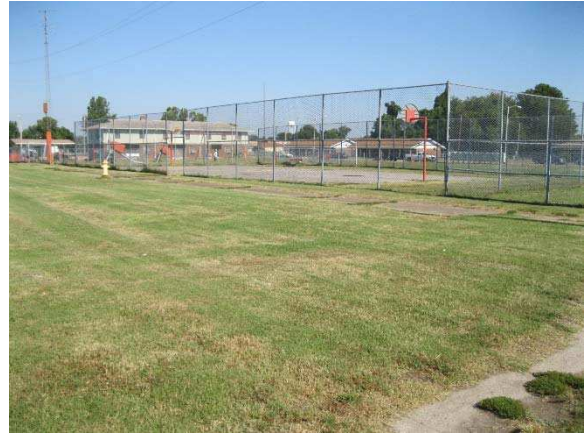
Playground and Play courts; the existing playground structures are aged, in need of repair, do not have the required impact surfacing, and are not accessible to persons with disabilities. The playcourts have broken or missing equipment (tennis nets, basketball goal nets), are in need of resurfacing, and are not accessible to persons with disabilities. (Images 9 and 10)

Replace playground structures with new equipment and safety surfacing that meet the current codes and ADA. Determine the play courts that are to be refurbished and make the necessary repairs. Unused play courts shall be removed and restored to lawn.

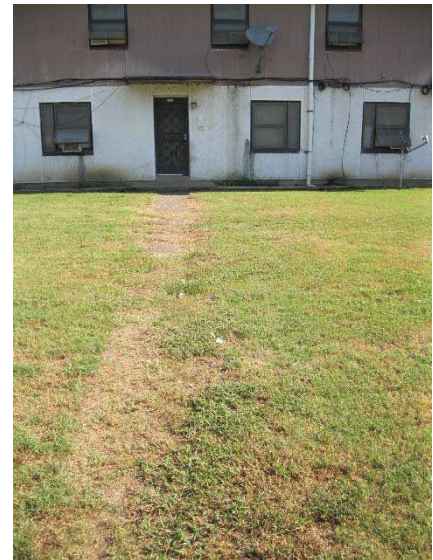
Image 11

Pedestrian circulation; the existing concrete walkways bisect the sites from street to street and do not limit access to any part of the site. The majority of the walks have pitted surfaces, are cracked, and have grass either growing in the joints or are partially covering the edges of the walks. This condition does not meet the ADA requirements. (Image 11)

Replace all walks throughout the sites with new concrete walks. Design the new walkways to provide defined pathways to units/buildings and minimize the amount of walks. All common areas and services at the sites will be served by new walks.

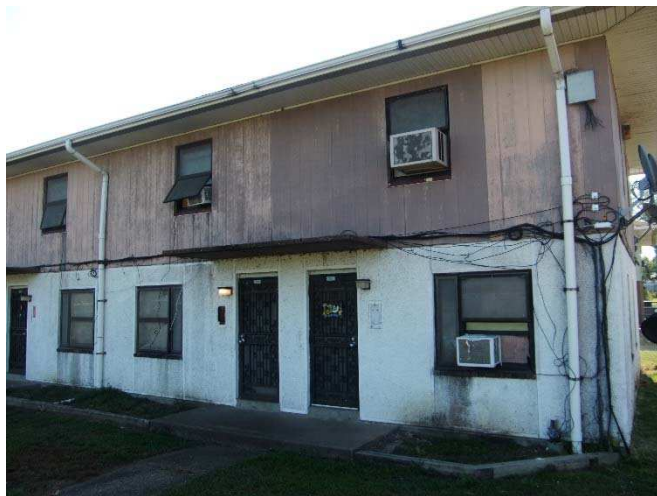
Image 12

The buildings are constructed of slab-on-grade first floor, structural concrete second floor, load-bearing exterior/interior masonry (cmu) walls. The original construction had low-slope roofs on wood framing. The roofs were overframed with steep-slope wood trusses and shingle roofing in the 1998. The original brick veneer is still visible at the Elmwood Place apartments (Image 13), but have been covered with stucco and siding at the McBride Place apartments. (Image 12)

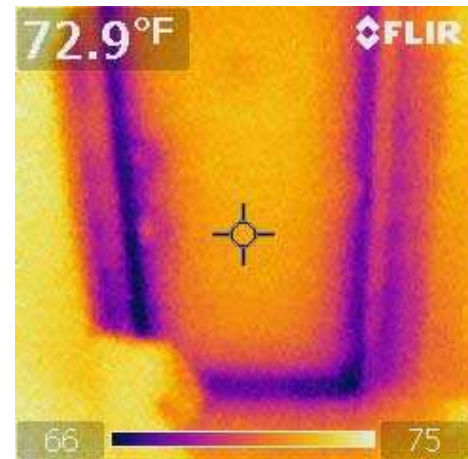
Image 14

The exterior doors, frames and hardware to the apartments need replaced. Several doors were found no longer anchored to the opening. The majority of the door openings have no weatherstripping, allowing air infiltration into the unit (see thermal picture, Image 14). Several apartments were found with no working lock on the exterior doors. The screen doors are very strong, but need hardware replaced in many locations. The windows need hardware replaced and are protected with exterior vandal screens that appear to prevent most occurrences of glass breakage.

All exterior doors and frames should be replaced, including hardware and weatherstripping. The screen doors, windows and window screens repaired.

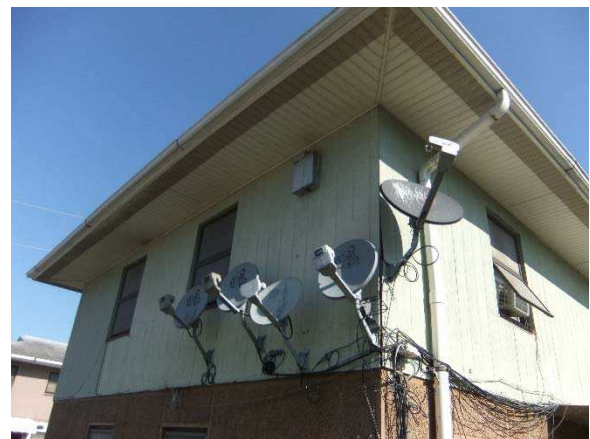
Image 15

Cable/satellite television wiring has been installed without any regard to aesthetics. (Image 15) It was noted by the HA that most of the wiring is no longer needed or working. Satellite dishes are also located on buildings without any regard to the mounting locations as it affects the building envelope.

Cable/Satellite wiring should be removed and the units pre-wired for the services. Common utility boxes can be provided to allow the services to the apartments without the need for the telecom company to add wiring or equipment to the building. The HA should adopt a policy to prevent the telecom companies from installing wiring or equipment to the buildings without permission from the HA.

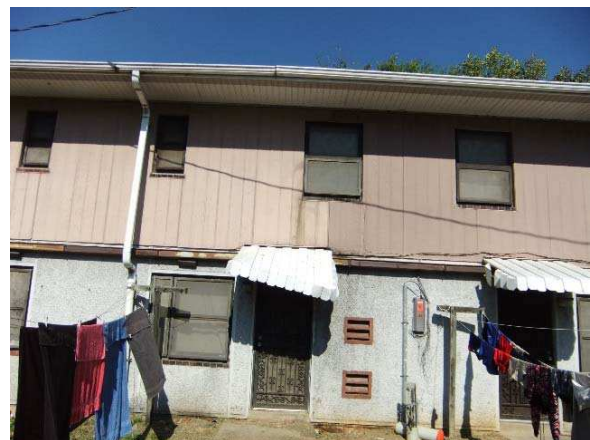
Image 16

Metal canopies are installed at the rear door entrance to the apartments. Almost all of the awnings need some level of repair or refurbishment. (Image 16)

To aid in the aesthetic value and provide a better cover for the apartment entrances, the metal awning should be removed and a framed canopy be constructed. The concrete stoop replaced with a larger stoop to match the canopies and frostwalls be constructed under the stoops to stabilize the stoop and prevent future areas for rodent nesting.

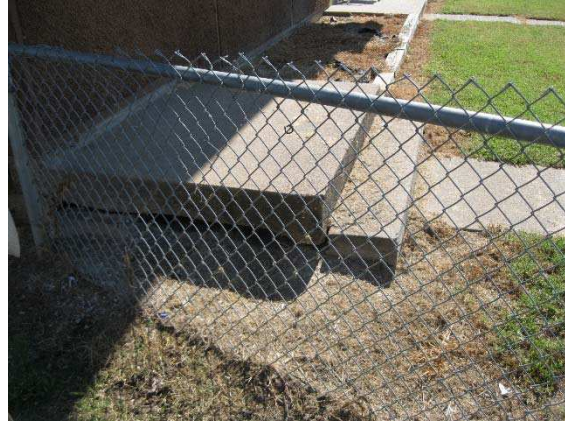
Image 17

The front stoops were not constructed with a perimeter frostwall. The lack of this frostwall has allowed voids under the stoop to become a point of erosion and for the nesting of rodents. Steps at the stoops have settled and become unlevel. Railings are needed at many locations due to the height above grade. (Image 17)

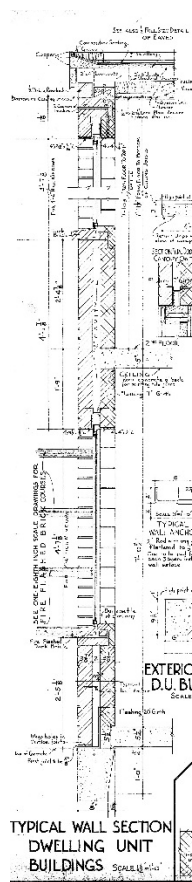
Image 18

The exterior walls are constructed of load-bearing cmu with brick veneer. An approximately 2" air-space (cavity) exists between the exterior brick and interior cmu. (Image 18) No insulation was installed in the original construction and no insulation has been known to have been installed as part of a modernization project. The addition of insulation to the wall system will be difficult as location of the insulation material in the wall could have severe negative effects. If the insulation is improperly placed, moisture could form inside the cavity, causing additional deterioration and mold problems. Application of the insulation to the interior will require furring of the interior walls, relocation of the baseboard heat piping and convector covers, modification to electrical systems, modification to all cabinets, shelving, and other equipment that abuts the exterior walls, and may create problems with tight spacing at stairs. Application of an insulation system on the exterior of the wall may be considered, but the long-term problems with maintenance of exterior insulation systems due to weathering and vandalism will be very costly if the system is damaged. Application of insulation into the cavity is not feasible or practical due to the requirement to penetrate the brick or cmu to inject insulating material. In addition, a cavity insulation will further negate the drainage of moisture from the cavity, leading to additional problems with mold as discussed above.

The exterior of the buildings need to be treated for the water infiltration and management. The exposed brick veneer should be pointed as necessary, cleaned and sealed. The siding on the 2nd floor

at McBride removed and evaluated if new siding is required or the brick veneer restored. As the stucco panels on the 1st floor at McBride will be difficult to remove and the damage to the brick beneath may be significant, the stucco can be restored and sealed. However, if the stucco remains, weeps should be added to the panels to aid in the water management of the cavity wall. It would be suggested that a prototype project be performed to determine if the stucco could be removed and the brick restored.

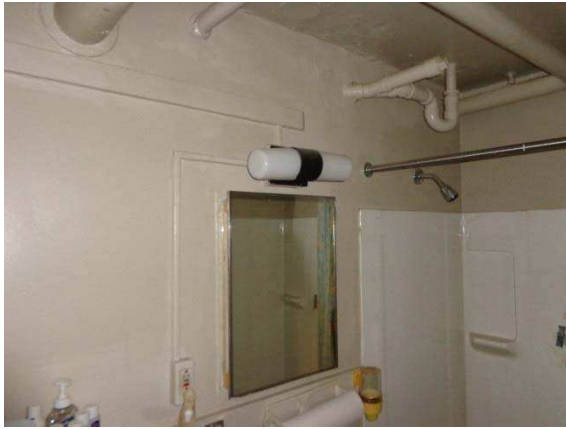
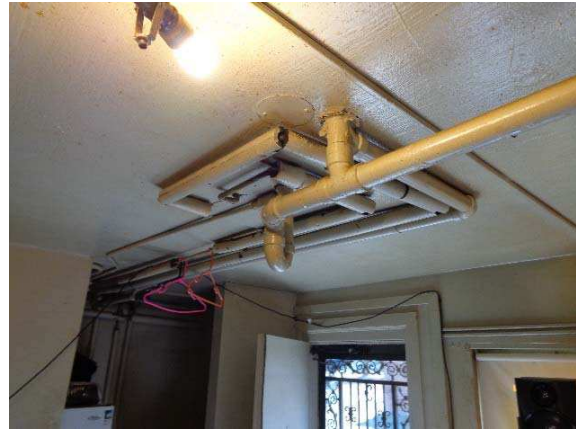
Problems with underslab sanitary lines and water piping were reported by the HA maintenance personnel. Repairs to these systems are difficult as it requires removal of concrete floor slab to excavate the existing lines and install new piping. Tenants would be relocated for a period as the work is performed and the plumbing is inoperable. The presence of asbestos containing flooring also adds another element of time and expense to perform this work. Repairs made to the sanitary system have resulted in exposed piping in bathrooms and kitchens as the access to the walls was not feasible. (Images 19 and 20)

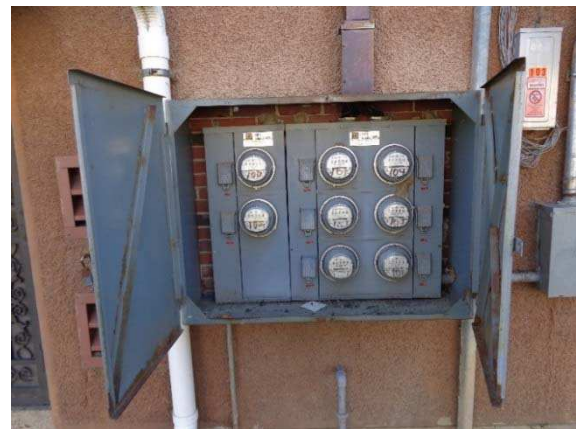
Image 21

The electric meter bases and disconnects for all apartments within a building are centrally located. Although the meter bases are aged, no current problems are reported. Each apartment is served with a 100 amp service. The meter bases are located within a cabinet and the cabinets are secured from tenant access. (Image 21)

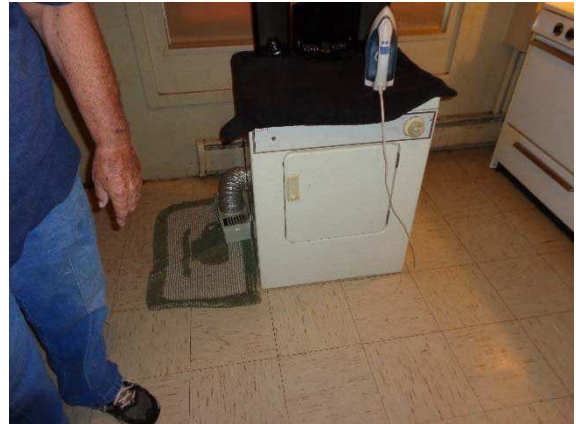
Image 25

The kitchen deterioration varies within the apartments, but all are in need of new cabinets and countertops within the next 5 to 10 years. Many have damaged or missing doors, leaking sinks and old appliances. All apartments have had vented range hoods installed since original construction, but the hoods need replaced. Washer/dryer connections are not present in all apartments, only a small percentage have connection boxes installed. Most tenants connect clothes washers to hose connections found under the kitchen sink. (Image 23) No drain has been provided, so the tenant either drains the washer into the kitchen sink (which is not designed/sized for this use) or drains the waste out the window into the yard (which causes lawn damage and soil/suds build-up). (Image 24) Dryer vents are not present in all units. Many tenants vent the dryer out a window or allow the dryer to vent into the apartment adding uncontrolled humidity into the apartment, which leads to failing paint and mold development. (Image 25)

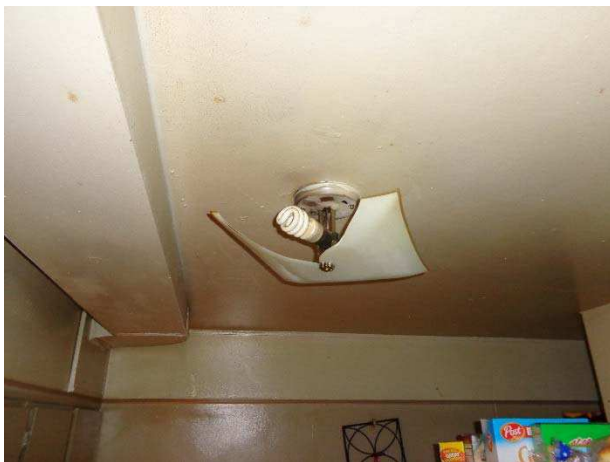
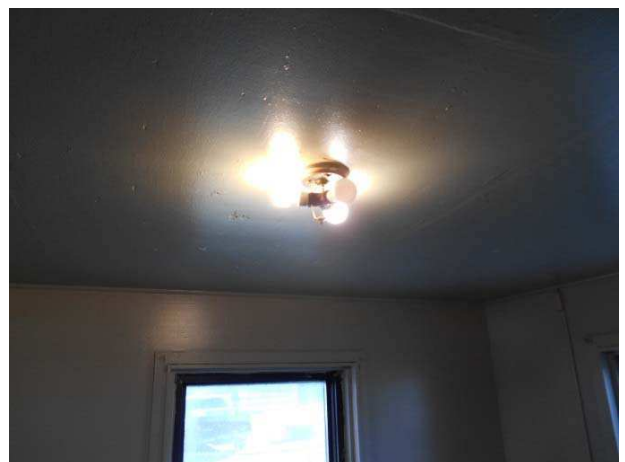
The majority of the light fixtures in the apartments are missing bulbs and the protective covers or are damaged. (Images 30 and 31) The electrical receptacles, switches, and wiring are old and need replaced.

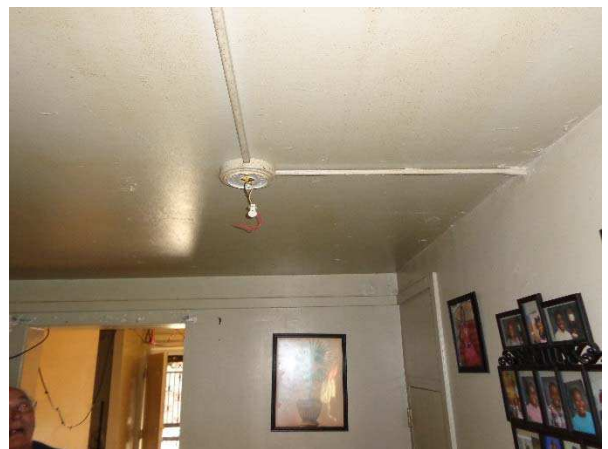
Image 32

Smoke and carbon monoxide detectors hard-wired 120v with battery backup. The majority of the detectors are missing, damaged or not working. (Image 32) The HA reports that tenants remove batteries, then damage or remove the detectors when the detectors "chirp" due to the missing battery.

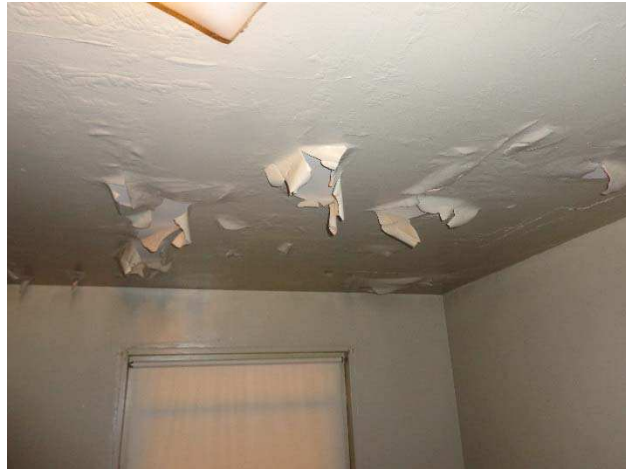
Image 33

Interior paint finishes on the second floor ceiling are peeling in many apartments. (Image 33) This may be due to humidity levels in the apartment, or due to incompatible latex/oil based paints. The ceilings need scraped, properly primed and repainted.
