Evaluation of Historic Property for the City of Tucson

1409 East Broadway

May 22, 2016

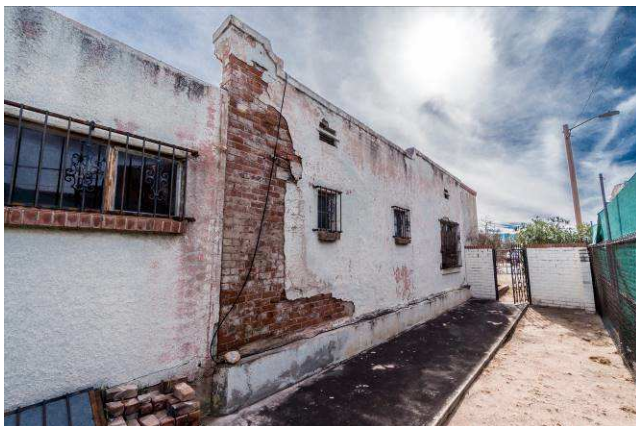
Exposed Brick and encapsulated stone foundation

- C. The furnace should be removed from the basement and the basement should be infilled with engineered fill to prevent further structural collapse.
 - D. Exposed exterior brick should be repointed.

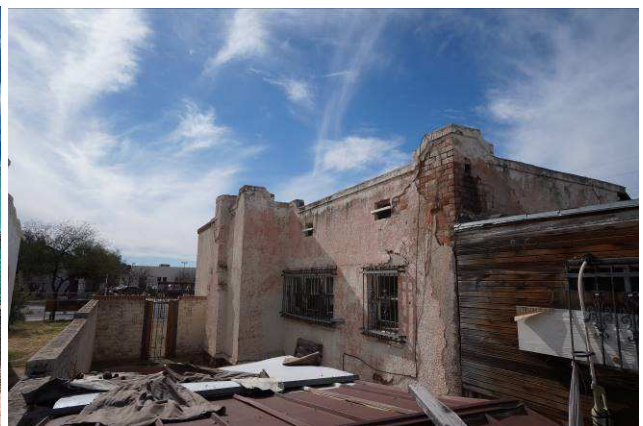
Missing Stucco at chimney, weather-beaten windows

- B. Restore wood windows.
- C. Abate and reglaze steel sash windows.
- D. Make minor repairs to interior doors.
- E. Repaint interior.
- F. Provide stucco finish at exposed brick.

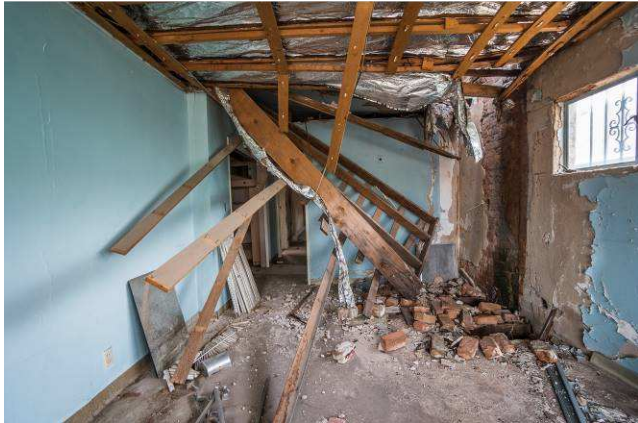
Collapsed beam and ceiling

- B. At the location of the collapsed beam, a new beam should be installed. The connection detail of this beam to the wall will need to be designed by a structural engineer.

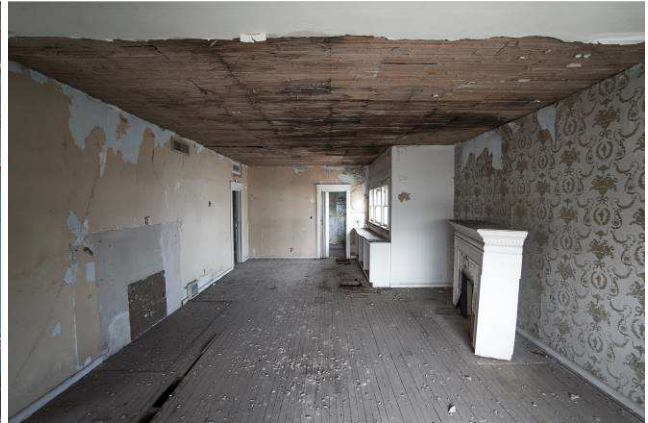
Plaster ceiling damage

- G. Paint entire exterior.
- H. All interior plaster finishes should be scraped and sanded to remove loose plaster and peeling paint. A bonding agent and skimcoat of imperial plaster should be applied to all wall and ceiling surfaces – where plaster is missing entirely from masonry, new metal lath should be fastened to the masonry and the wall replastered.

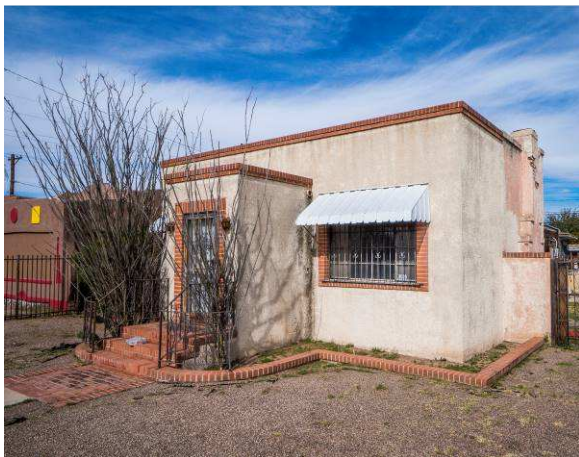
Southern Addition

A 275 SF addition was constructed at the south of the main building. The southern addition is double red brick with stucco and features prominent use of exposed red brick at the parapet cap, and framing the windows and doors. This exposed brick detailing is not present in the original building. The windows in this addition are steel sash. The eastern 2/3rds of the original southern façade of the building was removed as part of this addition – presumably a large wood beam has been installed to carry the remaining portion of the roof and masonry parapet above. The construction date for this addition is 1967.

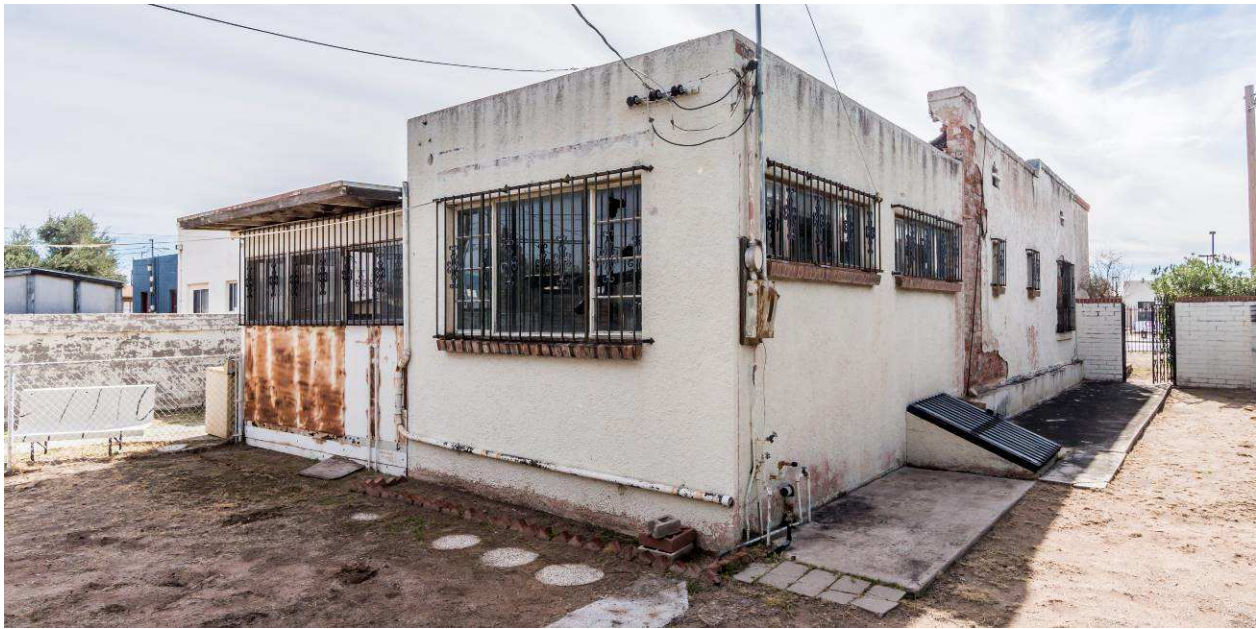
Northern Additions

A 490 SF addition was constructed at the north of the main building, possibly in two phases. The majority of the addition is double wythe red brick. This portion of the addition has steel sash windows. The exterior detailing of this addition is out of character with the original building, stucco is carried down to grade with no expressed foundation, and there is no stepping or banding at the parapet. Also associated with this addition is a basement accessed by an exterior storm door. The sole purpose of the basement is to locate and provide access to a gas furnace. The basement is totally unfinished with dirt floors – it is open to the crawl space. The western half of the original northern façade of the building has been removed at the connection of this addition to the original main building. A wood beam had been installed to carry the load of the original parapet and roofing, but this beam has subsequently collapsed. It appears that the end of the beam was subject to chronic water exposure and rotted over time, eventually slipping out of its pocket in the masonry wall. A 6'x6' section of the roof is collapsed, and water is free to enter the building unimpeded. It should be noted that this location is directly above the basement, which does not appear to have been constructed to any building code, and possibly undermines the buildings foundation. Continued water infiltration in this area may lead to collapse of the masonry wall over time. The construction date for this addition is unknown.

- 1) General approach.
 - A. The frame portion of the addition at the north of the building is very poor quality and condition and should be removed entirely. This addition includes the kitchen which should be relocated one room to the south. All fixtures, casework, and finishes in the kitchen should be removed. The masonry portion of this addition is in relatively good condition and may remain.

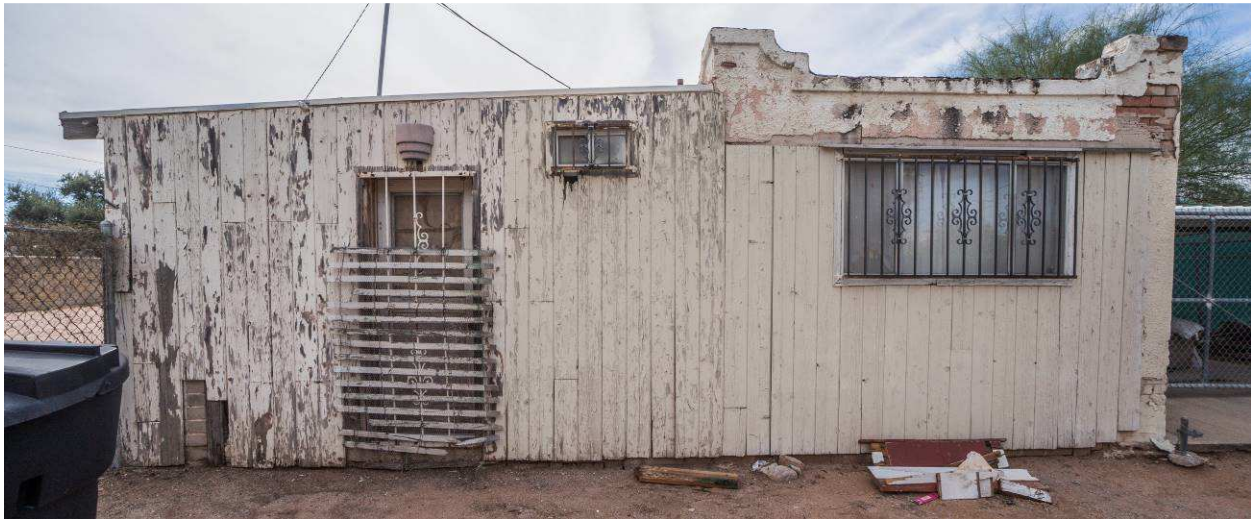
Outbuilding North façade

The condition of the outbuilding is poor. The building has seen very little maintenance over the years. Large sections of stucco are missing from the exterior. The exterior wood siding is in need of replacement. Exposed wood framing is weather-beaten and in some cases rotted.

- C. The entire addition associated with the out building should be removed and the building should be converted back to a garage or storage space. Guest houses and second units are not permitted in zone R-2 for lots of this size.
