## FIRE INVESTIGATION REPORT

Case # 18-591-06	Priority 1	Investigator Paul Ayres	Status Closed
Day of Fire Tuesday	Date of Fire 06/26/2018	Time of Fire 2:20 pm	Cause of Fire Undetermined
Date of Request 06/26/2018	Date Case Assigned 06/26/2018	Date of Investigation 06/26/2018	
City of Fire Gatesville	County of Fire Coryell		
Location of Fire 1507 West Main Street			
Type of Fire Investigation Origin and Cause	Injuries 13	Deaths 3

1. Undetermined
2. 1507 West Main Street, Gatesville, TX
3. Coryell Memorial Hospital
4. Tuesday, June 26, 2018

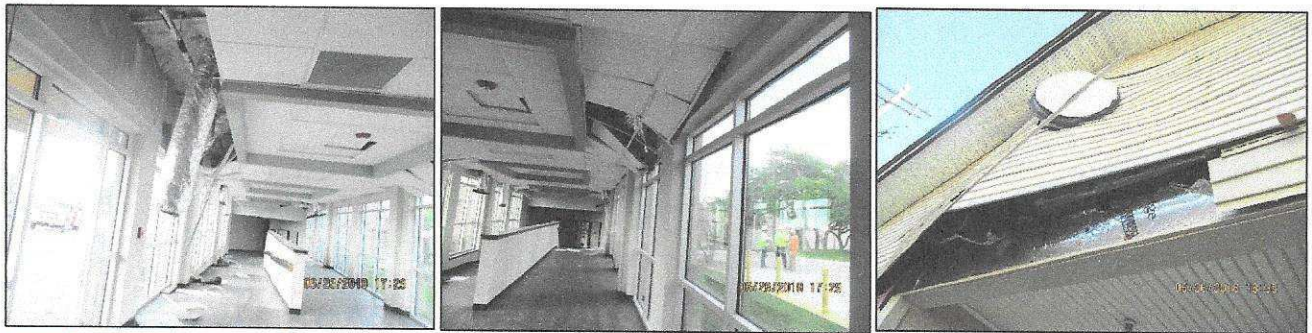
- 1.21 After examining the debris field, investigators focused on damage that was visible from the exterior and to surrounding structures. The existing hospital wing directly west of the explosion site sustained structural damage with buckling observed at the gable and at the eaves. Multiple windows were broken by the positive pressure front and glass was pulled back into the courtyard/loading dock area by negative pressure. Minor damage was observed inside a corridor just east of the explosion site, consisting of broken ceiling tiles and damaged ductwork.

Figure 4: Damage to surrounding structures

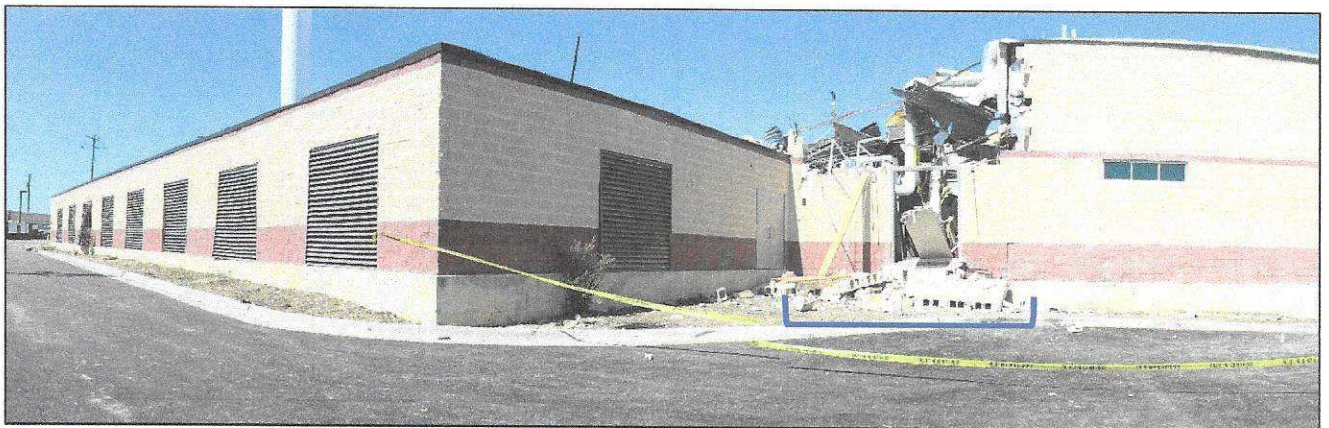
- 1.22 The west side of the explosion site was mostly intact with one area of significant damage. The west wall of the chiller yard was structurally intact, although a few vent panels for chiller ventilation were bulged or broken away from their brackets. A doorway and exterior wall at the southwest corner of the mechanical room, just south of the chiller yard, was significantly damaged with the top portions of the wall collapsed and the metal doors buckled and broken off their hinges (Figure 5; marked in blue).

Figure 5: Damage to West Side

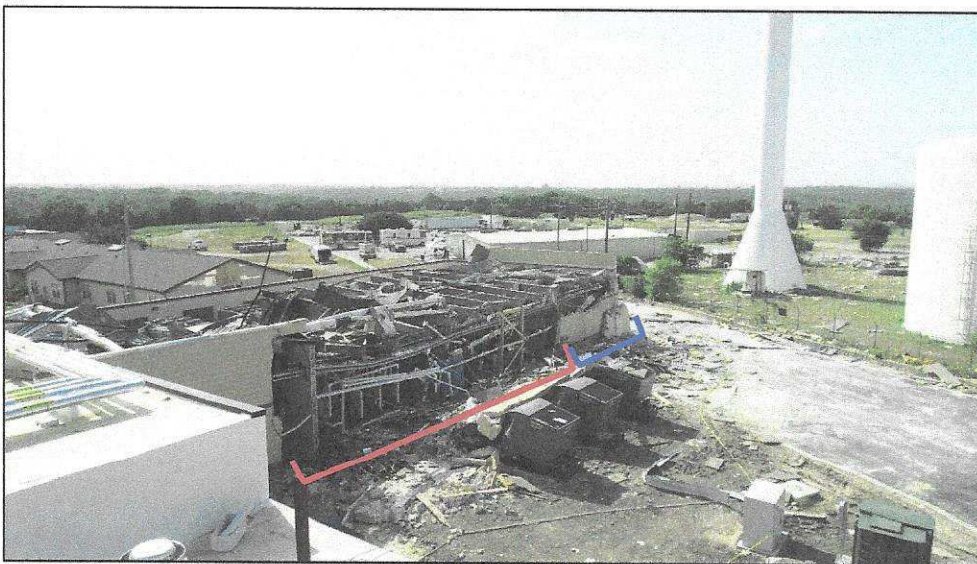
- 1.23 From the north, damage appeared relatively minor. While a large amount of debris was projected to the north, the northern wall of the structure was still intact and only leaning slightly at the top.
- 1.24 On the east side, the exterior wall of the mechanical room was collapsed. The most severely damaged portion of the wall was between a corridor at the south end of the mechanical room and the electrical rooms at the north end of the mechanical room (Figure 6; marked in red). This section of the wall appeared as though it had been pushed out at the top with the bottom being anchored and acting as a hinge. The wall had collapsed onto three emergency generators on the east side. A section of the same wall that was directly east of the electrical rooms was only collapsed at the top (Figure 6; marked in blue).

Figure 6: Damage to East Side

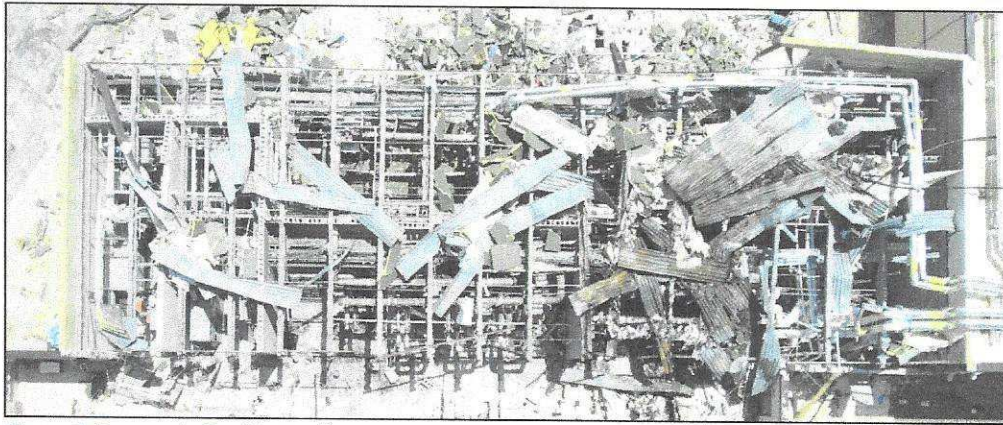
- 1.25 The entire roof over the mechanical room, boiler room, and electrical rooms had been destroyed by the explosion. Lightweight insulating material was launched into the air and was carried by prevailing winds. This explains the large debris field to the north of the explosion which is mostly lightweight materials. Metal roofing panels were scattered around the perimeter of the structure and some were still lying on the roof. Portions of the membrane covering were observed in the debris field. No portion of the roof over the mechanical room, boiler room, or electrical rooms was intact (Figure 7).

Figure 7: Damage to Roof Assembly

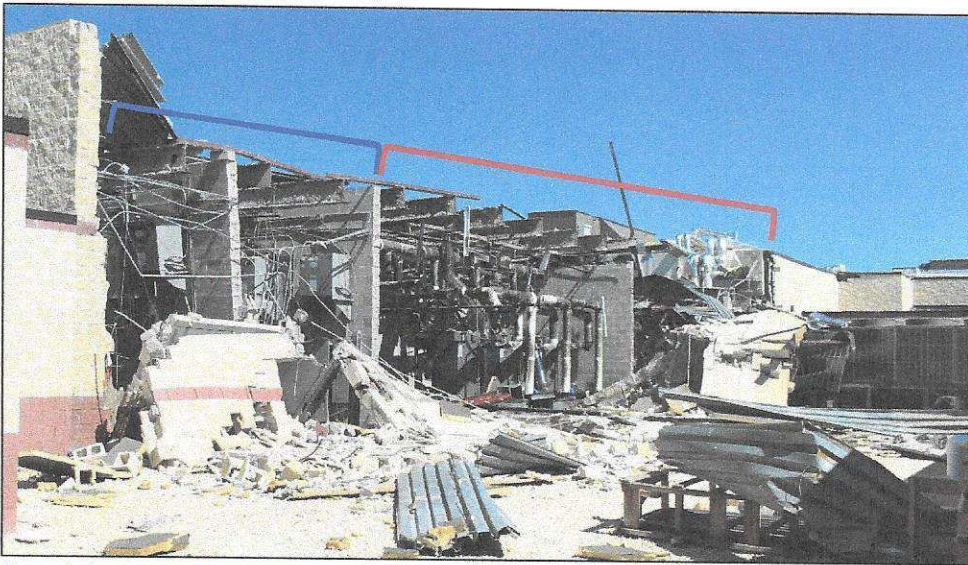
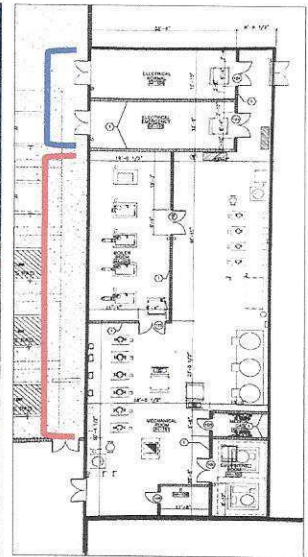
- 1.27 Investigators entered the chiller yard through a doorway on the north side. Once inside the chiller yard, investigators observed the western wall of the mechanical, boiler, and electrical rooms had completely collapsed into the chiller yard. The portion of the wall adjacent to the electrical rooms was mostly collapsed at the top with less damage to the lower sections of the wall (Figure 8; marked in blue). The portion of the western wall adjacent to the boiler room and mechanical room was completely collapsed with the top pushed out and the bottom acting as a hinge (Figure 8; marked in red). The western wall adjacent to the mechanical room was pushed further into the chiller yard than other portions of the wall. Based on these observations, it appeared that the majority of force was exerted at the south end of the mechanical room.

Figure 8: Damage to Western Wall of Mechanical, Boiler, and Electrical Rooms

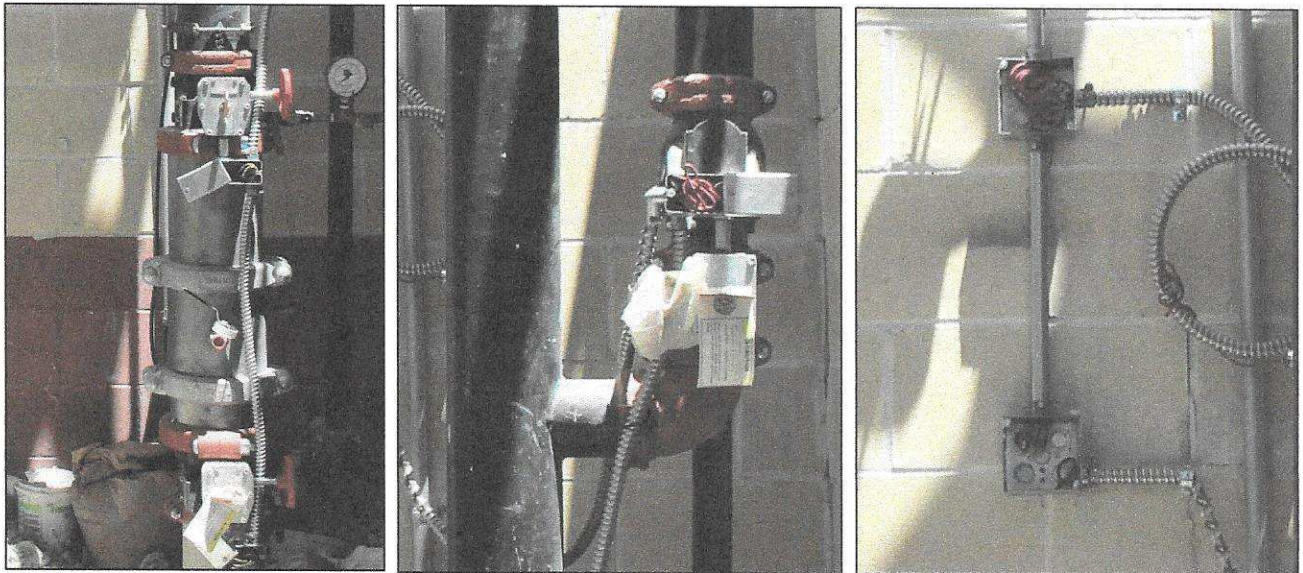
- 1.38 The structure had a fire sprinkler system (wet) and fire alarm system installed, but the sections in the damaged area were not yet operational because it was new construction. The valve at the base of the riser and an isolation valve were both in the closed position (Figure 9). Wiring had been pulled for the Initiating Device Circuit (IDC), but IDC modules for waterflow (alarm) and tamper (supervisory) were not yet installed (Figure 9). Wiring had also been pulled for the Notification Appliance Circuit (NAC), but not all notification devices were installed. Deputy State Fire Marshal Steve Walt conducted a comprehensive inspection of the fire protection systems on site. See the inspection report for further detail.

Figure 9: Fire Protection Systems

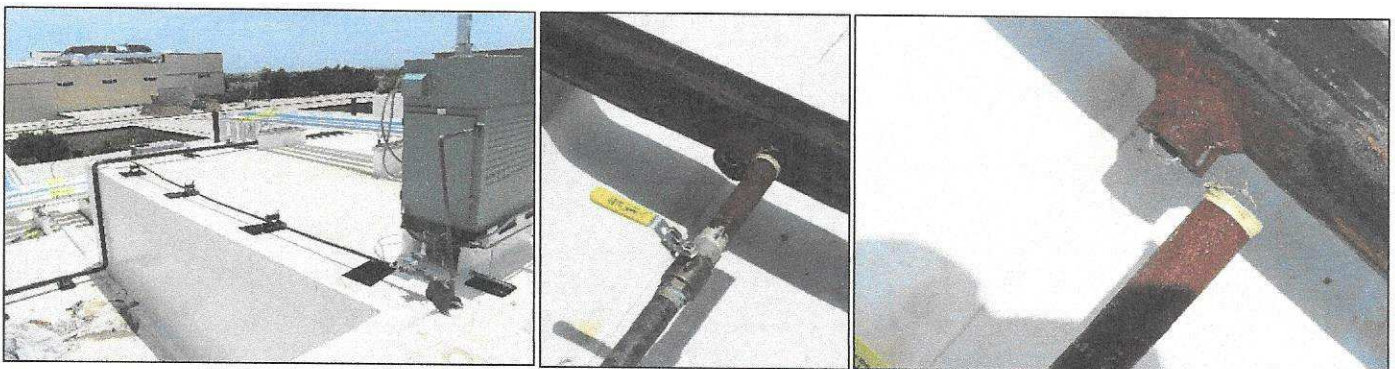
Figure 12: First indications of damage to the natural gas line were observed approximately 130 feet southeast of explosion site. The threads to the small diameter pipe were stripped and it became disconnected from the supply.

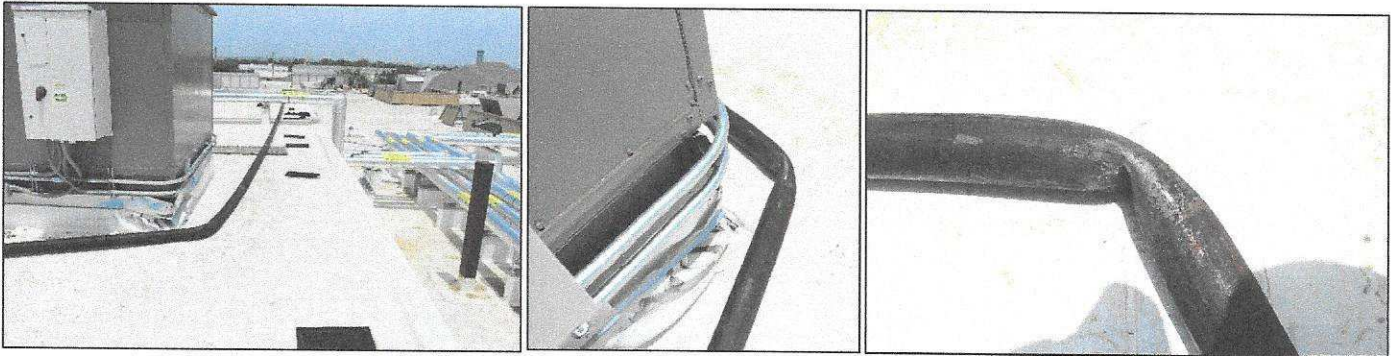
Figure 13: The natural gas line has dislodged from its support structures (black pads and rooftop rollers); severe bend/kink in gas line.

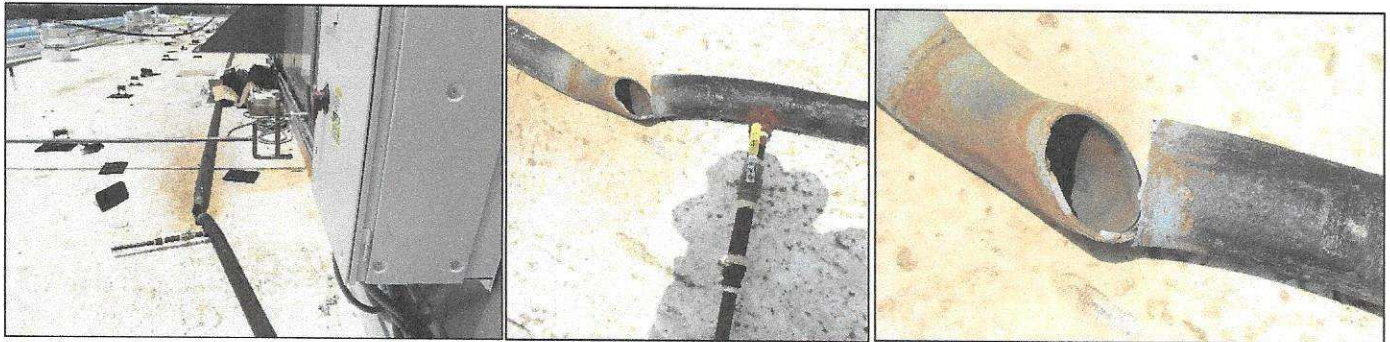
Figure 14: The natural gas line has dislodged from its support structures (black pads and rooftop rollers); fracture at a welded 90° elbow.

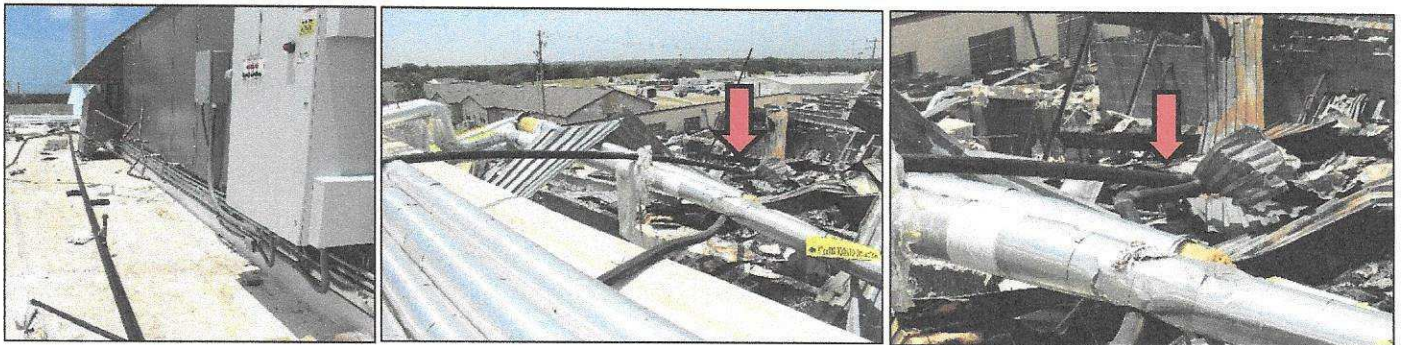
Figure 15: The natural gas line continued toward the mechanical room but was abruptly folded over by the force of the explosion.

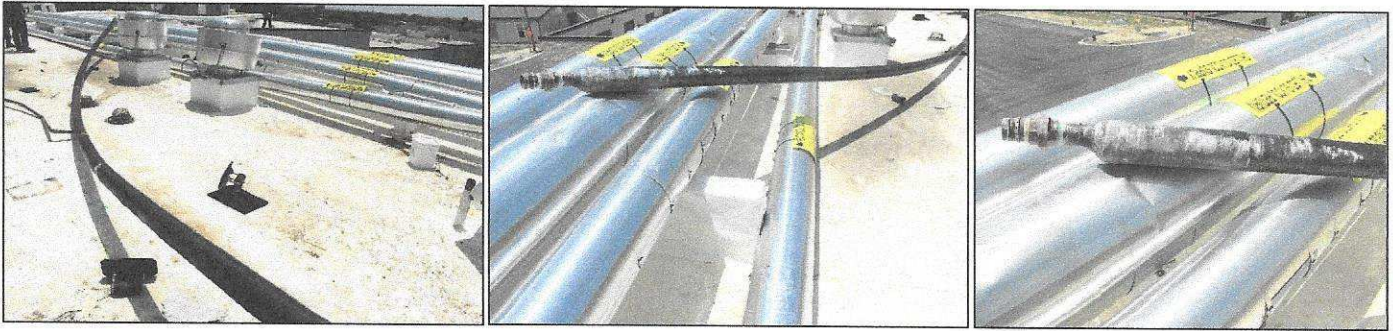
Figure 16: The portion of the natural gas line that was positioned over the mechanical room was thrown south of the explosion site. Note the slight bend caused by upward force of the explosion. A coupling was located at the end of this section.

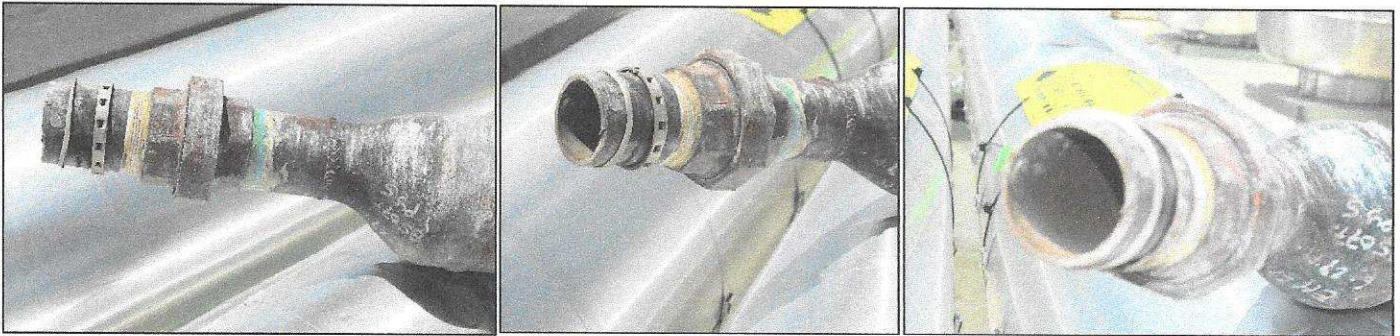
Figure 17: A coupling and fractured section of piping was located at the end of the section for in-line valve and regulator.

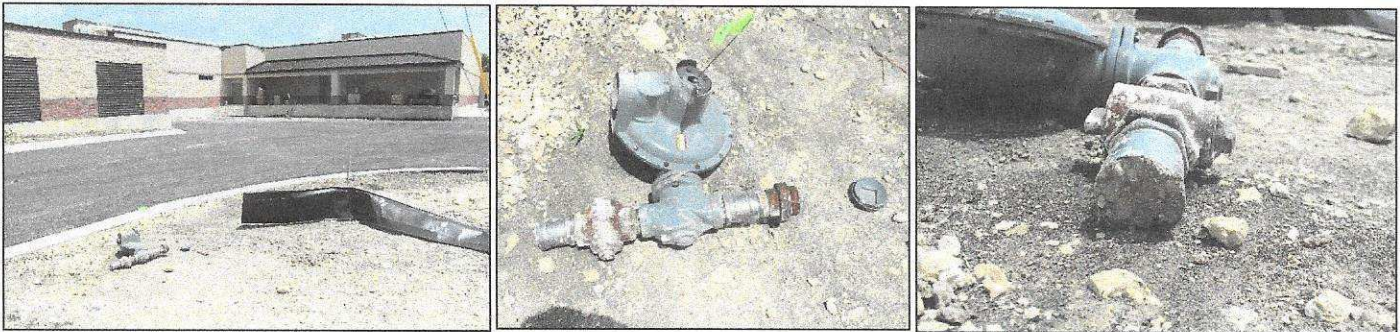
Figure 18: The in-line valve and regulator were located in the courtyard/loading dock area. The valve was in the open position.

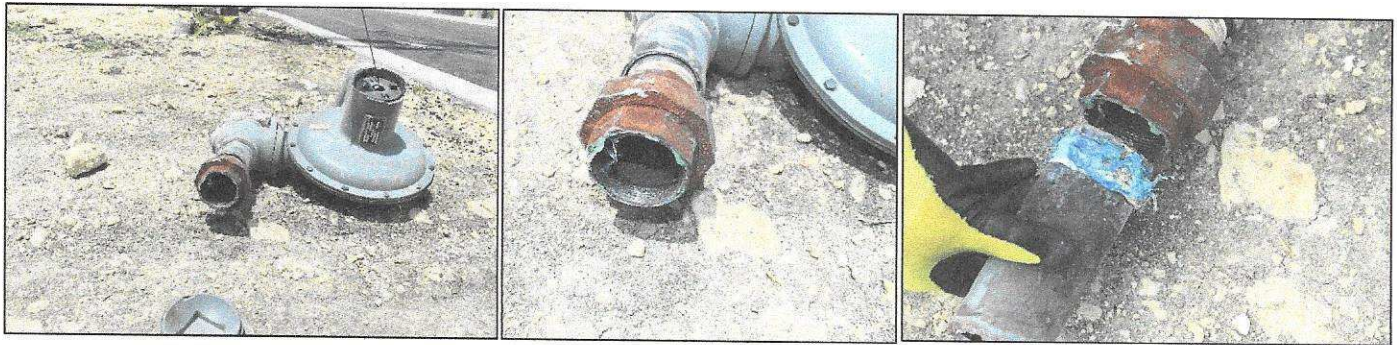
Figure 19: The coupling on regulated side of natural gas line matched a section of pipe found in the courtyard/loading dock area.

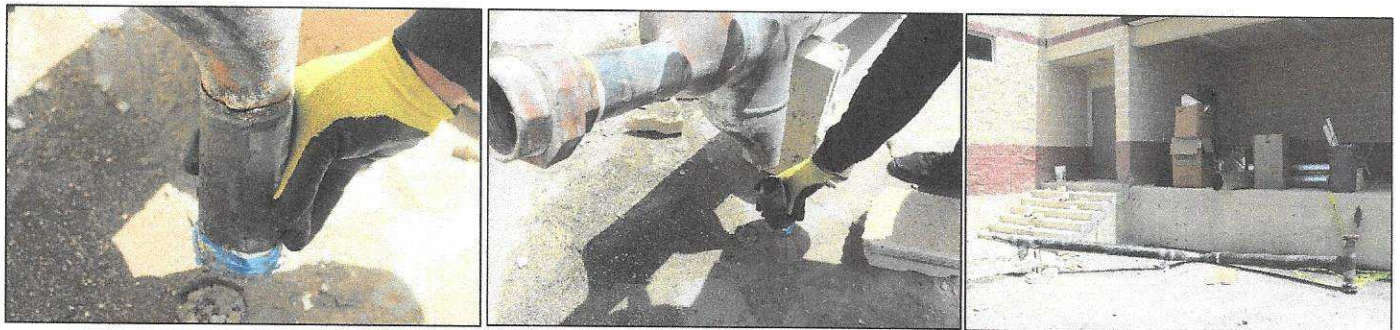
Figure 20: A large section of natural gas line was located next to the loading dock and was identified as the "tee" which split gas supply between the boilers and the water heaters. The section of pipe from Figure 19 matches the weld of the "tee."

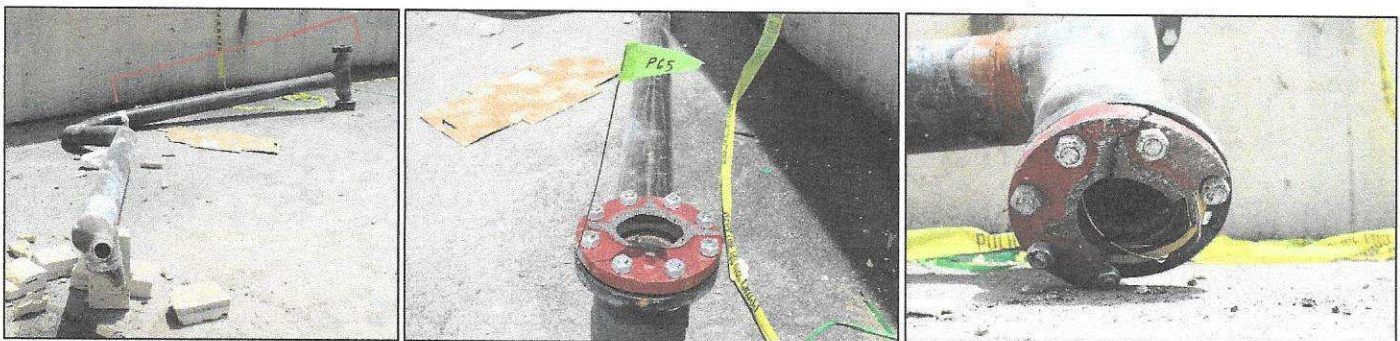
Figure 21: One side of the "tee" extended to the boiler room. The section above (marked in red) was identified as the riser to the boiler room. A "tee" was welded at the end of the riser with a fractured flange on each side of the "tee."

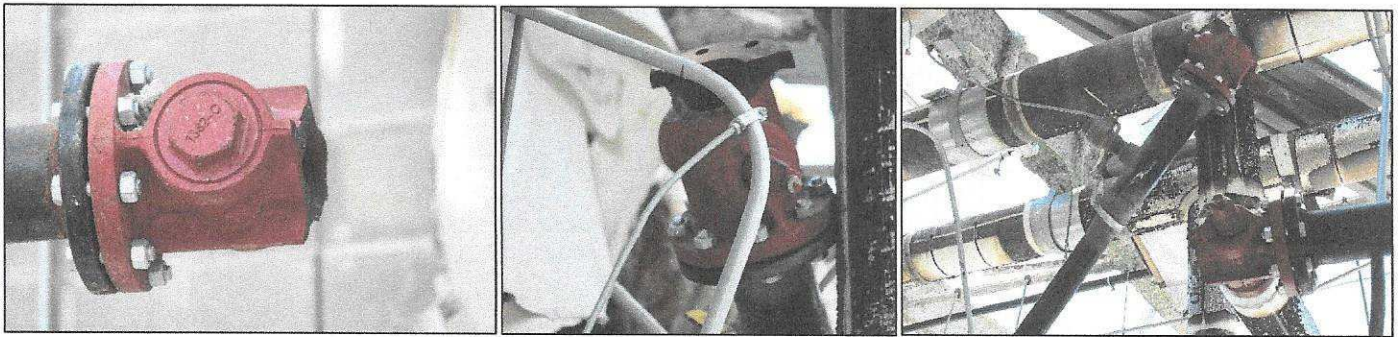
Figure 22: The fractured flanges shown in Figure 21 matched the fractured cast iron plug valve housings in the boiler room.

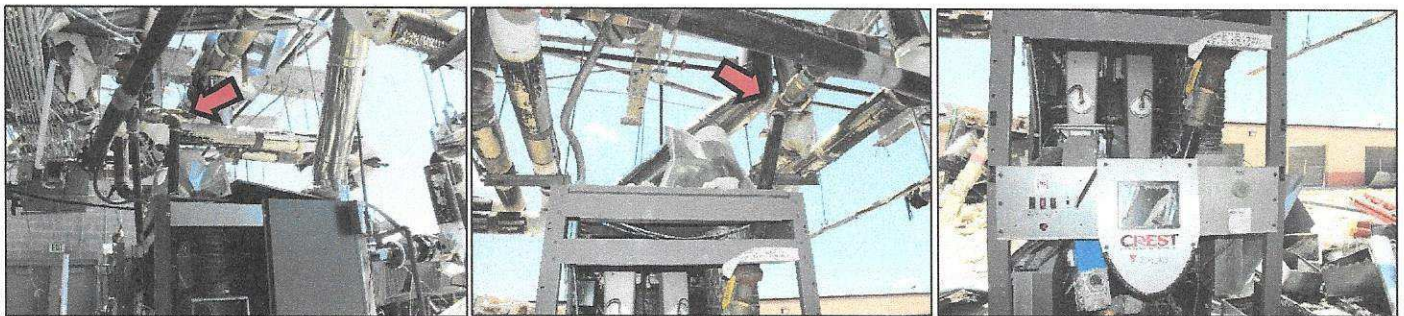
Figure 23: Natural gas lines extending from the supply to each boiler. In-line ball valves were in an open position.

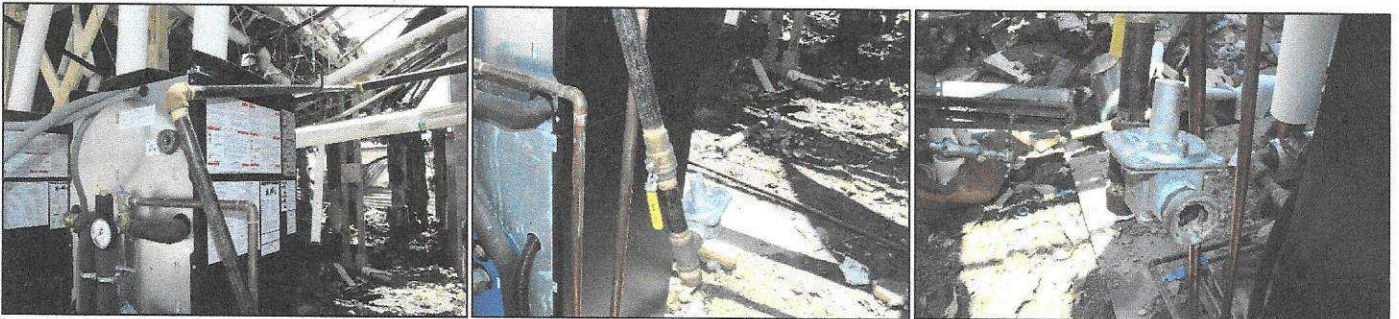
- 1.34 Further examination of the water heater units in the mechanical room revealed that the natural gas pipe supplying them had been disconnected at the coupling to the north and south units. These couplings were not sheared and did not exhibit any evidence of forceful separation. It was determined that the couplings were disconnected prior the explosion. The valves on both pipes were open, allowing natural gas to flow freely into the mechanical room. It is important to note that the most significant damage to the I-beams, electrical conduit, and glycol system was aligned with the location of the water heaters.

Figure 26: The natural gas line supplying the north and south water heater units were disconnected and the ball valves were in the open position.

- 1.49 Interviews conducted with construction employees revealed that plumbers were bleeding air off the natural gas lines. This information corroborated the open valves and disconnected gas lines observed during the scene examination. Witnesses denied smelling natural gas in the structure.
