Firefighter Fatality Investigation

Investigation FFF FY 13-06

West, Texas
April 17, 2013

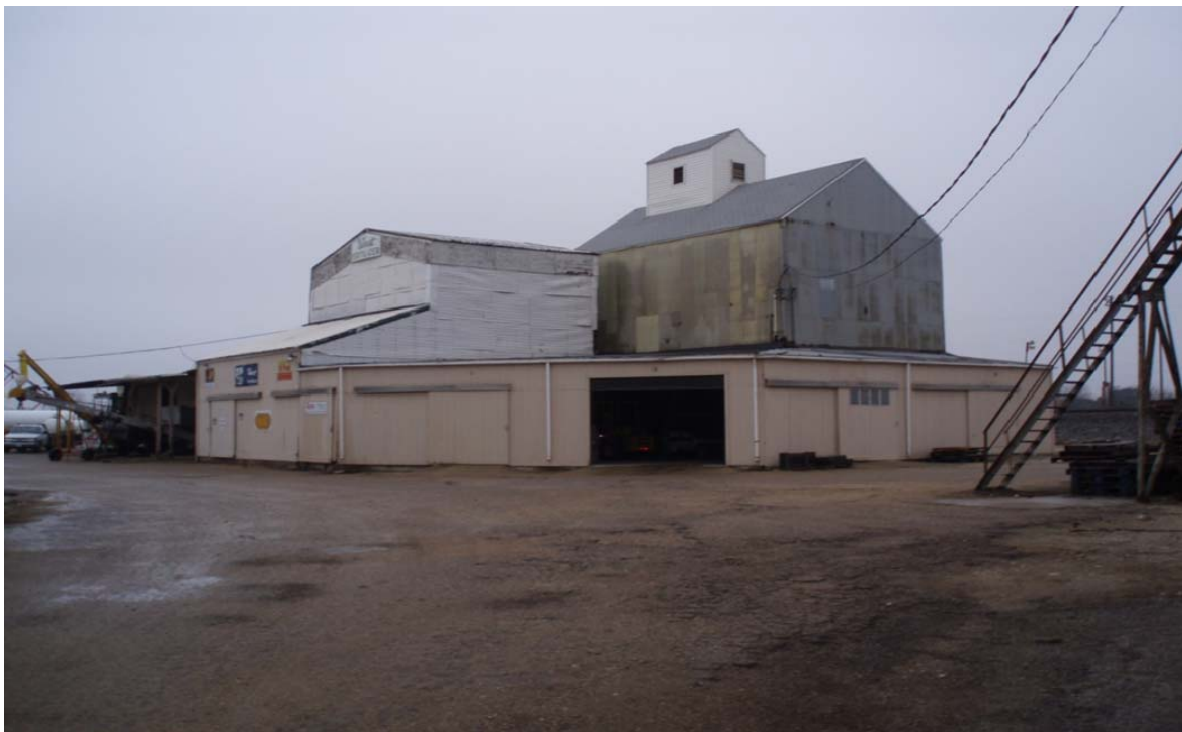
The bin contained an estimated 20-30 tons of ammonium nitrate. An air conditioner was installed to maintain low humidity levels and reduce “shrinkage loss” and caking of the ammonium nitrate product in the vertical bin. Investigators determined through interviews of the employees that the air conditioner was not in use the day of the incident.

View of the building from the northeast

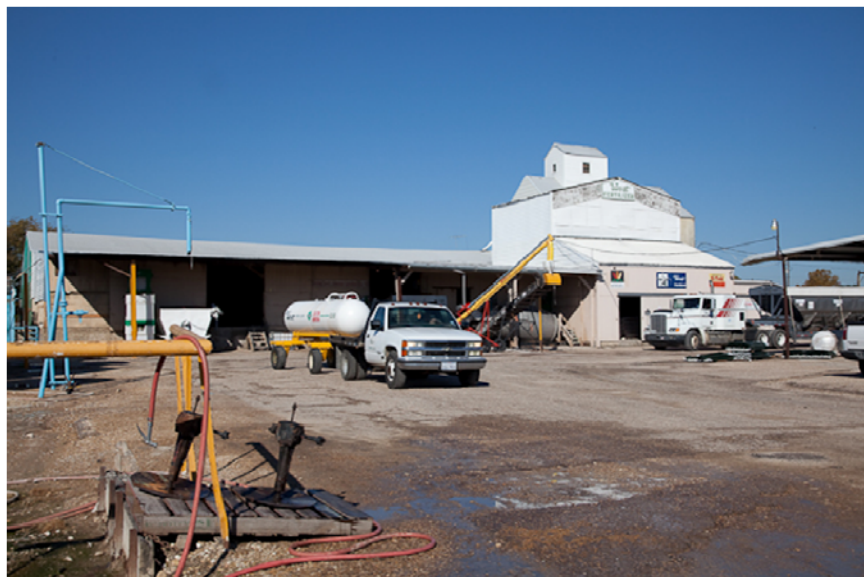
East side of the processing building where the mixing and delivery of chemicals occurred

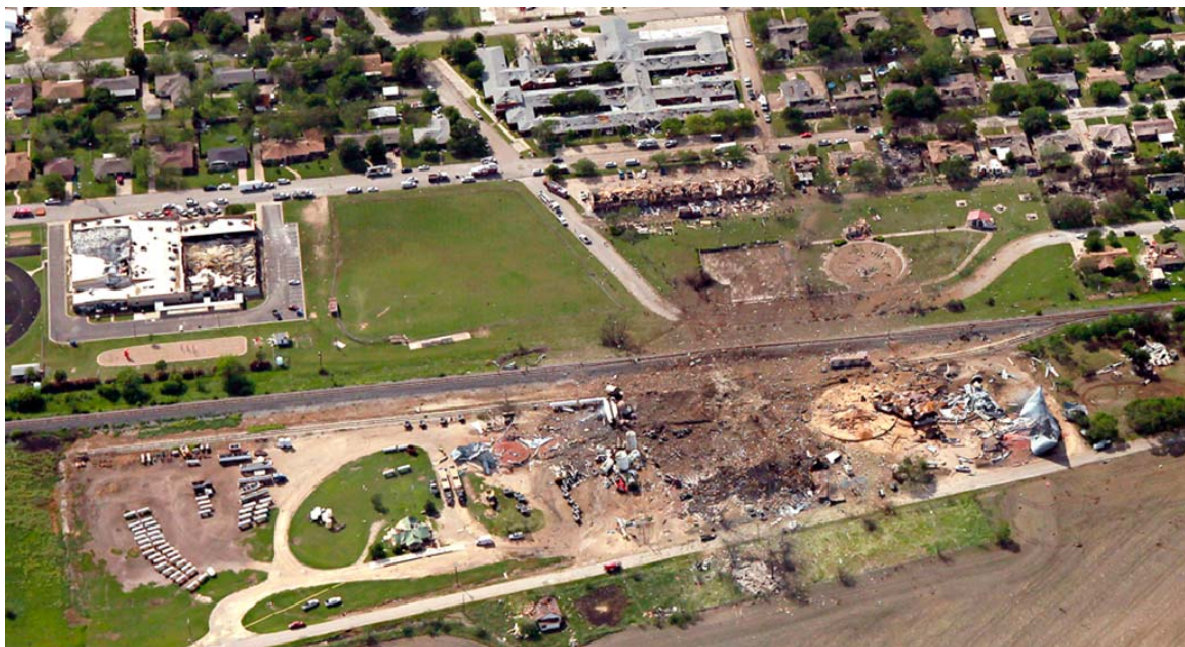
View of the site prior to scene excavation and examination

Throughout the initial 31 days, investigators conducted over 200 interviews, searched for evidence in a 37-block area, and excavated the entire 14 acres of the fertilizer facility, documenting, measuring, and securing hundreds of pieces of evidence. Additionally, reconstruction, to the extent possible, was completed. After more than 20,000 personnel hours were worked by more than 100 investigators from the SFMO and ATF, and prior to the final press briefing on May 16, 2013, several possible causes of the fire were eliminated; however, multiple potential causes could not be eliminated. As a result, at the time of publication of this firefighter fatality investigation report, the investigation is on-going, “open” and the cause of the fire at the West Fertilizer facility remains undetermined.

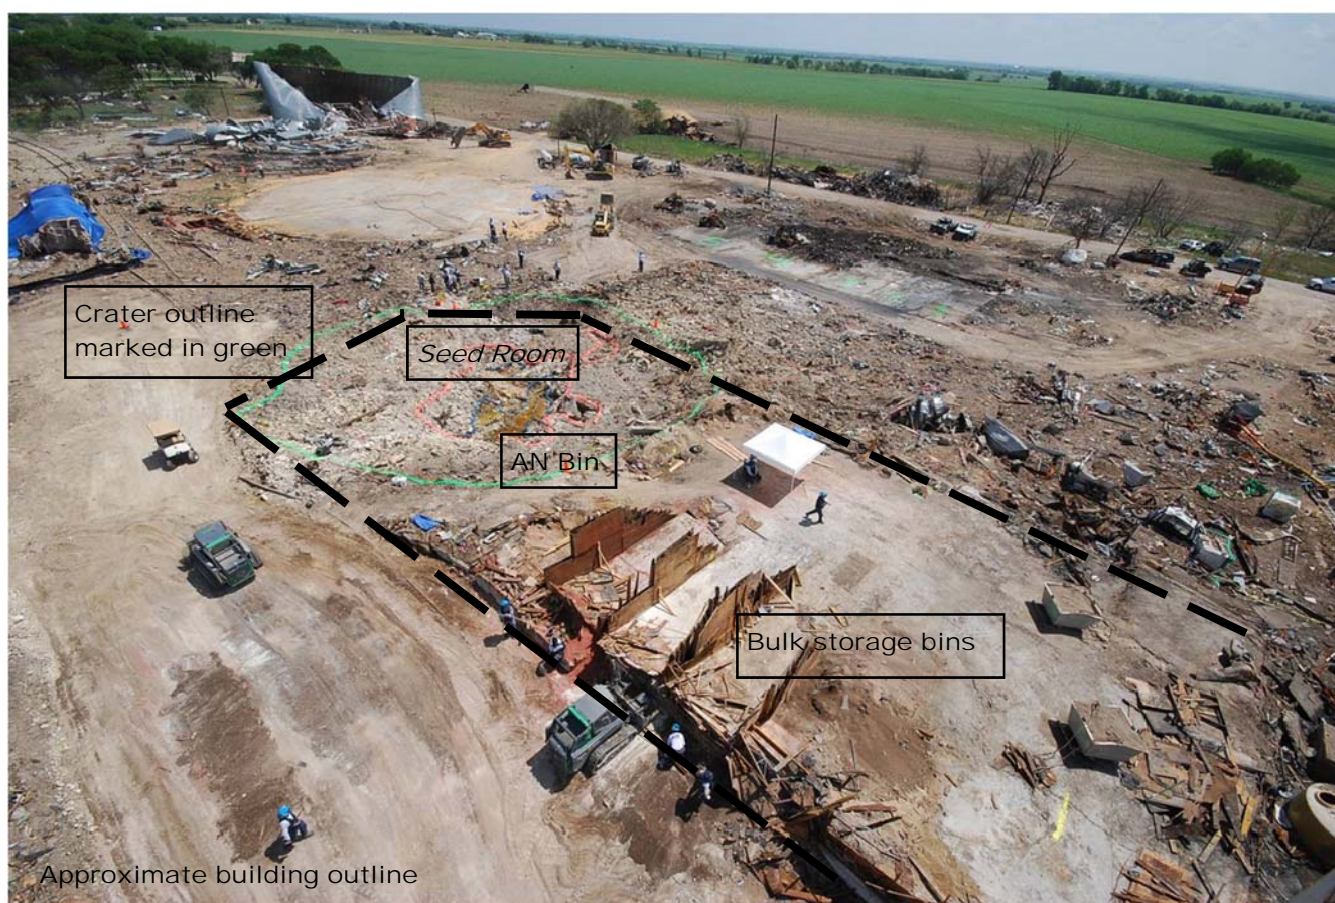
View of the scene during the examination and reconstruction

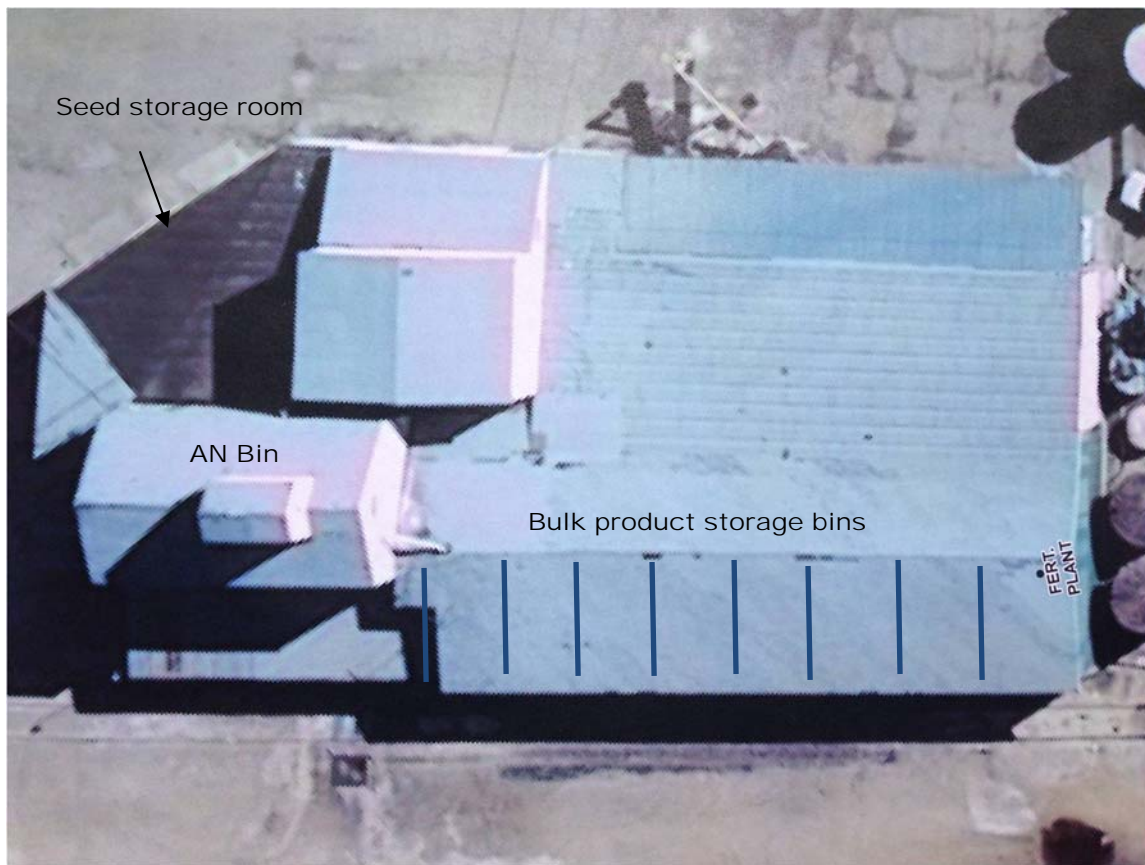
Comparison photos of the reconstruction and pre-blast photos of the processing building

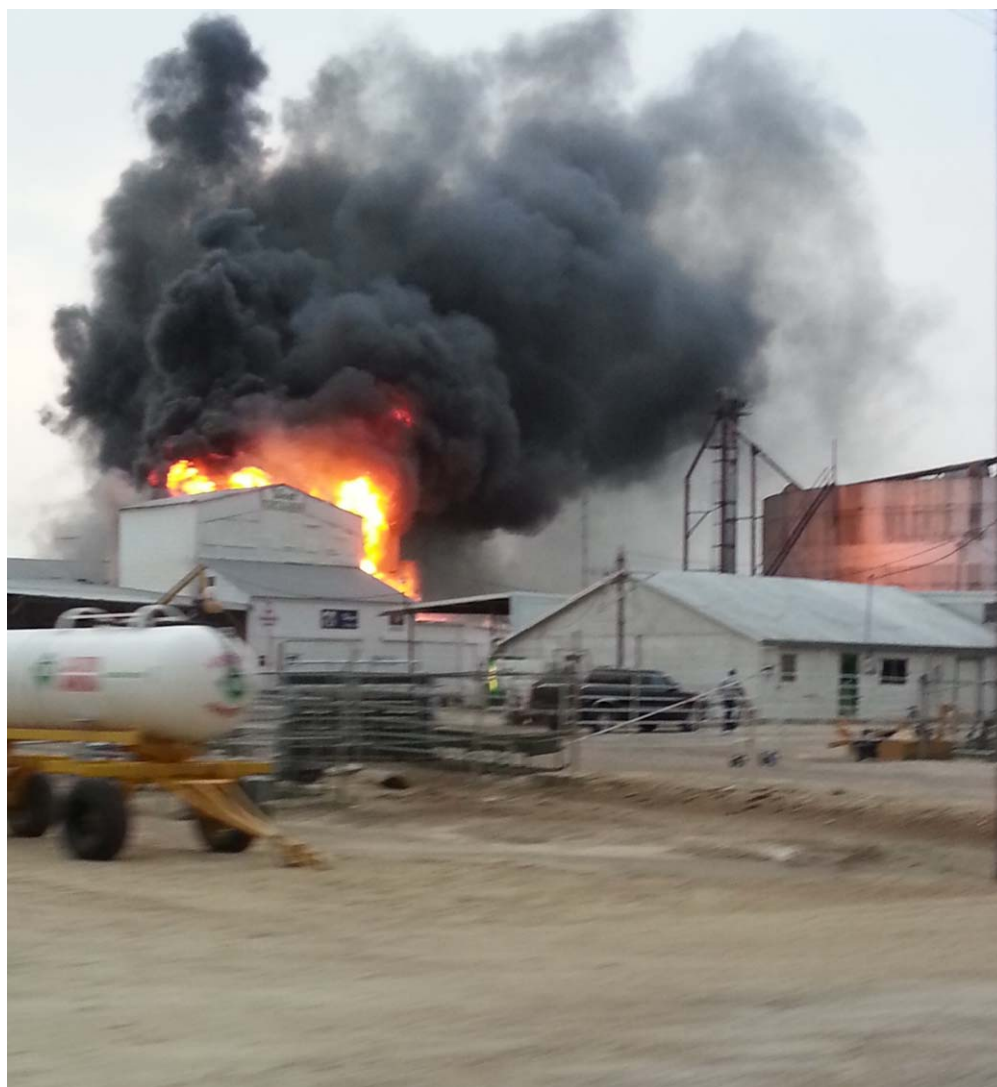
Passerby view of the east side of the building, approximate time 7:38 p.m. (Photo by Macik)

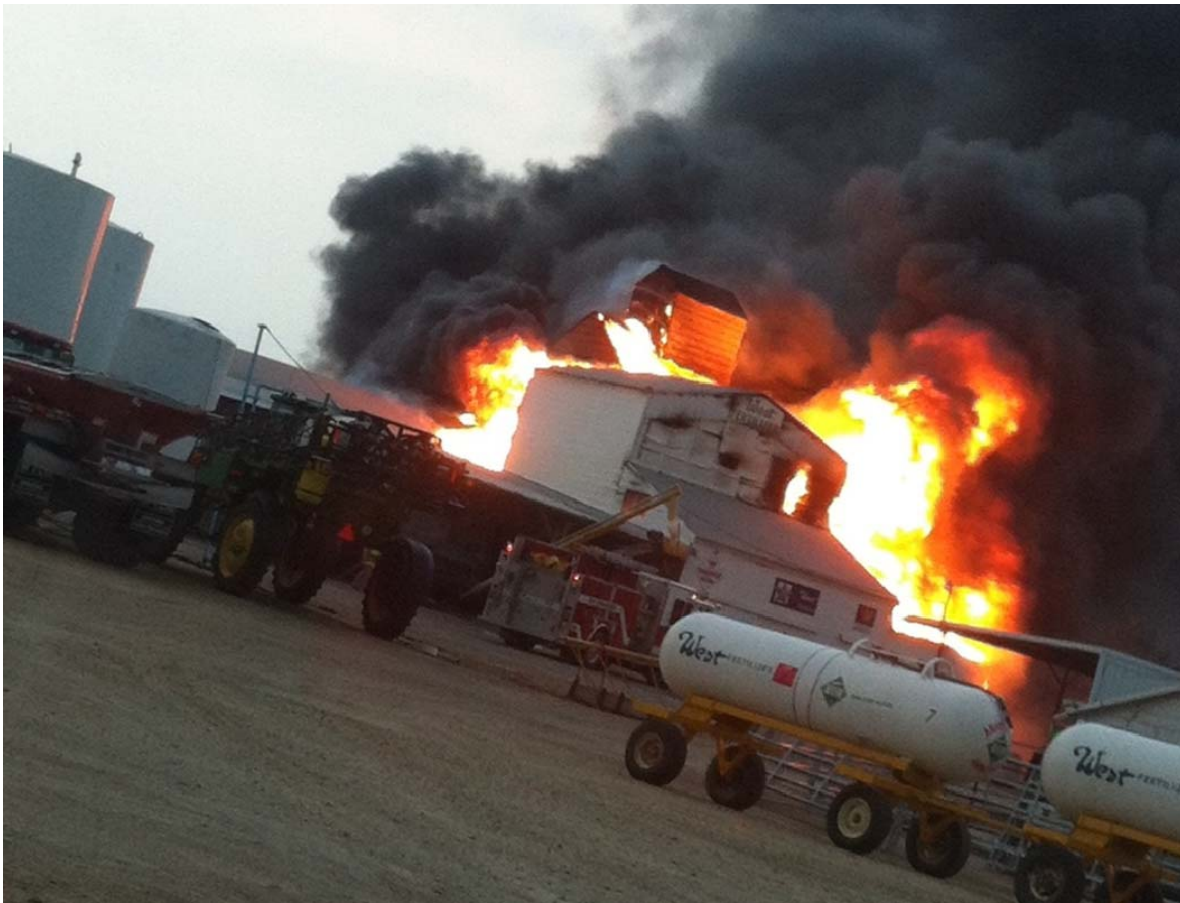
Passerby view of Engine 1 position at east side of building, approximate time 7:40 p.m. (Photo by Campbell)

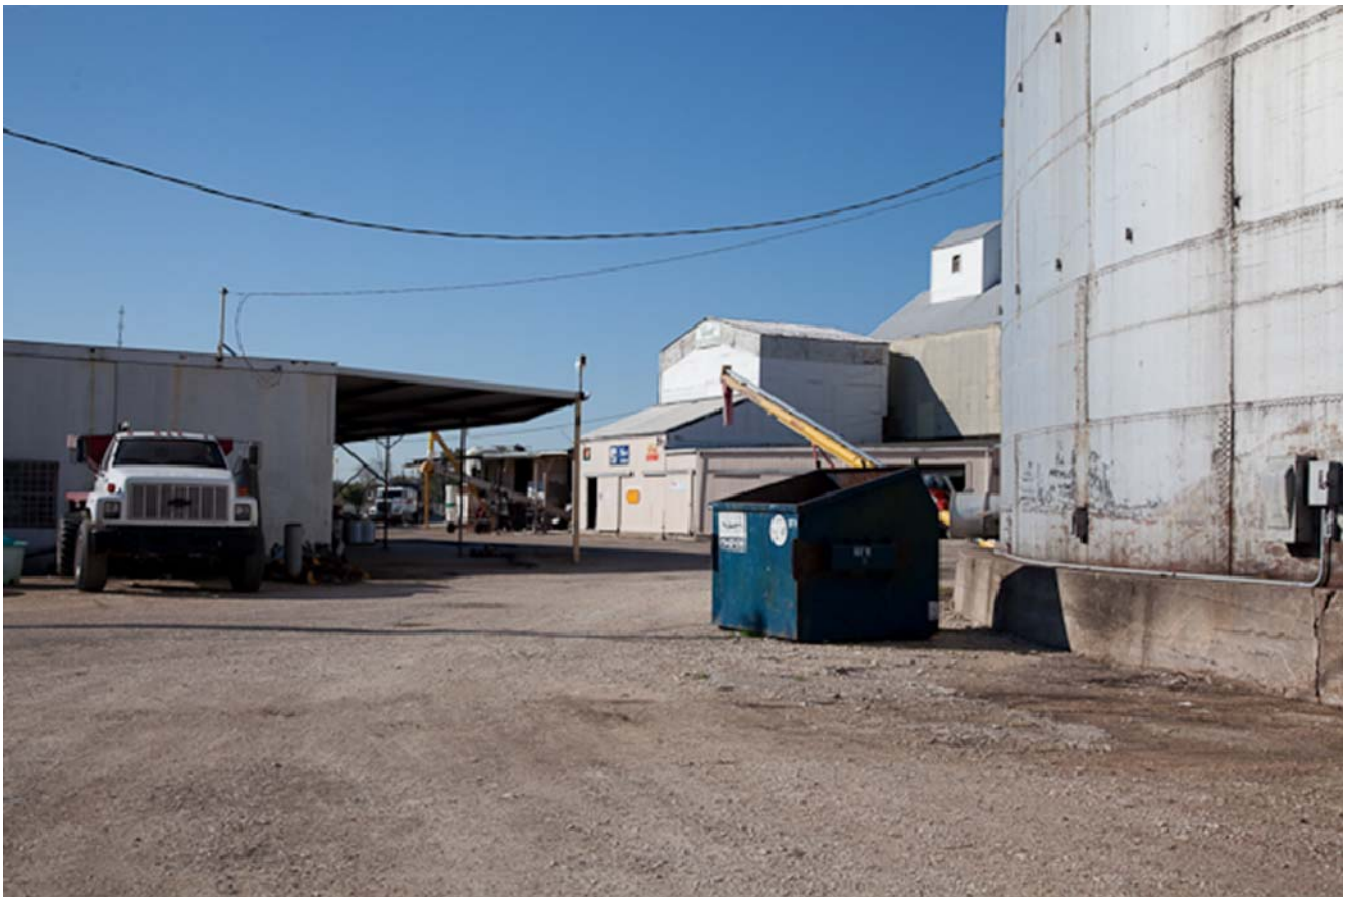
**The white brush truck was positioned under the electric service lines in this area before moving back
(Insurer photo)**

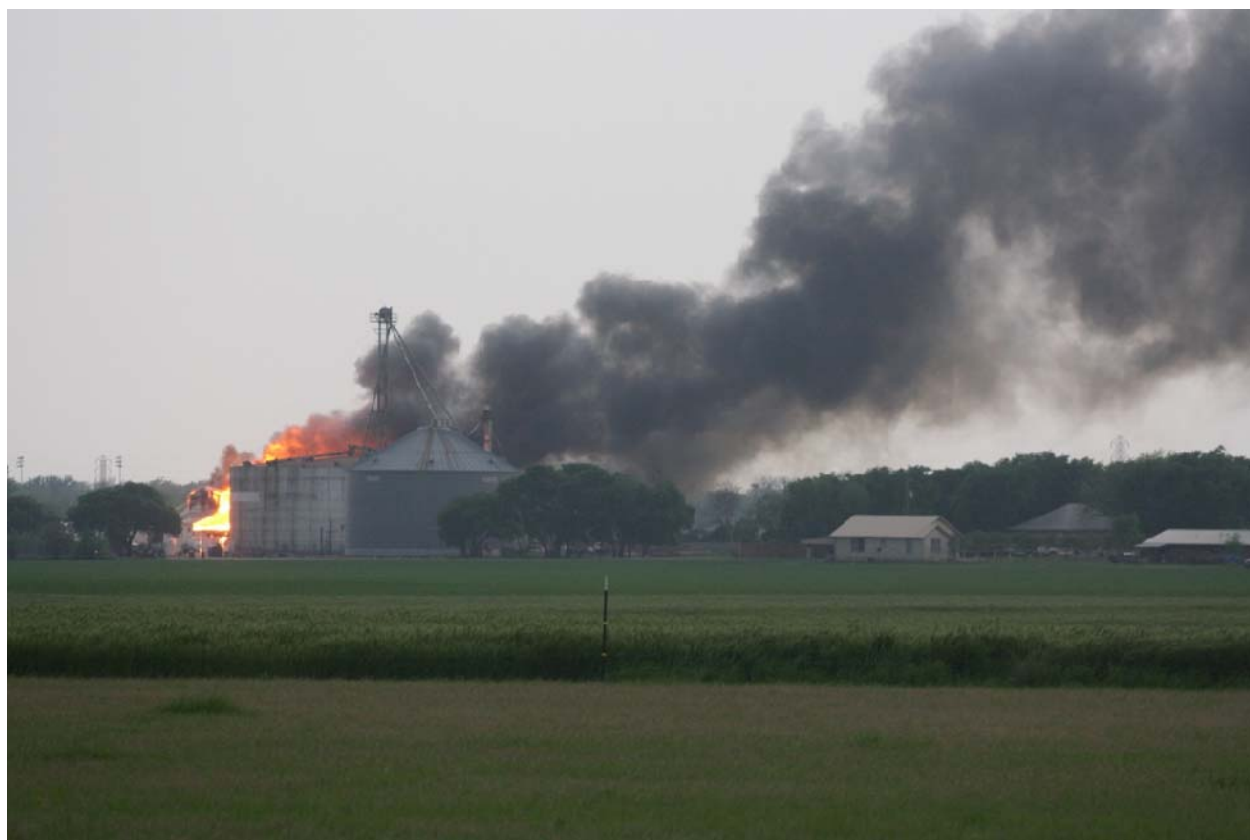
View of the site from the northeast (Photo by Wright)

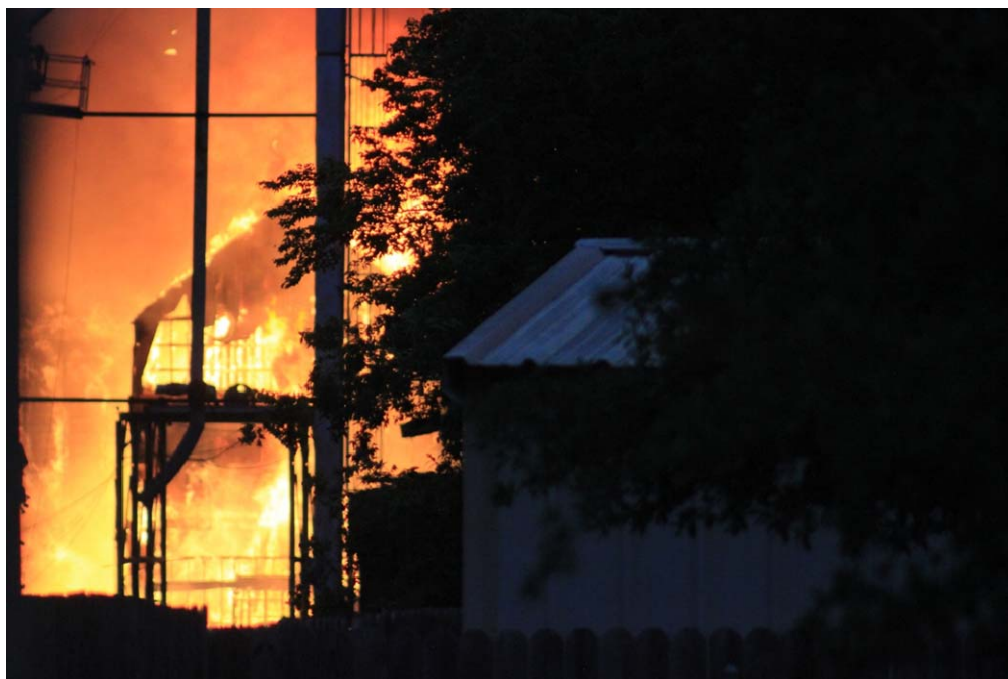
View from the north at approximate time 7:48 p.m. (Photo by Bajer)

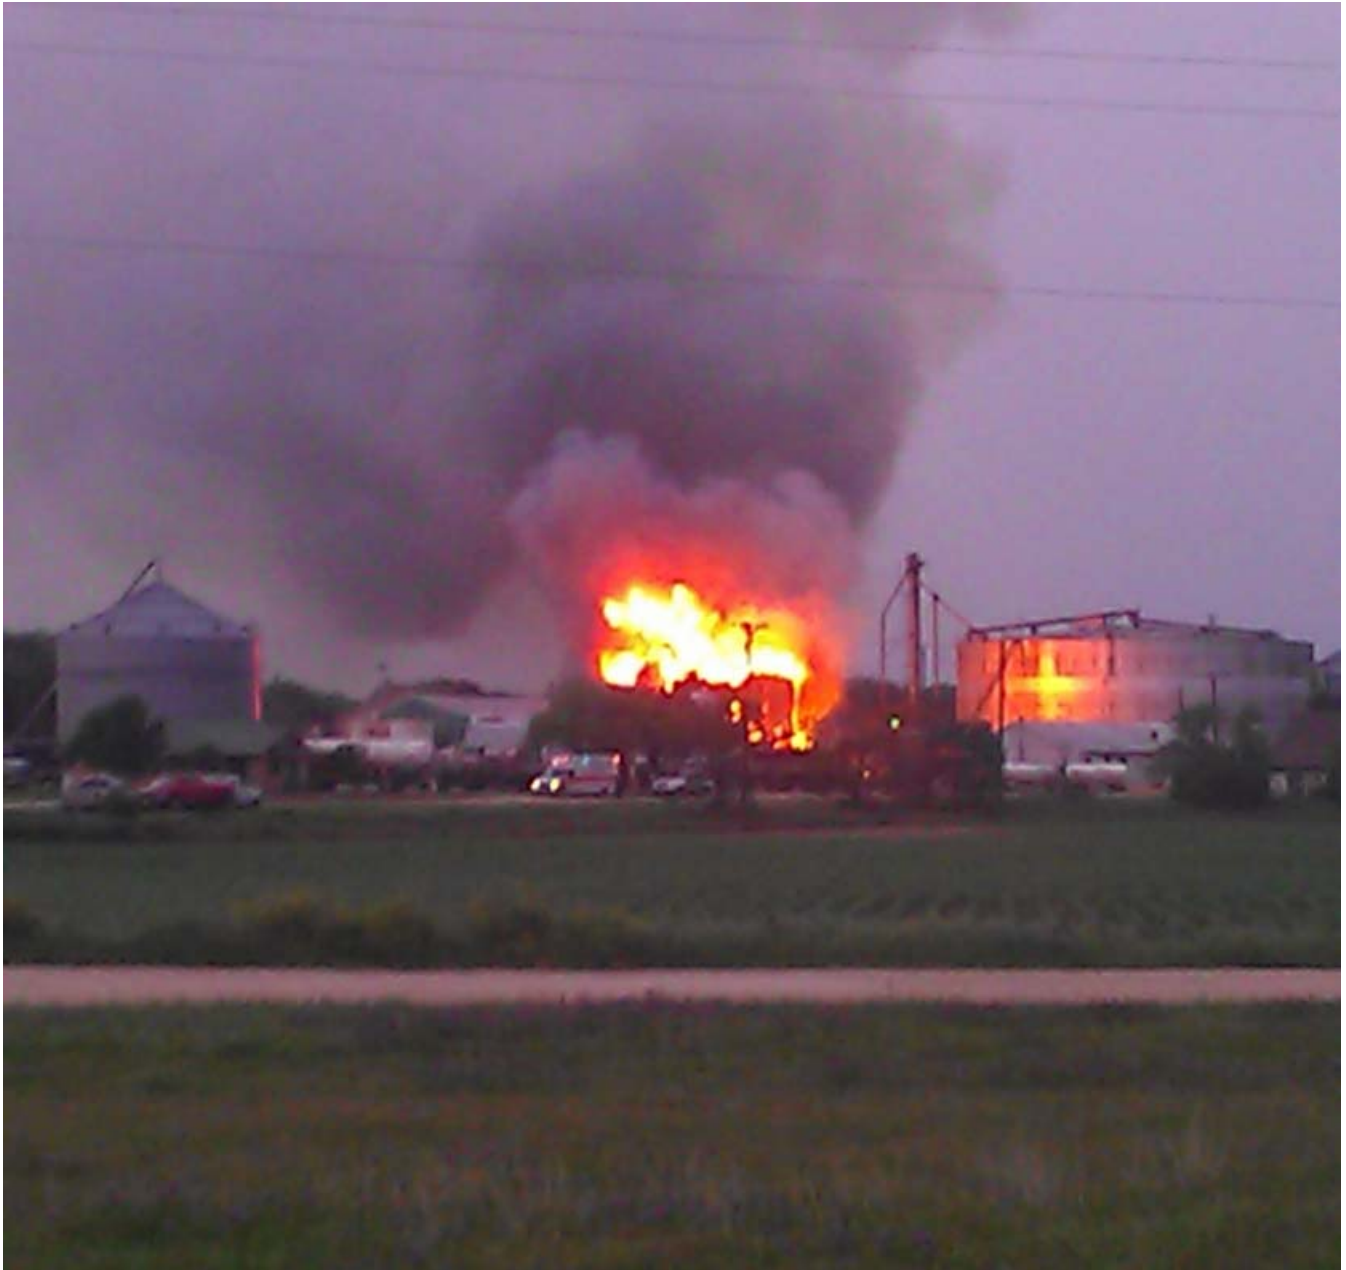
View from the southeast at approximate time 7:50 p.m. (Photo by Nathan Nors)

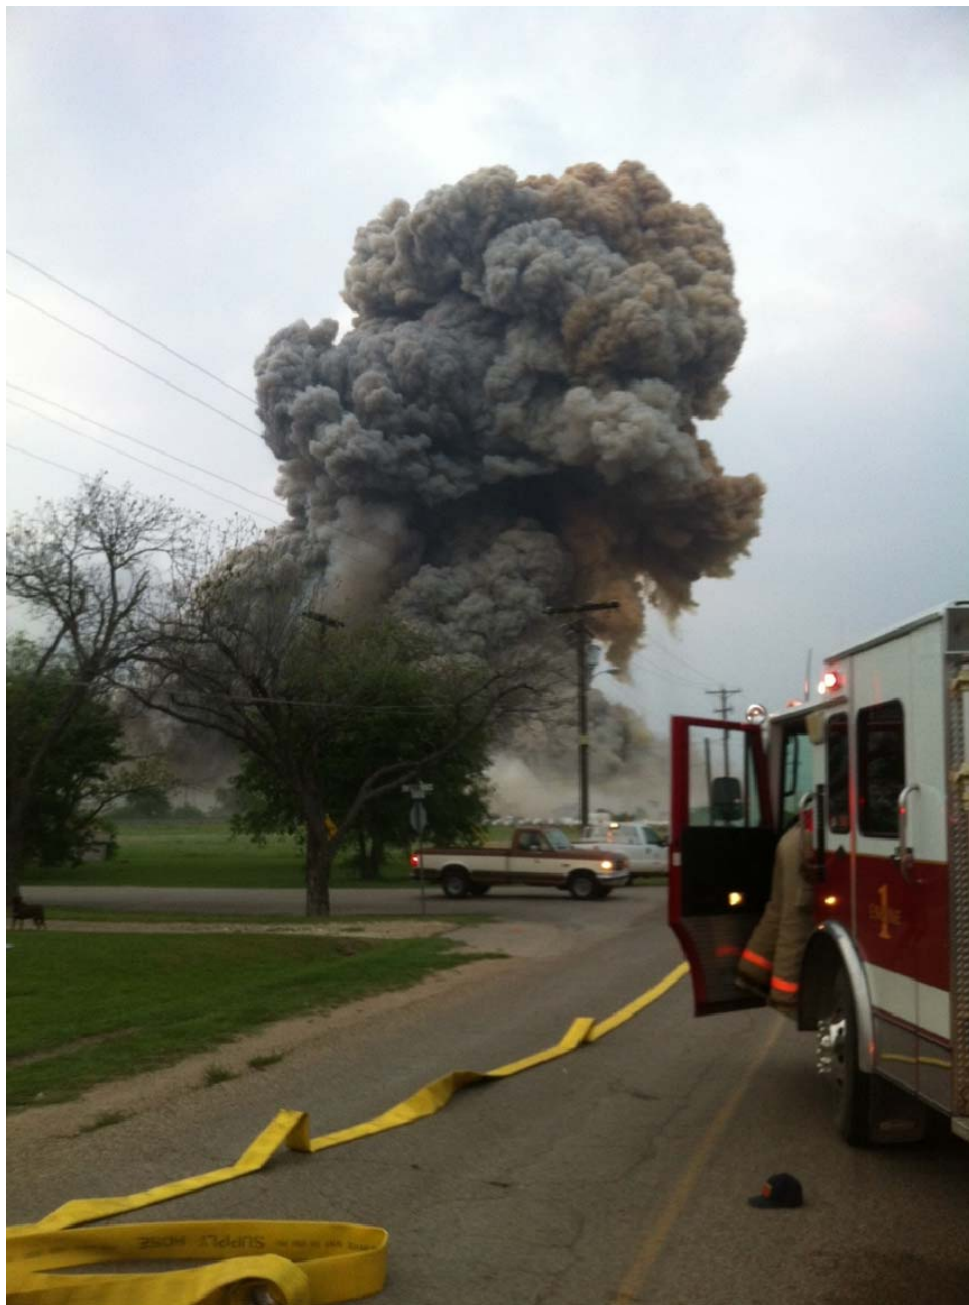
View of the plume of smoke after the explosion
(Photo by Kapavik)

The explosion occurred at approximately 7:51 p.m.

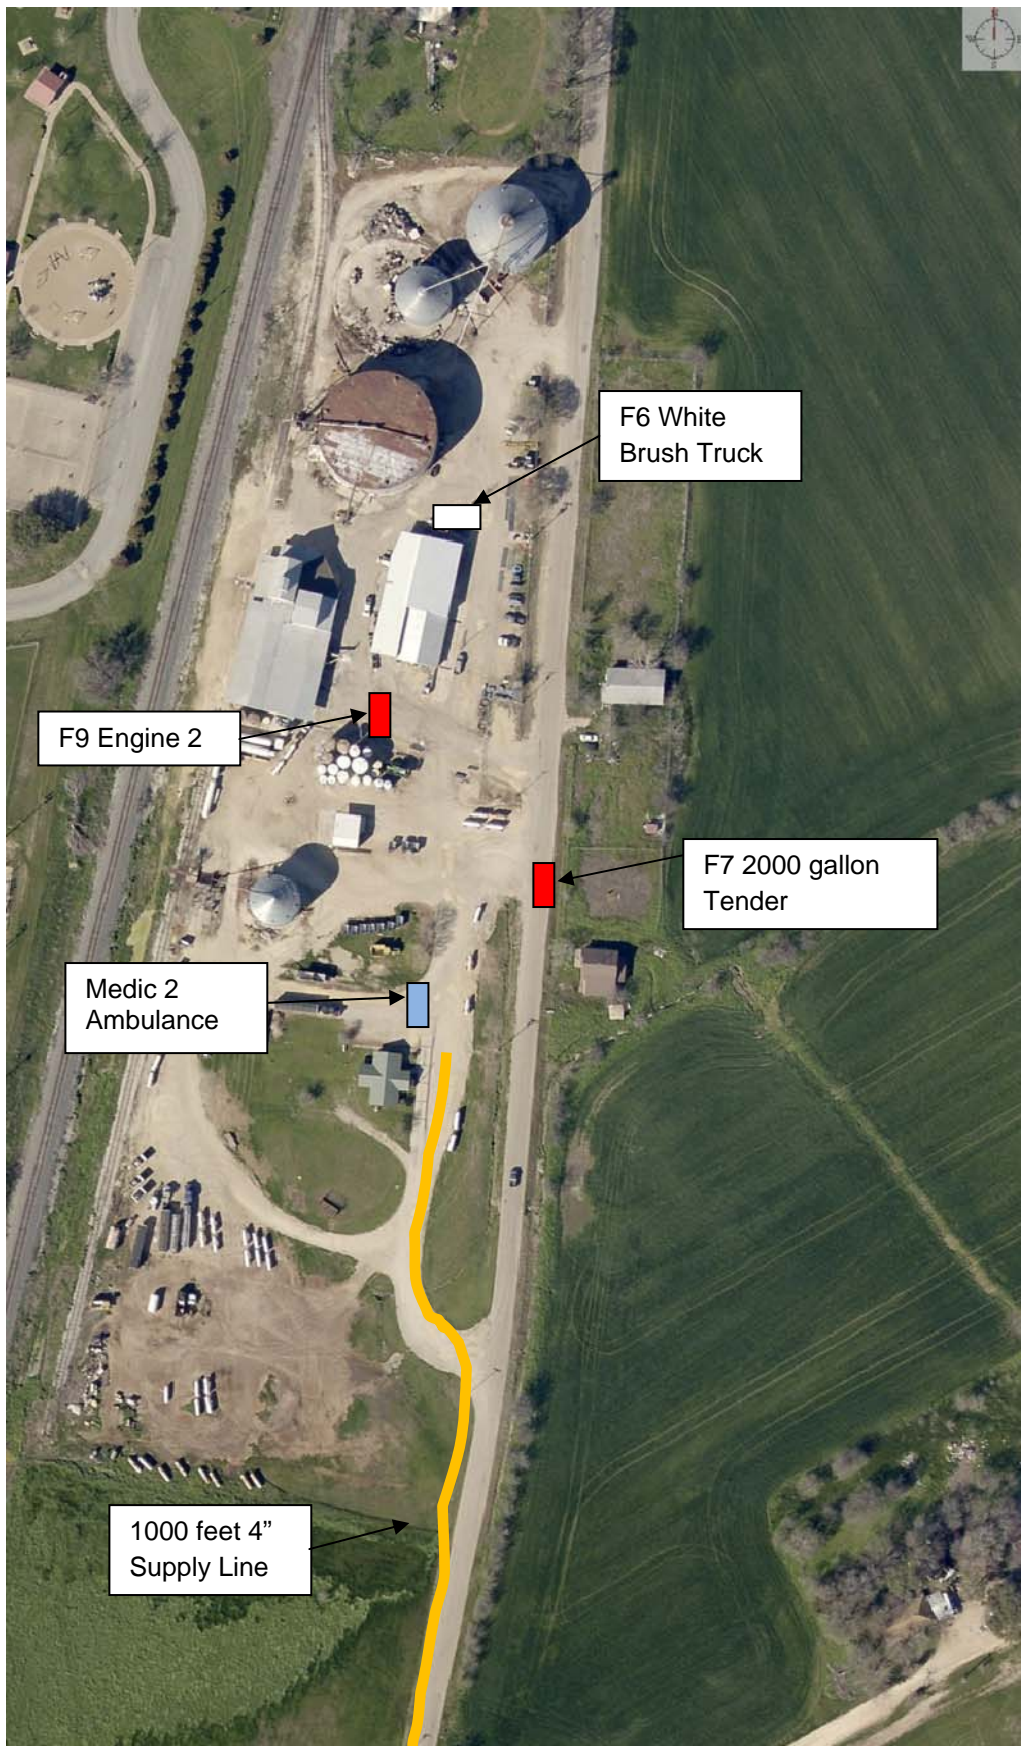
Approximate positions of apparatus at time of explosion
