INVESTIGATION REPORT

PREPARED FOR:
UNIVERSITY OF NORTHERN IOWA
CEDAR FALLS, IA

Prepared By:
HBK Engineering, LLC.
921 West Van Buren Street, Suite 100
Chicago, IL

HBK PROJECT # 18-0788
October 2, 2018

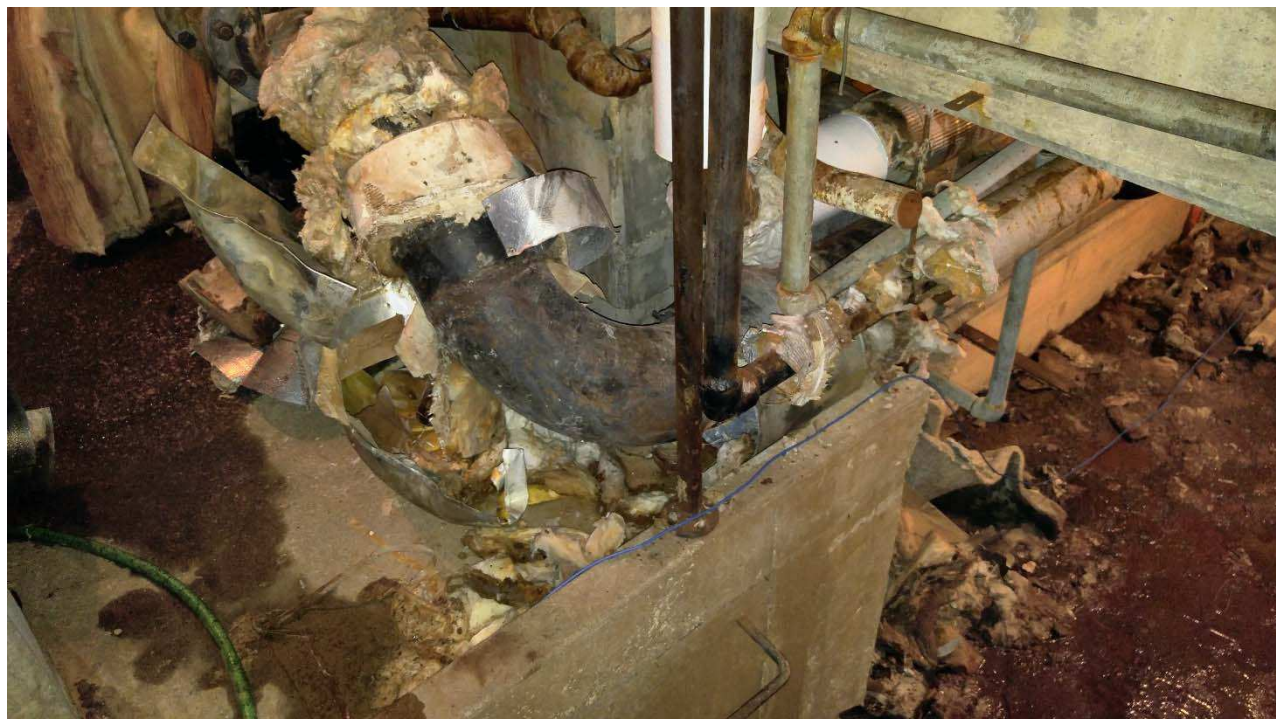
HBK performed a walkdown of the steam system in the utility tunnel, along with UNI staff. No obvious failure or breach was found – no pipe cracks or fitting failures were observed. Some pipe insulation was removed for additional visual access, but otherwise no system components were disassembled. One area of pipe insulation was discovered to be significantly wetter and more damaged than other areas in the utility tunnel, but no visible cause or leak was found. Since no failure location was found, UNI staff decided to perform a test where the steam system would be partially restarted at very low pressure to look for escaping steam. Condensate that had accumulated in the steam lines was allowed to drain out overnight, but otherwise the steam system was kept with the same valve positions as when the incident occurred.

Figure 1: Area where wet insulation was found at the south end of the utility tunnel. (The insulation was removed from the elbow as part of the investigation.)

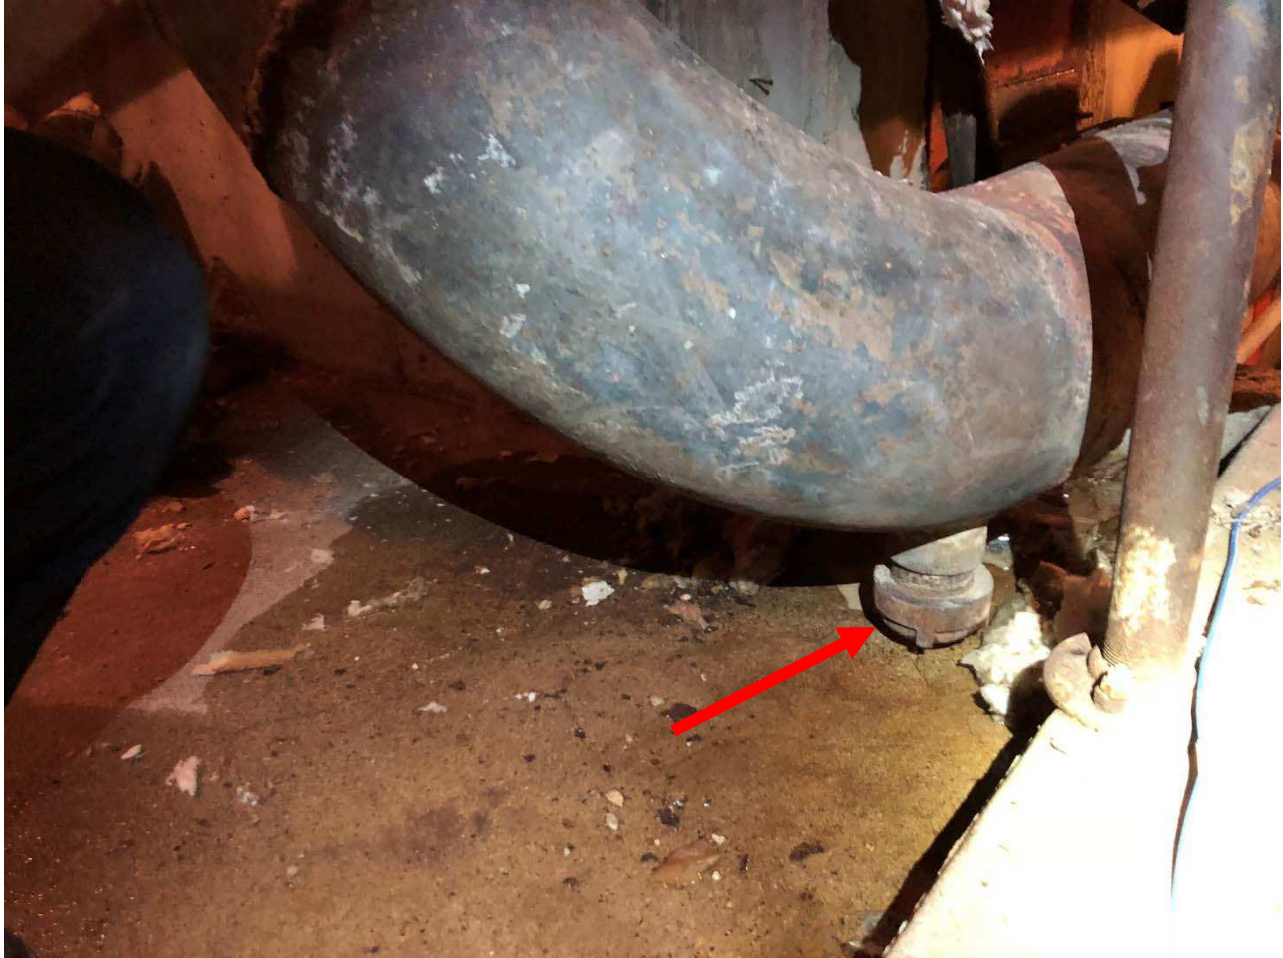
Steam appeared on camera approximately 10 minutes after the east remote steam valve was initially opened. Instructions were relayed to shut the east remote valve to shut the steam off. Once the system was verified to be shut down, UNI staff and HBK engineers entered the steam tunnel for further investigation. A small condensate drip was noted on a 2" capped pipe drain attached to the bottom of the steam supply line to the dining hall. Further investigation revealed the center part of the cap was missing. This drain is located near the south elbow of the steam supply line to the dining hall in the tunnel area, and is located upstream of the dining hall steam supply isolation valve. This cap is located in the area where wet insulation had been

observed the prior day. A second test was run which verified this pipe drain as the source of the steam leak observed on camera.

In HBK's opinion, the sudden, catastrophic failure of this cap is the likely cause of the incident. Such a failure would have allowed steam to immediately enter the utility tunnel and would likely have resulted in a loud noise, like the one a UNI worker reported hearing at the same time as the incident.

Figure 2: The location of the 2" drain and the failed cap. (All insulation has been removed as part of the investigation.)

The failed drain cap was removed and replaced with a plug fitting while HBK was on site. A valve in the steam supply line to the dining hall, that was previously known to have a leaky bonnet, was replaced with a new valve at the same time, while the complete system was shut down. The valve in the west loop steam supply line in the utility tunnel was closed to isolate the dining hall from the west loop. While HBK was on site, the steam supply to the dining hall was restarted and brought online using only the east loop supply line. No further steam leaks or abnormal operation were observed. This concluded HBK's site visit.

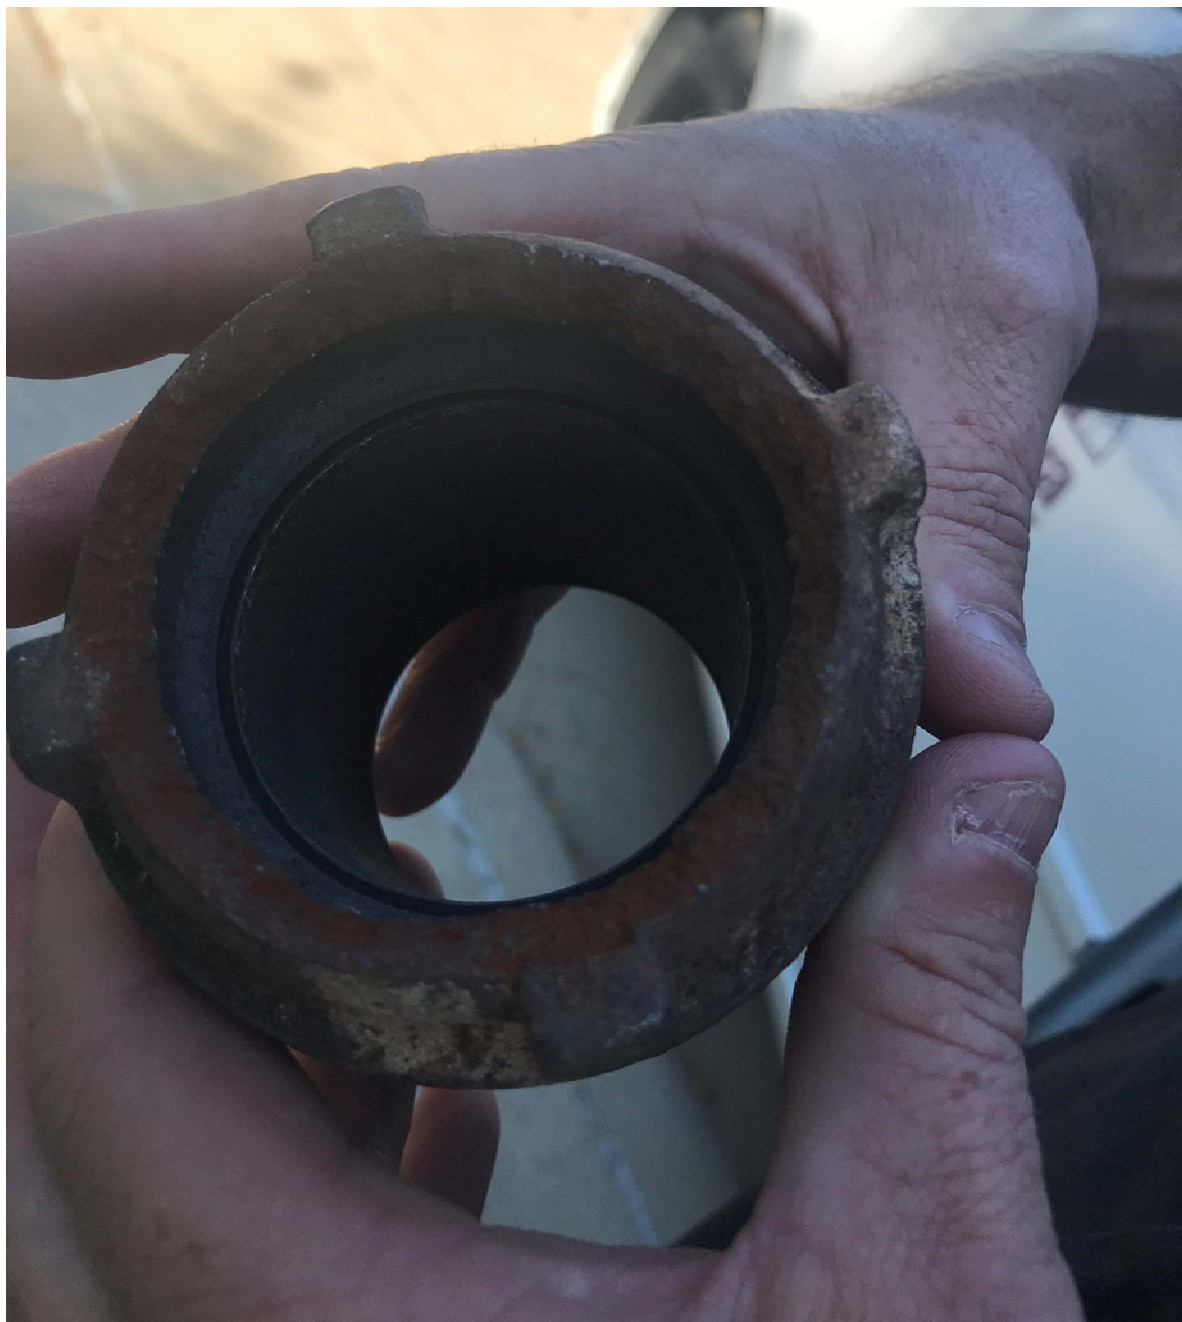
Figure 3: The failed cap after it had been removed from the steam pipe.
