# Aviation Investigation Final Report

<b>Location:</b>	Naples, Florida	<b>Accident Number:</b>	ERA24FA110
<b>Date &amp; Time:</b>	February 9, 2024, 15:11 Local	<b>Registration:</b>	N823KD
<b>Aircraft:</b>	BOMBARDIER INC CL-600-2B16	<b>Aircraft Damage:</b>	Destroyed
<b>Defining Event:</b>	Powerplant sys/comp malf/fail	<b>Injuries:</b>	2 Fatal, 4 Minor
<b>Flight Conducted Under:</b>	Part 135: Air taxi & commuter - Non-scheduled

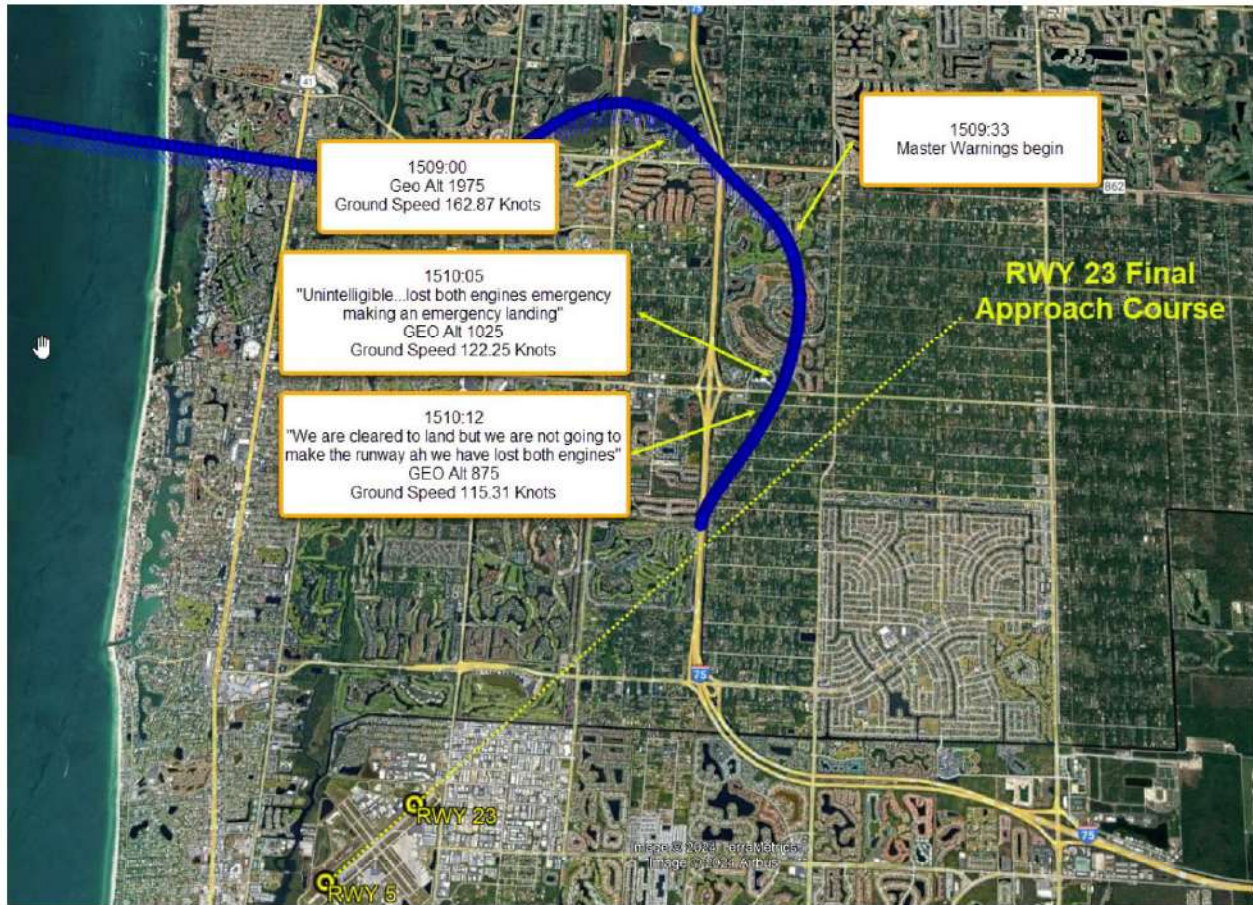
Twenty-three seconds later, at 1510:03, about 1,000 ft pressure altitude and 122 kts, on a shallow intercept angle for the final approach course, the crew announced, "...lost both engines... emergency... making an emergency landing" (see figure 1). The tower controller acknowledged the transmission and cleared the airplane to land. At 1510:12, about 900 ft and 115 kts, the crew replied, "eh we're clear to land but we're not gonna make the runway uh we've lost both engines."

Figure 1. ADS-B ground track (blue dots) with annotations of specific events during the approach, including time and the airplane's geometric altitude and ground speed (source: FAA).

There were no further transmissions from the flight crew, and the ADS-B track data ended at 1510:47, which was the time the airplane touched down on Interstate 75 in Naples, Florida.

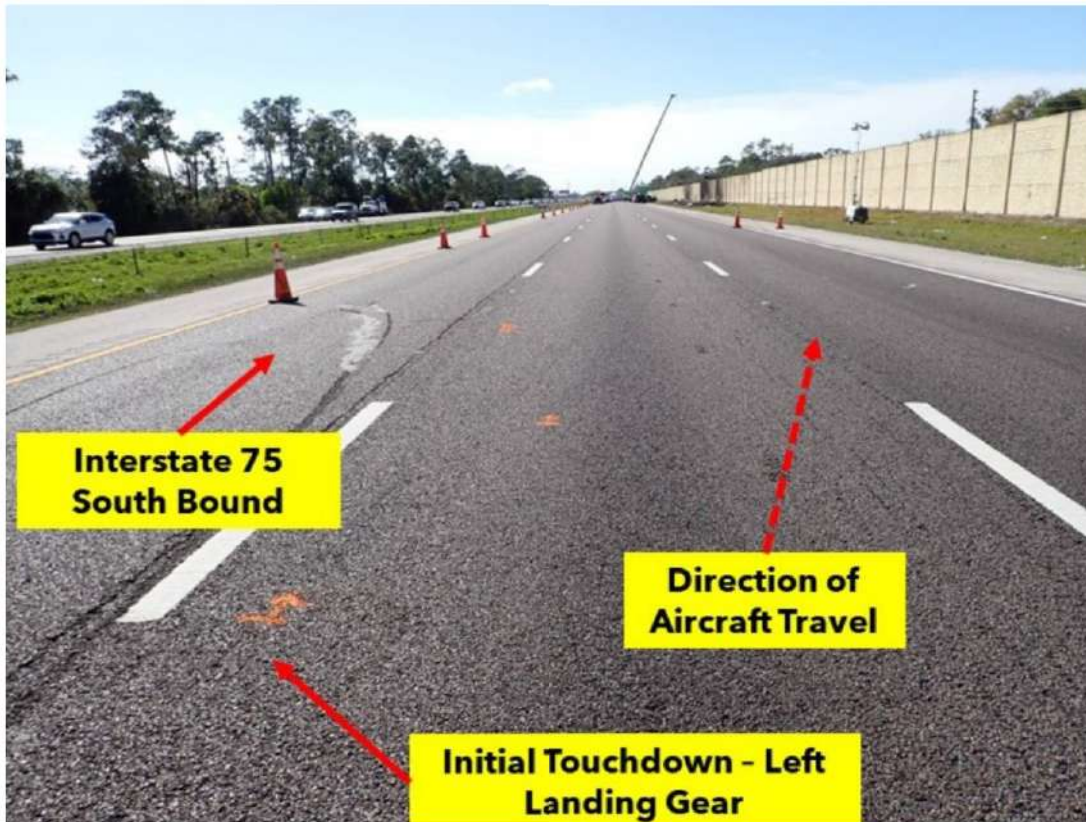
Examination of the accident site revealed tire marks on the southbound lanes of Interstate 75 consistent with the left main landing gear (see figure 2). The airplane came to rest about 1,000 ft past the initial touchdown point, upright in the grass area between the breakdown lane and the sound barrier wall and facing north, opposite the direction of travel.

Figure 2. Initial touchdown point on Interstate 75.

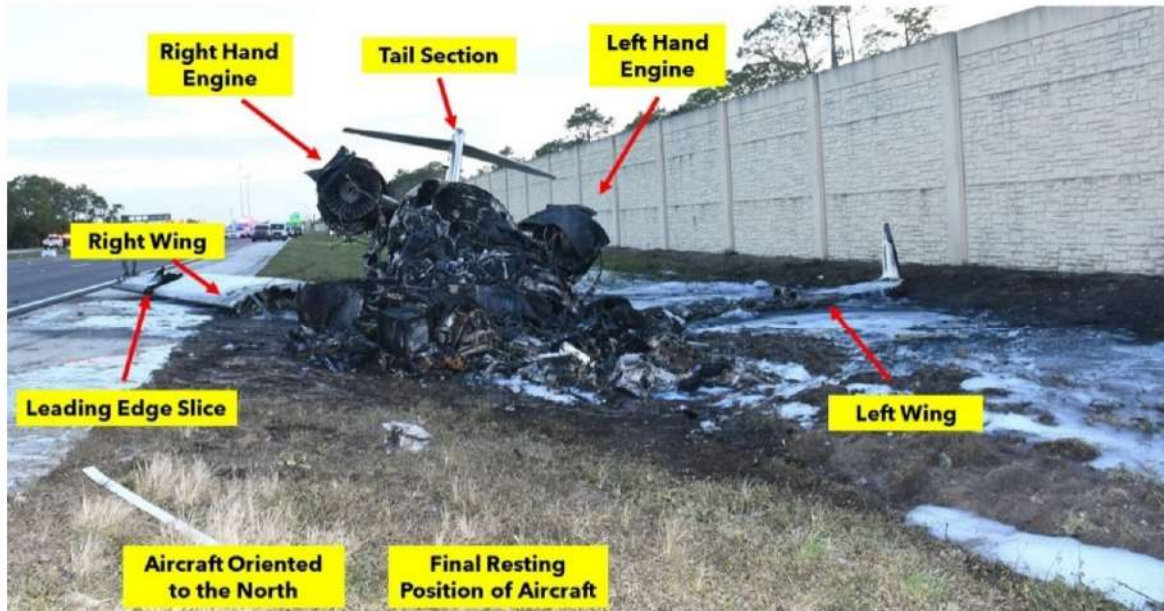
The forward portion of the fuselage was consumed by postimpact fire (see figure 3). All major components of the airplane were accounted for at the scene, and the ground surrounding the wreckage was fuel-soaked, having an odor consistent with Jet A fuel. The cockpit center console was found separated from the main wreckage. Both engine thrust levers were found near the IDLE stop position. The flap selector handle was found in a position consistent with 45° flap extension.

Figure 3. Main wreckage as found.
