Aviation Investigation Preliminary Report

Location:	Naples, FL	Accident Number:	ERA24FA110
Date & Time:	February 9, 2024, 15:11 Local	Registration:	N823KD
Aircraft:	BOMBARDIER INC CL-600-2B16	Injuries:	2 Fatal, 4 Minor
Flight Conducted Under:	Part 135: Air taxi & commuter - Non-scheduled

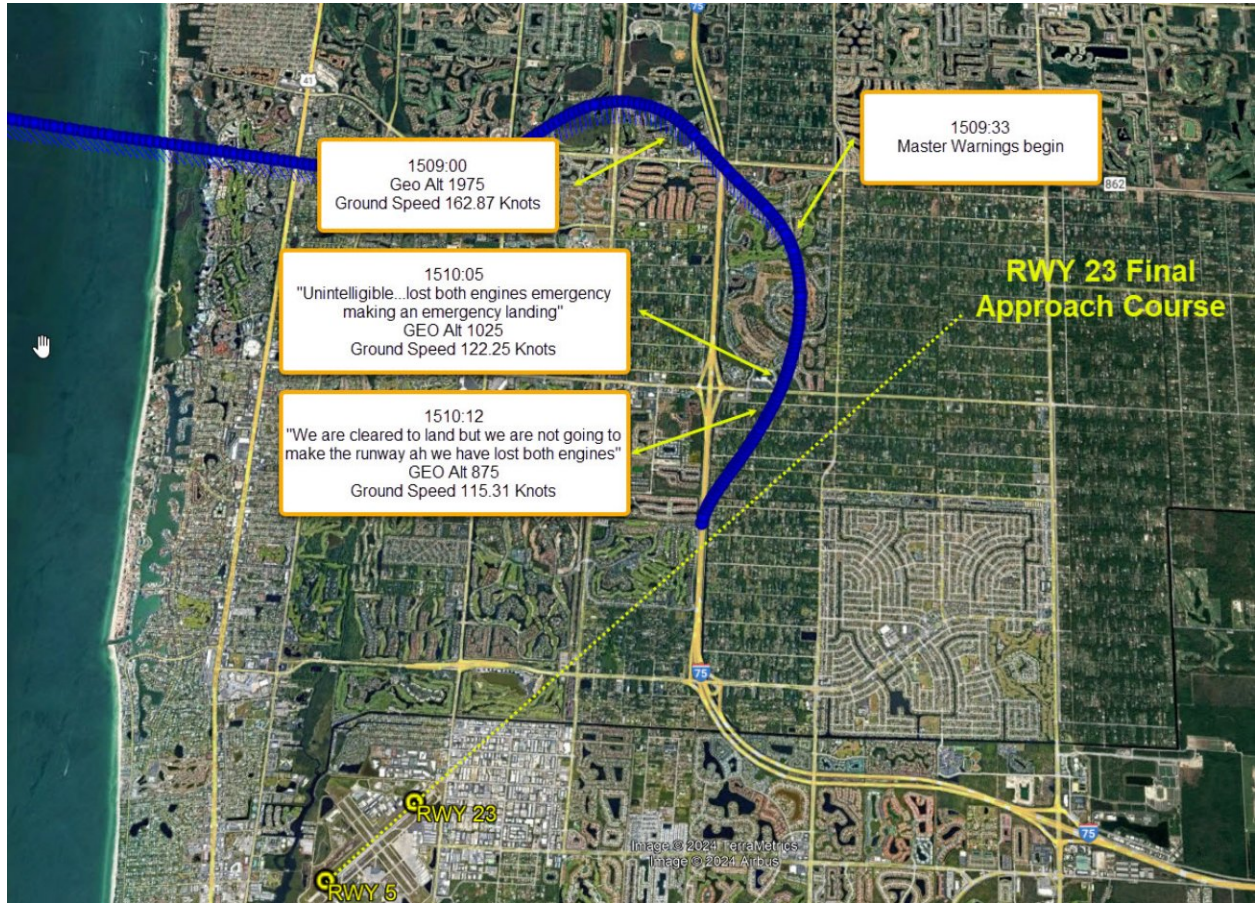
Twenty seconds later, at 1510:05, about 1,000 ft msl and 122 kts, on a shallow intercept angle for the final approach course, the crew announced, "...lost both engines... emergency... making an emergency landing" (see figure 1). The tower controller acknowledged the call and cleared the airplane to land. At 1510:12, about 900 ft and 115 knots, the crew replied, "We are cleared to land but we are not going to make the runway... ah... we have lost both engines."

Figure 1 – Plot of the airplane’s ADS-B ground track (blue dots) with annotations of specific events during the approach that include time as well as the airplane’s geometric altitude and groundspeed (source: Federal Aviation Administration).

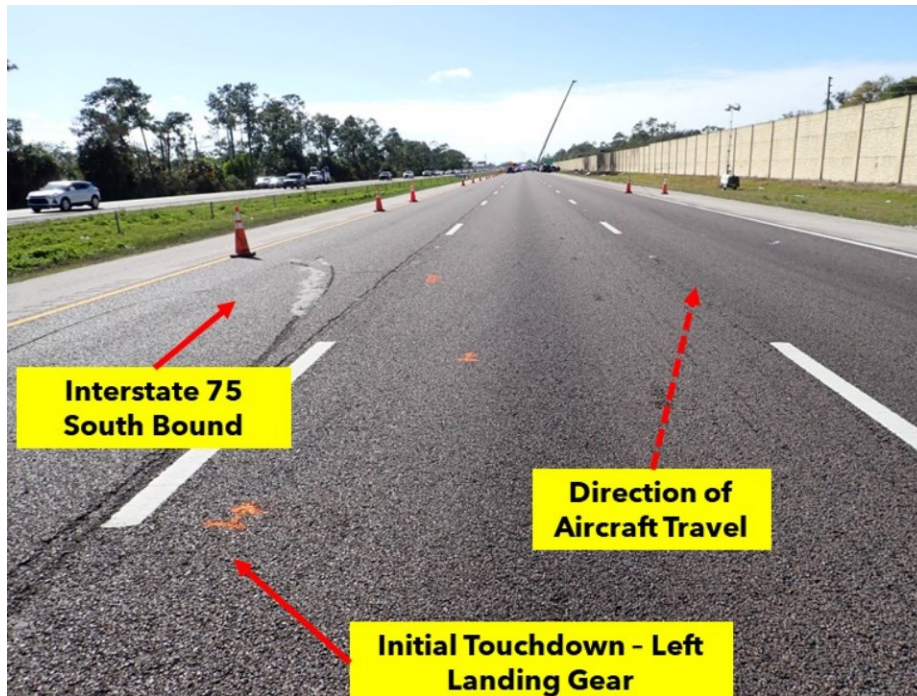
Examination of the accident site revealed tire marks on the southbound lane of Interstate 75 consistent with the left main landing gear (see figure 2). The airplane came to rest about 1,000 ft past the initial touchdown point, upright in the grass area between the break-down lane and the sound barrier wall facing north, opposite the direction of travel.

Figure 2 Annotated photograph of the airplane's initial touchdown point on Interstate 75.

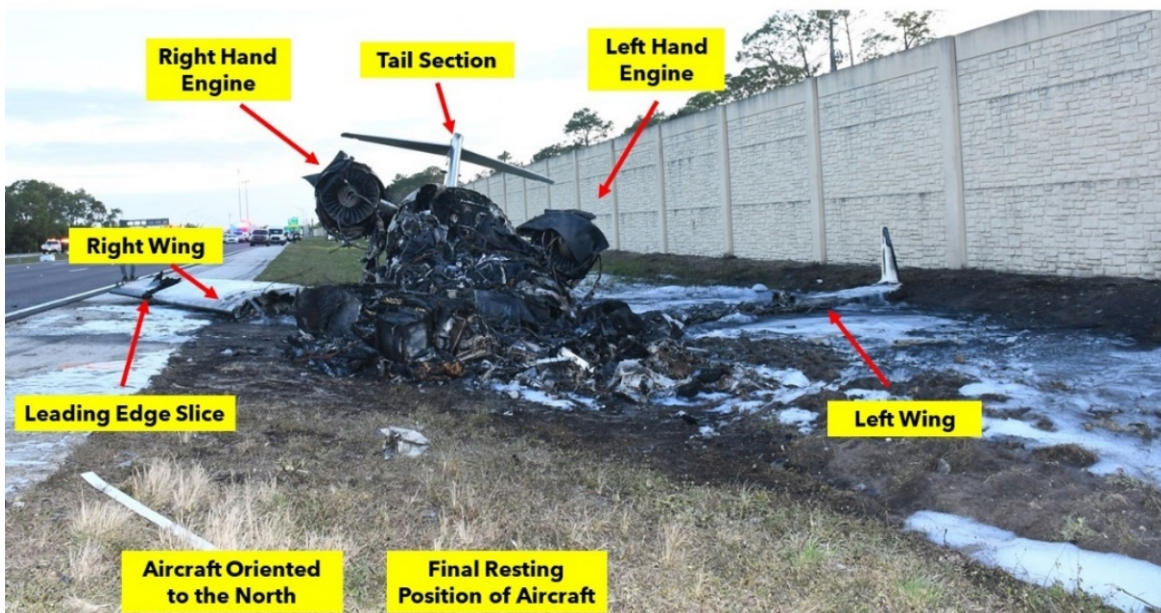
The forward portion of the fuselage was consumed by the post-impact fire (see figure 3). All major components of the airplane were accounted for at the scene, and the ground surrounding the wreckage was fuel-soaked having an odor consistent with Jet-A fuel. The cockpit center console was found separated from the main wreckage. Both engine throttle levers were found near the IDLE stop position. The flap selector handle was found in a position consistent with 45° flap extension.

Figure 3 – Annotated photograph of main wreckage as found.
