REPORT OF SUBSURFACE EXPLORATION AND GEOTECHNICAL EVALUATION CHIEF LADIGA TRAIL SINKHOLE EVALUATION JACKSONVILLE, ALABAMA BUILDING & EARTH PROJECT NUMBER: BH160076

Subject: Report of Subsurface Exploration and Geotechnical Evaluation Chief Ladiga Trail - Sinkhole Evaluation Jacksonville, Alabama Building & Earth Project No.: BH160076

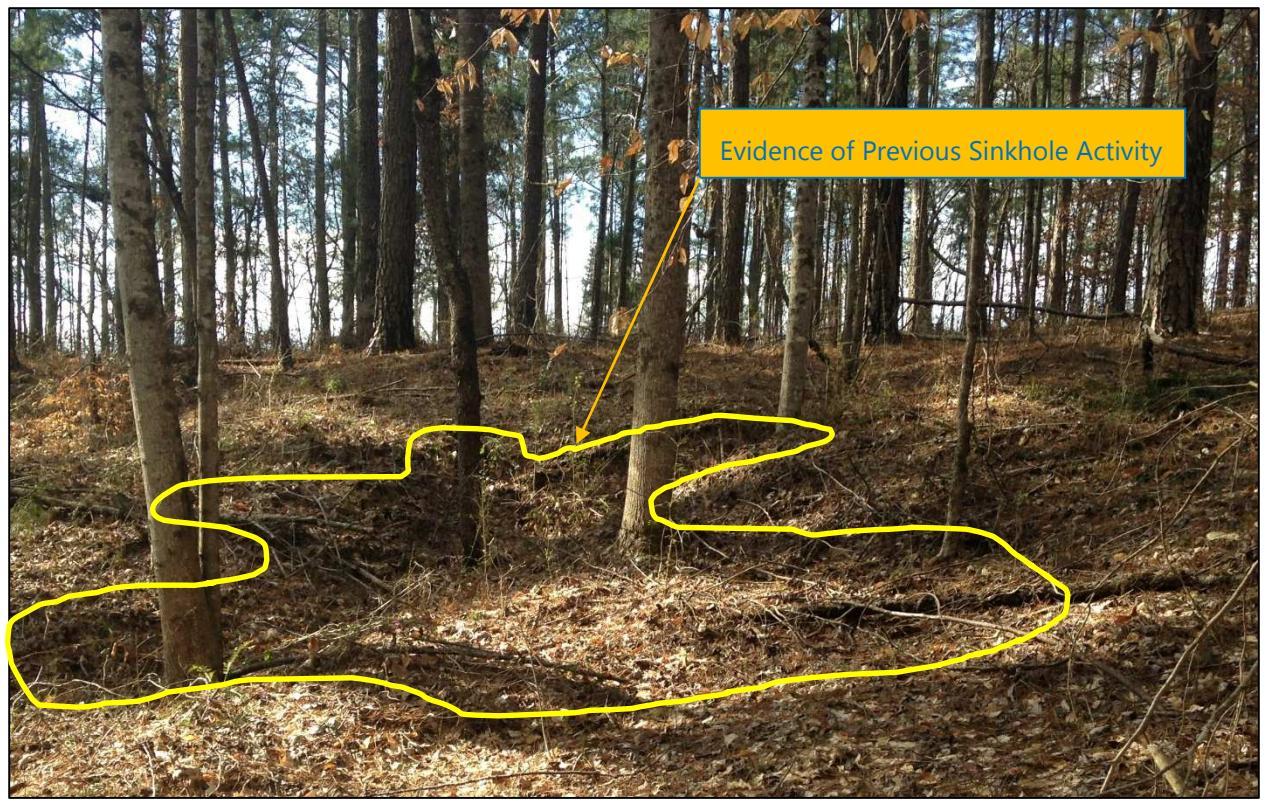
The subject site is located on the Chief Ladiga Trail, about <sup>1</sup>/<sub>2</sub> miles north of the intersection with Warren Drive, in Jacksonville, AL. This area of the trail is bordered to the west by cleared pasture land, and to the west by a wooded area. The area generally drains to the north, where a large creek crosses the trail, approximately 1 mile to the north. A drainage ditch was observed to the east, as well as evidence of previous sinkhole activity. These dropouts were wooded and covered in leaves, indicating that sinkhole activity occurred some time ago. A photo of this area is shown below (Figure 1).

Figure No. 1 – Previous Sinkhole Activity, located east of Ladiga Trail

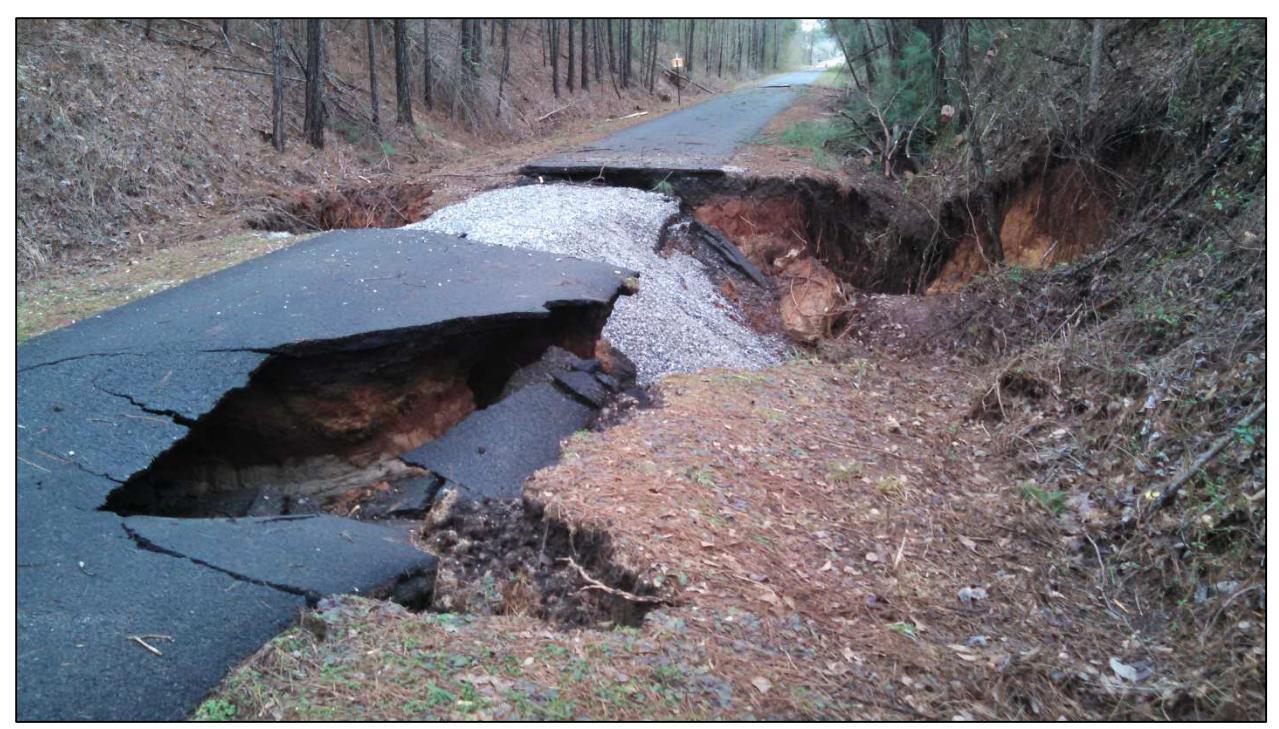
At the time of our initial visit, on February 26, 2016, sinkhole 1 and sinkhole 2 were observed present in the trial (Figures 2 and 3). Prior to our visit on March 4, 2016, when drilling was performed, sinkhole 2 had increased in size, and blocked access to the trail. Sinkhole 3 had also formed since our initial visit. A rain event had previously occurred on March 3. Photos of the sinkholes and surrounding areas are shown below.

Figure No. 2 – Sinkhole No. 1, looking south (03-04-16)

We believe the most feasible remediation option is to implement a remediation grouting program. The recommended grouting process is intended utilize Low Mobility Grout (LMG) to form a grout cap over the upper rock zone, and improve the consistency of the overlying material by compaction grouting.

A typical grouting program would be initiated on a 10 to 15 foot spacing in the vicinity of the known sinkholes. Depending on the grout take and pressures in the primary injection, secondary or tertiary grout holes may be required. The total size of the treated area will depend on the conditions encountered during the grouting process.

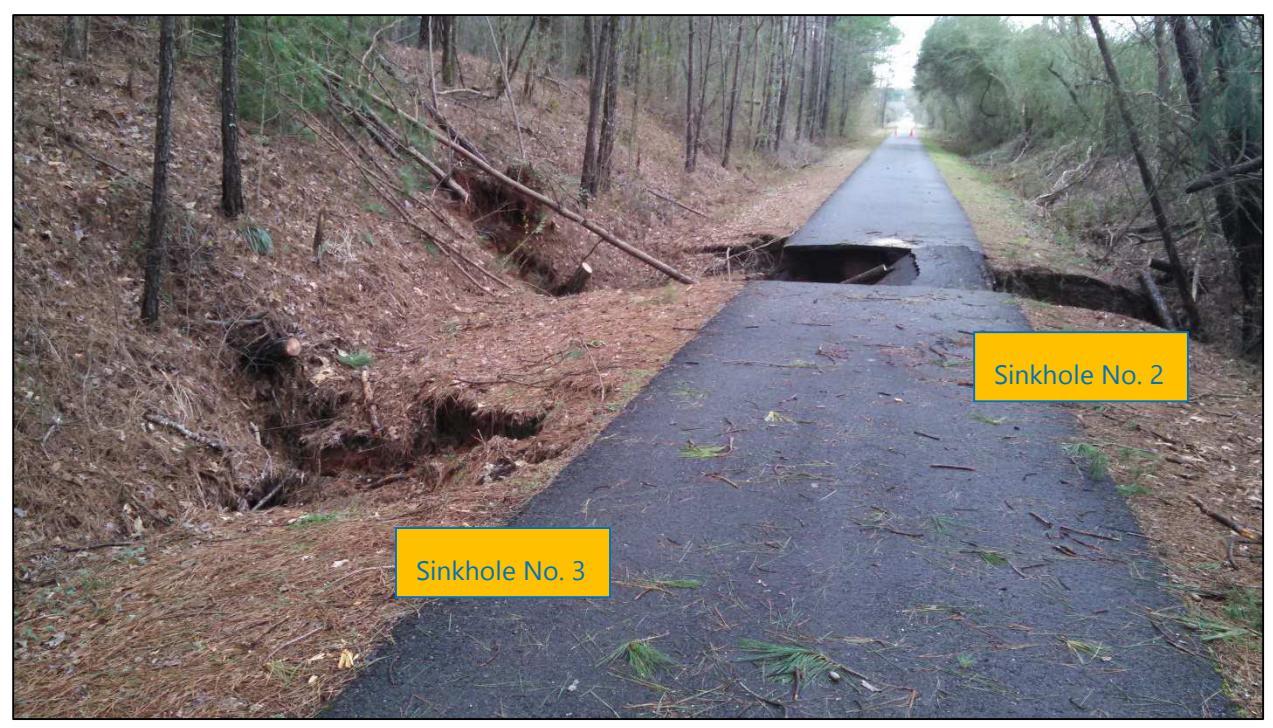
Figure No. 3 – Sinkholes No. 2 and 3, looking south (03-04-16)

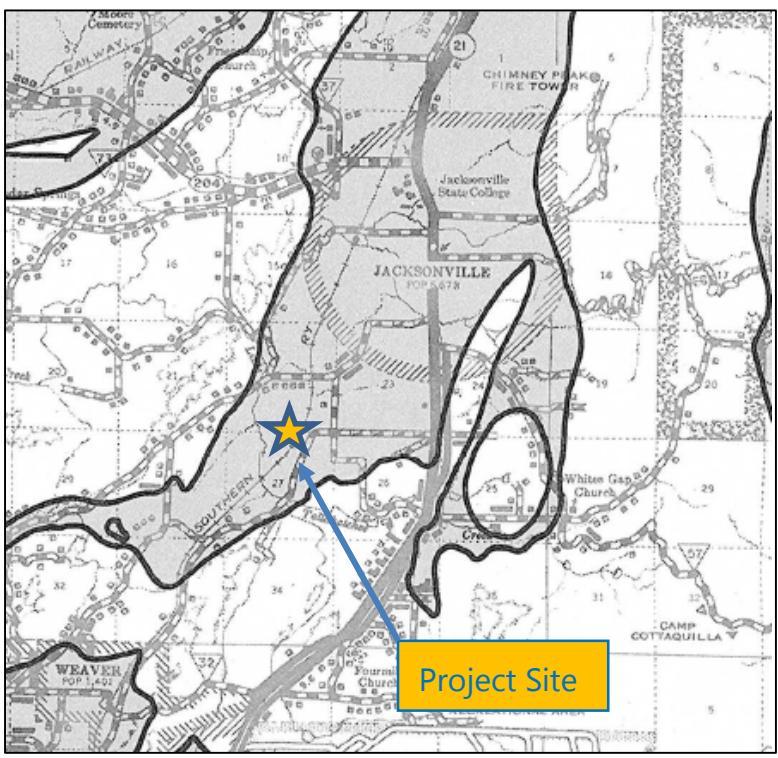
The Alabama Department of Transportation Sinkhole Map for Calhoun County (1977) is shown below. The map shows the area is prone to sinkholes (shaded area), but does not indicate any known sinkholes in the vicinity.

Figure No. 4 - ALDOT Calhoun County Sinkhole Map (1977)

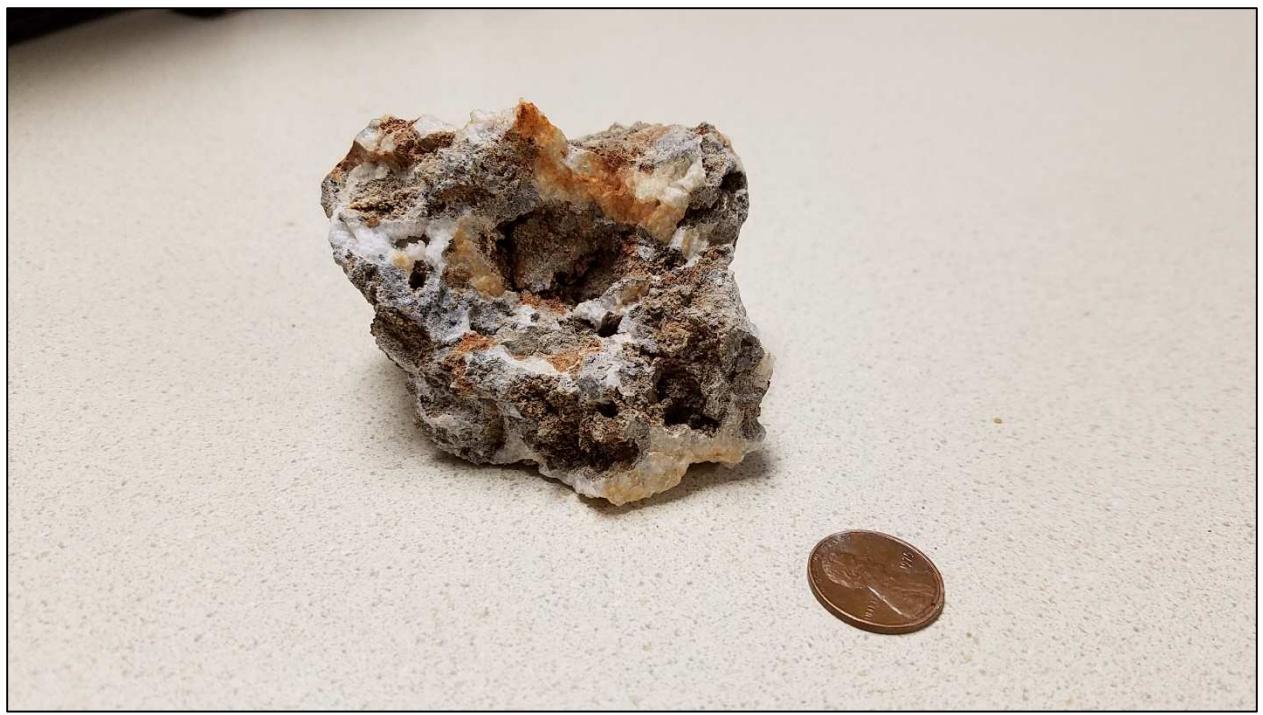
A sample of limestone bedrock was taken from one of the sinkholes, and can be seen in the photo below. The rock sample is relatively lightweight and porous, with many voids present.

Figure No. 5 – Photo of limestone sampled from Sinkhole No. 1

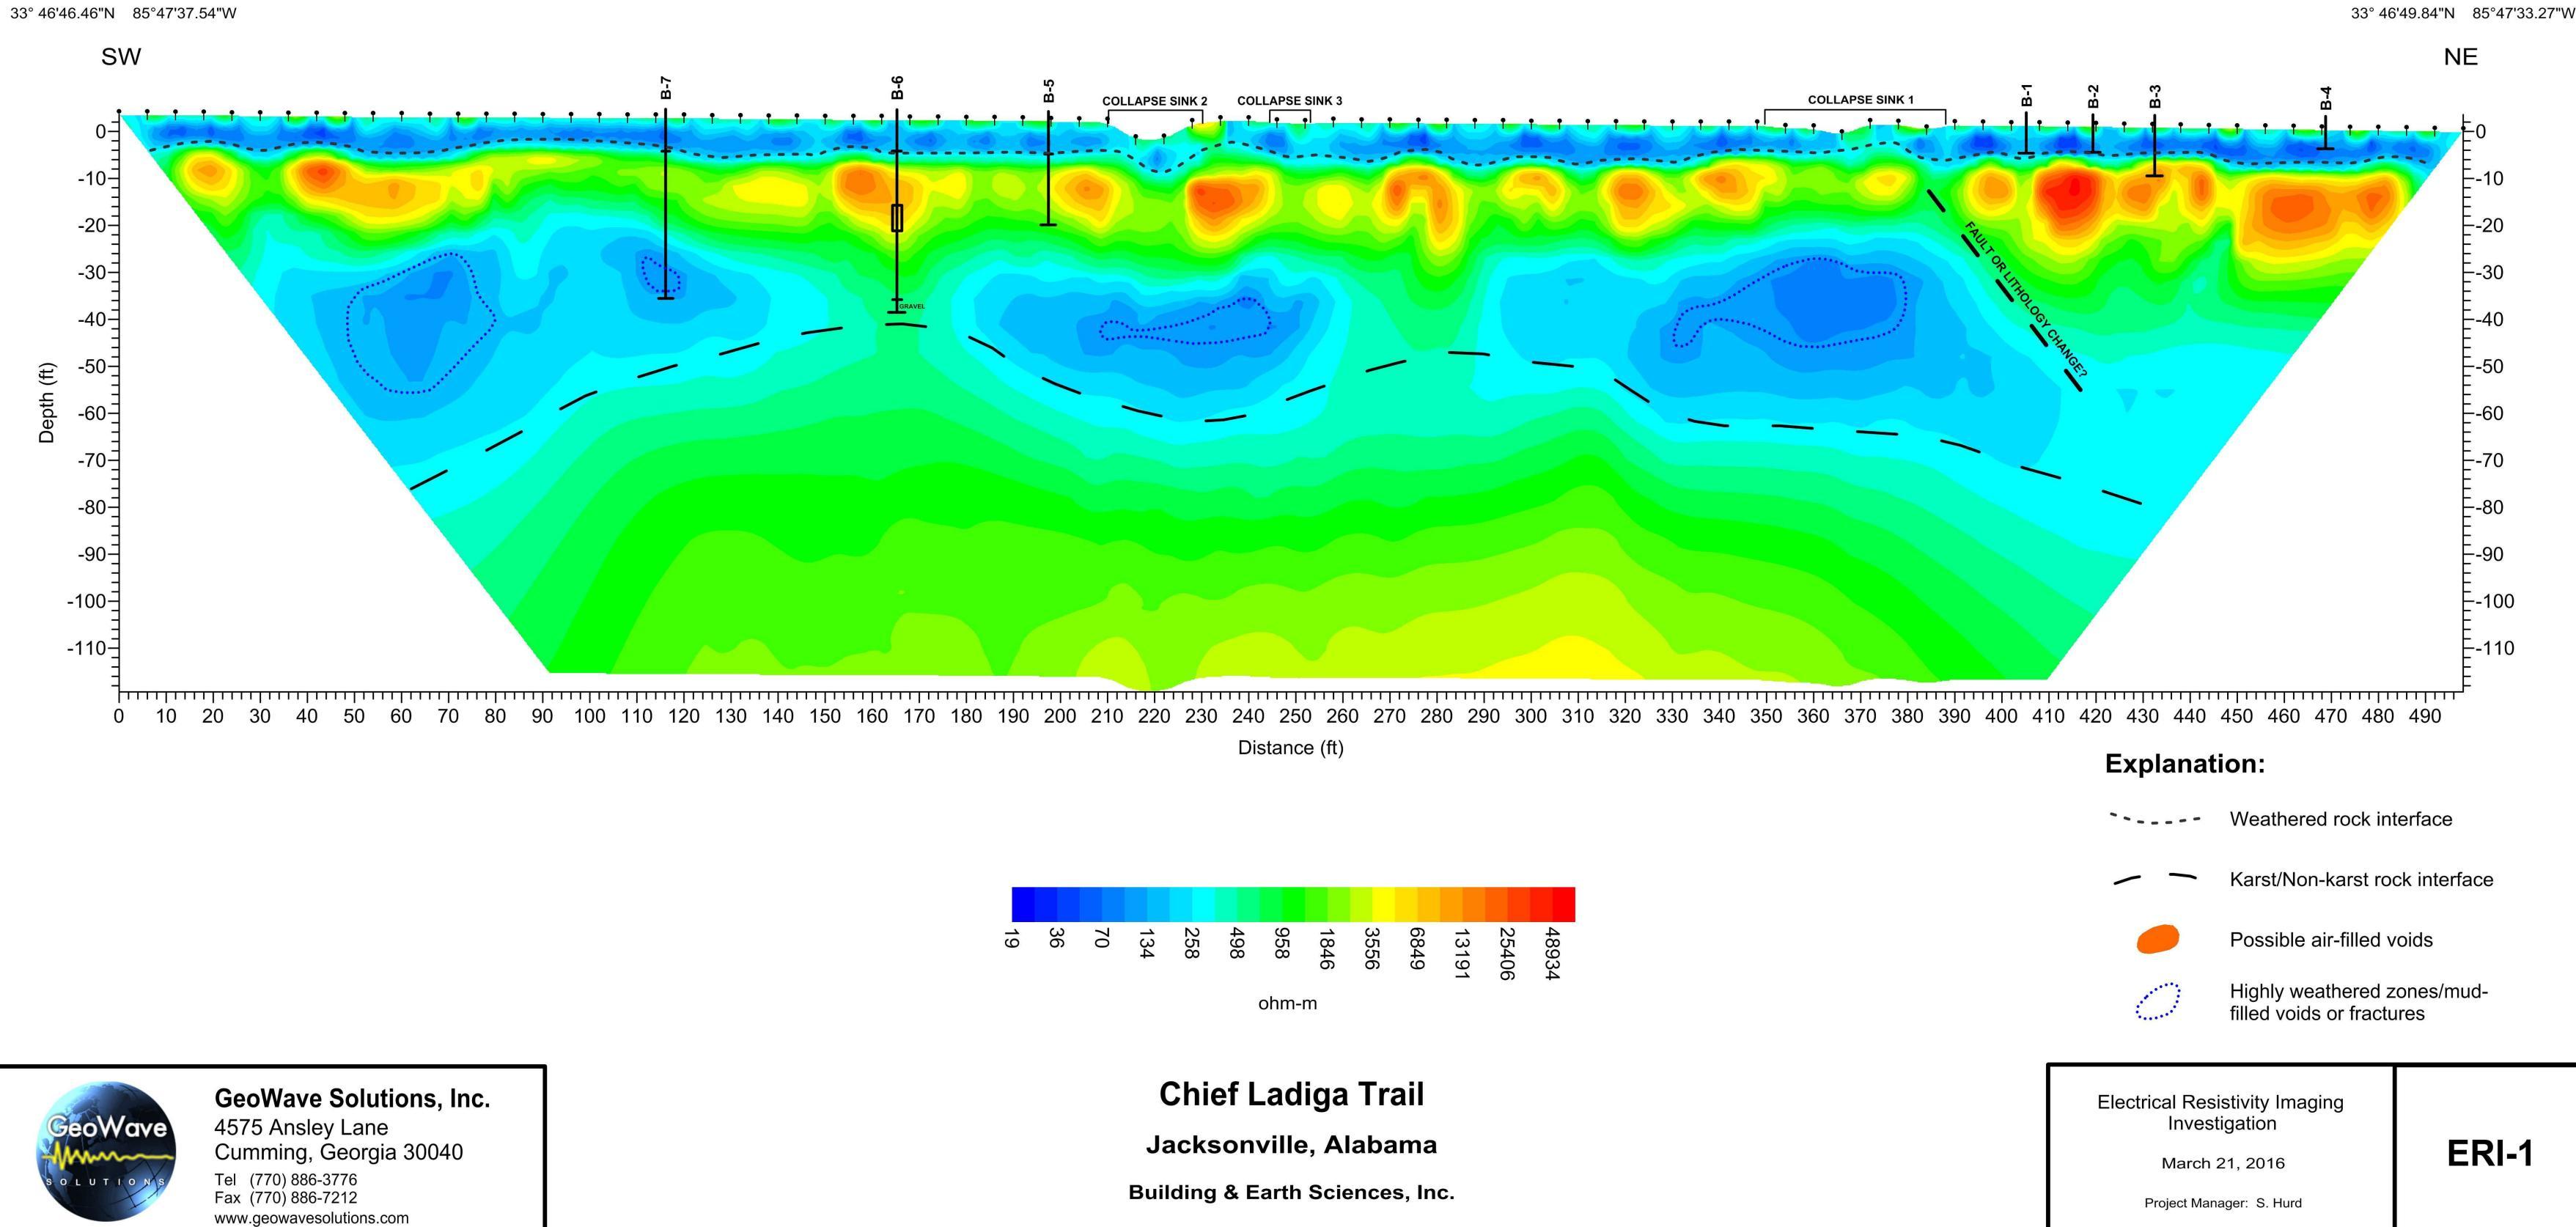
ERI-1

The middle layer of rock is mostly conductive, consisting of highly weathered rock with cavities back-filled with mud and saturated sediment. Two of the three large conductive anomalies in this layer lie directly below the collapse sinks observed on the surface. It is likely that surface water and sediment are migrating from the surface down into these zones. We suspect that the conductive zone, located approximately 90 to 150 feet south of sinkhole no. 2 is a possible location for a future collapse to emerge. The prominent cavities are located at depths of about 25 to 30 feet, and extend to depths of about 50 to 60 feet.

This thin, conductive layer extends from the surface to approximately 5 feet in depth. Its conductive nature is the result of a clay-rich soil retaining moisture. Small pockets of increased clay/increased moisture content are identified in areas where darker blue contours are present. For the most part, soil conditions beneath the collapse sinks are less conductive than many other areas on the model. This is likely due to the soils being well-drained at the collapse areas and the less consolidated nature of the sediment below the sinkholes.

We also recommend that the area north of sinkhole No. 1 be further evaluated during the grouting process to determine if the near surface anomalies identified on the ERI survey are actually air-filled voids as identified in the study. If voids are encountered, then additional grouting will be required in those areas.
