BUSINESS AFFAIRS AND HUMAN RESOURCES
NOVEMBER 24, 2014

IDAHO STATE UNIVERSITY

Purchase of real property to replace the existing executive residence owned by the institution and to sell the existing residence.

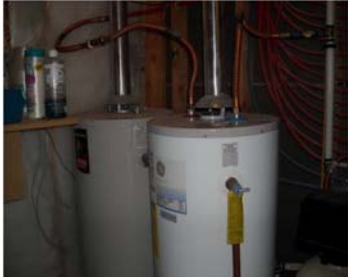
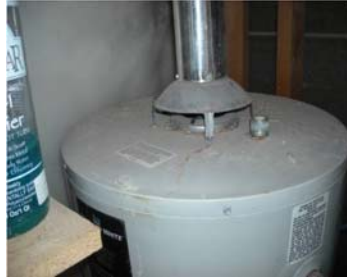
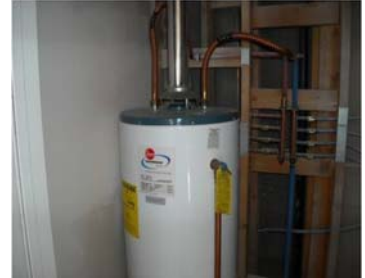
The left water heater in the mechanical room is not connected to the water distribution system. Recommend a qualified plumber review and make necessary connections for proper use and function as desired.

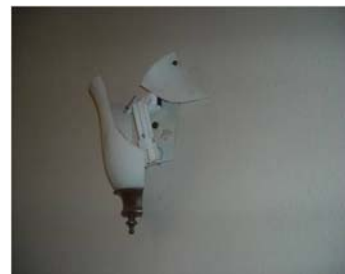
Wall light fixture on basement stairway is damaged. Repair/replace as desired.

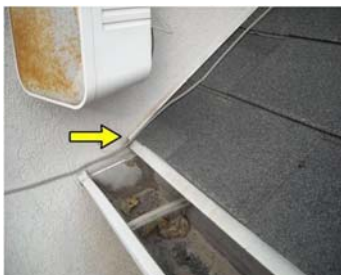
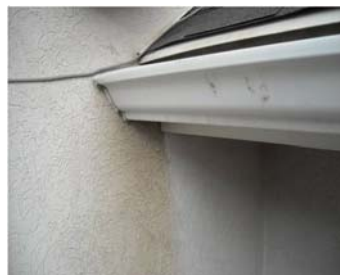
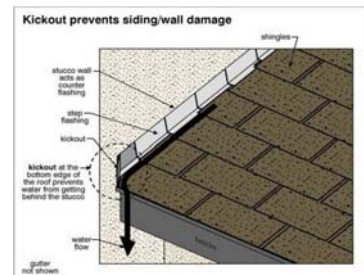
Venting

Evidence of previous leak around flue pipe. Leak does not appear to be active at the time of inspection, Protimeter Moisture meter used for detection. Monitor area and repair as needed.

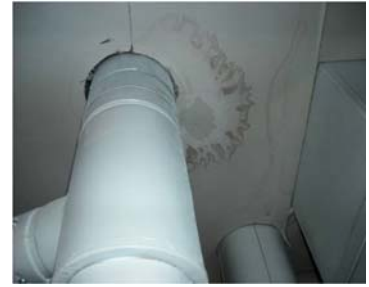
Vanity

Past staining under 2nd floor bathroom vanity

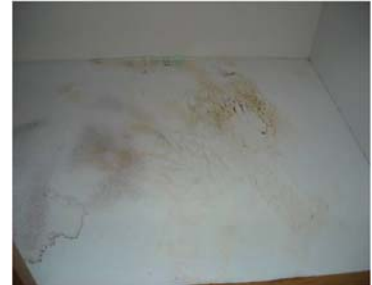
Tub Faucet/Mixer

Second floor tub/shower faucet is very stiff, indicating abuse / wear or lack of use. Recommend a qualified plumber review and make necessary repairs / replacement for proper use and function.
