Re: Inspection Summary/ Violation Letter
CSX Bridge over the Grand Calumet River
Hammond, Lake County

NPDES Industrial Facility Inspection Report

Name and Location of Facility Inspected: CSX Bridge over the Grand Calumet River South of Marble Street Hammond IN 46327	County: Lake	Receiving Waters/POTW: NA	Permit Expiration Date: No Permit
			Design Flow: NA

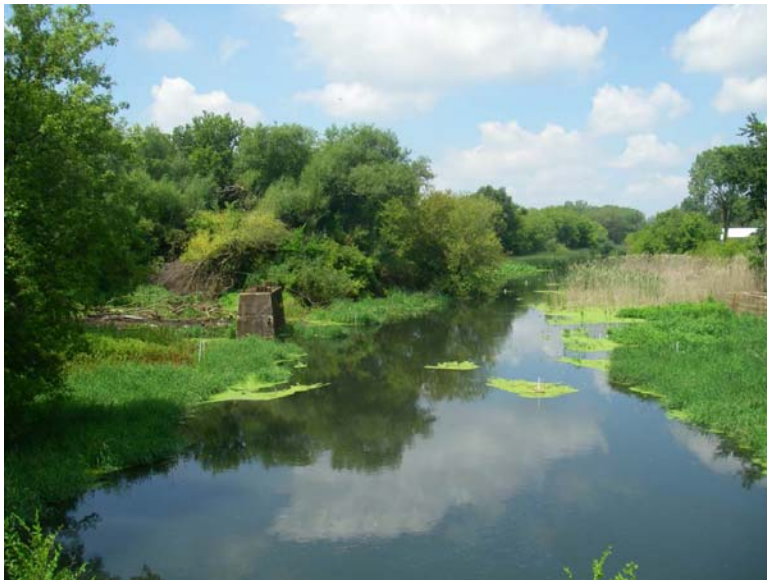
The remaining bridge was no longer visible. It could not be determined, at the time of the inspection, when the remainder of the bridge was removed.

Facility: CSX Bridge over the Grand Calumet River
Photographer: Nicholas Ream
Date: 07/17/2015 Time: 12:30 PM
Others Present: Rick Massoels, Ashley Snyder, Dan Goldblatt
Location/Description: West view of where the bridge formerly sat. A concrete support is visible in the center left.

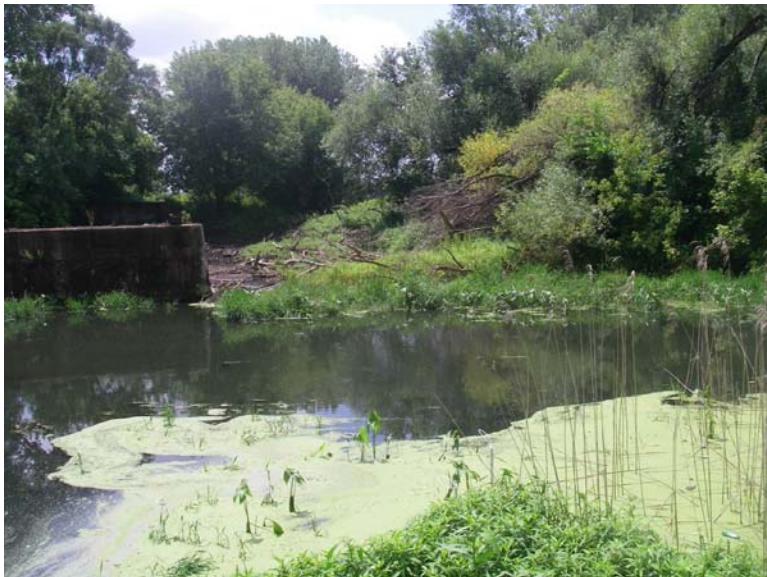
Facility: CSX Bridge over the Grand Calumet River
Photographer: Nicholas Ream
Date: 07/17/2015 Time: 12:50 PM
Others Present: Rick Massoels, Ashley Snyder, Dan Goldblatt
Location/Description: Southwest view of the area the bridge once stood.

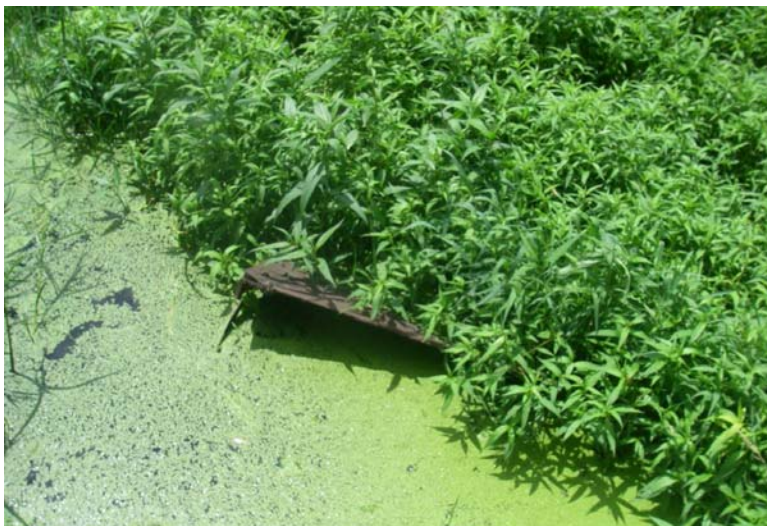
At the time of the inspection, it was observed that two pieces of bridge steel from the bridge truss system were in the Grand Calumet River, in violation of IC 13-18-4-5 and 327-2-1-6(a)(1). These materials will need to be removed from the river.

Facility: CSX Bridge over the Grand Calumet River
Photographer: Nicholas Ream
Date: 07/17/2015 Time: 1:00 PM
Others Present: Rick Massoels, Ashley Snyder, Dan Goldblatt
Location/Description: Down and south view of a steel piece of the truss as seen from the north concrete support.

At the time of the inspection, it was observed that two pieces of bridge steel from the bridge truss system were in the Grand Calumet River, in violation of IC 13-18-4-5 and 327-2-1-6(a)(1). These materials will need to be removed from the river.

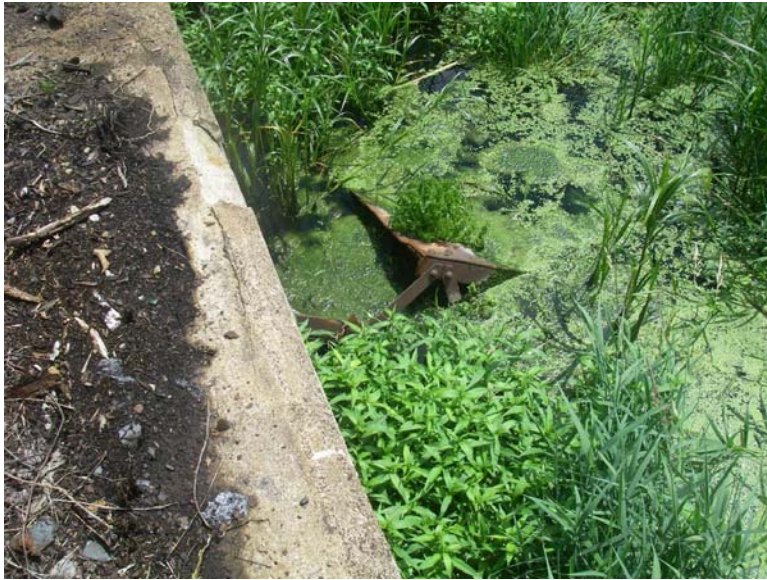
Facility: CSX Bridge over the Grand Calumet River
Photographer: Nicholas Ream
Date: 07/17/2015 Time: 1:00 PM
Others Present: Rick Massoels, Ashley Snyder, Dan Goldblatt
Location/Description: Down and southeast view of a second steel piece of the truss as seen from the north concrete support.
