Grand Teton National Park
Moose-Wilson Corridor Road Safety Audit

Conducted September 9-11, 2013

Victoria Brinkly, Western Federal Lands, FHWA

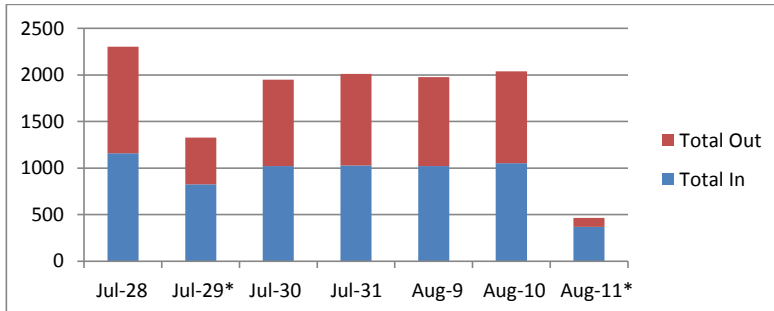
Figure 5 - Traffic at Granite Entrance Station
 *Incomplete due to equipment malfunction.

In addition to these tube counts, approximately seven days of vehicle counts were taken in late July and early August near the Granite Canyon Entrance Station with a system that could capture vehicle direction and bicycle presence. These counts showed the directional split of the traffic is approximately 50/50, with ~~an approximately a pretty much~~ even split of the total daily traffic ~~for-between~~ inbound and outbound traffic (Figure 5). The counts also show a distribution of 97-percent of the traffic being vehicular and 3-percent being bicyclist (Figure 6).

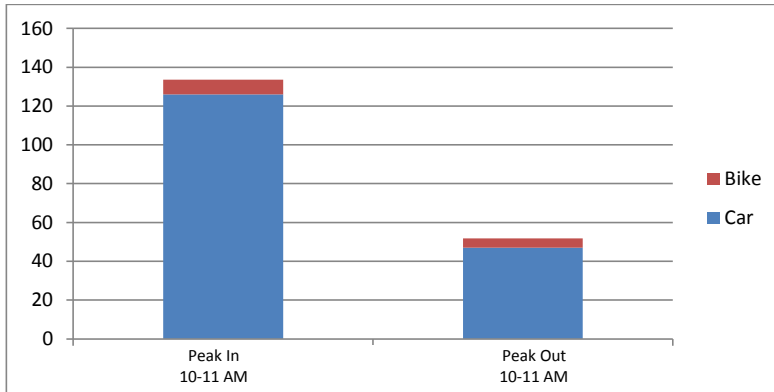
Figure 7 - Peak AM Average Traffic

Due to incomplete data on two days due to equipment malfunctions (July 29 and August 11) only the five full days of traffic counts were used for evaluating the morning and afternoon peak hours for traffic volume. The morning peak hour of traffic for both inbound and outbound traffic was between 10:00-11:00 AM for both vehicles and bicycles. The afternoon peak hour of traffic for both inbound and outbound vehicular traffic was between 4:00-5:00 PM on Sunday through Friday, and between 3:00-4:00 PM on Saturday. For bicycles, the afternoon peak hour varied from as early as 12:00-1:00 PM to as late as 3:00-4:00 PM.

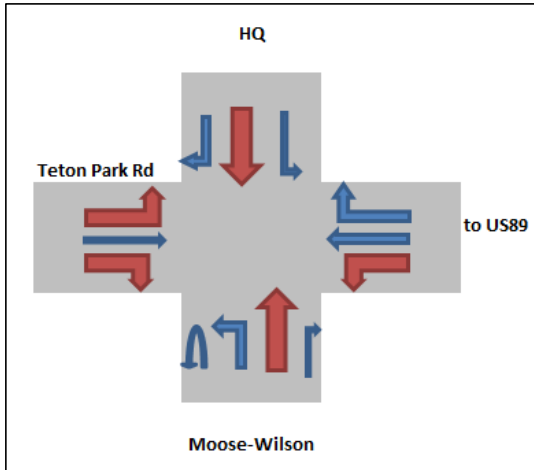
Figure 9 - Turning Movements at Teton Park Rd

Intersection turning movements were gathered at the intersection of Moose-Wilson Road with Teton Park Road (on a Sunday) and at the intersection with the LSR (on a Saturday). This data also included vehicle type breakdown by car, van, bicycle, and motorcycle. This classification was ~~only~~ for the total daily vehicular traffic ~~only, so consequently bicycle traffic~~ ~~no~~ peak hour of bicycle traffic at these intersections is ~~un~~known. For the Moose-Wilson/Teton Park Road intersection, the predominate traffic movements overall and for the AM and PM peak hours were the through movements on Moose-Wilson Road ~~(to/from Park Headquarters)~~ and the left turns from westbound Teton Park Road to Moose-Wilson Road. The right and left turns from eastbound Teton Park Road to Moose-Wilson Road were about even for the day, with left turns peaking in the morning and right turns peaking in the afternoon (Figure 9). For the Moose-Wilson/~~LSA-LSR~~ intersection, the dominate traffic movements overall and for the AM and PM peak hours were the north and south through movements on Moose-Wilson Road and the ~~east-~~

Since the Park Headquarters [are at is located on](#) the [southbound-northbound](#) approach of the intersection of Moose-Wilson Road with Teton Park Road, this could explain the majority of the traffic being north and south through movements as Park employees access the Headquarters and/or attend to maintenance and wildlife issues on Moose-Wilson Road. The morning peak left turns into Headquarters may also be attributed to employees making the left from Teton Park Road to head into work from other employee housing farther up Teton Park Road. The afternoon peak right and left turns onto Moose-Wilson Road may be attributed to visitors and employees who are returning to their residences near Teton Village [and Wilson](#). Less than 1-percent of the total traffic can be attributed to bicycles, with the majority traveling straight through in both directions on Teton Park Road.

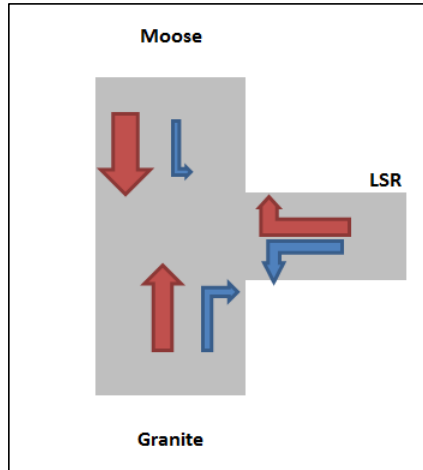
Figure 10 - Turning Movements at LSR

to-north right turns from LSR to Moose-Wilson (Figure 10). See Appendix X for traffic counts and directional distribution for both of these intersections.

The turning movements at the intersection of Moose-Wilson Road at the LSR show approximately equal left and right turns into the LSR, with about a 70-30 split of the vehicles leaving the LSR going north toward Moose as opposed to south to Teton Village. Approximately 3-percent of the total traffic can be attributed to bicycles, with the majority traveling straight through in both directions on Moose-Wilson Road.

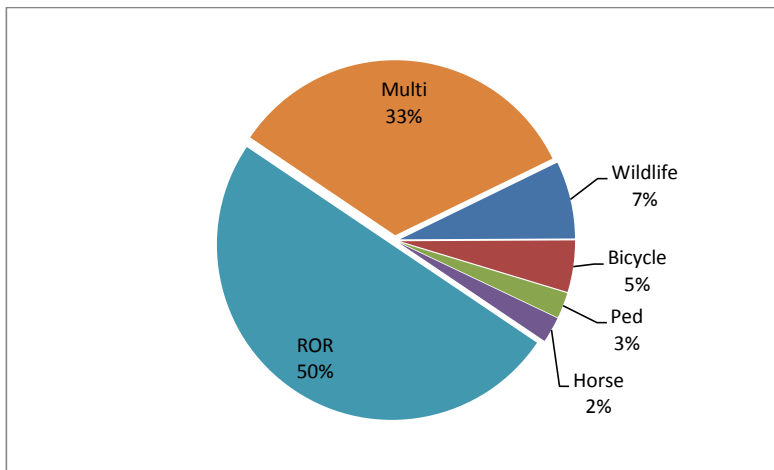
Figure 11 - Collision Type

The crash frequency for Moose-Wilson is 3.8 crashes per year or 0.5 crashes per mile per year. Similar roads in Wyoming have XX crashes per year. Approximately 90-percent of the crashes (38 total) were property damage only (PDO), with the remaining incidents consisting of three injury crashes (two involving bicyclists), and a pedestrian-involved incident with no reported injuries. Half of the crashes (21) involved single vehicles in run-off-road incidents and a third (14) of the crashes involved multiple vehicles (Figure 11). Approximately 20-percent of each of these types of crashes involved government vehicles. The other crashes included collisions with wildlife (3 elk), bicycles (2), a pedestrian, and a horse.

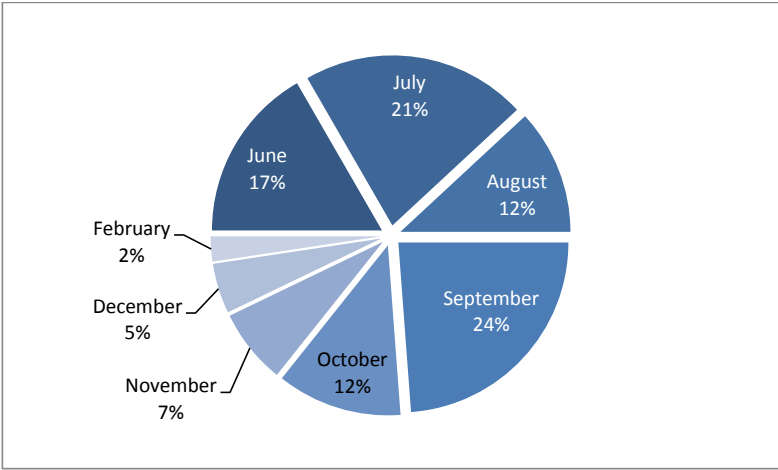
Figure 12 - Crashes by Month, 2002-2012

The majority of the reported crashes happened between June and September, the peak visitation months of any year, with about 25-percent of the crashes occurring during the rest of the months. In other words, one-quarter of the 12 months in a year experience 75-percent of the crashes (Figure 12).

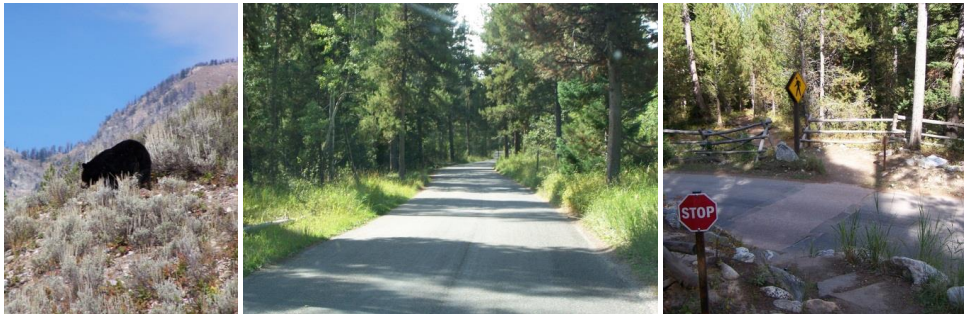
- **Wildlife:** There is outstanding wildlife viewing opportunities in addition to Park staff being responsive to any wildlife jams that occur.
- **Surface Condition:** The unpaved section undergoes maintenance three times per year, there is an awareness of surface concerns, and there is a desire to improve the conditions for ALL road users even if it is difficult to address everything with the resources on hand.

- **Road Characteristics:** Park staff and visitors like the rural, meandering characteristics of the road. The current road characteristics also tend to keep speeds low which most likely contributes to the low number of crashes and crash severities, in addition to the lack of wildlife injuries or deaths.

- **Positive Warning and Guidance:** While there could be improvements to warning and guidance messages on the route, there were signs to inform motorists of pedestrian crossings, a narrow bridge, horses, and vehicle restrictions. The hiking trails crossing Moose-Wilson also had signs and guidance to alert pedestrians of the upcoming intersection.

From left to right – black bear, roadway characteristics, and signing for pedestrians and vehicles.
