Waterloo Art Center

Dec 2020 Report

Prepared by Design Connect, Cornell University

Prepared for Village of Waterloo

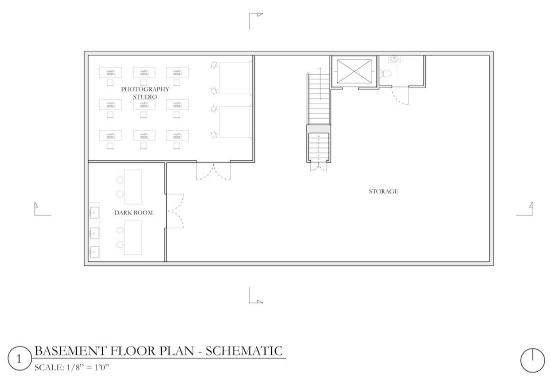
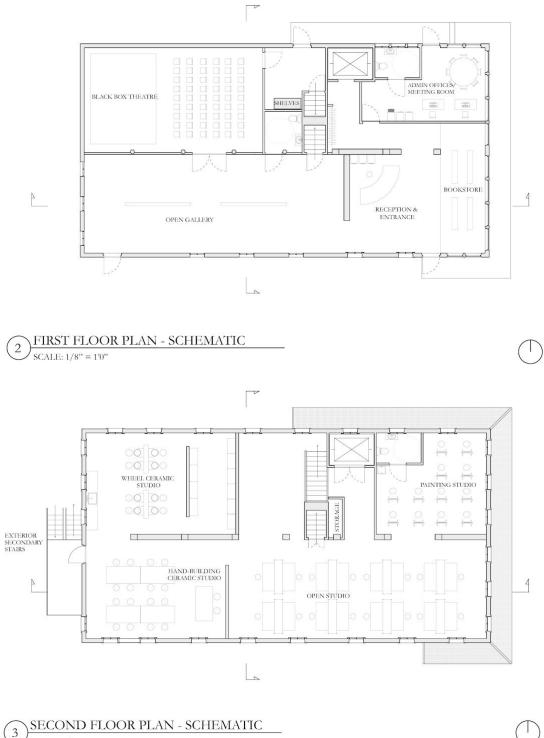
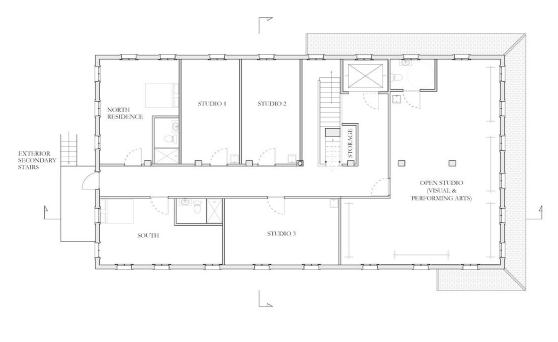
6.4.1 Floor Plans

SCALE: 1/8" = 1'0"

The ground floor houses the proposal's primary programs and promotes an increased potential for foot traffic by maintaining an entirely glazed front facade and establishing minimal partitions throughout the floor. Glazing and daylighting conditions were fully kept in their existing condition, utilizing this arrangement to place open, public areas such as the reception and a bookshop towards the front and create a public gallery and a black box theater in the back, where windows have been previously covered or removed. An administrative office, to be also utilized as a small conference room, is also located on the ground floor for ease of access and flexibility.

The building's second floor hosts the greatest expanse of open studio spaces, providing opportunities for cross-disciplinary collaborative work efforts as well as larger scale classes and community engagement. The large open studio takes up a majority of the square footage for artists that would like to rent a single desk workspace. Located along the southern edge of the floor, this space is sure to provide excellent natural daylighting, as well as options to share work with other fellow artists. Additionally, a ceramic studio, including hand building and wheel throwing resources has been created towards the western edge of the floor; a corresponding kiln can easily be installed on the exterior grounds of the Art Center to meet all safety requirements, while maximizing the use of the ceramics studio. Supplementarily, a small painting studio where independent artists or classes can be held, has been allocated along the north-eastern corner.

The third floor provides the most privatized areas within the building, hosting two studio apartments for rotating resident artists and a range of private studio spaces that local artists may rent for classes or personal work efforts. Additionally, being the top-most floor of the building, these spaces can take advantage of additional daylighting opportunities through the implementation of skylights. While the designated built spaces within this floor are less flexible in their programmatic use, they provide opportunities for a steady source of income to fund the Waterloo Art Center.
