April 30, 2020

Grandad Bluff Coalition  
128 29th St S, La Crosse, WI 54601  
c/o Christine Clair

**RE: Evaluation of Bluffsides Stability, Erosivity, and Potential Degradation of Grandad Bluff  
from Mountain Bike Path Construction, Operation, and Maintenance**

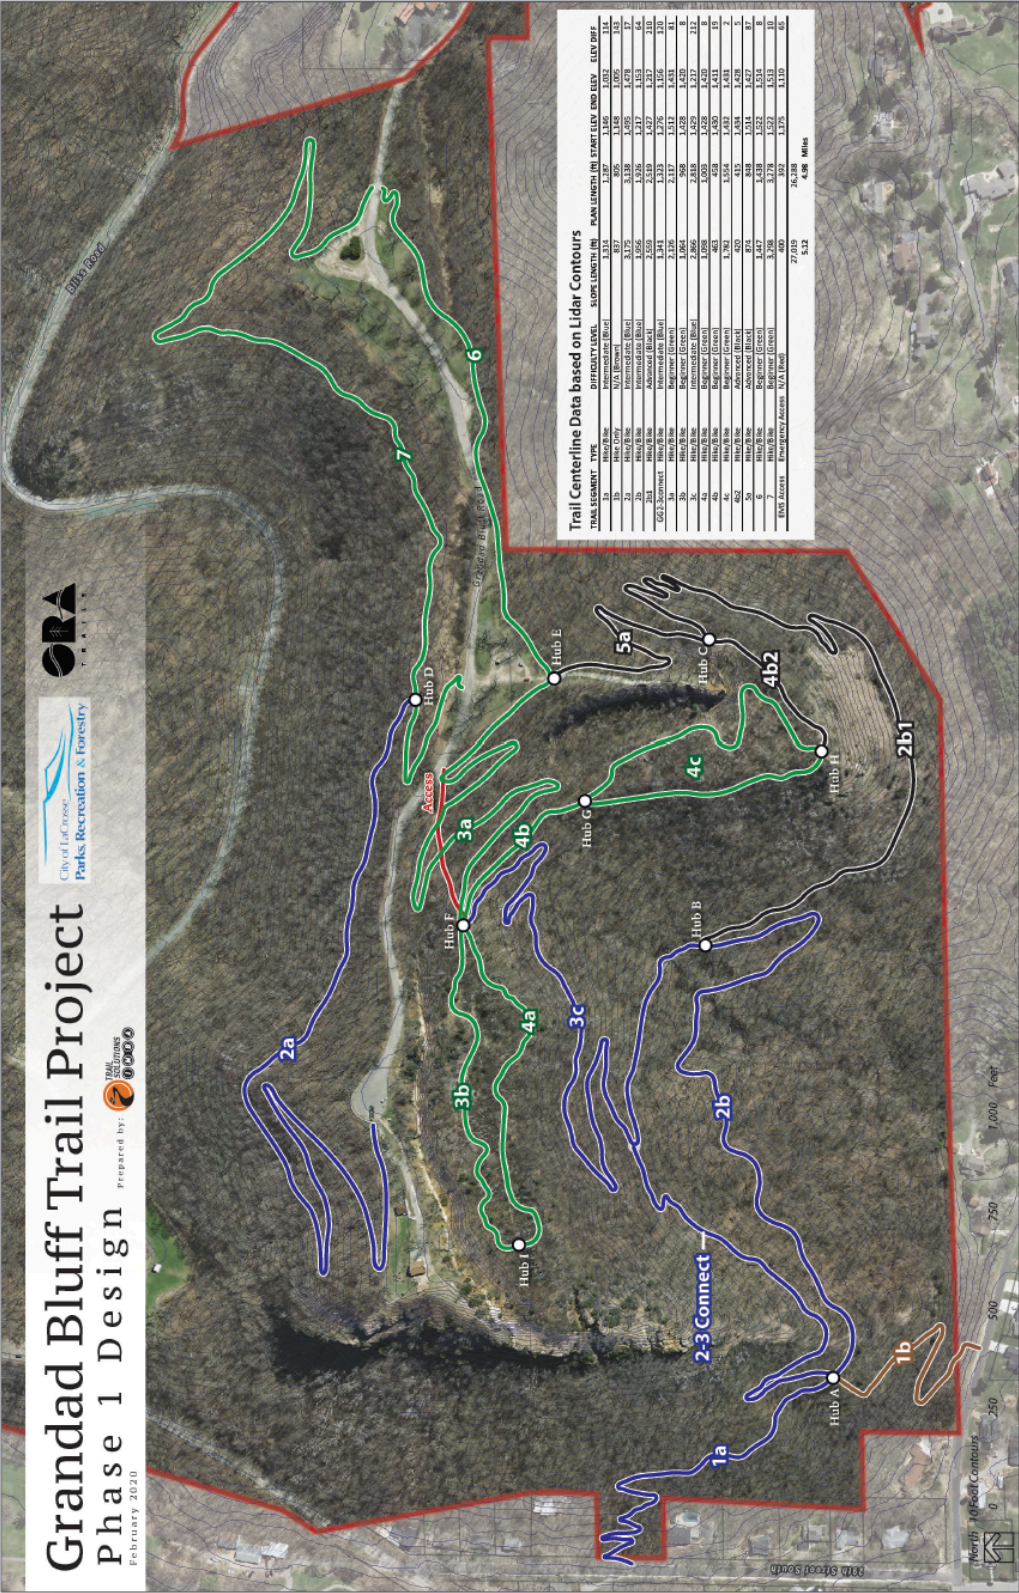
Figure 1. Proposed Trail Layout.

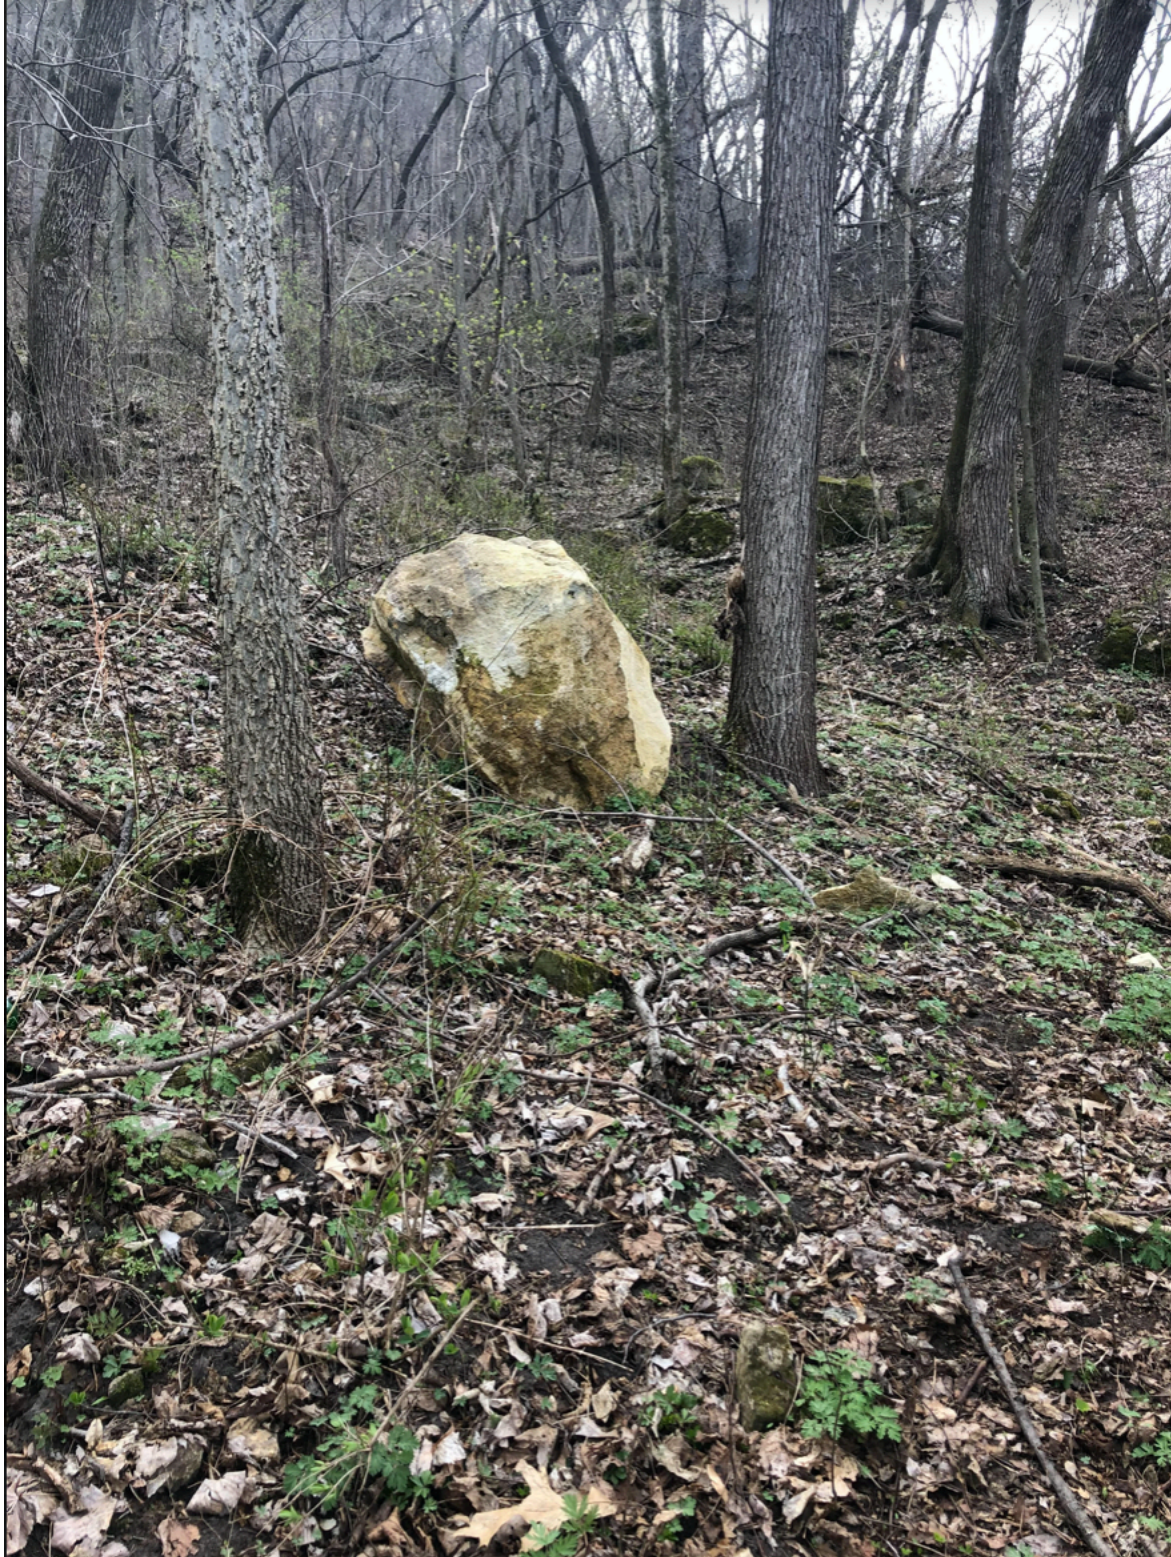
**Figure 2. Example of dislodged boulder on Grandad Bluff.**

1. ***Bike paths should not be located within 100 m upslope of occupied residences or structures*** as there is the potential for safety issues related to rockfalls or other slope movements caused by disturbances of naturally steep slopes. “Rockfall” is defined as *the movement of rock of any size from a bluff or other slope that is so steep the mass continues to move down the slope* (see **Figures 2 and 3**, for example). Movement may be by free-falling, bouncing, rolling or sliding. In many regions, the greatest amount of rockfall occurrences are during rainstorms when fine-grained supporting materials are washed away from beneath larger rocks. This also holds true for wind, snowmelt and channeled runoff, such as typically occurs on artificially constructed trails on steep slopes. The second major cause of rockfall is freeze-thaw cycles. Because of the channelization and routing of water along or across trails on steep slopes, construction of trails on these steep slopes generally enhance the potential for freeze-thaw cycles and thus the potential for increased rockfall occurrences. There is further evidence that shallow slope failures are possible, associated even with structural elements (see, for example, retaining wall failure in **Figure 4**). As such, it is my opinion that any retaining elements for the proposed bike paths should be designed by a licensed professional engineer. Paths constructed on slopes steeper than 35 degrees should have similar consideration for professionally engineered designs.

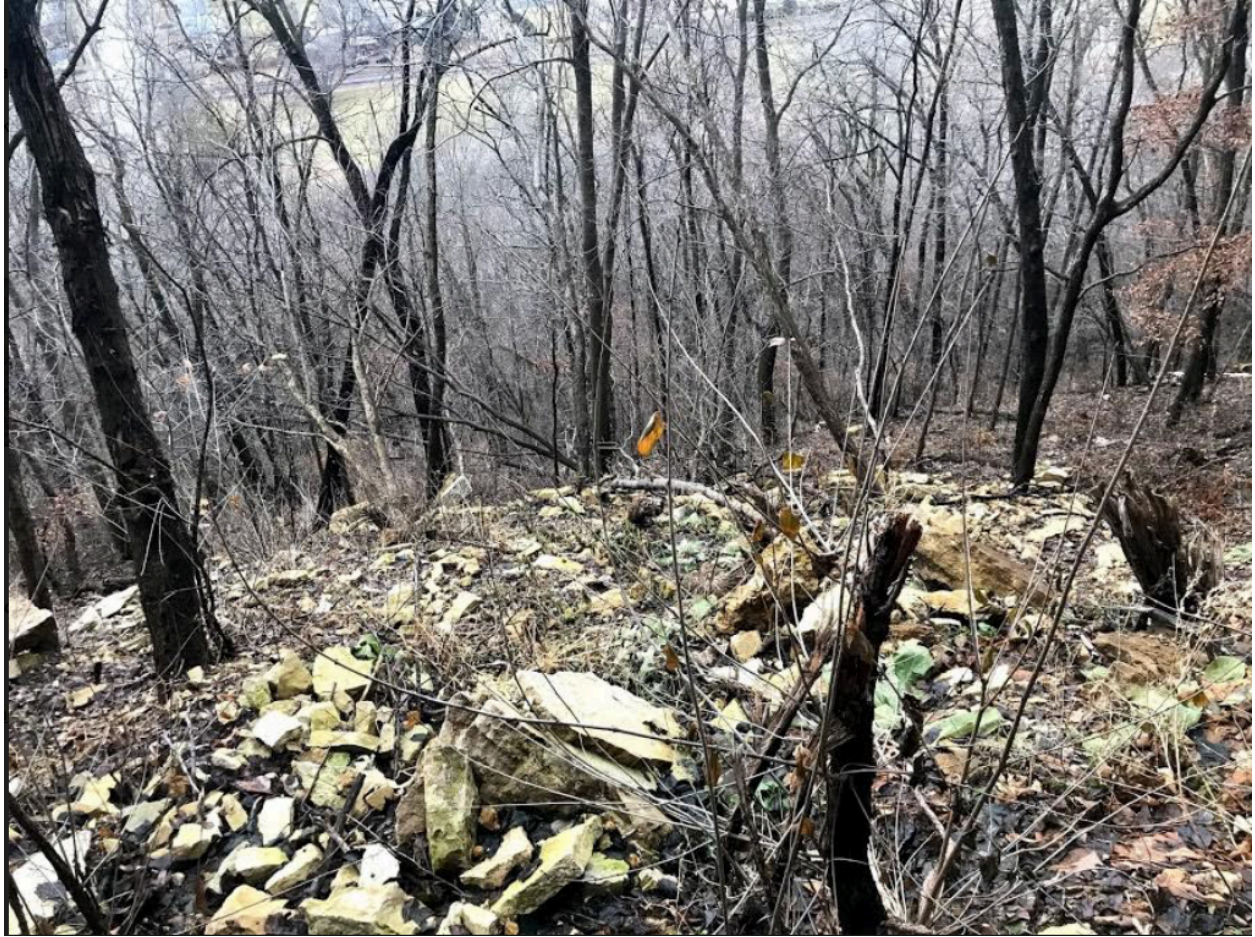
**Figure 3. Evidence of rock instability on Grandad Bluff.**

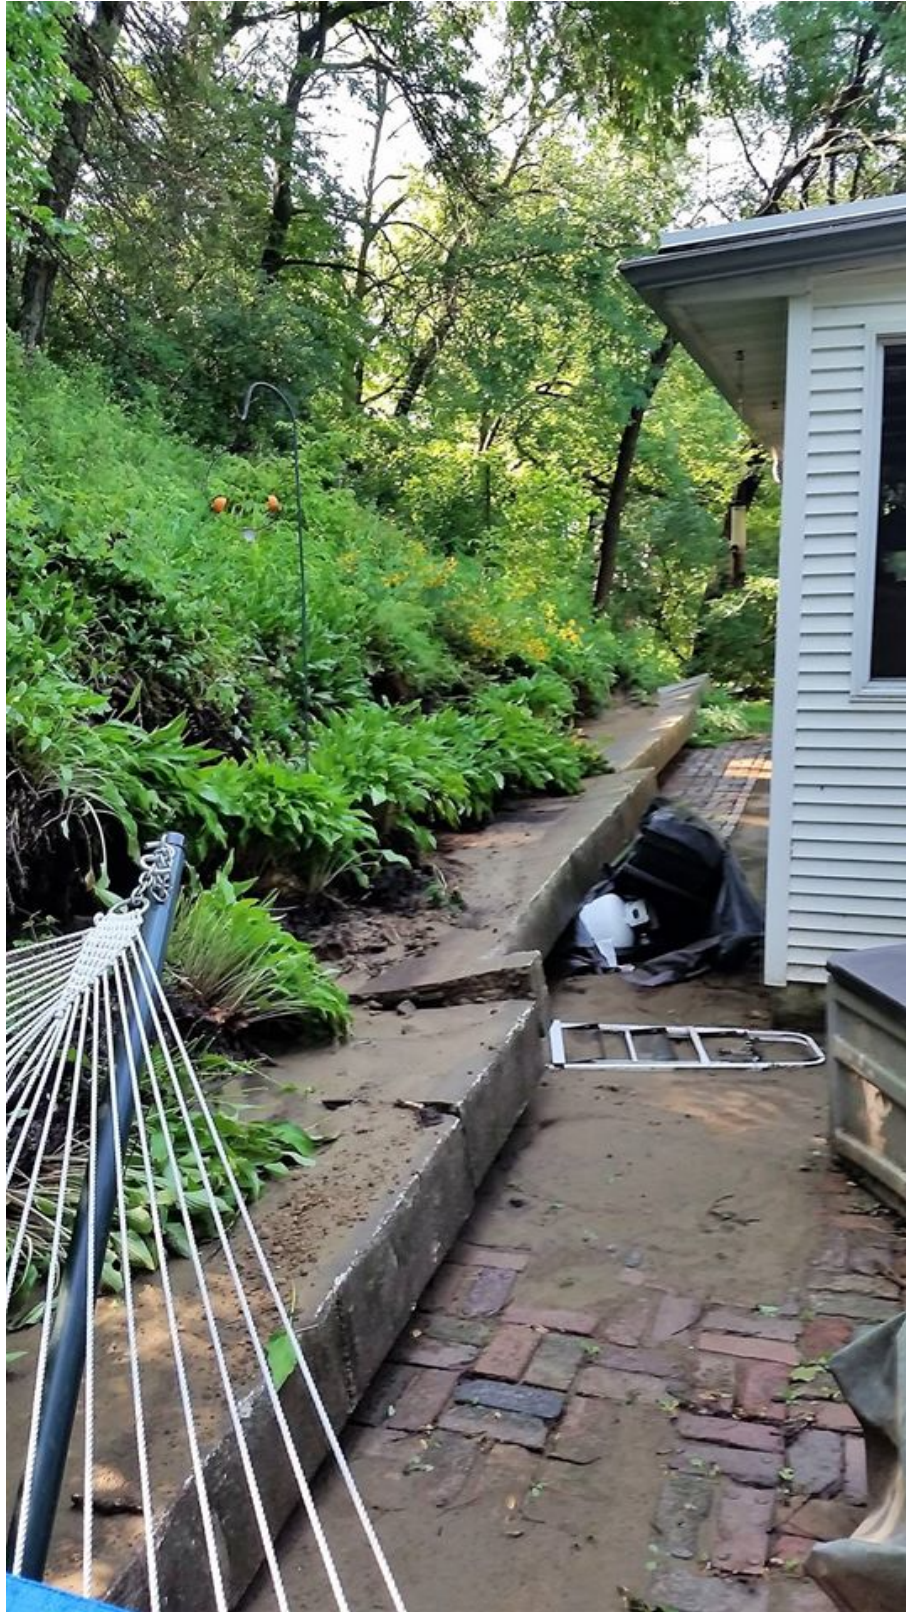
**Figure 4. Evidence of bluff instability as manifested by retaining wall failure.**

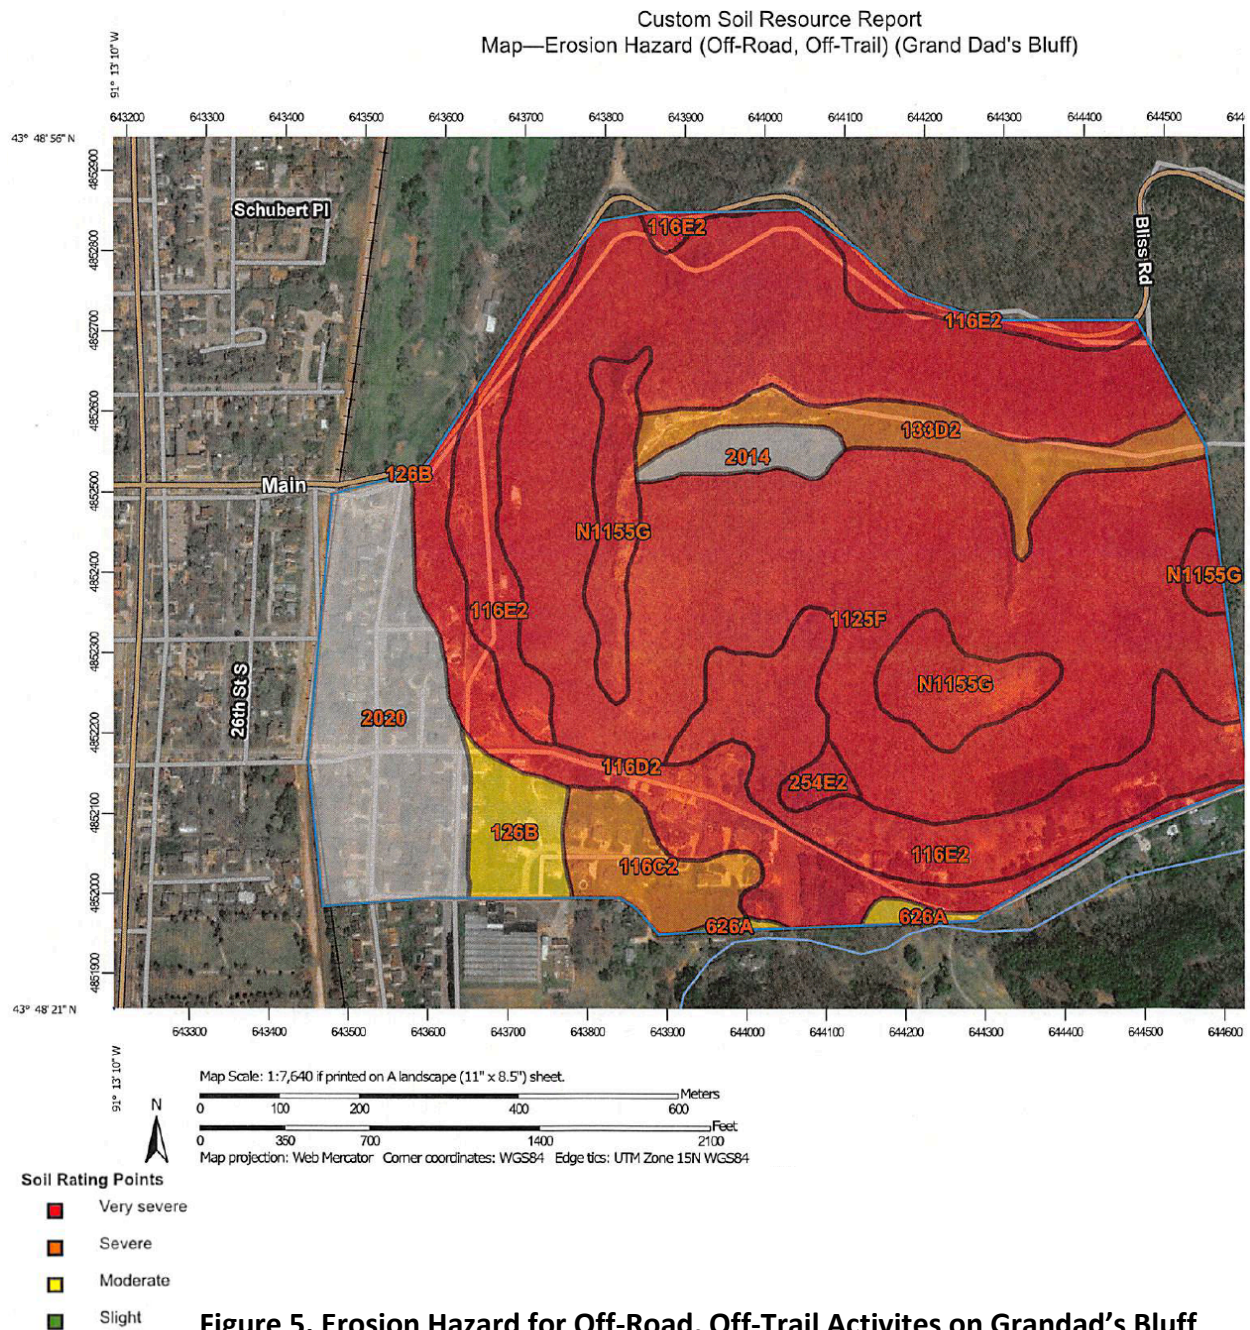
**Figure 5. Erosion Hazard for Off-Road, Off-Trail Activities on Grandad's Bluff (USDA Soil Conservation Service Custom Soil Resource Report for La Crosse County)**

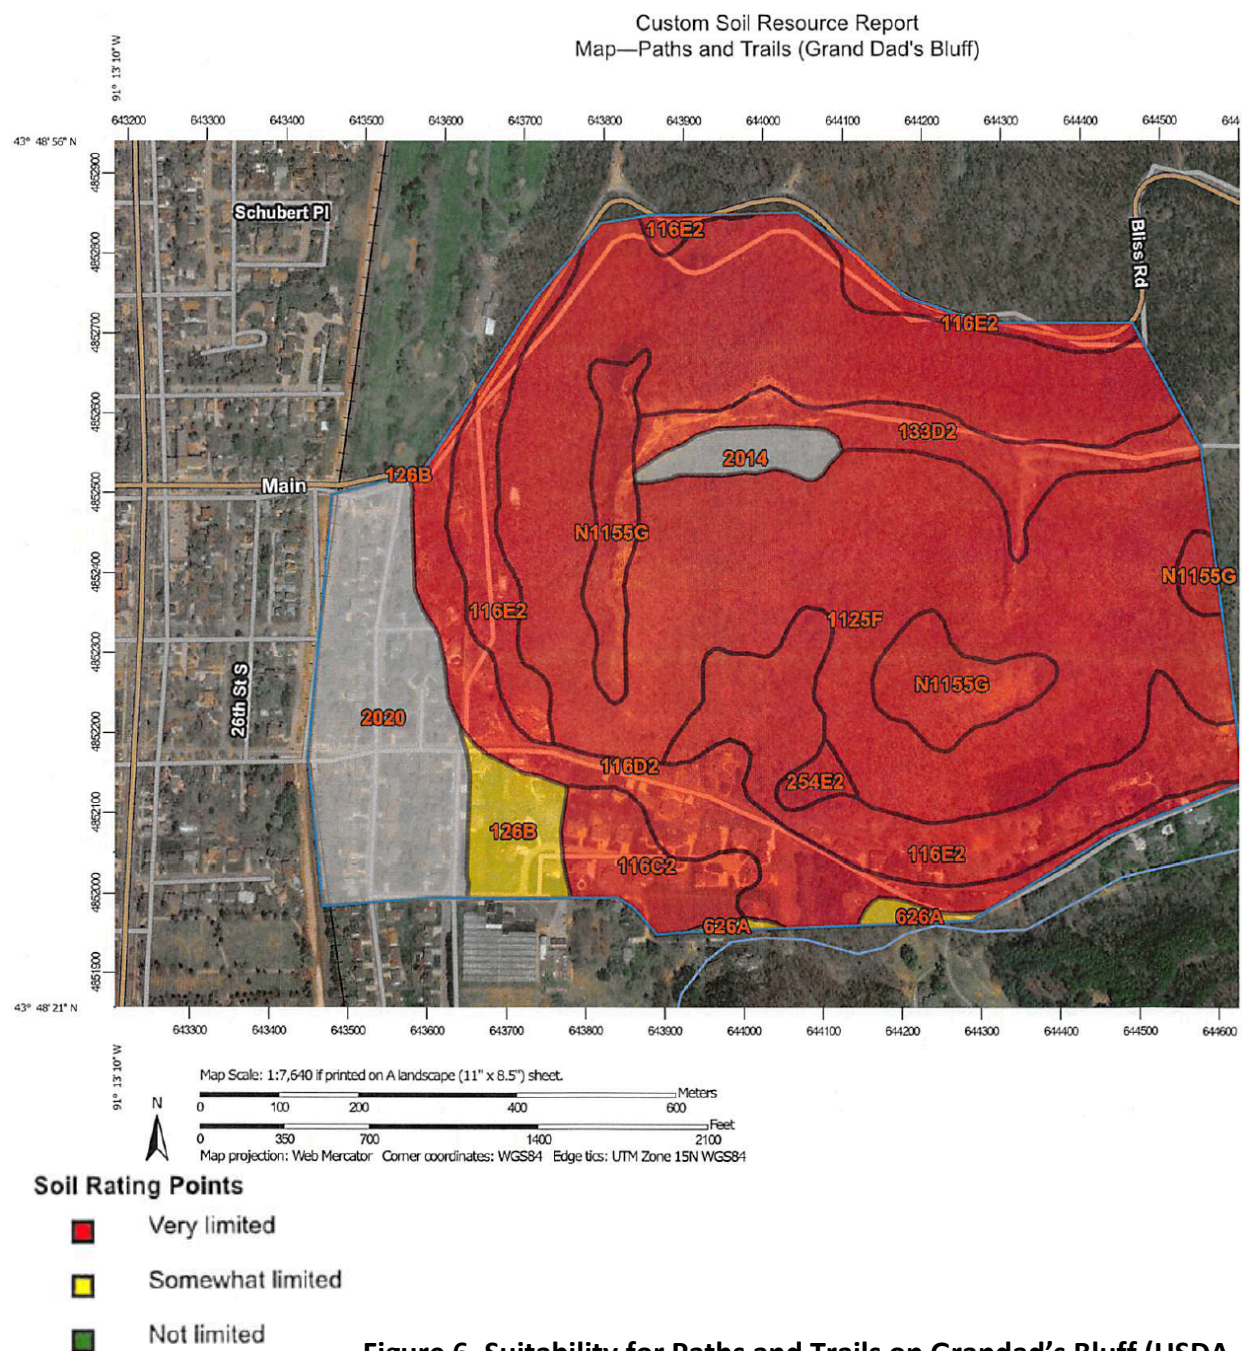
of the canopy which could lead to modification in micro-topography and micro-climate. Erosion (see **Photos 3 and 5**) and increased storm water conveyance (as would be conveyed on paths as shown in **Photos 2 and 4**) would be exacerbated by climatic issues such as increased occurrence of precipitation events and intensity of such events (e.g., extreme frost depths, excessive snow, high-intensity rain events). Because of shallow surface soils across Grandad Bluff, there is very limited capacity for shallow soil to absorb, retain, and moderate stormwater conveyance. These opinions of increased erosive potential with the construction and operation of an extensive trail system is not just my individual technical opinion, but is also very bluntly detailed in a Custom Soil Resource Report prepared by the USDA Natural Resources Conservation Service for La Crosse County (2020) in which the majority of Grandad Bluff is classified as “very severe” in terms of erosion hazard specific to off-road and off-trail situations (**Figure 5**). This very severe rating indicates that ***significant erosion is expected, loss of soil productivity and off-site damage are likely, and erosion-control measures are costly and generally impractical.*** For paths and trail potential, this same report indicates that Grandad Bluff is rated as “very limited,” see **Figure 6**. Very limited is defined to mean:

*the soil has one or more features that are unfavorable for the specified use and that these limitations generally cannot be overcome without major soil reclamation, special design, or expensive installation procedures. Poor performance and high maintenance can be expected.*

**Figure 6. Suitability for Paths and Trails on Grandad's Bluff (USDA Soil Conservation Service Custom Soil Resource Report for La Crosse County)**

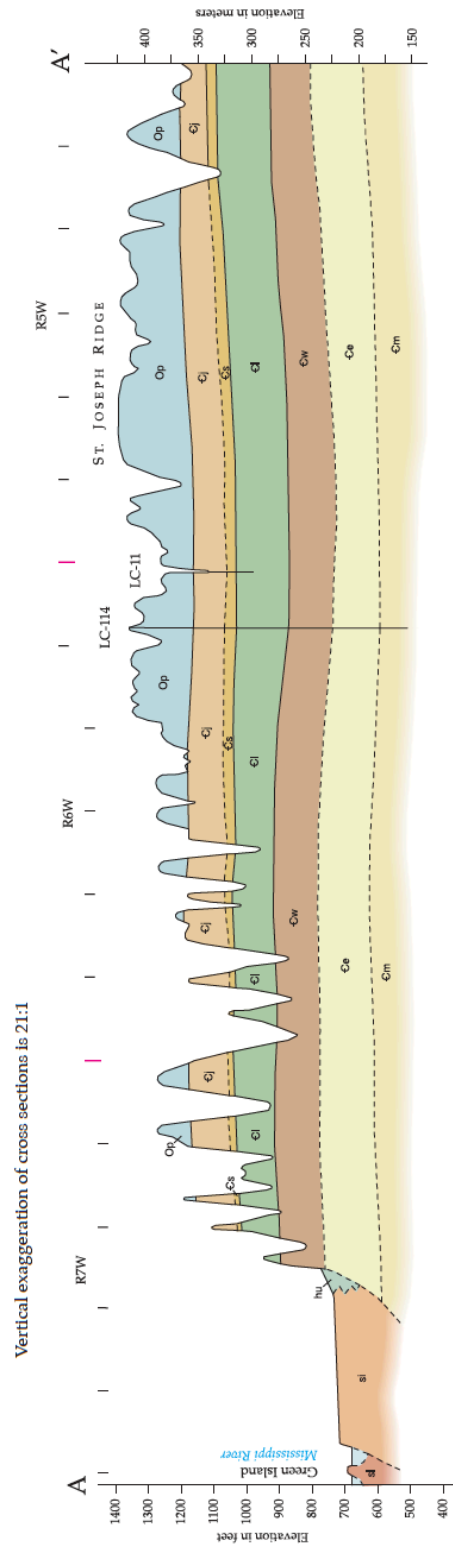
3. ***High-intensity mountain biking on Grandad Bluff would indelibly and irreparably impact the tranquility, setting, and nature of these areas.*** On the geological and cultural significance of Grandad Bluff, I believe that construction, operation, and maintenance of an extensive set of off-road biking paths would cause irreparable harm. La Crosse County is characterized by unique contrasts in topography and geology (see **Figure 7**) and Grandad Bluff epitomizes these contrasts. Grandad Bluff—an elevated mesa with a flat top and steep cliff sides—is a highly visible icon of geologic forces. Grandad Bluff is one of the few places for which a panoramic view of the City of La Crosse and the confluence of three rivers is found and, on a clear day, three separate states are visible. These blufflands are unique landforms that were formed over the course of tens of thousands of years and were not “bulldozed” by the Wisconsin Glaciation. Scenic America labeled these Upper Mississippi Blufflands as a top ten “last chance” landscape for which these naturally occurring, geologically significant features face harm from development and human activity. Grandad Bluff has unique rock outcroppings, including the dolomite of the Prairie du Chien group (**Photo 1**) capping Cambrian-era Jordan Sandstone. This geological setting (see **Figure 7**) is

**Figure 7. Geologic Map and Cross Sections of La Crosse County, Wisconsin (from Evan 2003) showing the unique and irreplaceable natural geology of the Blufflands.**

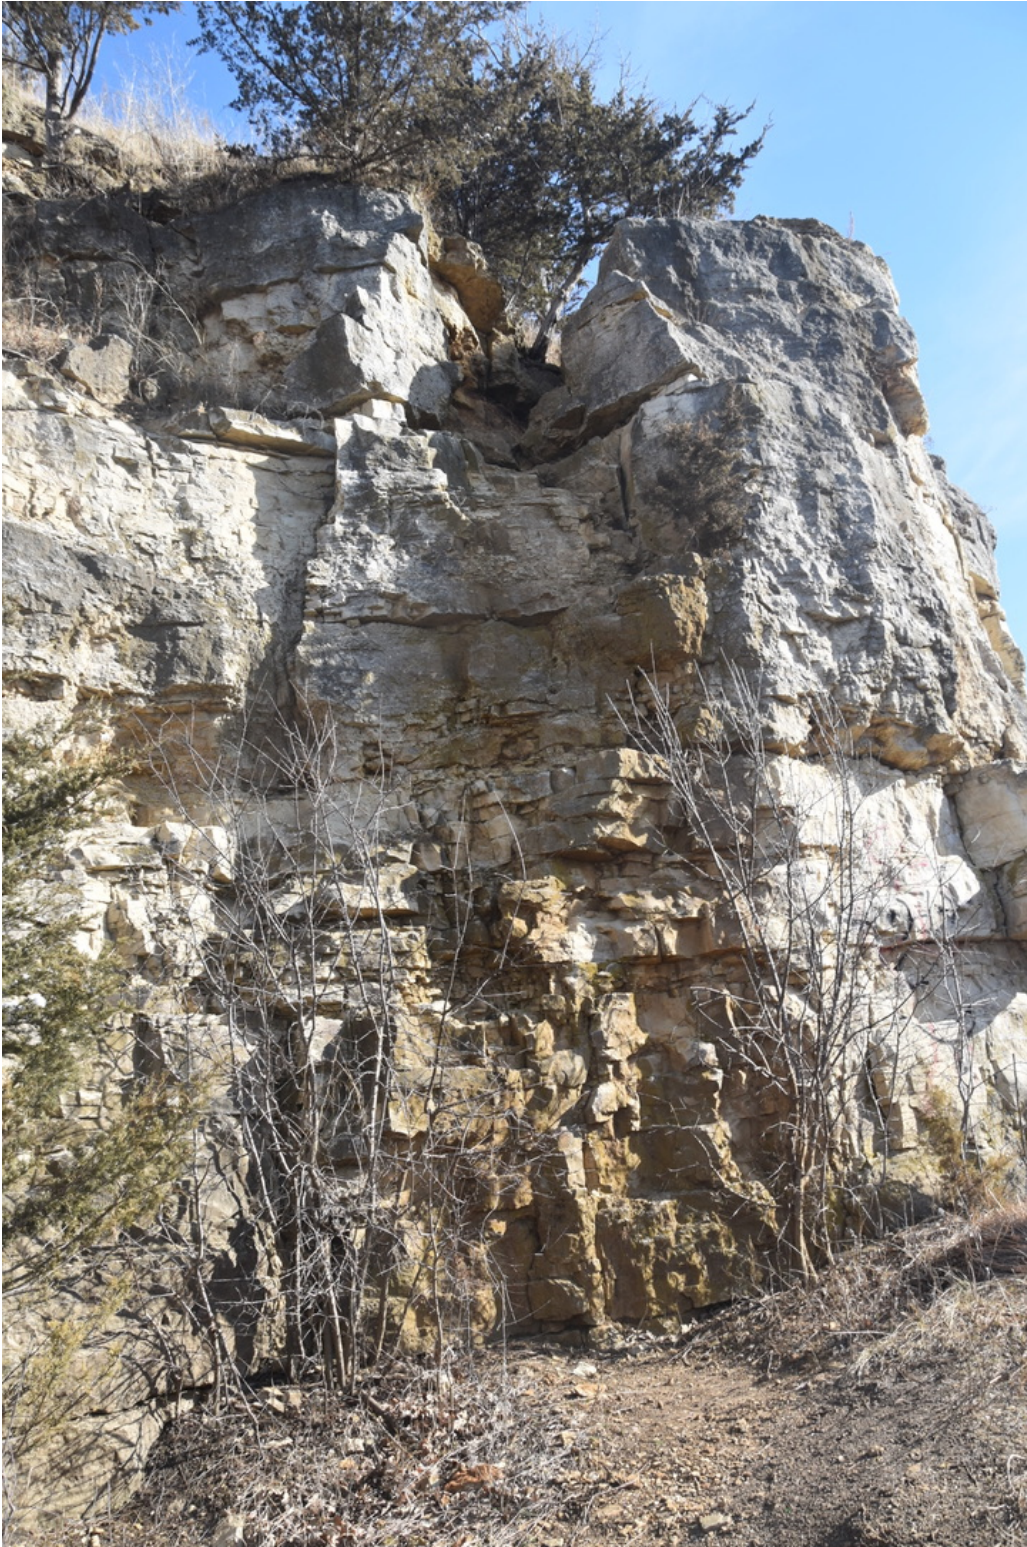
not only geologically unique, but also susceptible to mass movements (see **Photo 1** in comparison to **Figure 8**).

**Photo 1:** Capstone Rock (Prairie du Chien Dolomite) at Grandad Bluff (03/21/20).

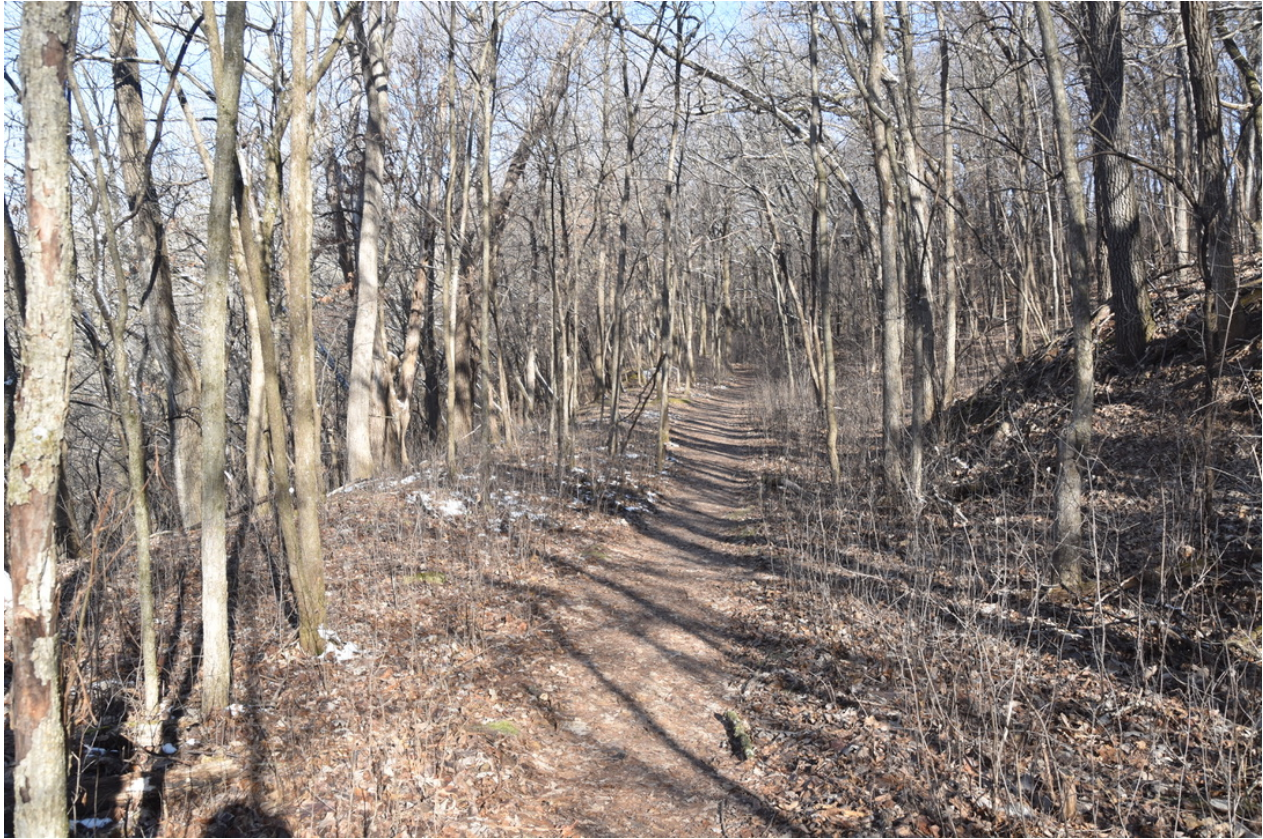
2. Construction of trails on steep slopes such as those found throughout Grandad Bluff would lead to the modification of existing drainage patterns (see **Photos 2 and 4**), the removal of the thin upper soil horizon, soil compaction in places, and also the potential for an opening

**Photo 2:** Compaction leading to depressed path and conduit for stormwater flow and Grandad Bluff (03/21/20).

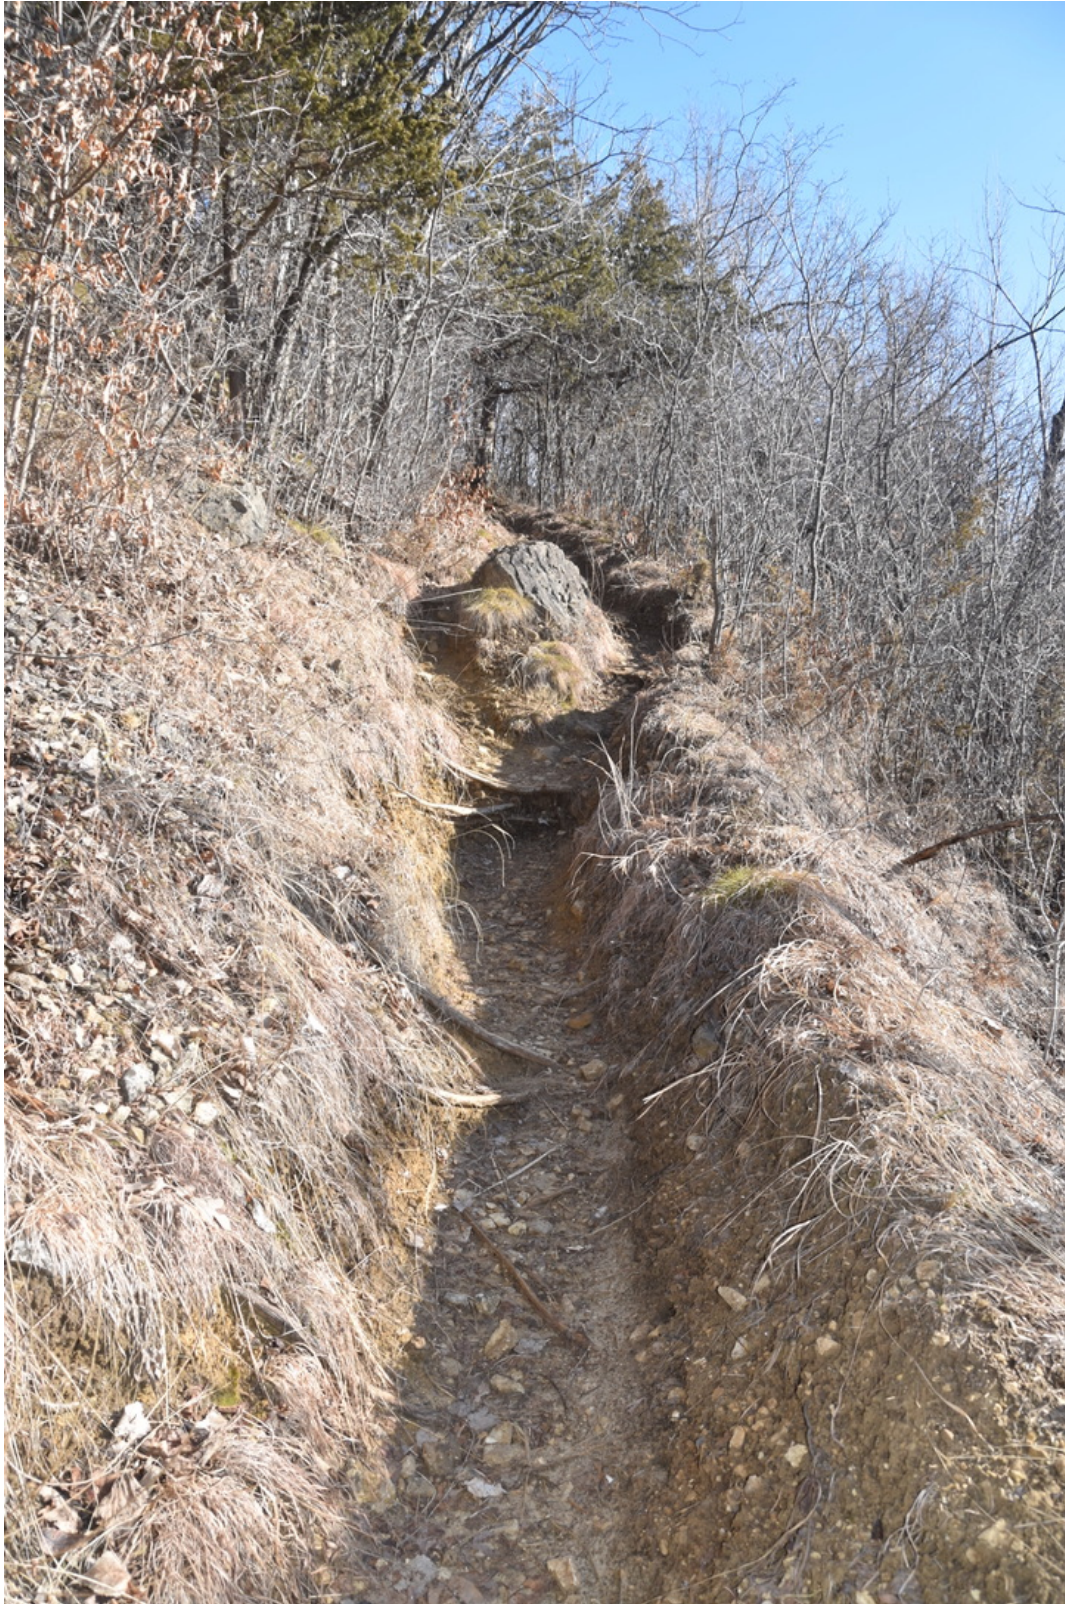
**Photo 3:** Example of the power of erosion on Grandad Bluff (03/21/20).

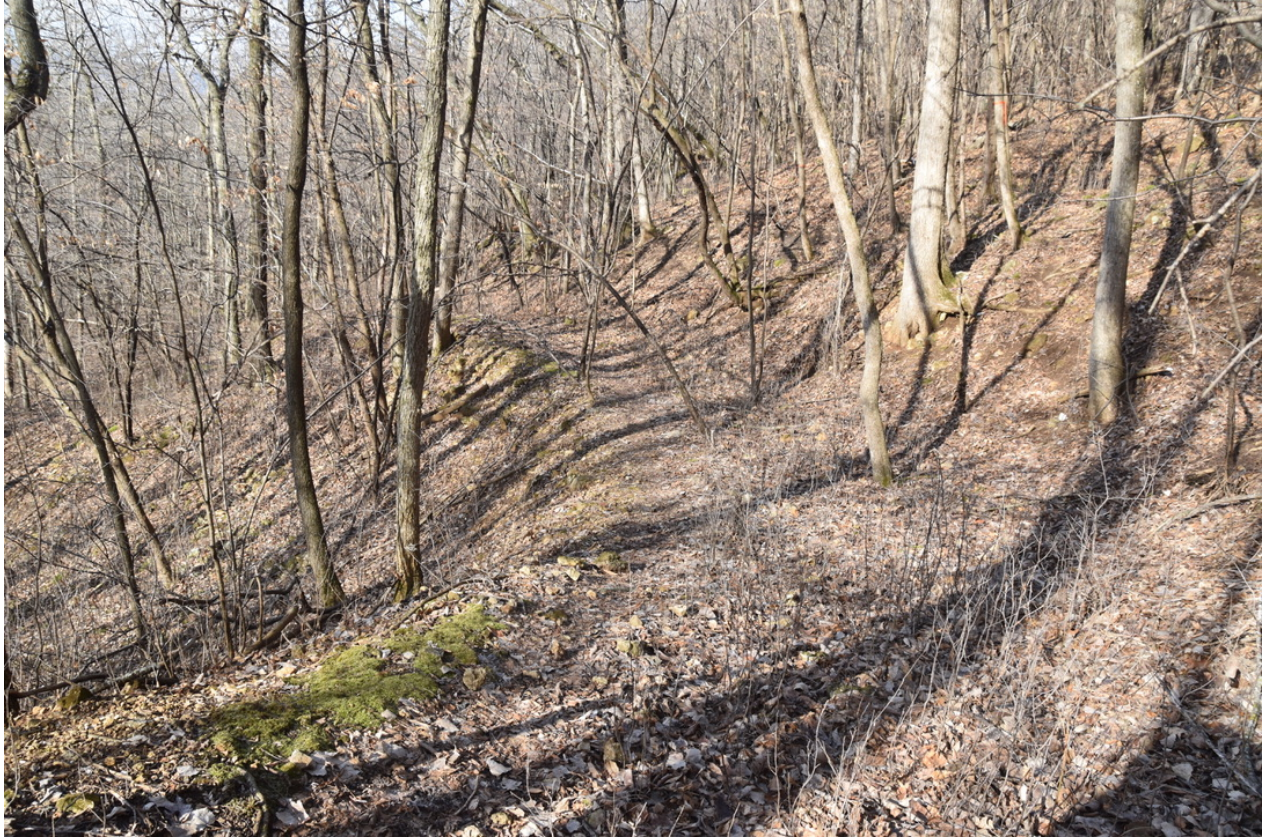
**Photo 4:** Existing path cuts across a moderately steep slope on Grandad Bluff (03/21/20).

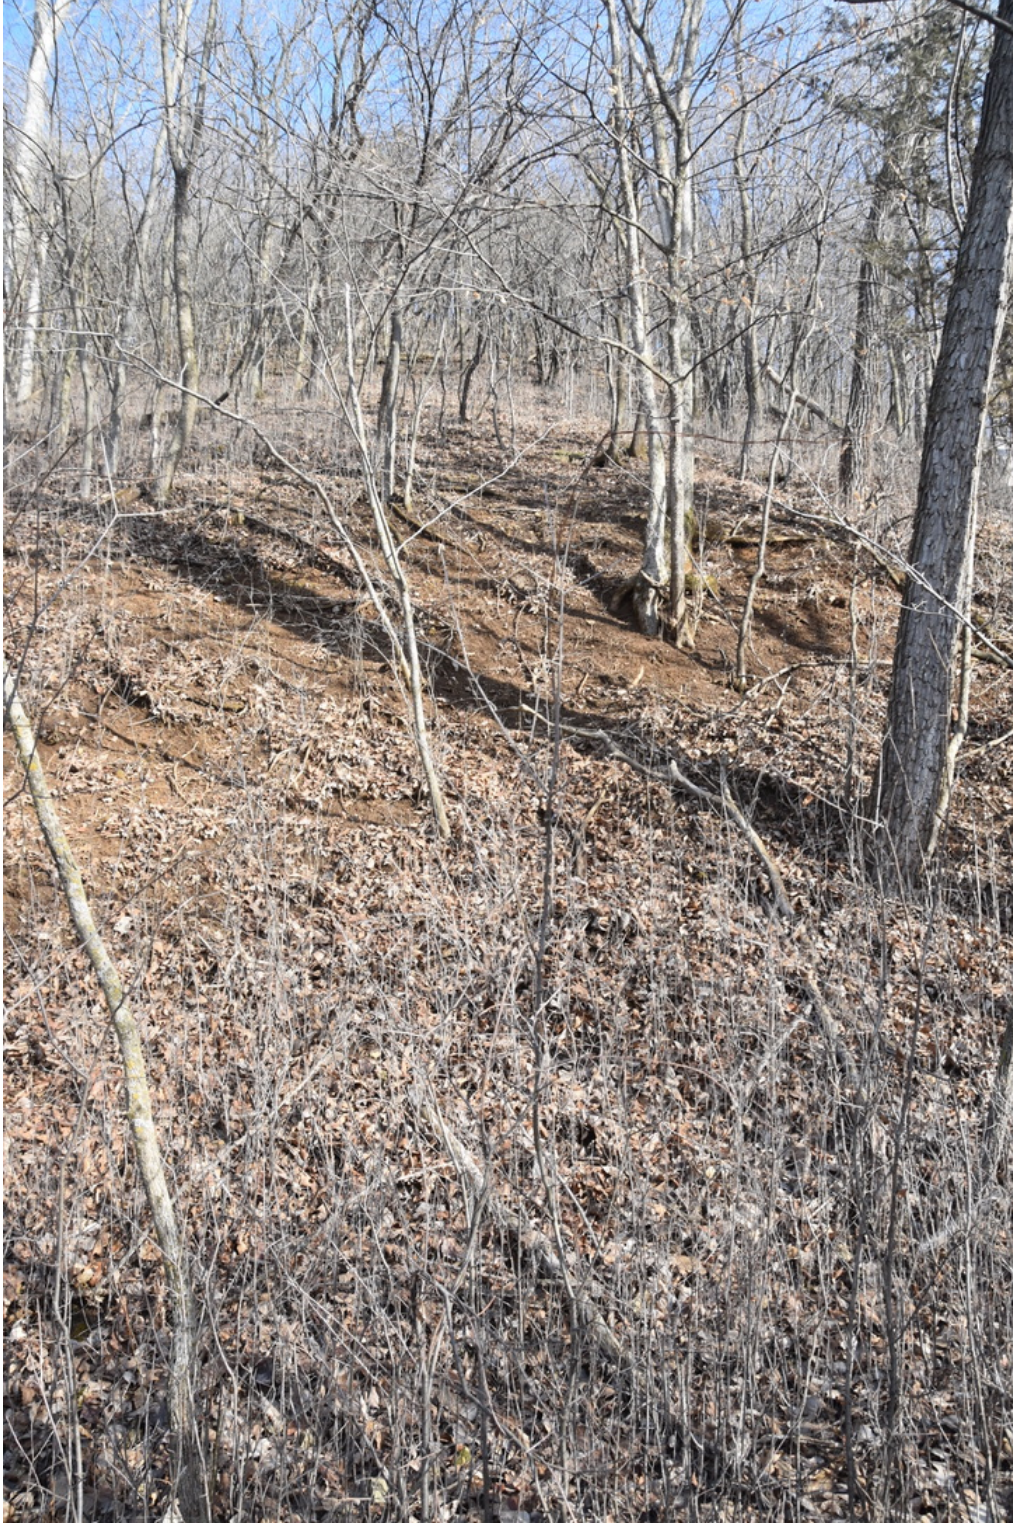
**Photo 5:** Erosion prevalent on steeper slopes, shown is a 47.9-degree portion of mid-slope of Grandad Bluff (03/21/20).
