## HISTORIC PRESERVATION COMMISSION

Request Type: Demolition Historic Preservation Permit per Chapter 20.85.085

Site Address 110 North Higgins Ave., Missoula

## **Application Supplement for Demolition Permit**

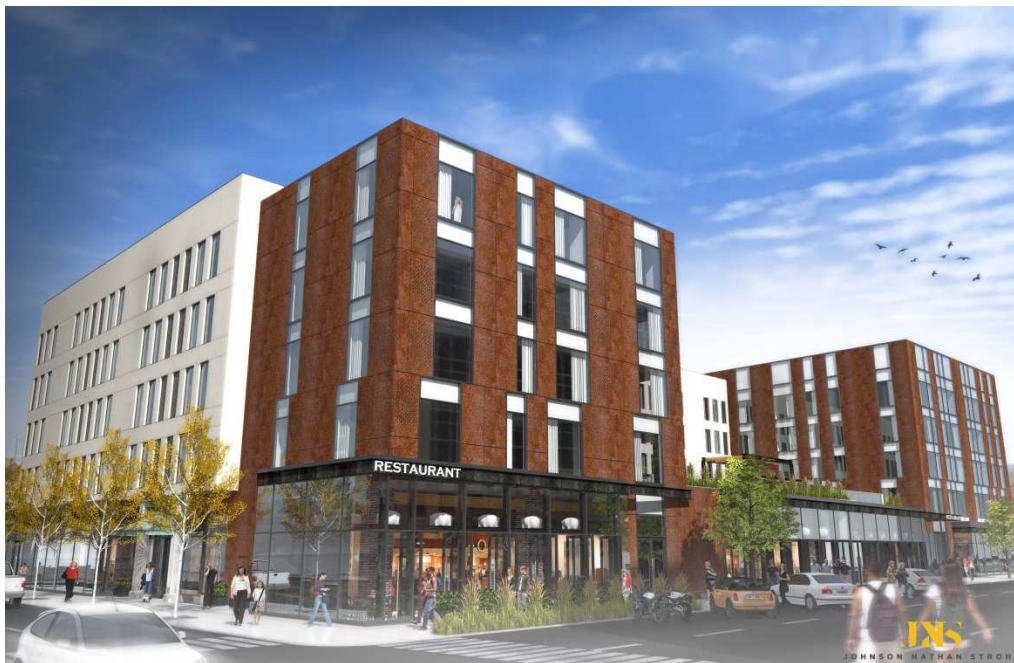
The new Mercantile envisioned by HomeBase is a proposed mixed-use project anchored by a 154-room custom Residence Inn by Marriott hotel. The project will include hotel amenities such as meeting space, fitness, pool, lobby and related back of house functions. The ground level also includes approximately 24,000 square feet of retail space that is designed to attract restaurants, bars and other local businesses. Connecting the hotel function and retail portion of the ground floor is a feature called The Mercantile Mews, a large internal “alley” that encourages pedestrian activity to all uses within the building, and connects Pattee to Higgins Avenue.

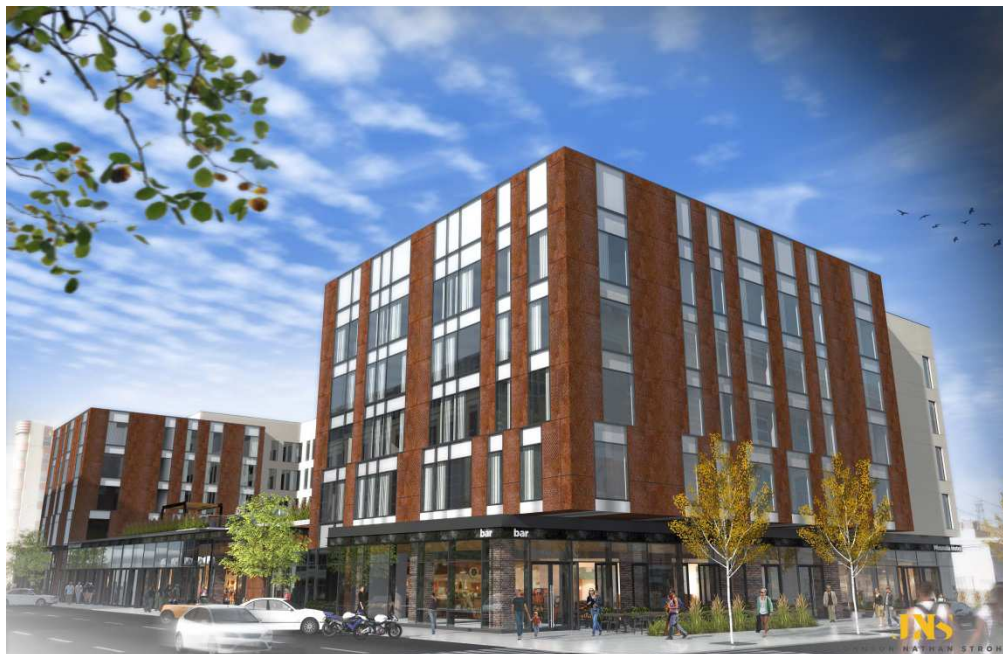
The design is current in nature incorporating many of today’s design standards including lots of natural light, high ceilings, flexibility and convenient pedestrian accessibility. At the same time, the project includes a nod to the former Mercantile building by including the use of salvaged materials such as wrapped brick columns, timbers, wood columns, tin ceilings and the copper canopy along Higgins Avenue. With the cooperation of historians in the community, The Mews

would like to be a walk-thru memory lane showcasing material, images and artifacts from the former Mercantile thereby preserving the sentimental history of the Missoula Mercantile for all.
