Los Lunas River Mile 163 River Maintenance Project Environmental Assessment - DRAFT

Middle Rio Grande Project, New Mexico

Initially prepared by SWCA Environmental Consultants (2022) and updated by Bureau of Reclamation (2024)

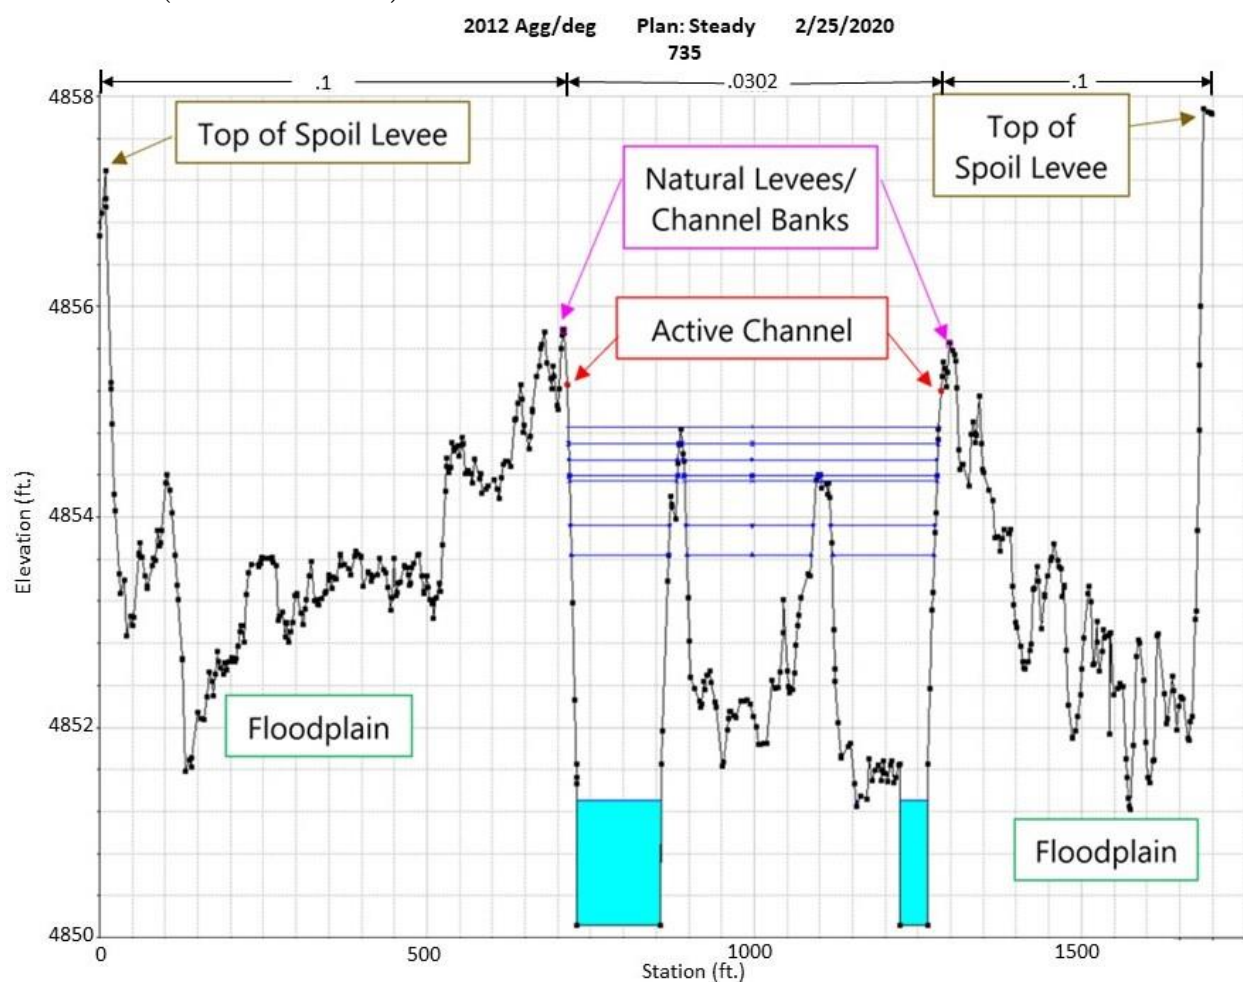
Figure 2. A semi-perched cross-section typical of Isleta to Belen (location is Agg-Deg Rangeline 735) (Kuria and Klein 2020b).

This subreach has a semi-perched channel where the riverbanks are higher in elevation than the adjacent floodplain and spoil levee toes (Figure 2). The spoil levees are non-engineered river levees built for flood protection and are used to dispose of spoil from river and canal excavations. The toe is the base of the levee that contacts the river floodplain. Therefore, once flows overbank the main channel banks, the water tends to move laterally down to the levee toe, with some continuing downstream parallel to the levees. There are limited locations where the overbanked water can return to the main channel. During high flows, these conditions result in saturated levee toes (sometimes requiring emergency maintenance to prevent levee failure) and water stranding in the floodplain. The endangered Rio Grande Silvery Minnow (*Hybognathus amarus*; silvery minnow) may also be stranded in these areas. In 2019, repairs of spoil levee in this area cost the MRGCD over \$1.2 million (Reclamation 2021)

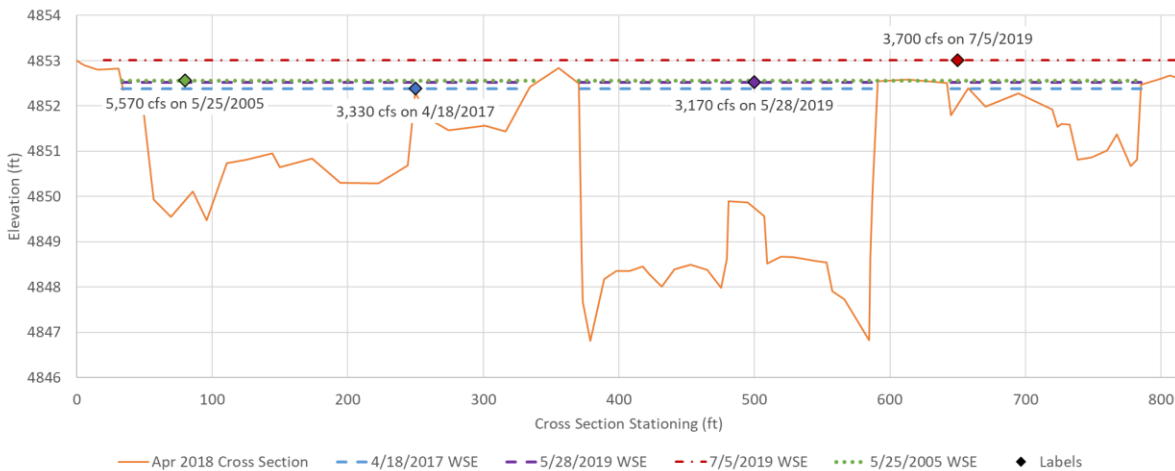
Figure 3. Water surface elevation from 2005 through 2019. The orange line shows the 2018 cross section profile of the river upstream of NM-6 bridge (CO-738.1 or RM161.4) (Kuria and Klein 2020b).

Anecdotal accounts suggest that in recent years the historic riverbanks in the subreach are overbanking at progressively lower flowrates. Field measurements of water surface elevations (WSE) at different flow rates over years also confirm this (Figure 3). In 2005, over 5500 cfs was conveyed below the same elevation that 3700 cfs was conveyed in 2019.

This can be attributed mostly to channel narrowing via vegetation encroachment and bank and bar sediment accretion, but minor channel bed aggradation between Isleta Diversion Dam and the NM6 bridge may also play a role. Channel narrowing and channel aggradation data between 1992 and 2012 are presented in Table 1.1 (Reclamation 2021). However, the 0.2 feet of aggradation between 2002 and 2012 is well within the margin of error over that period of time and length of river.

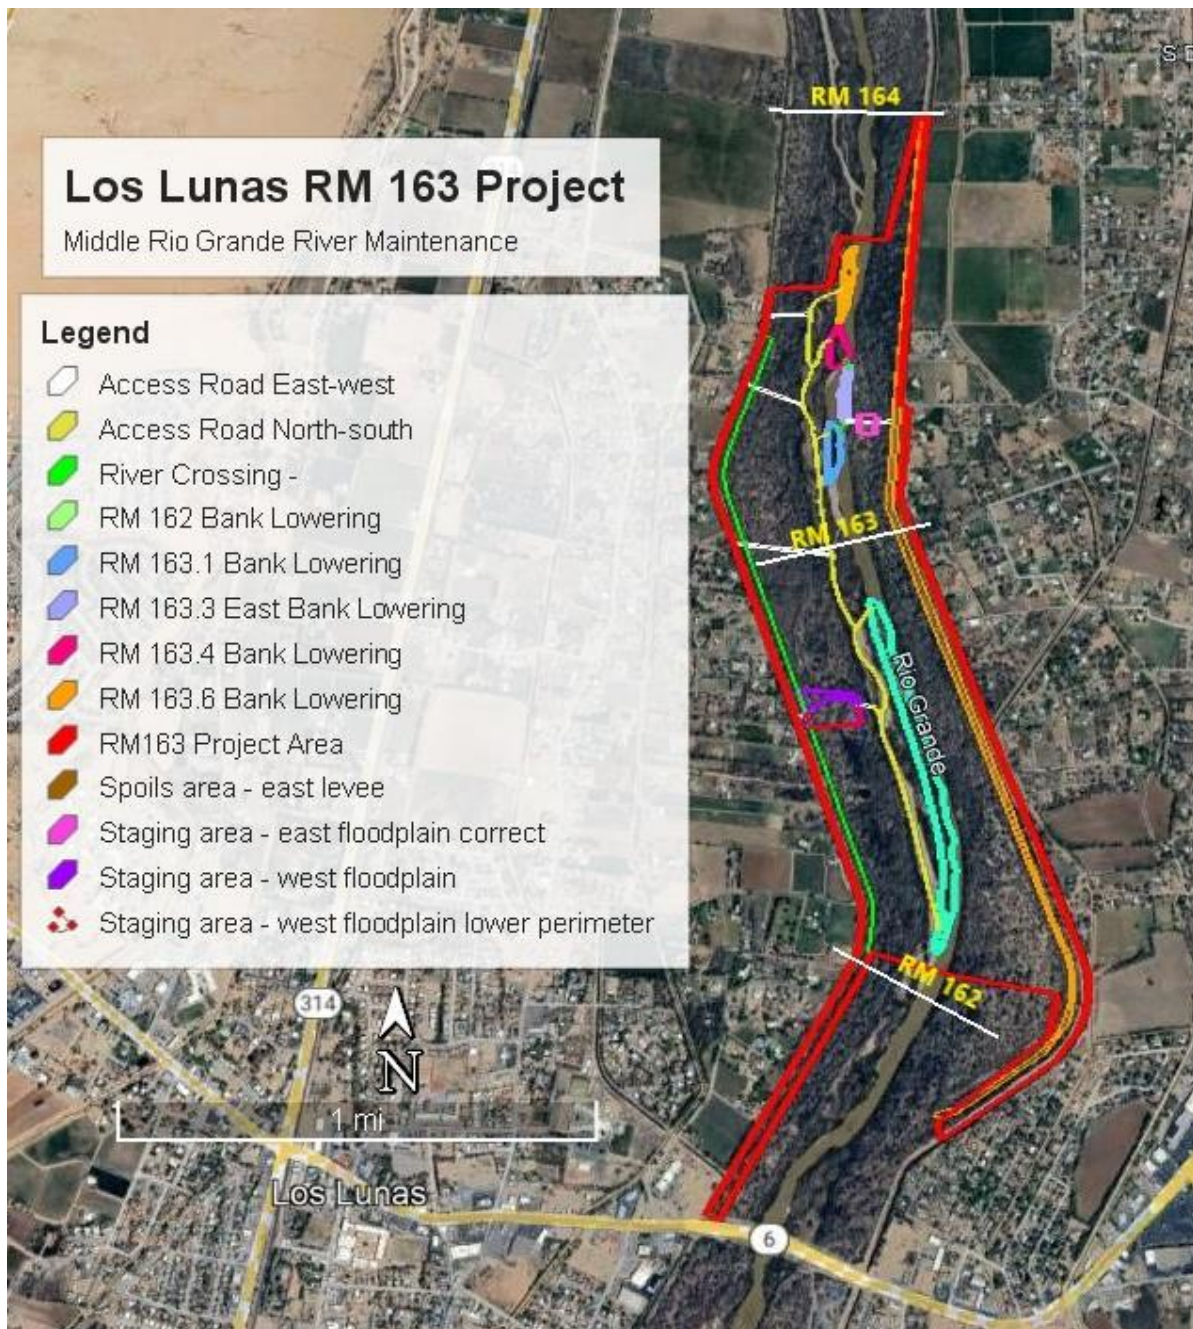
Figure 5. Project components along with staging areas and access routes

Access to the project site for mobilization and demobilization would occur from NM6. Four of the bank lowering areas are located inside the active river channel with dry access via the western floodplain between RM 162 and RM 164. One bank lowering area is located on the eastern floodplain between RM 163.3 and RM 163.6. Therefore, access to these construction sites would be through the spoil levee roads on both the west and east sides of the river. Proposed access routes and the western staging area are shown in Figure 5 and additional maps are located in Appendix A. Unless prior permission is obtained, no access through or disturbance of Isleta Pueblo land shall occur within the context of this project.

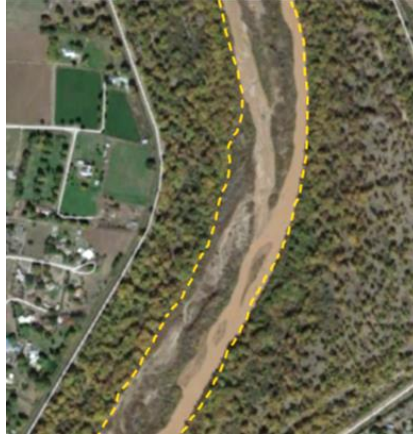
Figure 18: Aerial image demonstrating historic channel, historic floodplain, historic banks, and inset floodplain

Term	Definition	Figure 1 Key
Historic Channel	550-foot-wide channel established by jetty jacks in 1960s-1970s	(everything inside yellow lines)
Historic Floodplain	Floodplain outside the historic channel	(everything outside yellow lines)
Historic banks	Banks of historic channel that are 1-4 feet higher than historic floodplain and levee toes	(immediately outside yellow lines)
Inset Floodplain	Floodplain inside the historic channel, established in 2000s and later by vegetating sandbars	(vegetated areas inside yellow lines)
Active Channel	Non-vegetated channel	(non-vegetated areas)

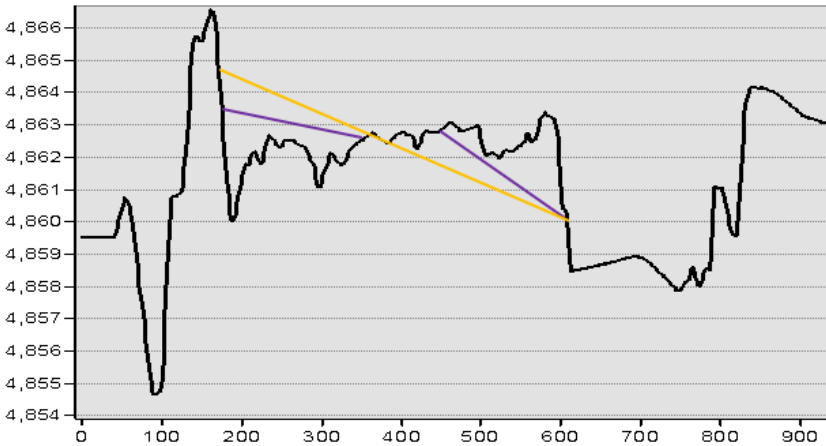
Figure 19: Example cross section demonstrating two potential modified terrains after cross section reset

An alternative strategy (purple line in Figure 19) is to limit the cut and fill activity to and leave a narrow middle strip of vegetation in the floodplain relatively undisturbed. The strip of undisturbed vegetation can't be widened without sacrificing proper drainage.

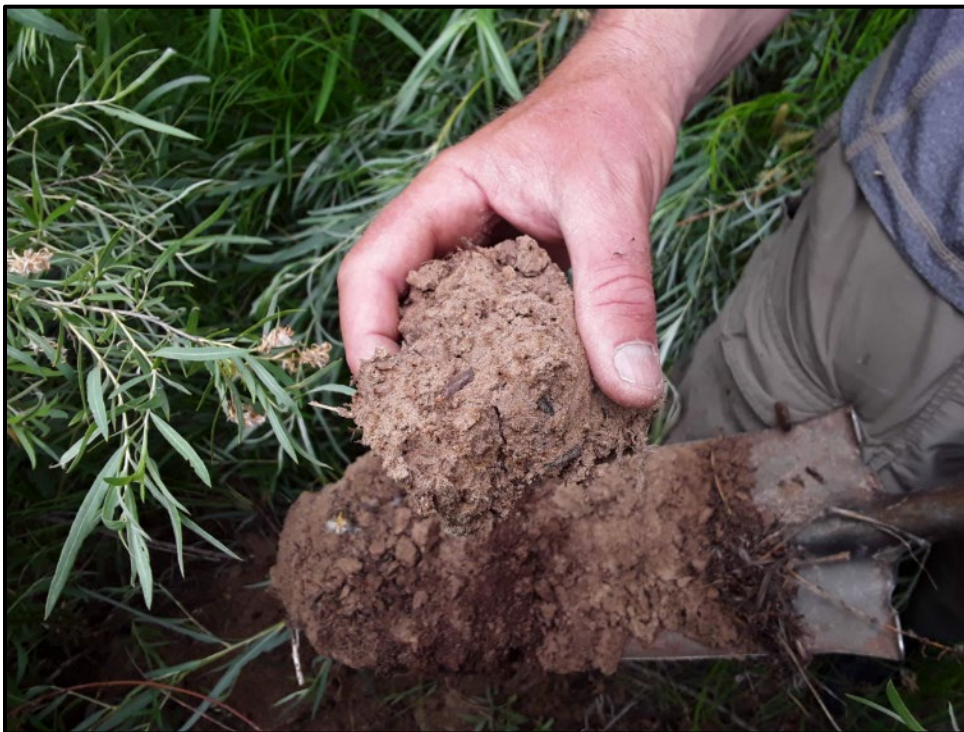
Photograph B-22. View of wetland soil profile with hydric soil indicators.
