**Report on the Investigation into  
The Death of Susan Harrington**

**Two-Vehicle Fatal Collision  
Police Involved**

**State Route 40  
Town of Argyle  
Washington County**

**Prepared by  
Investigator Jeremy Shultis**

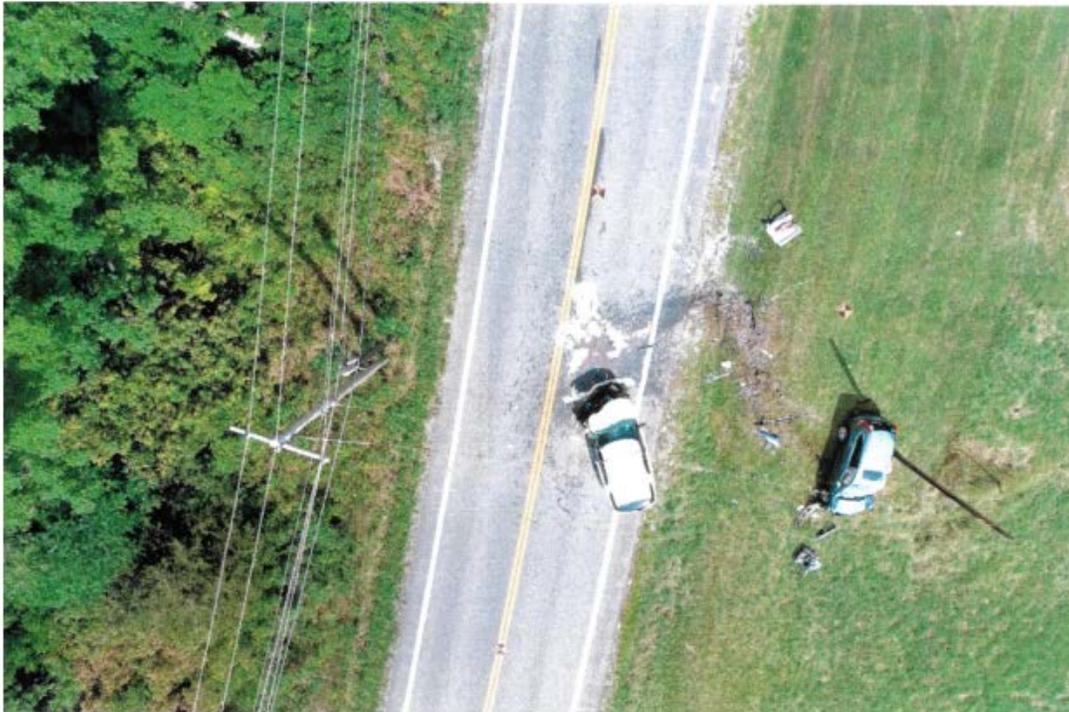
continued traveling in a straight-line crossing over the double yellow center lines and traveling into the north bound lane. As Ms. Harrington entered the curve she appears to have negotiated the curve until realizing that she was about to be struck by Deputy Winch's vehicle, at which point she applied the brakes and steered her vehicle to the right. Deputy Winch's vehicle struck Ms. Harrington's vehicle head on, the collision causing his vehicle to spin 180 degrees before coming to rest in the northbound lane facing North. Ms. Harrington's vehicle was also spun 180 degrees and ultimately came to rest in a field east of the roadway facing South. The below photograph is an aerial view depicting both vehicles; the top of the picture is north, Ms. Harrington's vehicle is on the right, and Deputy Winch's patrol vehicle is on the left.

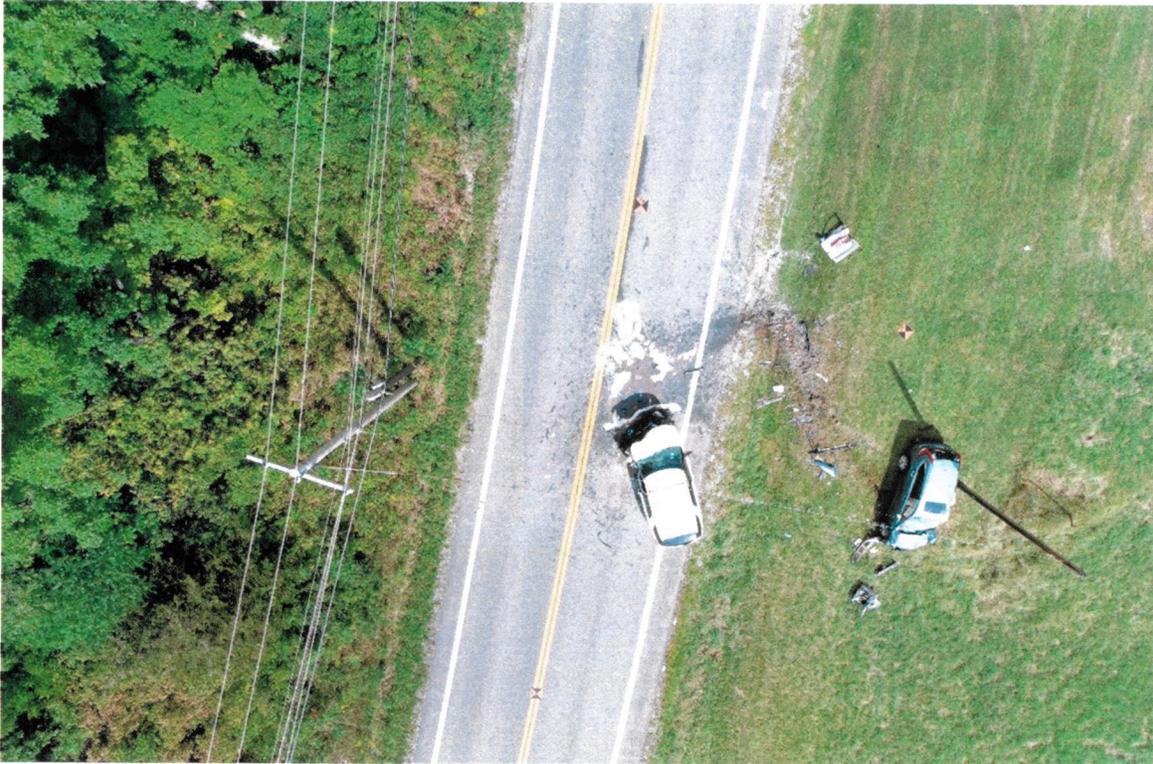
**Aerial View of collision scene, top of the picture is north**

At the scene of the collision, State Route 40 was a two lane, asphalt-surfaced roadway oriented in a general north-south direction with asphalt-surfaced shoulders adjacent to both travel lanes. Northbound traffic traversed a slight left curve while southbound traffic traversed a slight right curve. The lanes were demarcated from each other by a solid double yellow line, indicative of a no passing zone. The roadway width was approximately 28.8 feet wide as measured from the edge of pavements, with the southbound lane being approximately 11.3 feet wide and the northbound lane being approximately 11.4 feet wide as measured from their respective edge of pavements to the center of the double yellow lane marking. The northbound and southbound shoulders were approximately 2.7 feet wide and 3.4 feet wide respectively, as measured from the edge of pavement to the approximate center of their respective solid white lane marking. The posted speed limit in this area of State Route 40 was 55 mph.

The evidence at the scene included tire marks, pavement scars, furrows, vehicle debris, both vehicles and the deceased operator of Vehicle #2. The first evidence observed was a tire mark that was oriented to the north and originated approximately 0.08-foot from the center of the northbound fog line. The tire mark was approximately 15.1 feet in length and was consistent with being made from the left side tires of Vehicle #2 as it was braking prior to impact. Approximately 28.5 feet north of the north end of this tire mark was a series of gouges on the asphalt on the east shoulder in proximity to the fog line. These gouges are consistent with being the area of impact between the vehicles. These gouges were made by the undercarriage components of the vehicle front ends as they were forced

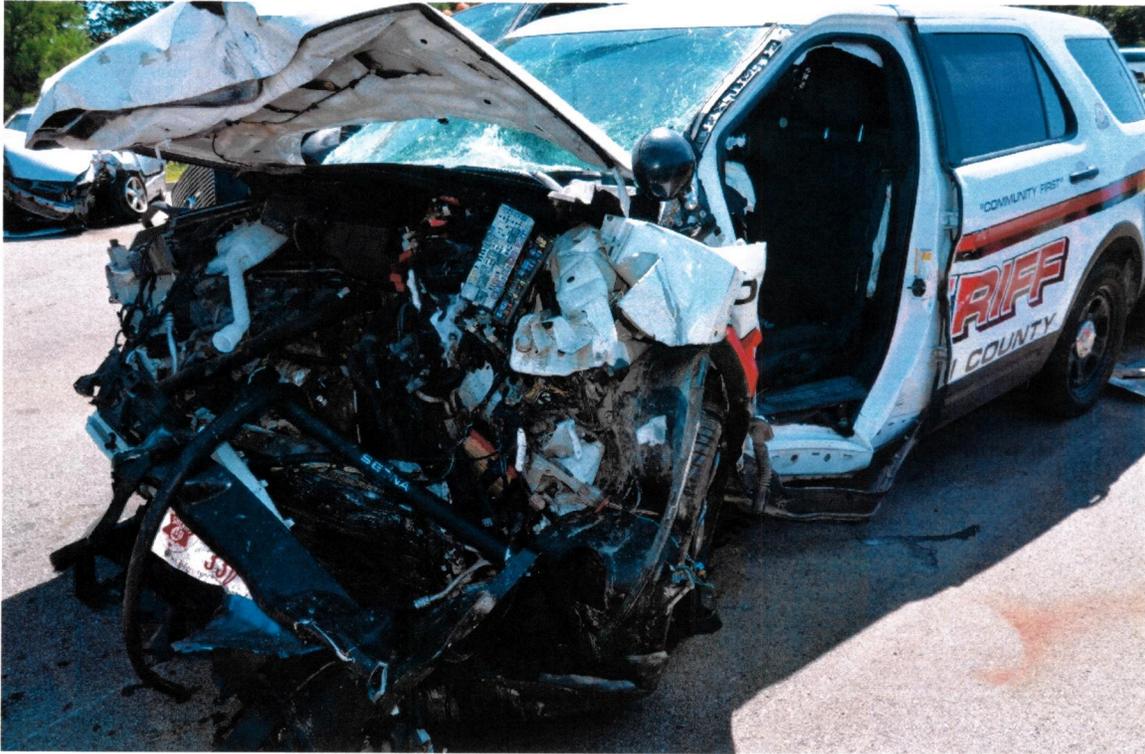
**Vehicle #1 at SP Latham**

On August 20, 2019 at the SP Latham impound lot in Latham, New York, Trooper Travis Kline and I inspected Vehicle #1. Vehicle #1 exhibited severe damage consistent with a frontal collision with deeper intrusion on the front left. Vehicle #1 was equipped with three-point lap belt/shoulder harnesses for all seating positions with supplemental front and side curtain airbags. Upon inspection, the driver's seatbelt was found to be retracted and free spooling. There was stretching and melting of the webbing due to load stressing. This evidence was consistent with the driver of Vehicle #1 wearing his seatbelt at the time of the collision. The driver's front airbag and both side curtain airbags had deployed. No evidence of pre-collision tire defects or failures were observed on any of the tires, nor was there any evidence of pre-impact steering deficiencies or failures.

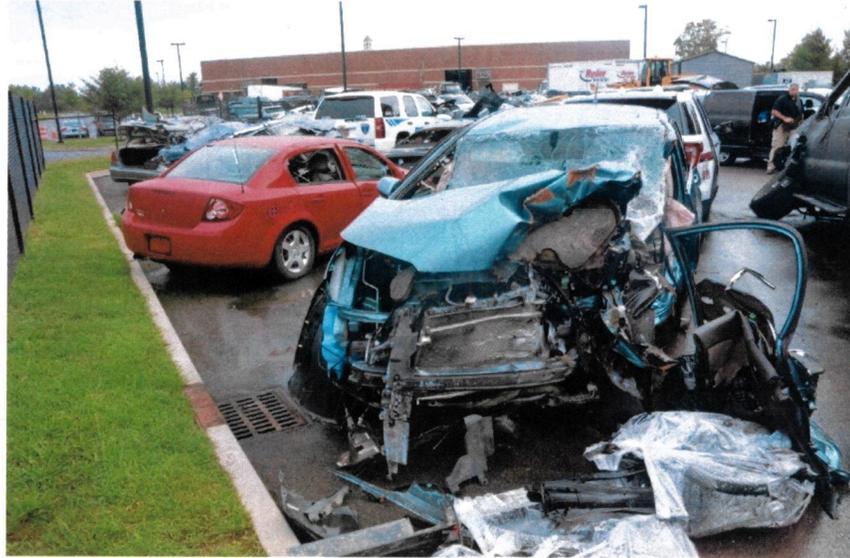
Vehicle #2 at SP Latham

On August 21, 2019 at the SP Latham impound lot in Latham, New York, Troopers Kline, Blakely and I inspected Vehicle #2. Vehicle #2 exhibited severe damage consistent with a frontal collision with deeper intrusion on the front left. Vehicle #2 was equipped with three-point lap belt/shoulder

harnesses for all seating positions with supplemental front, seat side and side curtain airbags. Upon inspection, the driver’s seatbelt was found to be extended and locked. The webbing had been cut by responding medical personnel. There was stretching and melting of the webbing due to load stressing. This evidence was consistent with the driver of Vehicle #2 wearing her seatbelt at the time of the collision. The driver’s side front airbag, driver’s side seat airbag and both side curtain airbags had deployed. No evidence of pre-collision

tire defects or failures were observed on any of the tires, nor was there any evidence of pre-impact steering deficiencies or failures.

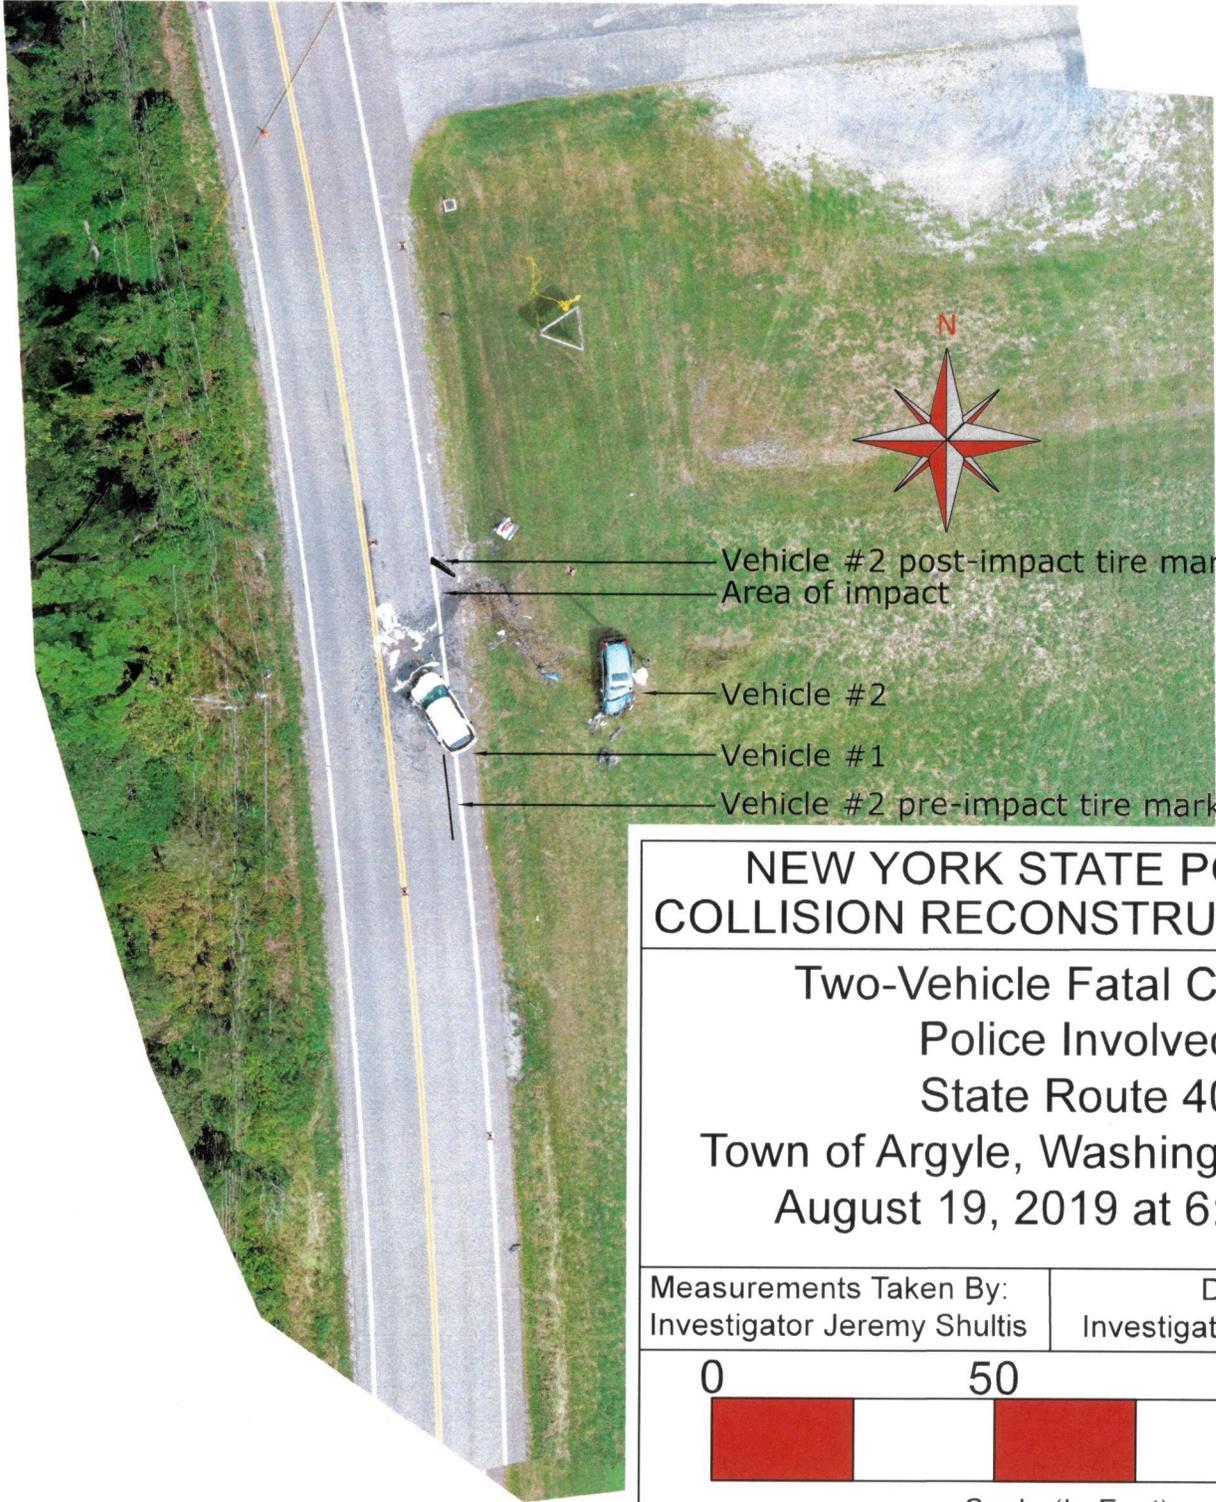
**NEW YORK STATE POLICE  
COLLISION RECONSTRUCTION UNIT**

The primary cause of this collision was failure to maintain his lane, on the part of Vehicle #1 operator, Cori J. Winch. The lack of driver input on his part was consistent with fatigue and/or falling asleep while operating the vehicle.

**Two-Vehicle Fatal Collision  
Police Involved  
State Route 40  
Town of Argyle, Washington County  
August 19, 2019 at 6:37 a.m.**
