# FINAL Preliminary Assessment Report Camp Grayling, Michigan

Perfluorooctane-Sulfonic Acid (PFOS) and Perfluorooctanoic  
Acid (PFOA) Impacted Sites  
ARNG Installations, Nationwide

August 2018

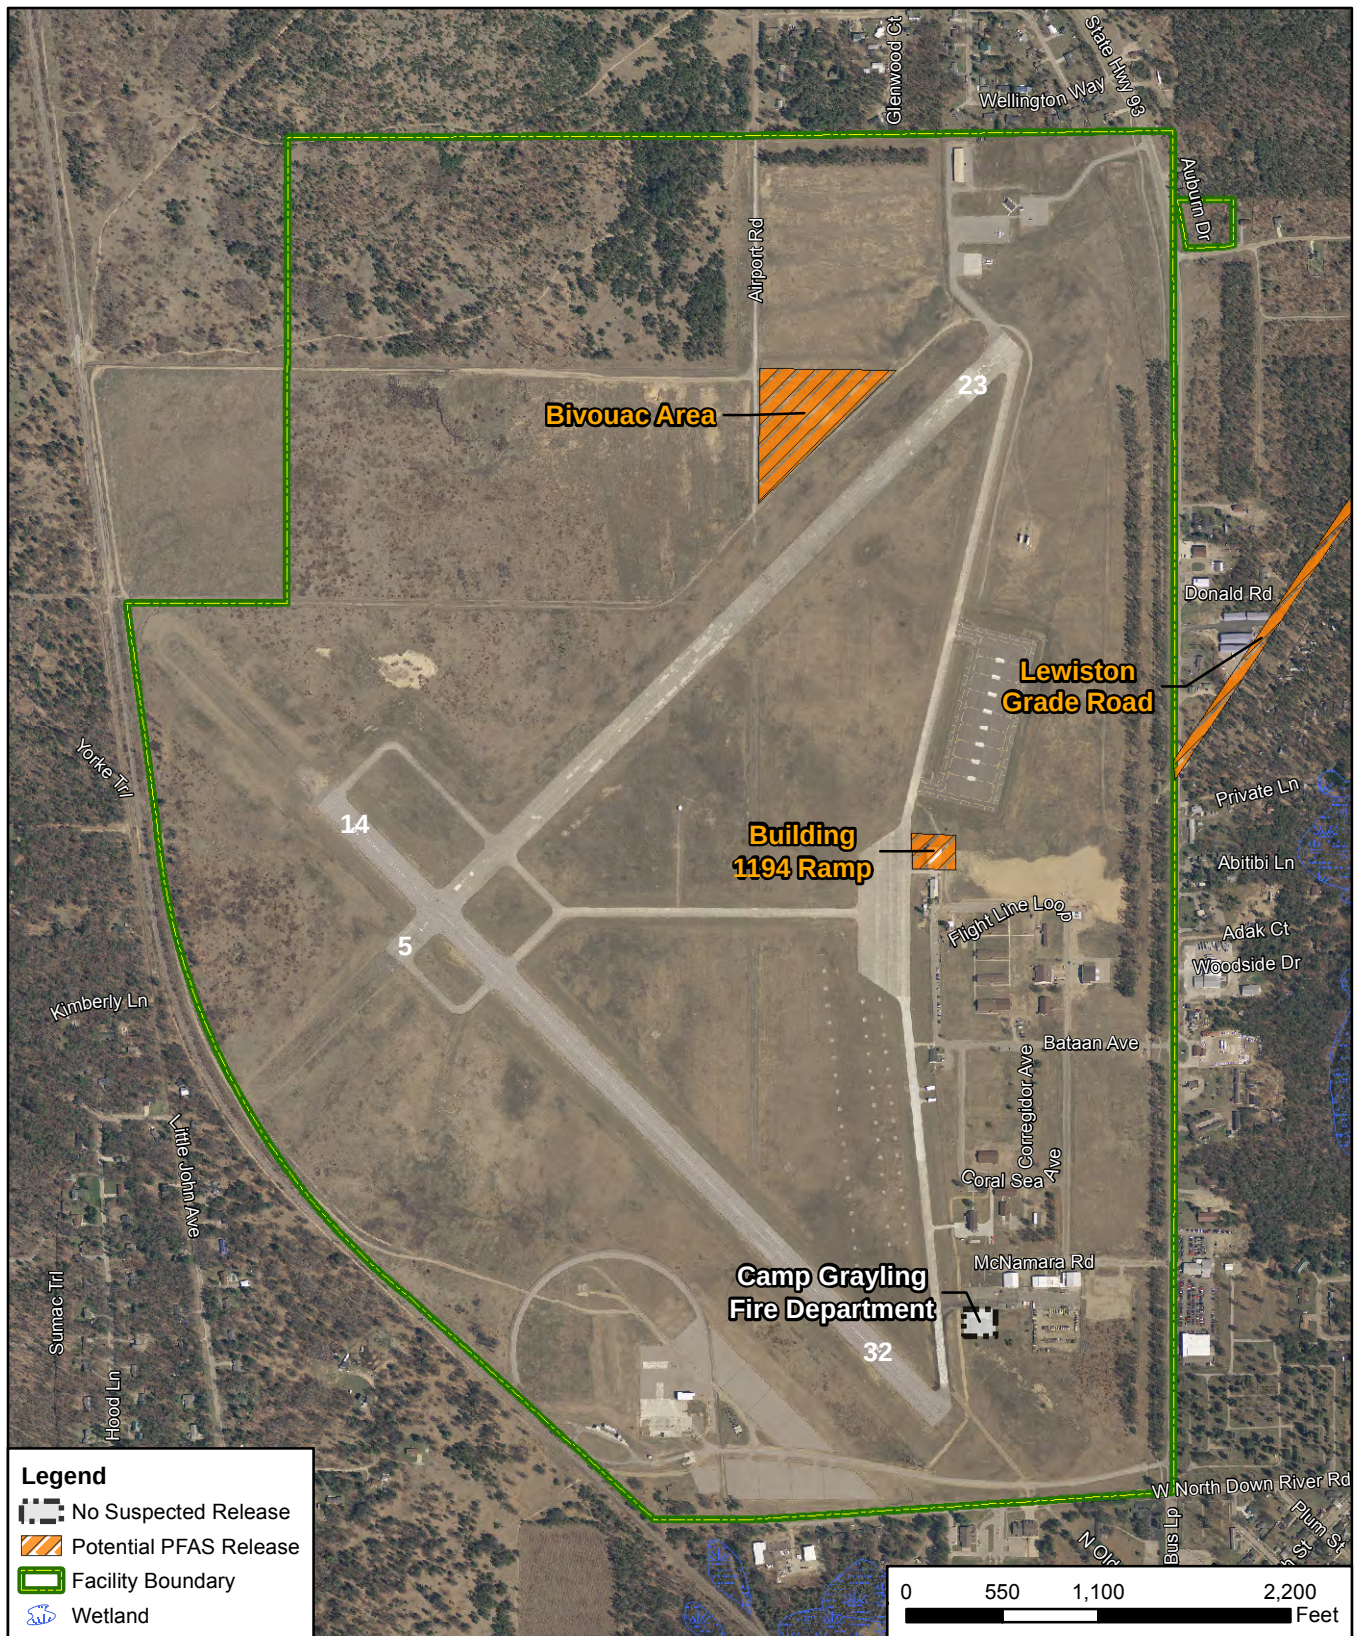
**Figure 3-1**

Three non-FTAs were assessed at GAAF during the PA. Two of these areas were identified as having a potential PFAS release and one was determined to have no suspected release. A full description of GAAF can be found in **Section 2.1**. Non-FTAs at GAAF are shown on **Figure 3-1**.

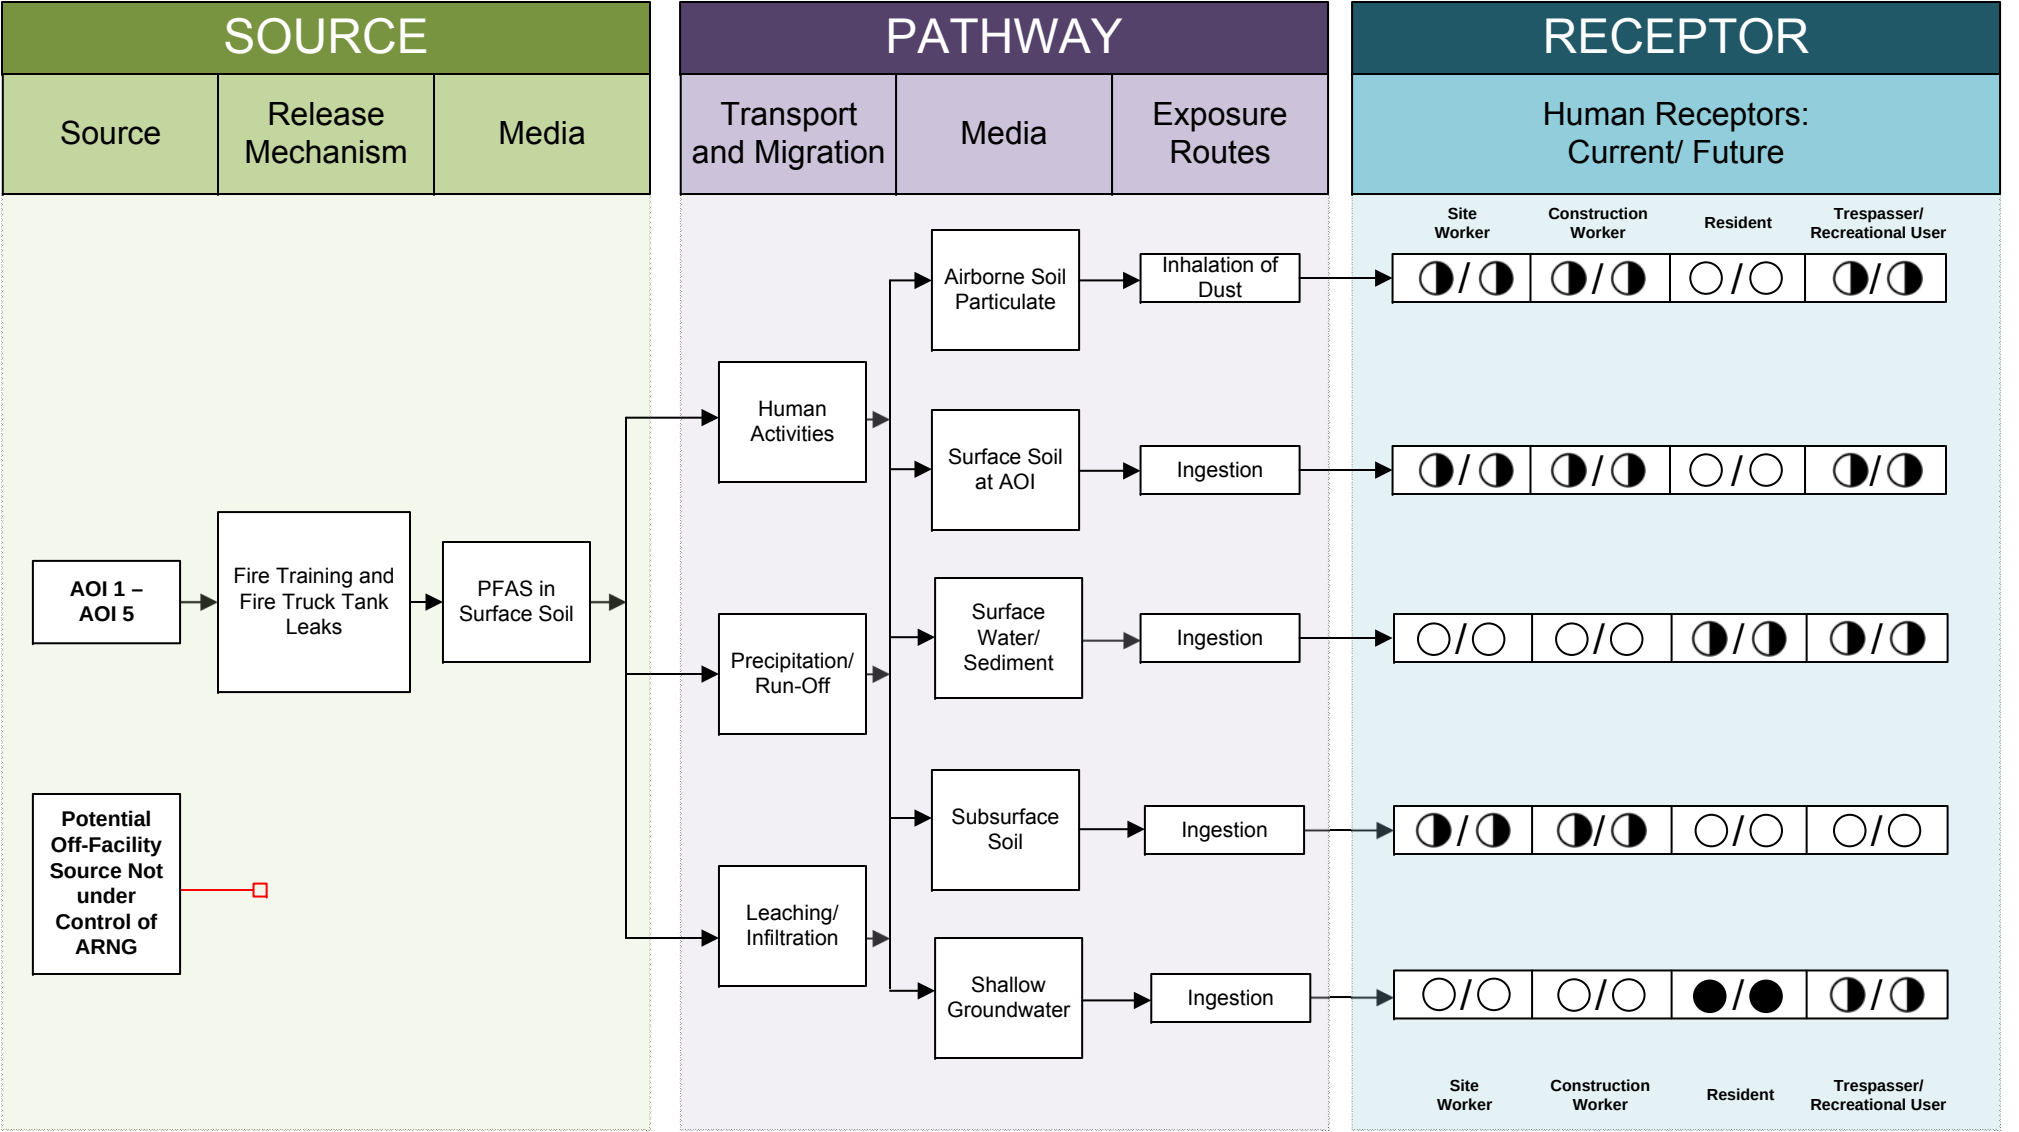
**Figure 6-2**  
Conceptual Site Model  
AOI 1-AOI 5 Grayling Army Airfield

GAAF AOIs may have migrated from the soil to groundwater and nearby surface water bodies via infiltration. The main stem and East Branch of the Au Sable River lay to the west and east of the GAAF boundary, respectively, off-facility. Preliminary data suggest the presence of a groundwater divide at the airfield between the river branches. Infiltration of rainfall recharges groundwater and likely follows a shallow flow system that discharges to either branch of the river, supporting water levels. Therefore, the ingestion exposure pathways for surface water and sediment are potentially complete for residents and recreational users of the Au Sable and the East Branch Au Sable (e.g., swimming and fishing).

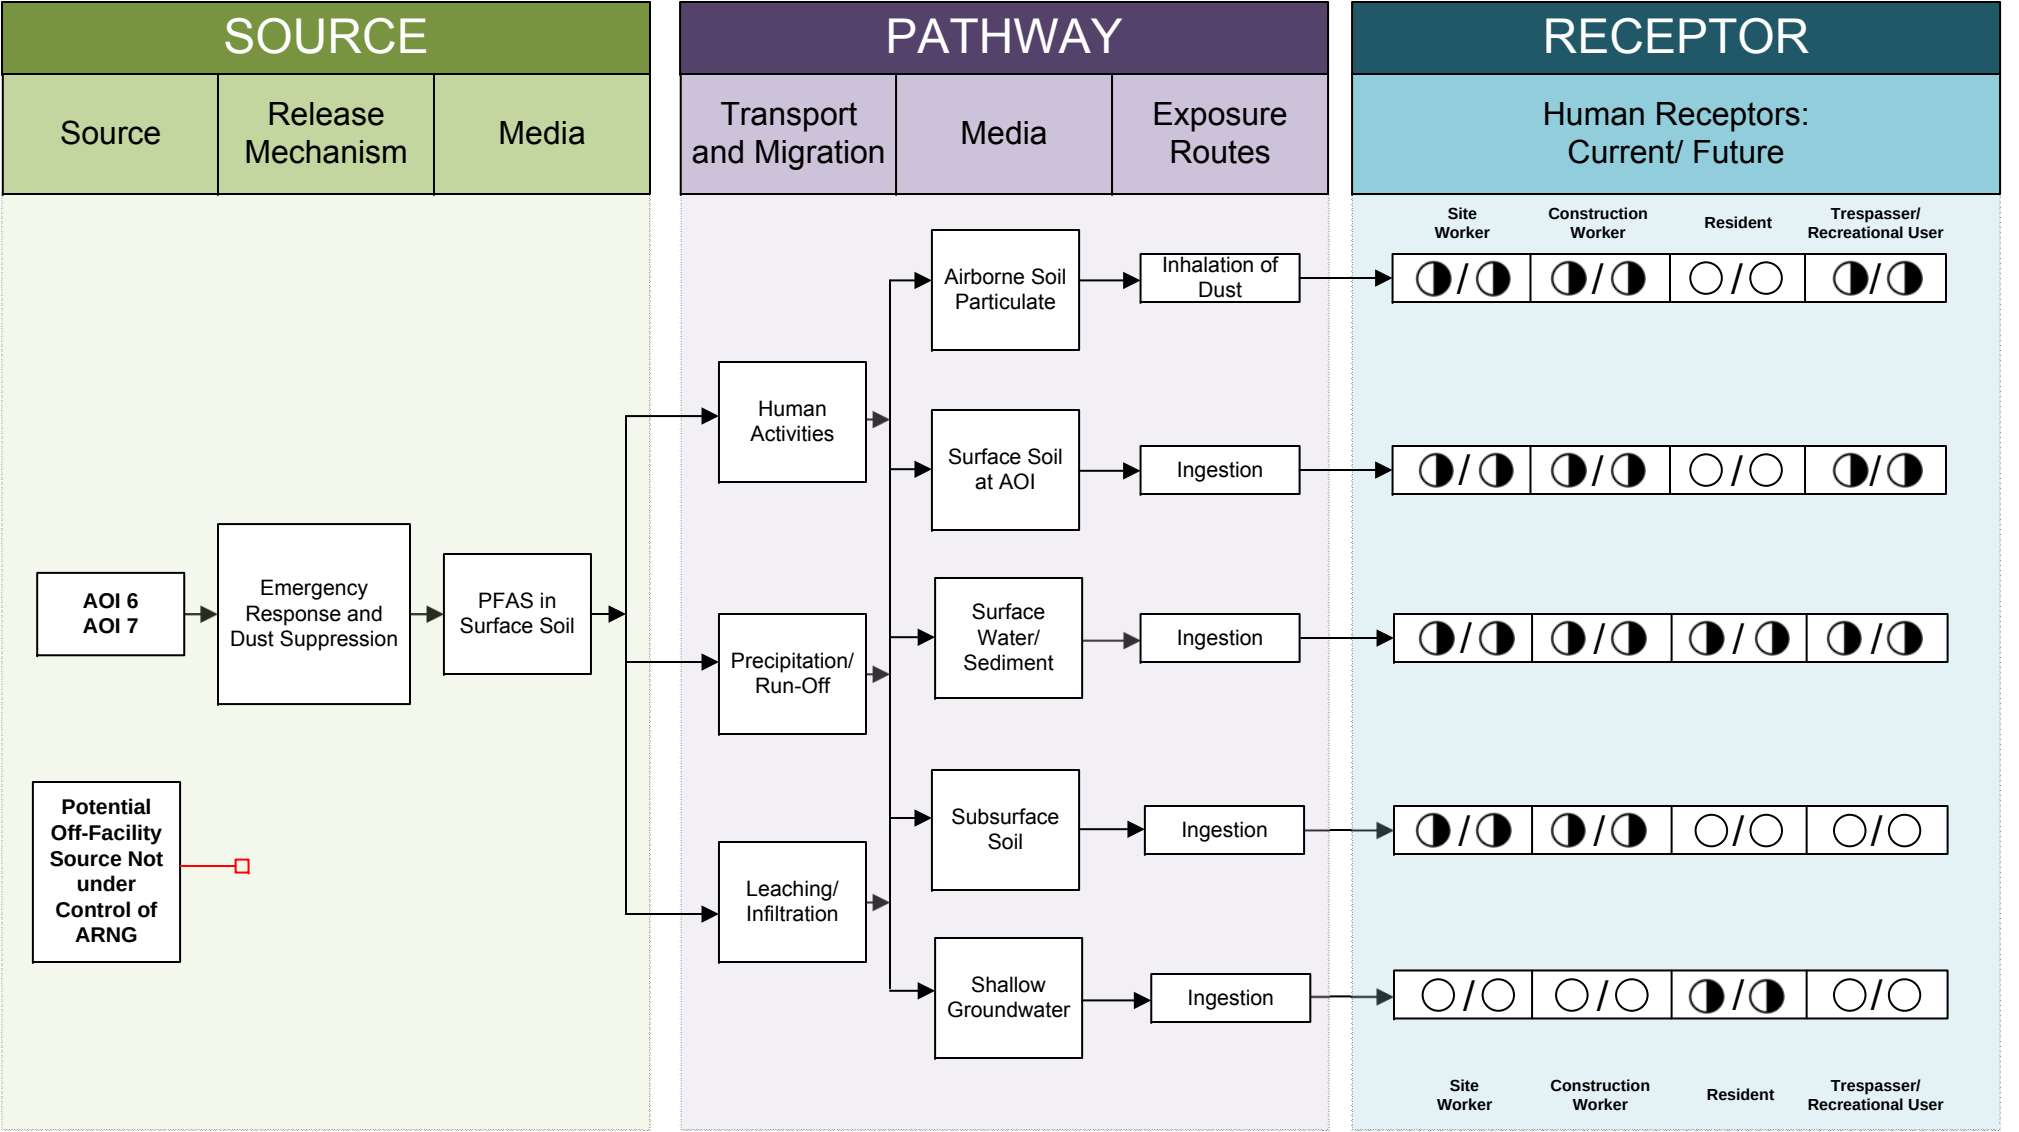
Figure 6-4  
Conceptual Site Model  
AOI 6 & AOI 7 North Post

Given the length of time since the potential AFFF releases (greater than 30 years) and the high degree of soil permeability, potential PFAS contamination at the fence line, and potentially within the range complex, may have migrated from the soil to groundwater and nearby surface water bodies via infiltration. Therefore, the ingestion exposure pathways for surface water and sediment are potentially completed for site workers, construction workers, and trespassers. Rainfall infiltration recharges groundwater that discharges to either the North Branch Au Sable and the East Branch Au Sable and associated lakes. Therefore, the ingestion exposure pathways for surface water and sediment are potentially complete for residents and recreational users off the North Branch Au Sable and East Branch Au Sable and associated lakes (e.g., swimming and fishing).

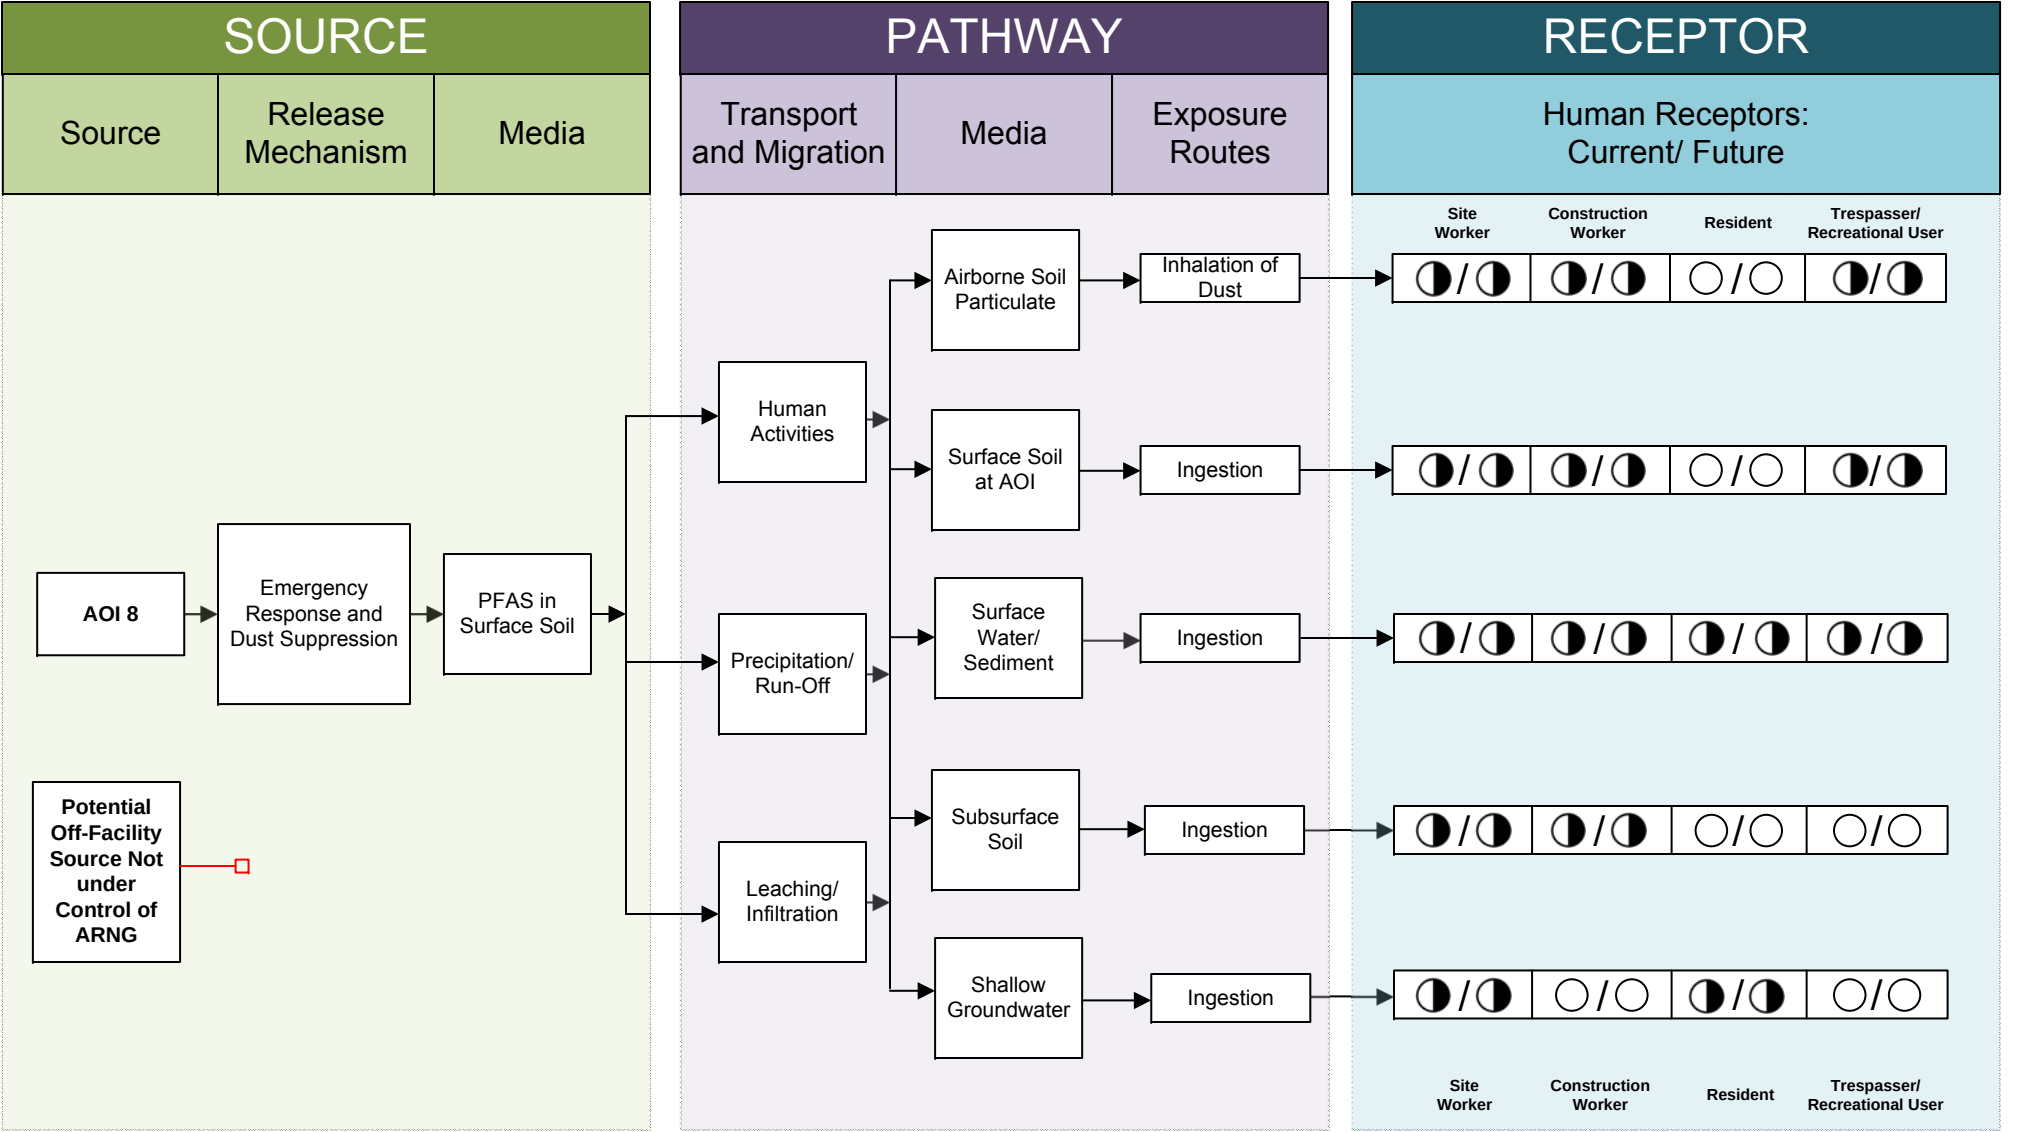
**Figure 6-5**  
Conceptual Site Model  
AOI 8 Range 30 Complex

Potential PFAS contamination may have migrated from soil to groundwater, and subsequently nearby surface water bodies via infiltration. The AOI is located approximately 1 mile east of KP Lake and 2 miles west of the North Branch Au Sable River. Groundwater likely flows in a predominantly east to southeastern direction towards North Branch Au Sable River, although it is not known if any localized flow towards KP Lake is present. Therefore, the ingestion exposure pathways for surface water and sediment are potentially completed for site workers, construction workers, trespassers, residents, and recreational users of the North Branch Au Sable River and KP Lake (e.g., swimming and fishing).

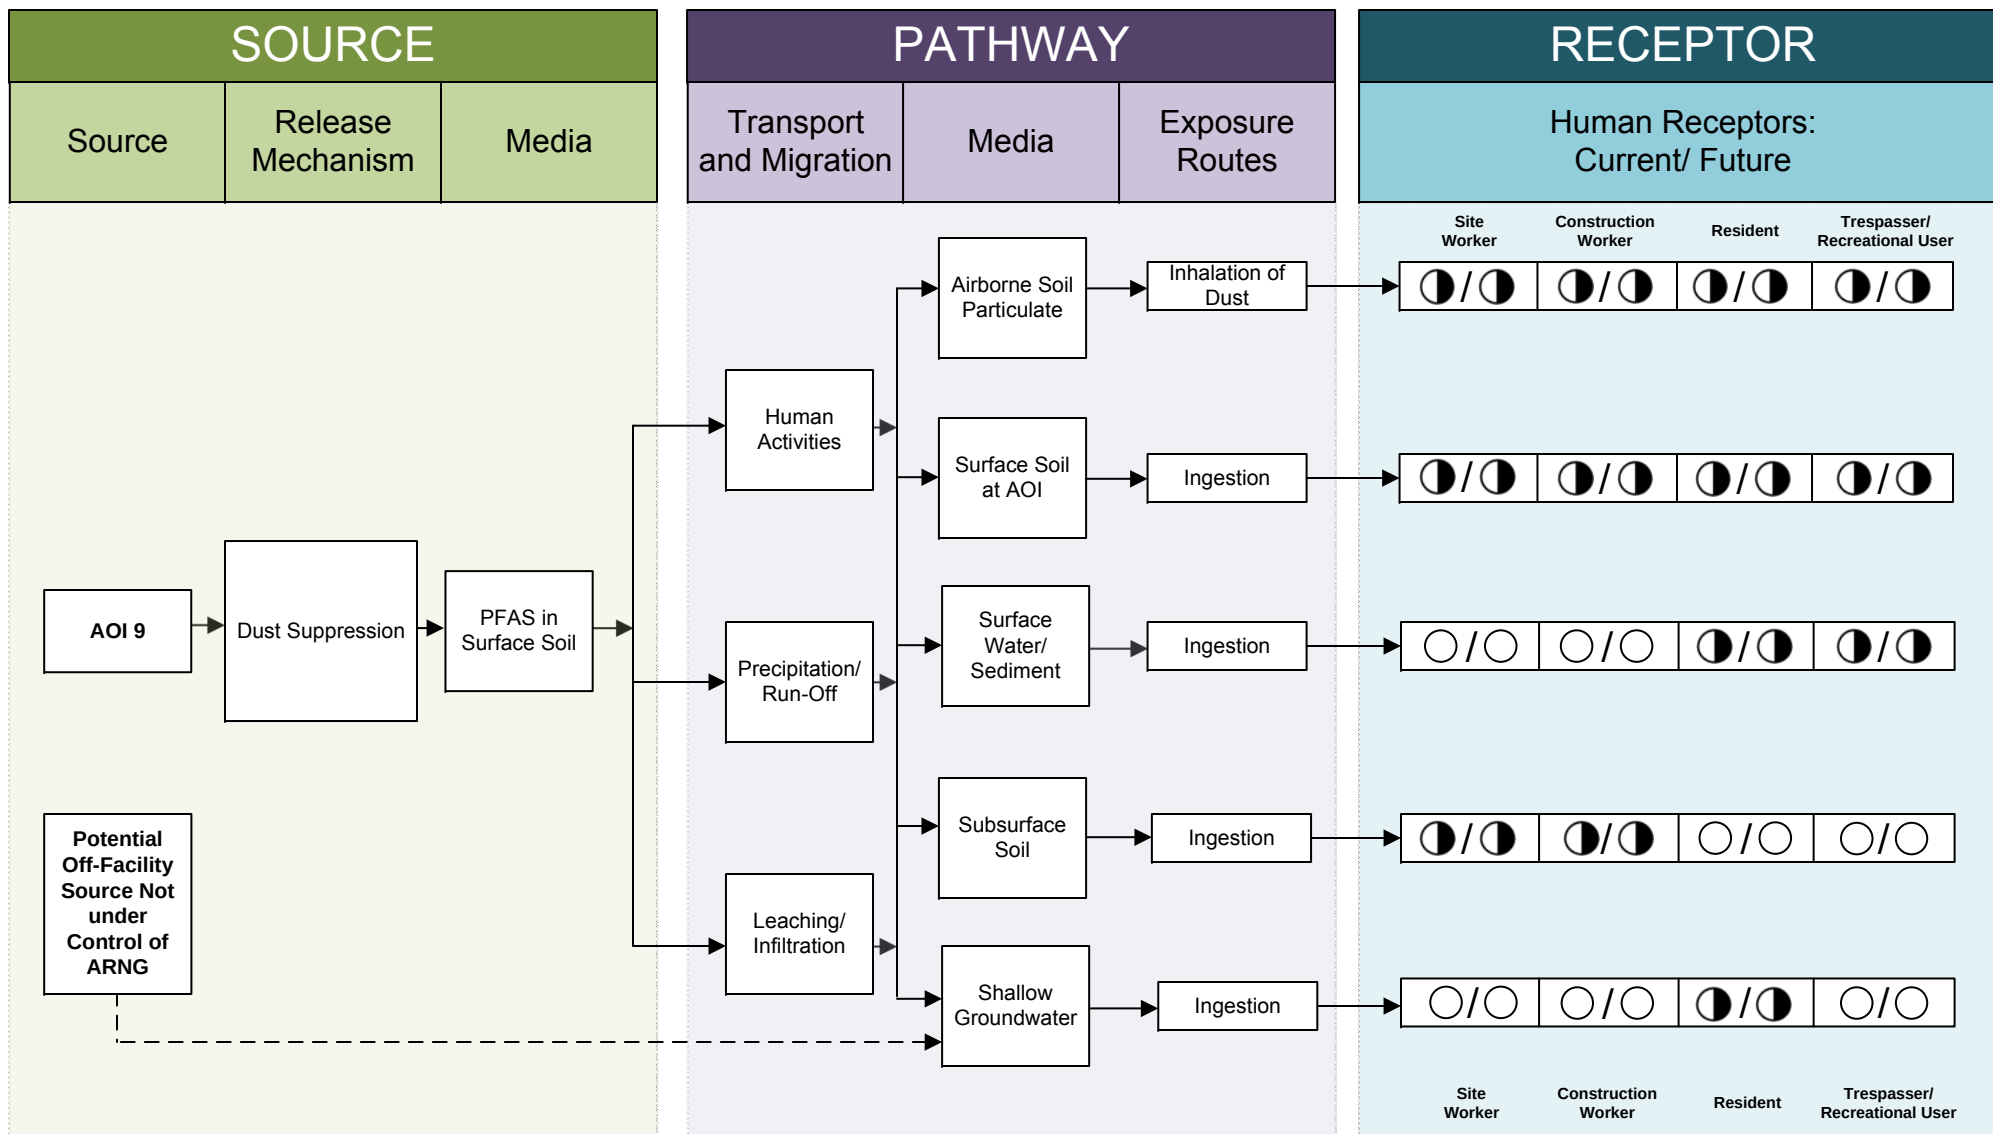
**Figure 6-6**  
 Conceptual Site Model  
 AOI 9 Lewiston Grade Road

Lewiston Grade Road parallels the East Branch Au Sable River approximately 0.5 miles to the northwest. An unnamed tributary of the East Branch Au Sable River is located approximately 1,000 feet from the road. The road is mostly rural with a few private residences located off of it. Based on aerial imagery, a few of these residences on the south side of Lewiston Grade Road have small private lakes. Shallow groundwater likely flows in a southeastern direction towards the river. Potential PFAS contamination along the road may have infiltrated shallow groundwater and migrated to these nearby surface water bodies. The ingestion exposure pathways for surface water and sediment are potentially complete for residents and recreational users of the East Branch Au Sable River and the private lakes (e.g., swimming and fishing).

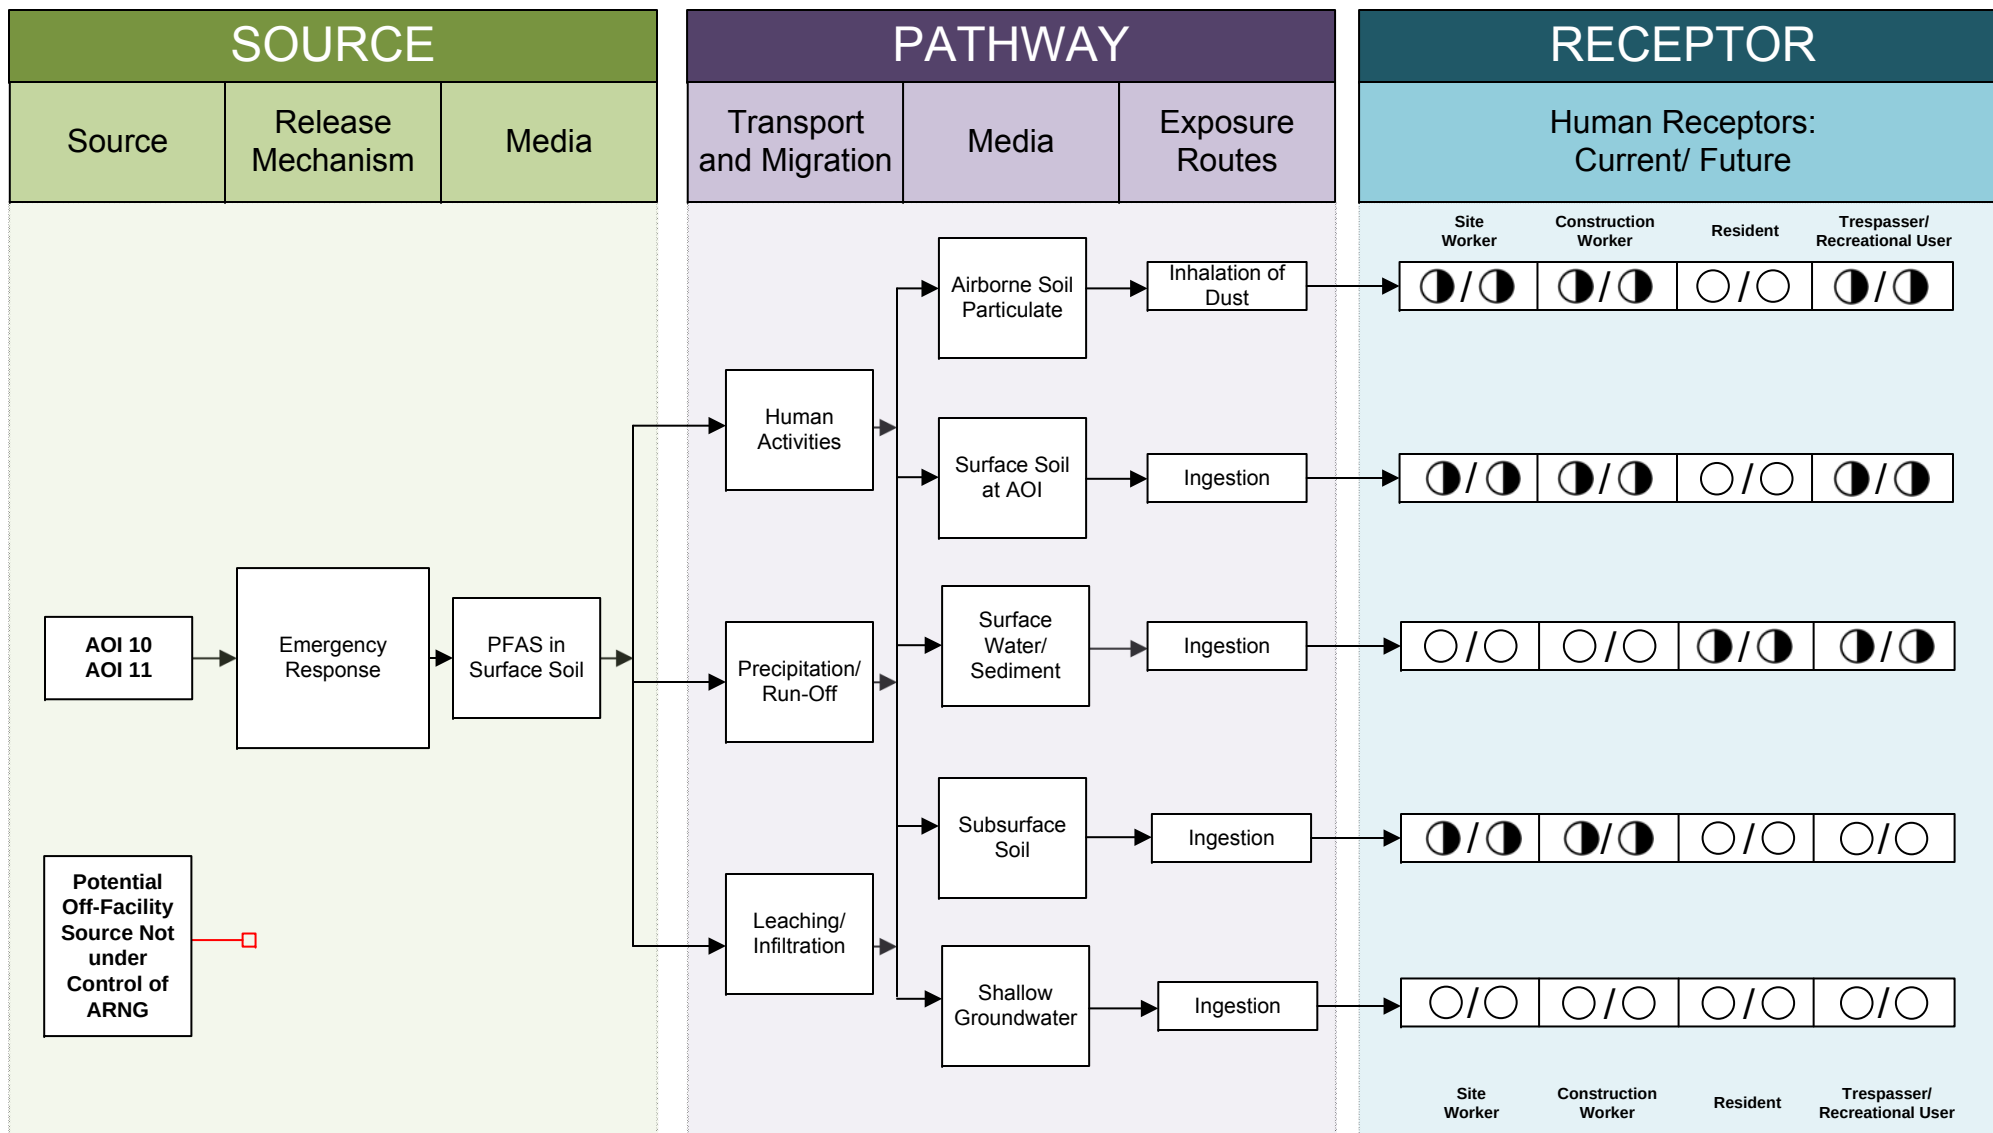
**Figure 6-8**  
 Conceptual Site Model  
 AOI 10 & AOI 11 Range 8 and Small Arms Ranges

Located in the northern portion of the South Post, Range 8 drains to the north towards a large forested/shrub wetland area that ultimately drains to Portage Creek, a tributary of the Manistee River. Potential PFAS contamination from the range may have infiltrated shallow groundwater and migrated north towards the wetland and potentially Portage Creek which drains Lake Margrethe. The ingestion exposure pathways for surface water and sediment are potentially complete for residents and recreational users of the Portage Creek (e.g., swimming and fishing).

The Small Arms Ranges AOI is less than 1 mile to the west of Lake Margrethe and is located within a topographical low point between two hill systems to the north and south that have an approximate 100 foot elevation difference from their peaks down to AOI 11. Shallow groundwater likely flows in an easterly direction towards the western area of the cantonment and the lake. Potential PFAS contamination from the range may have infiltrated shallow groundwater and migrated towards Lake Margrethe. The ingestion exposure pathways for surface water and sediment are potentially complete for residents and recreational users (e.g., swimming and fishing) of Lake Margrethe (see **Section 6.4.6** for discussion of Lake Margrethe AOI).

One potable well is located downgradient of the AOI, immediately adjacent to Lake Margrethe on-facility. This well was tested by the MIARNG and found to have detections of PFAS; the well is not in use and is scheduled to be abandoned according to the Camp Grayling Environmental Quality Specialist. Therefore, the ingestion exposure pathway for groundwater is incomplete for the Small Arms Range AOI. AOI 11 is shown on **Figure 6-7** and the CSM is presented on **Figure 6-8**.

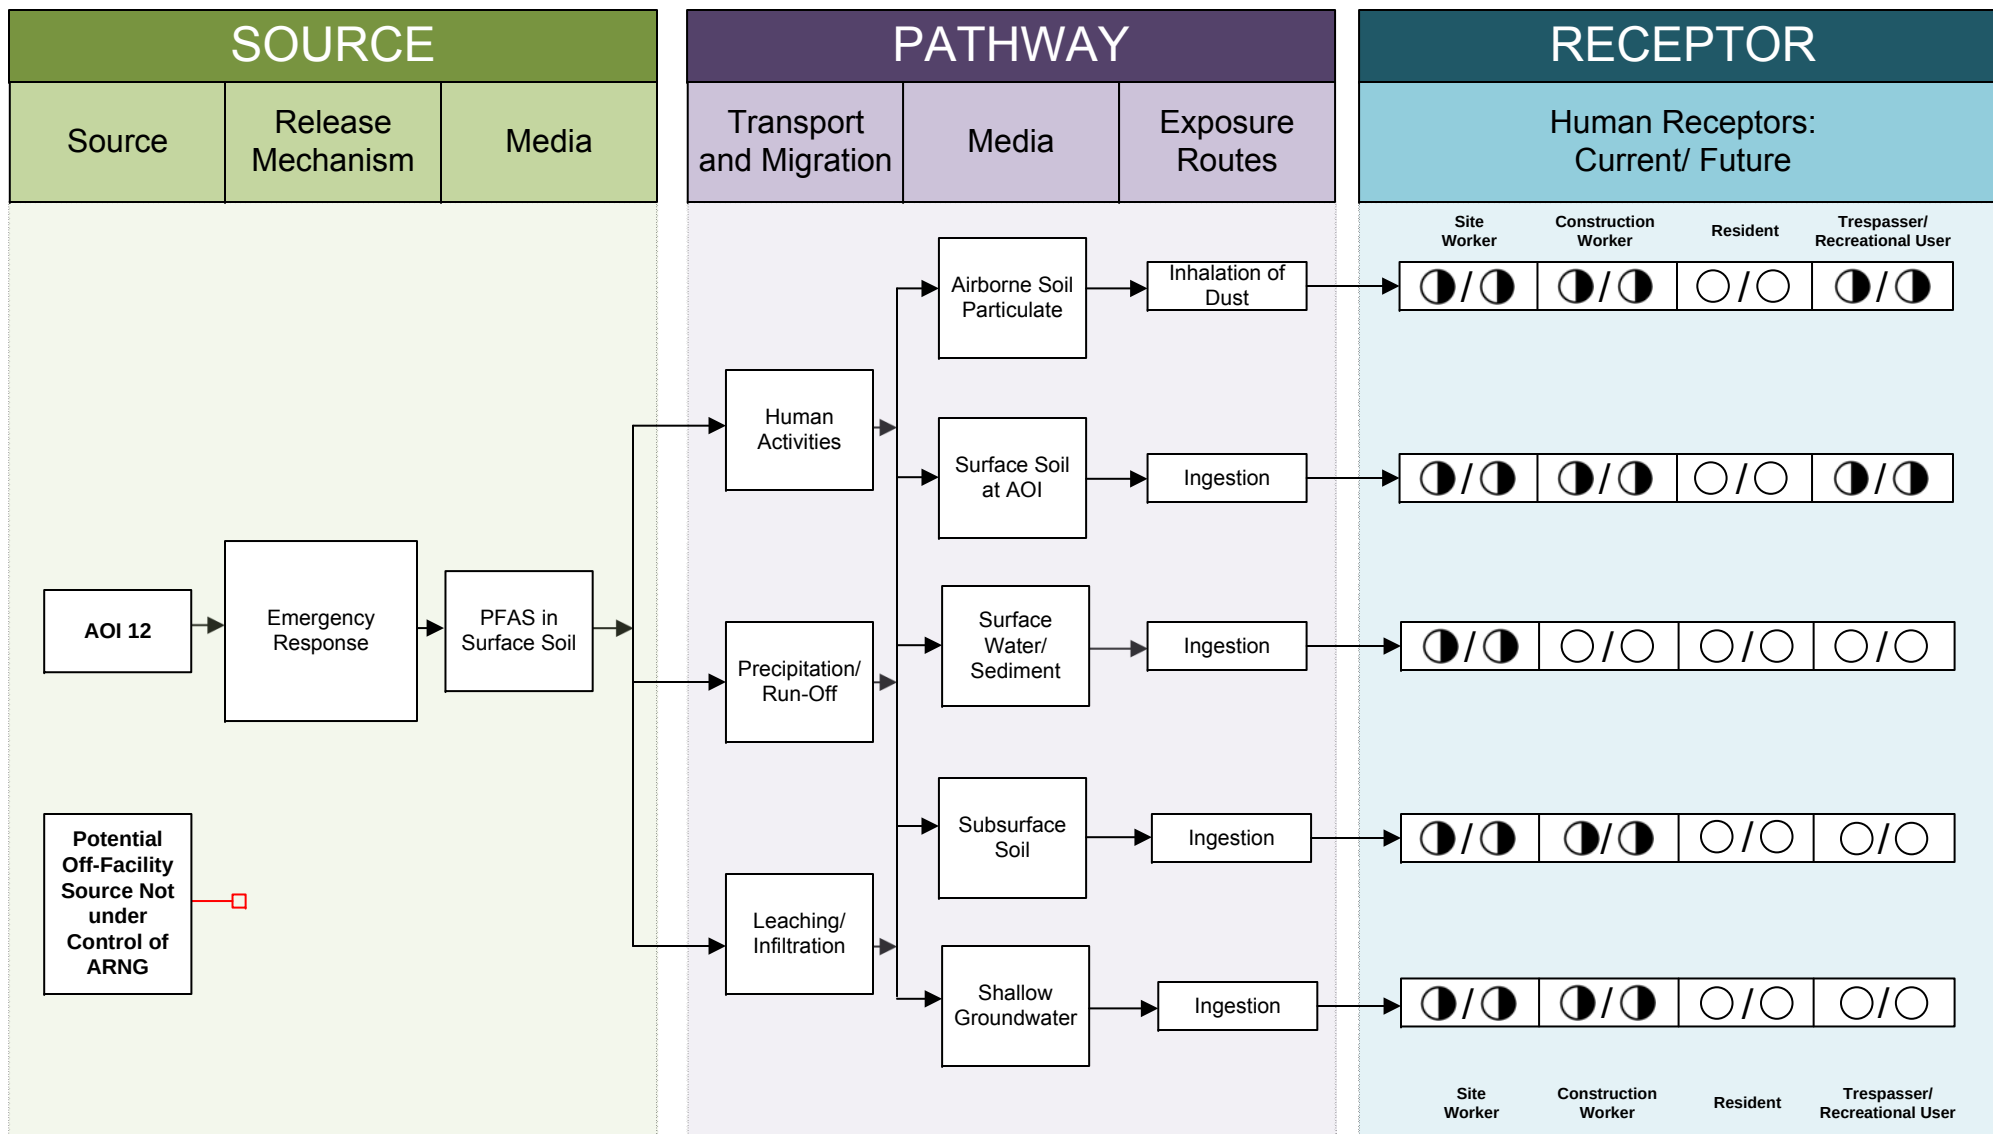
**Figure 6-9**  
 Conceptual Site Model  
 AOI 12 Light Demolition Ranges

have infiltrated shallow groundwater and migrated to these ponds. Due to size and restricted access, recreational users are unlikely at these ponds, however, if future training activities are conducted at the ponds (i.e., bridging) the ingestion exposure pathways for surface water and sediment are potentially complete for site workers.

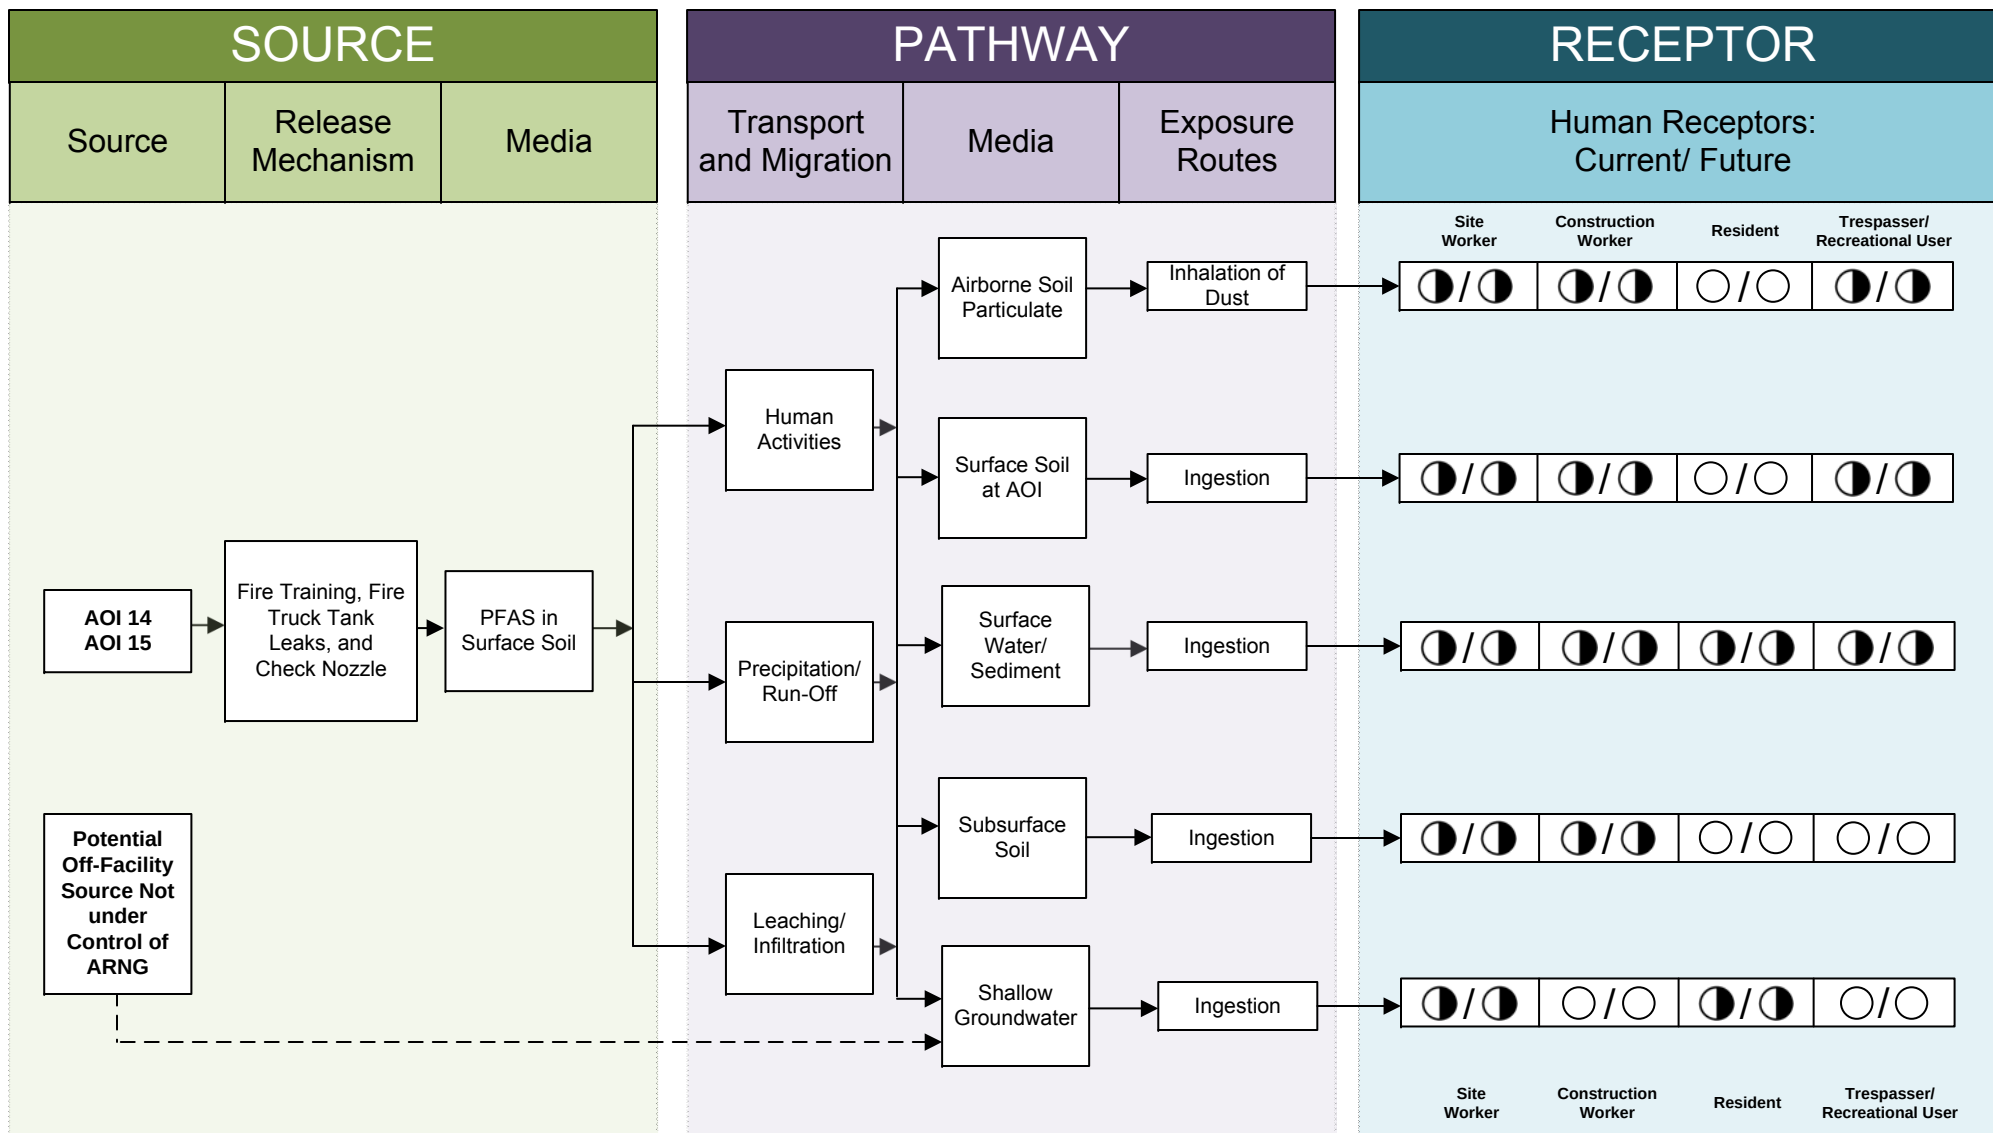
**Figure 6-12**  
Conceptual Site Model  
AOI 14 & AOI 15 East & West Cantonment

The East Cantonment AOI is located immediately adjacent to Lake Margrethe. Groundwater flows to the west and discharges to the lake. Potential PFAS contamination from the cantonment may have infiltrated shallow groundwater and migrated to the lake. The ingestion

The West Cantonment AOI is located immediately adjacent to Lake Margrethe. Groundwater flows to the north and northeast towards an unnamed stock pond that connects to Lake Margrethe. Potential PFAS contamination from the cantonment may have infiltrated shallow groundwater and migrated to the pond and lake. The ingestion exposure pathways for surface water and sediment are complete for site workers, construction workers, residents, trespassers, and recreational users of Lake Margrethe (e.g., swimming and fishing).

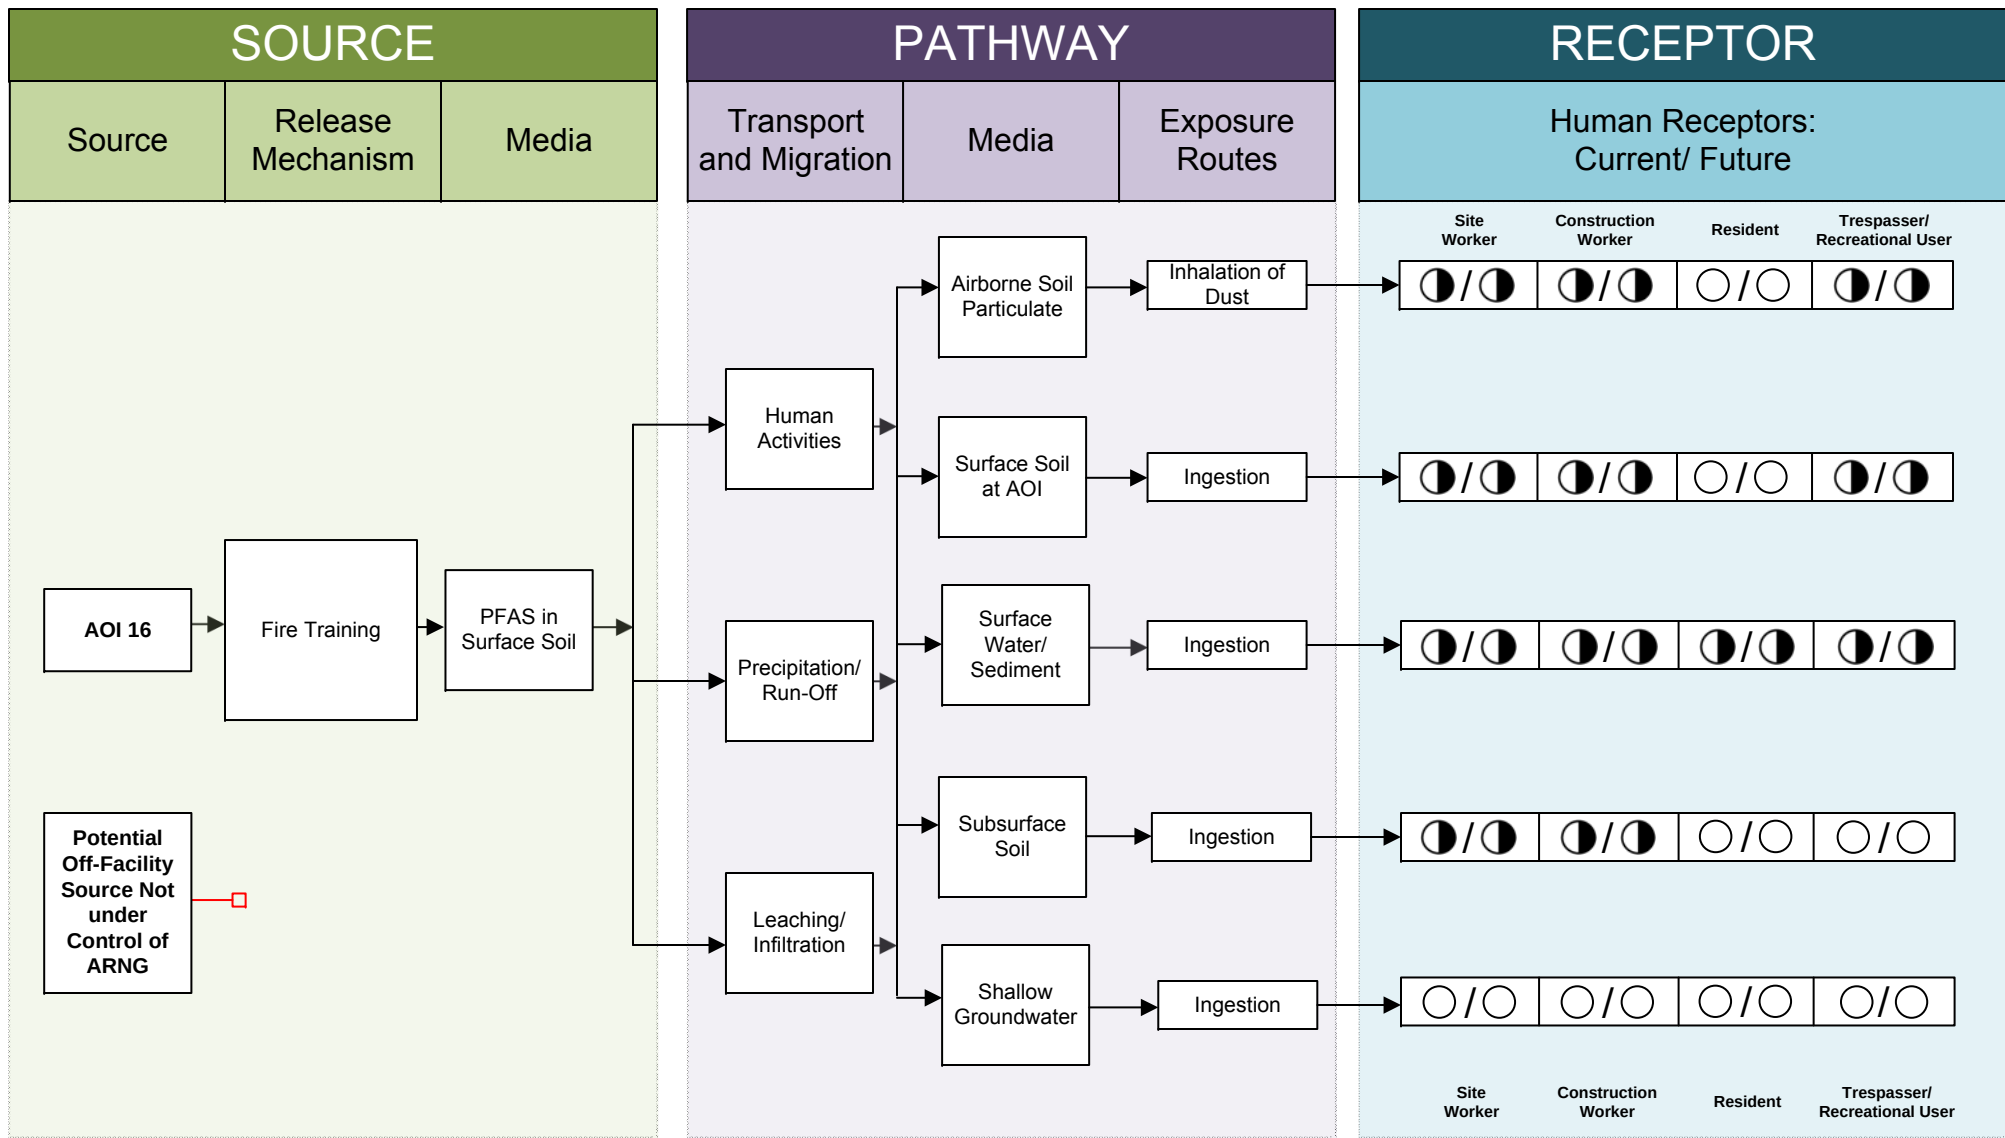
**Figure 6-13**  
Conceptual Site Model  
AOI 16 Wilson Hill

No surface water bodies are present within the AOI; Lake Margrethe is located approximately 0.5 miles to the northwest. Groundwater likely flows in a northwesterly direction towards the lake. Potential PFAS contamination from training activities may have infiltrated shallow groundwater and migrated towards the lake. The ingestion exposure pathways for surface water and sediment are potentially complete for site workers, construction workers, residents, trespassers, and recreational users of Lake Margrethe (e.g., swimming and fishing).
