# FINAL Preliminary Assessment Report Camp Grayling, Michigan

Perfluorooctane-Sulfonic Acid (PFOS) and Perfluorooctanoic  
Acid (PFOA) Impacted Sites  
ARNG Installations, Nationwide

August 2018

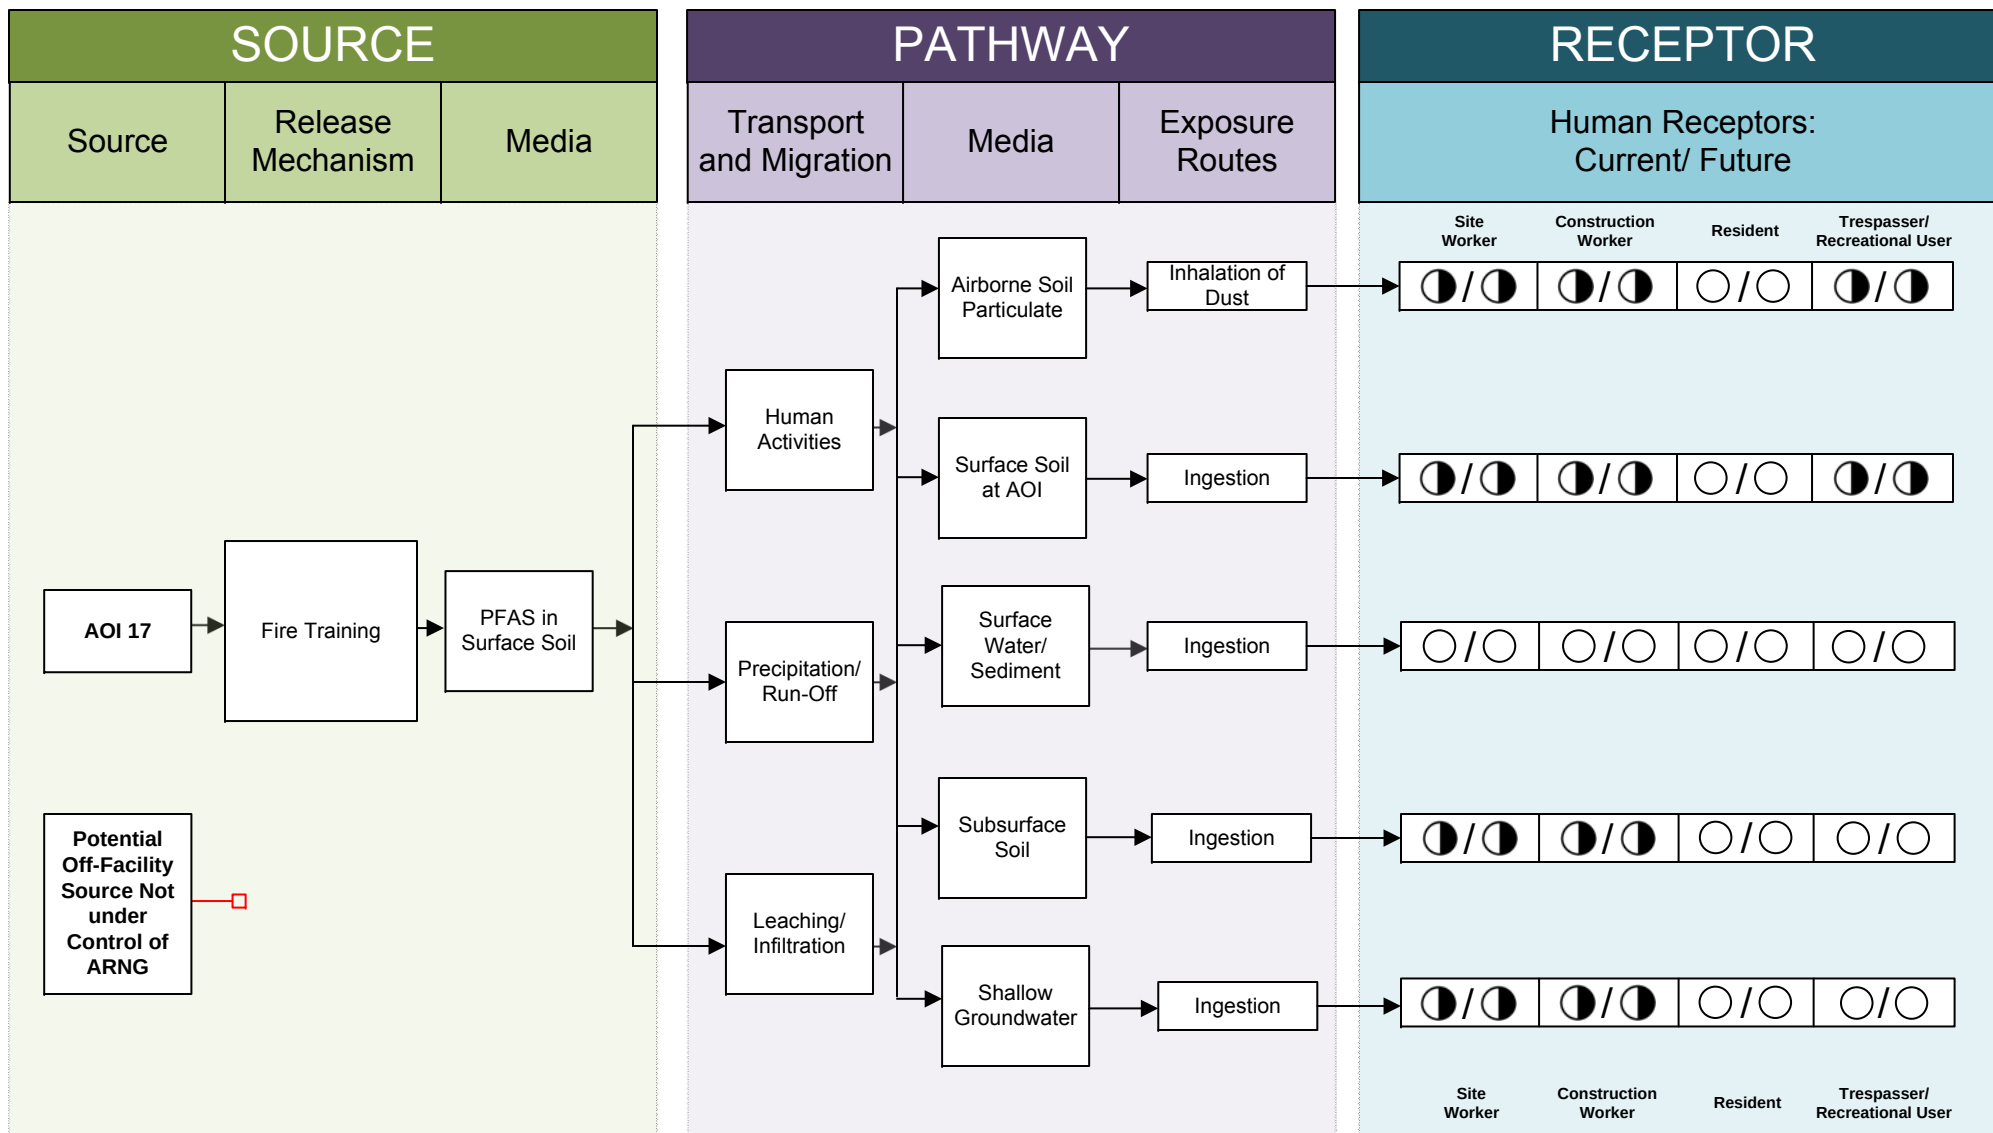
**Figure 6-14**  
 Conceptual Site Model  
 AOI 17 Former Ammunition Storage Plant

No surface water bodies are present within the AOI; Lake Margrethe is located approximately 1 mile to the north, past Wilson Hill. Groundwater likely flows in a predominantly northern direction towards the lake; however, shallow groundwater may be influenced by local topographical features, namely Wilson Hill, and flow in a northwesterly direction. Although potential PFAS contamination from training activities may have infiltrated shallow groundwater and migrated in the direction of the lake, due to topographical influences and the distance to the lake from the potential source area, surface water and sediment pathways are considered incomplete for AOI 17.

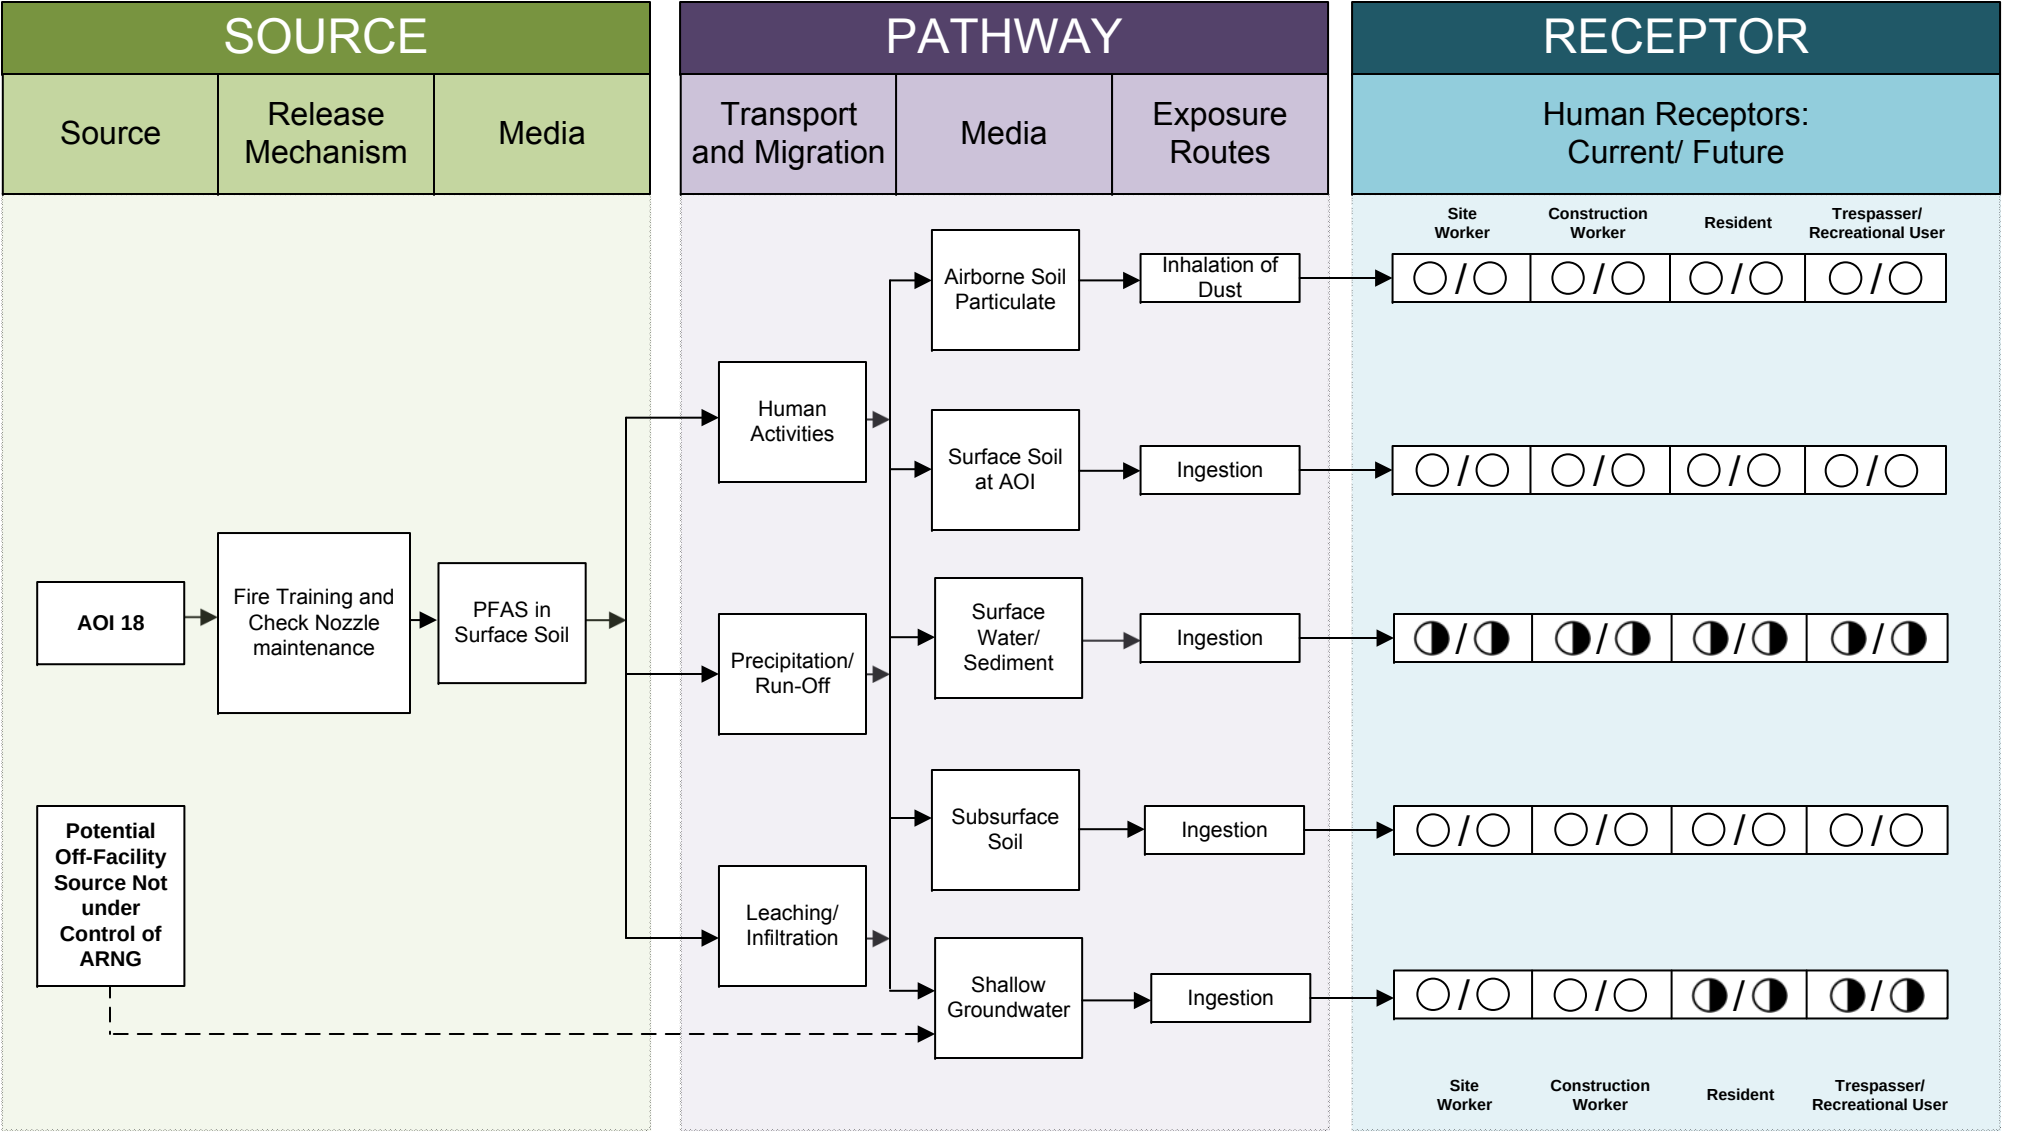
**Figure 6-15**  
Conceptual Site Model  
AOI 18 Lake Margrethe

AFFF was potentially released into Lake Margrethe during check nozzle maintenance activities. Additionally, PFAS contamination, from other potential releases of AFFF within the cantonment, may have infiltrated shallow groundwater and migrated to Lake Margrethe.

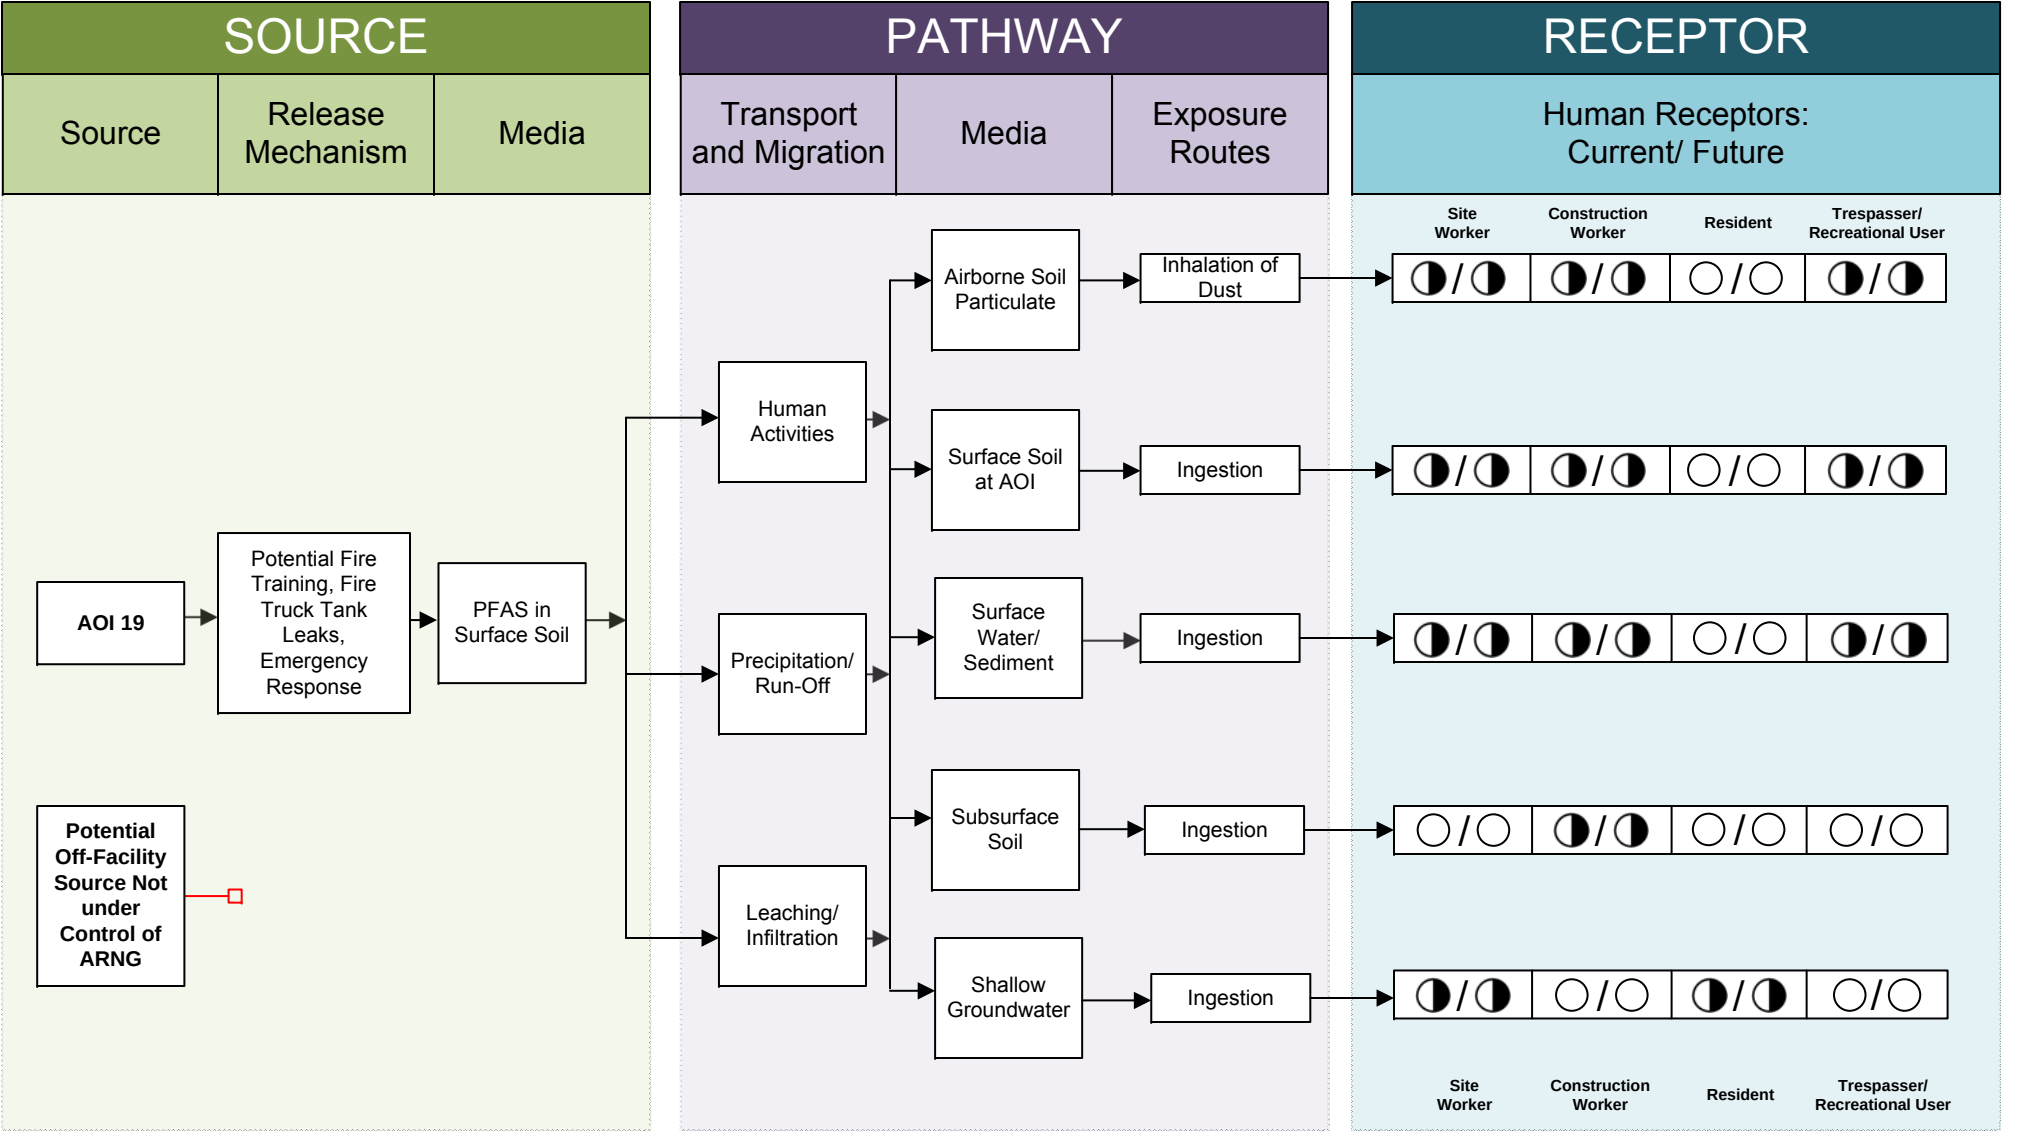
**Figure 6-17**  
Conceptual Site Model  
AOI 19 Howes Lake

The AOI is located along the southwestern shore of Howes Lake. Groundwater likely flows in a general west to southwest direction towards a large freshwater forested shrub wetland and the Manistee River. Because there is uncertainty regarding the location of training, surface water and sediment at Howes Lake may also have been affected. The ingestion exposure pathways for surface water and sediment are potentially complete for site workers, construction workers, trespassers, and recreational users of Lake Margrethe (e.g., swimming and fishing).

According to the MDEQ Wellogis database, several Type I public wells, associated with the Shawono Center, are located immediately to the east (upgradient) of the Howes Lake AOI. The closest downgradient residential wells are located approximately 1.2 miles to the west of the AOI. The ingestion exposure pathway for groundwater is potentially complete for site workers and residents at the Shawono Center. AOI 19 is shown on **Figure 6-16** and the CSM is presented on **Figure 6-17**.
